The Americold facility located at 240 Chester Street, St. Paul, Minnesota was inspected for asbestos containing materials. The materials found to contain asbestos are listed below:

CENTER OFFICE ABOVE DOCK
ASBESTOS INSPECTION FOR
AMERICOLD
240 CHESTER STREET
ST. PAUL, MINNESOTA 55107

RES Project #: 12237
Date: 09/11/2012
SHEET
A2
OF 2 SHEETS

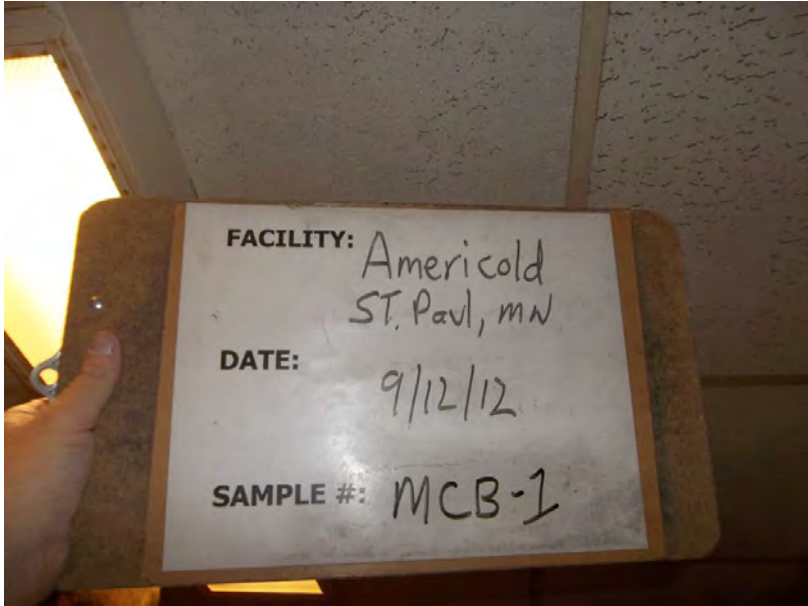
MCB-1

MCB – 2' X 2' ceiling tile, fissures and pinholes, located in the north dock office contains 3% chrysotile asbestos as analyzed by Polarized Light Microscopy. This miscellaneous material was friable and in good condition at the time of sampling.

2' X 2' CEILING TILE, FISSURES AND PINHOLES

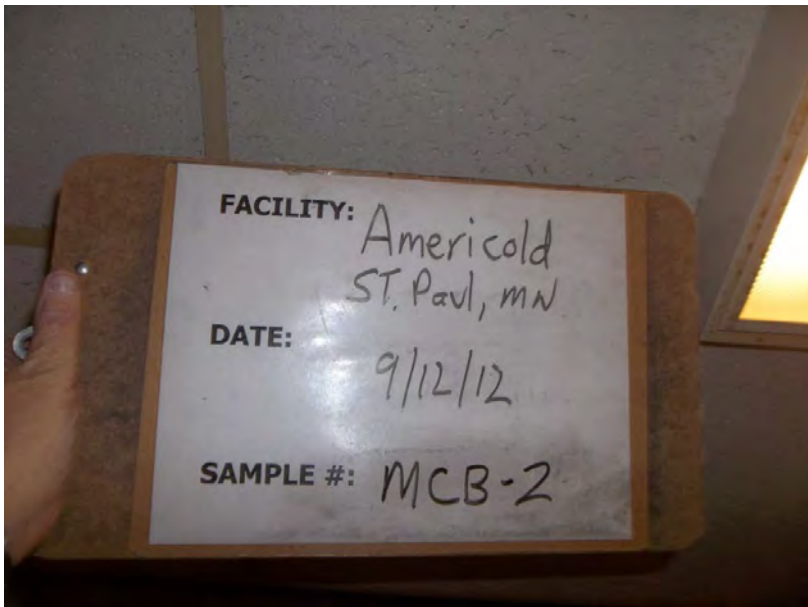
MCB-2

2' X 2' CEILING TILE, FISSURES AND PINHOLES

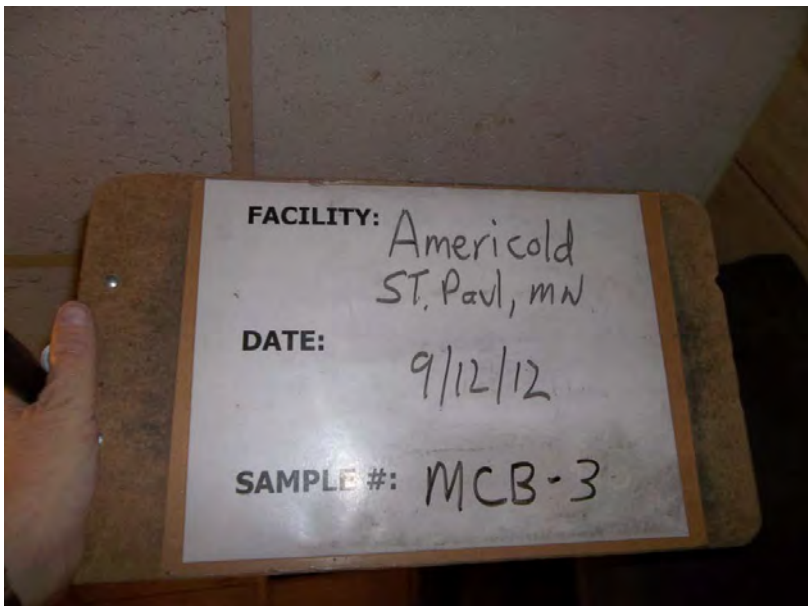
MCB-3

2' X 2' CEILING TILE, FISSURES AND PINHOLES

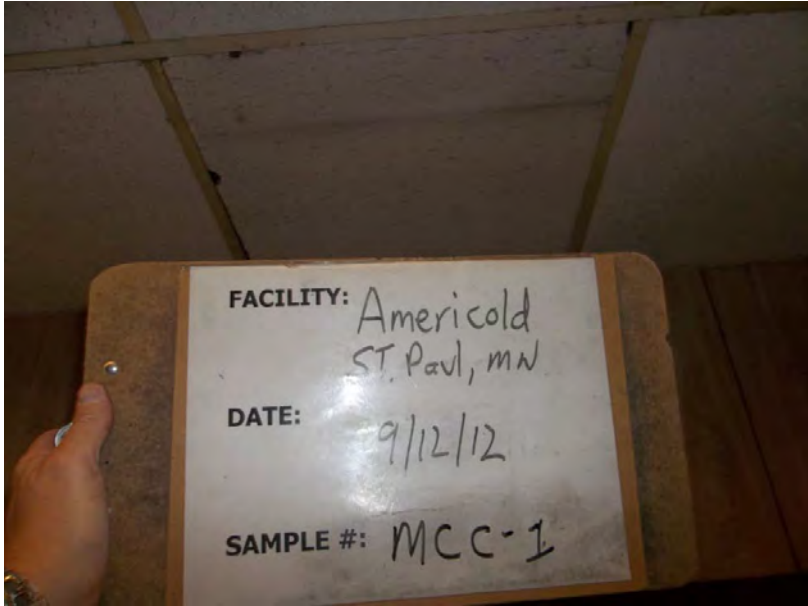
MCC-1

2' X 2' CEILING TILE, DEEP FISSURES
AND PINHOLES

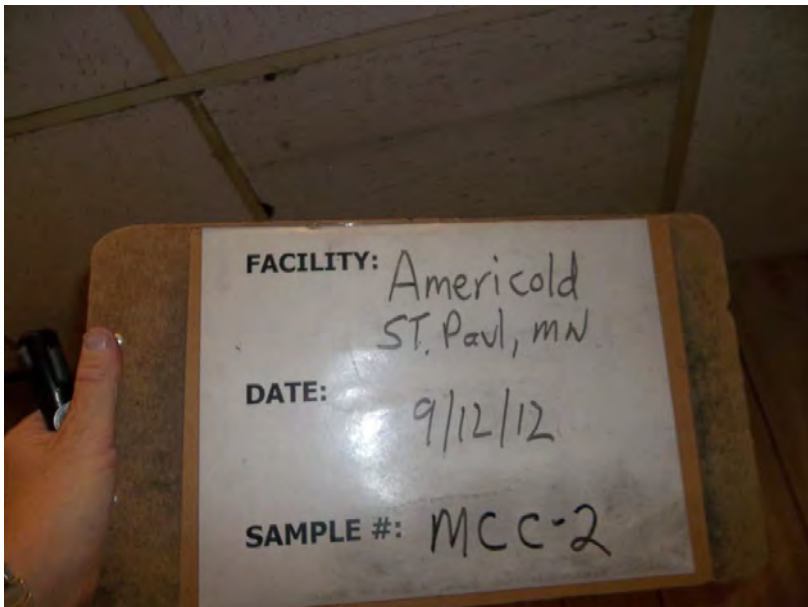
MCC-2

2' X 2' CEILING TILE, DEEP FISSURES
AND PINHOLES

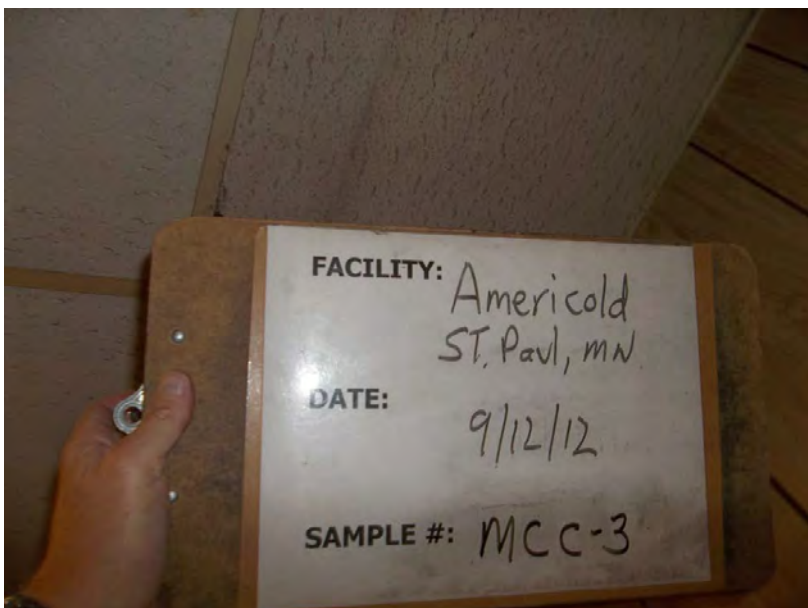
MCC-3

2' X 2' CEILING TILE, DEEP FISSURES
AND PINHOLES

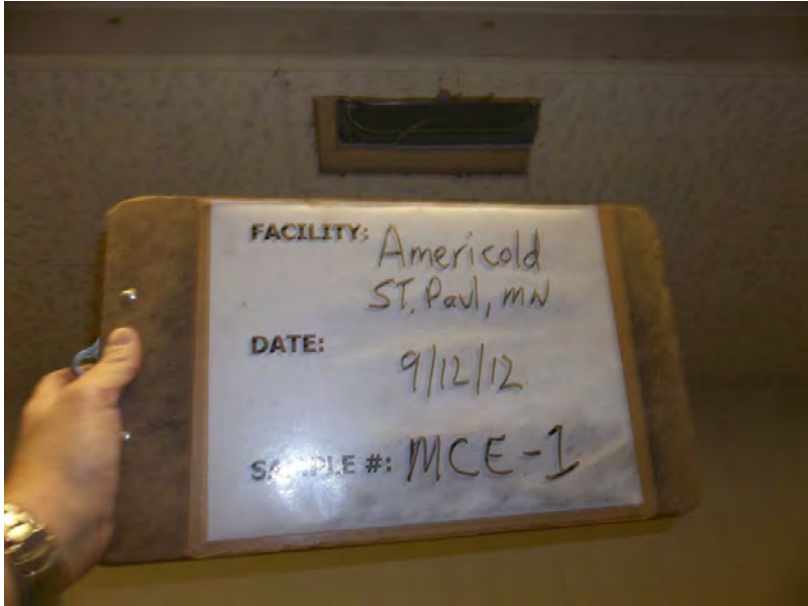
MCE-1

1' X 1' CEILING TILE, SPLINED, FISSURES AND PINHOLES

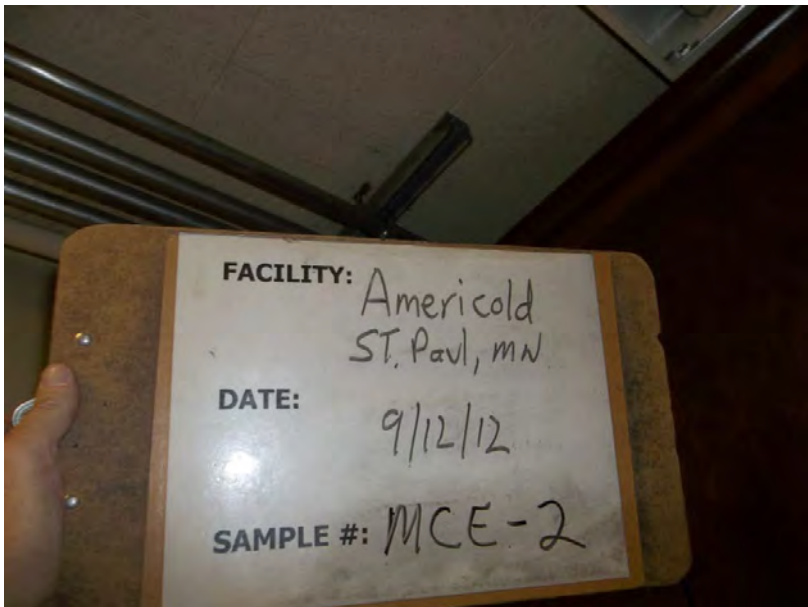
MCE-2

1' X 1' CEILING TILE, SPLINED, FISSURES AND PINHOLES

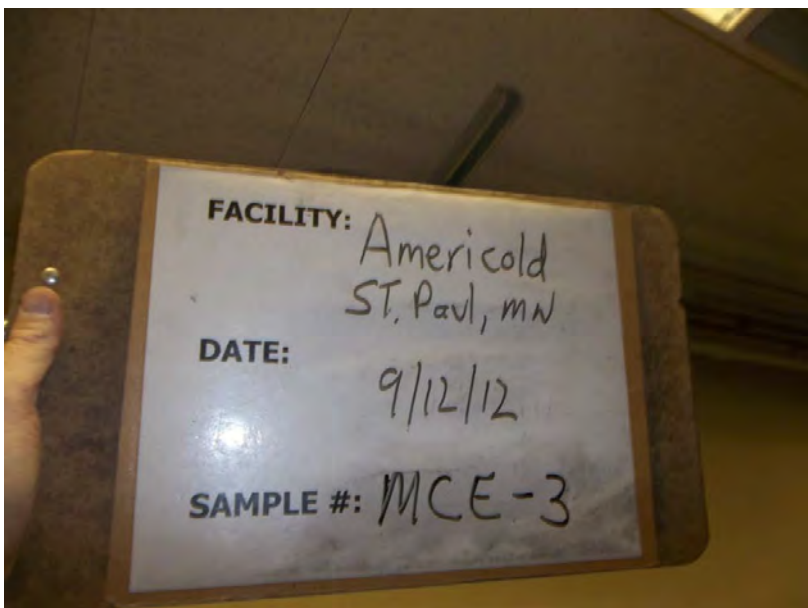
MCE-3

1' X 1' CEILING TILE, SPLINED, FISSURES AND PINHOLES

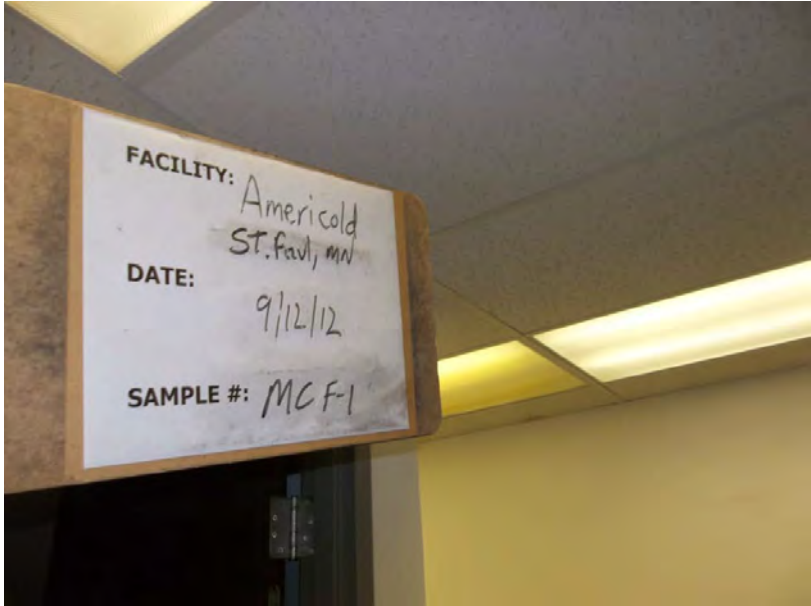
MCF-1

2' X 4' CEILING TILE, LONG FISSURES
AND PINHOLES

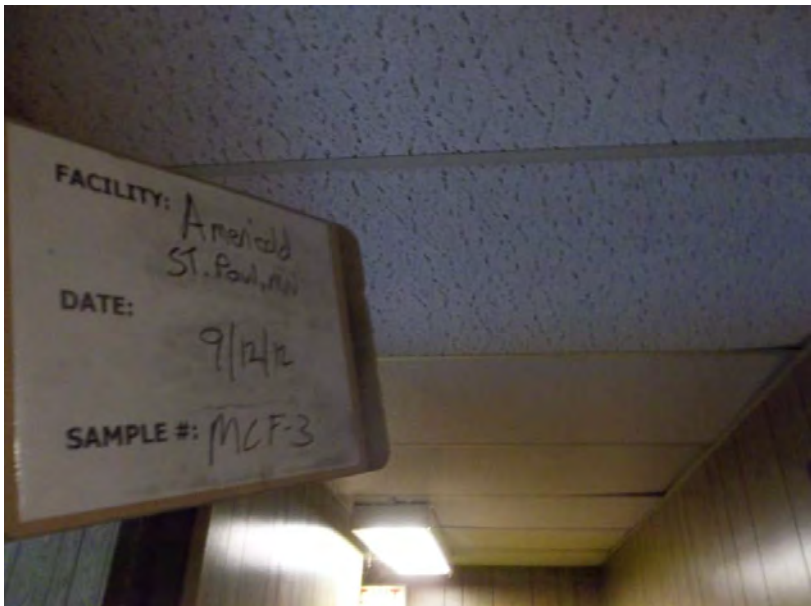
MCF-3

2' X 4' CEILING TILE, LONG FISSURES
AND PINHOLES

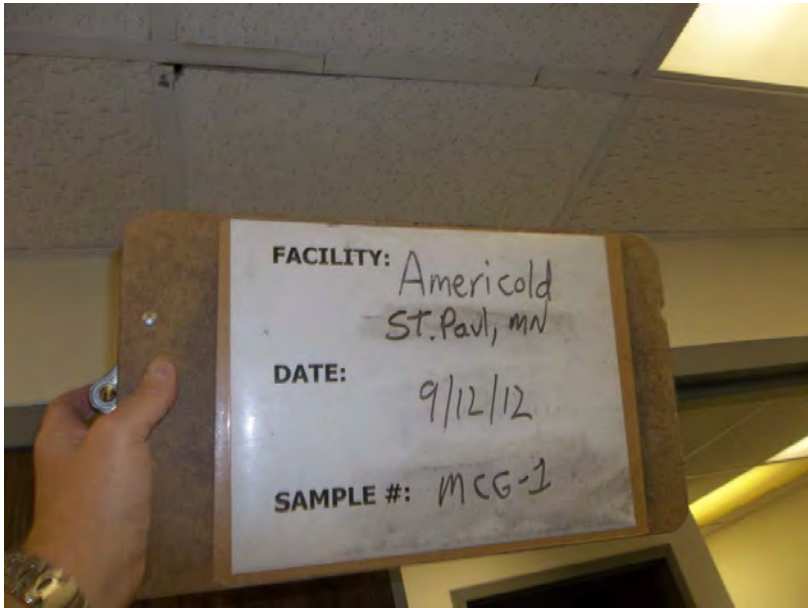
MCG-1

2' X 4' CEILING TILE, SMALL FISSURES AND PINHOLES

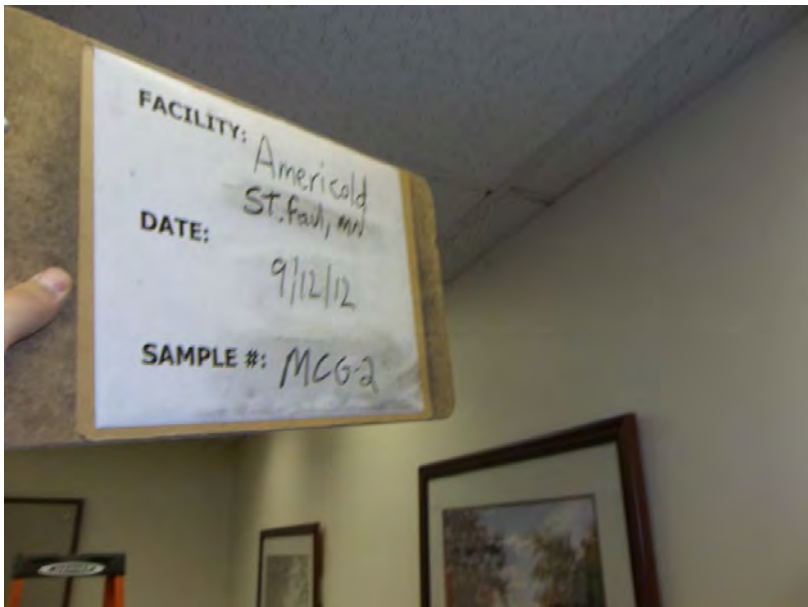
MCG-2

2' X 4' CEILING TILE, SMALL FISSURES AND PINHOLES

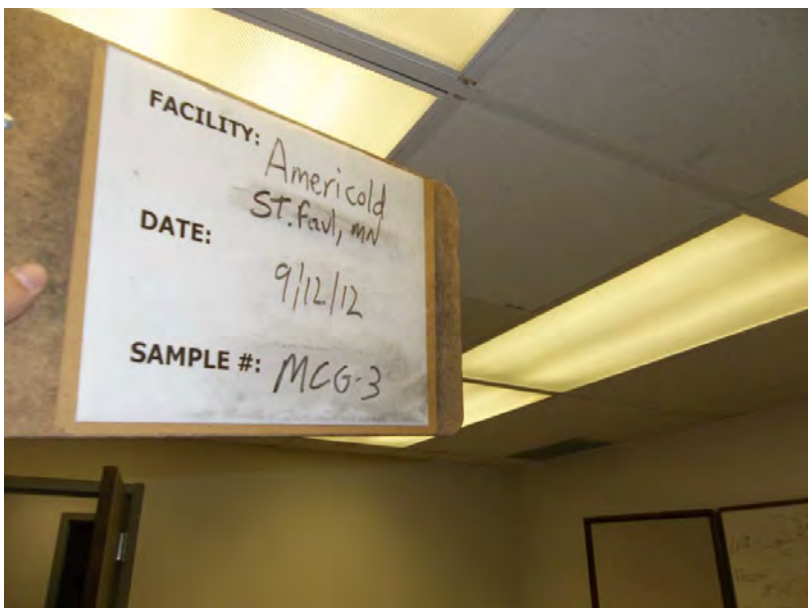
MCG-3

2' X 4' CEILING TILE, SMALL FISSURES AND PINHOLES

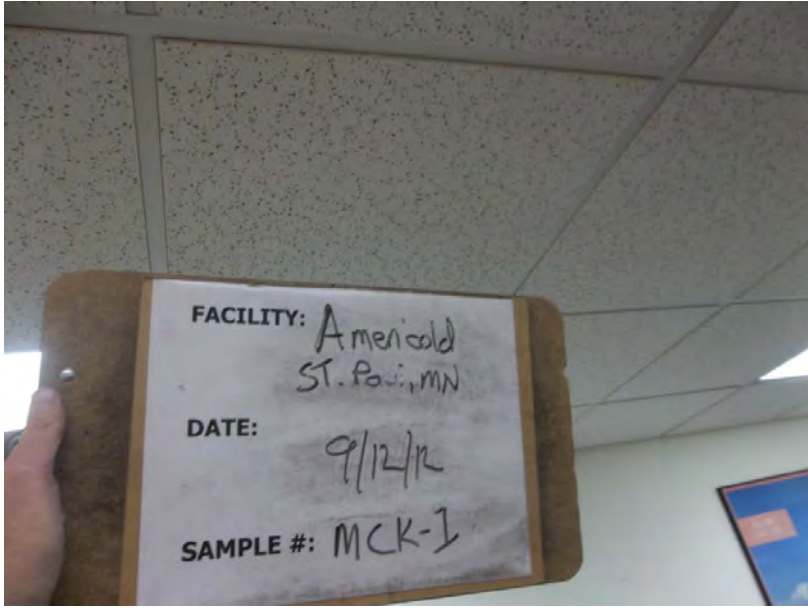
MCK-1

2' X 2' CEILING TILE, FISSURES AND PINHOLES (RECESSED)

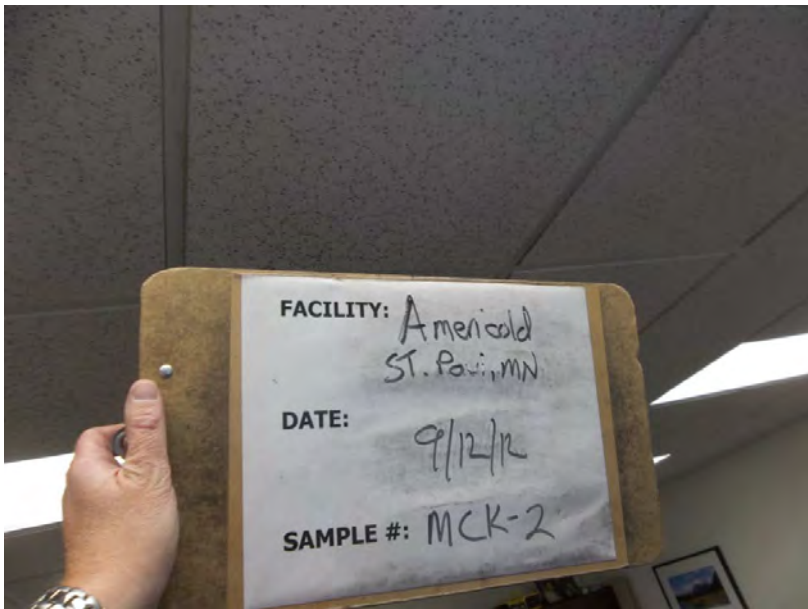
MCK-2

2' X 2' CEILING TILE, FISSURES AND PINHOLES (RECESSED)

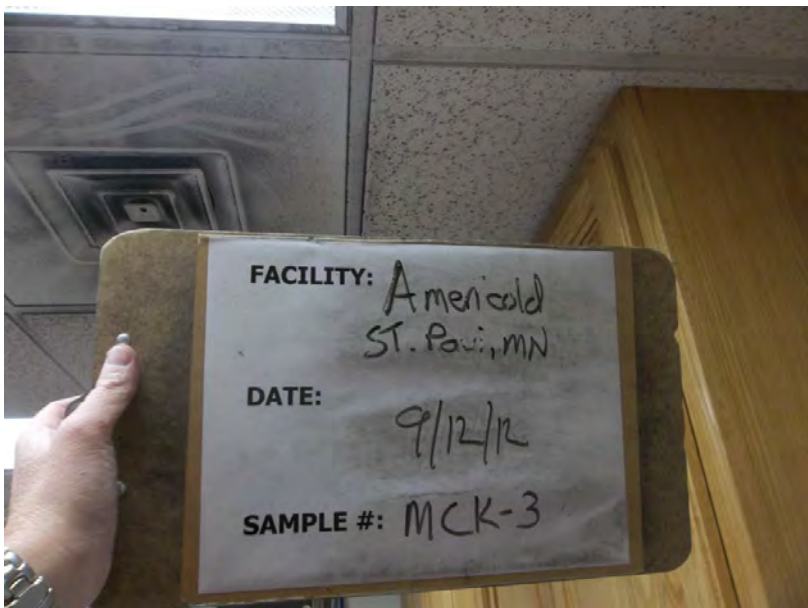
MCK-3

2' X 2' CEILING TILE, FISSURES AND PINHOLES (RECESSED)

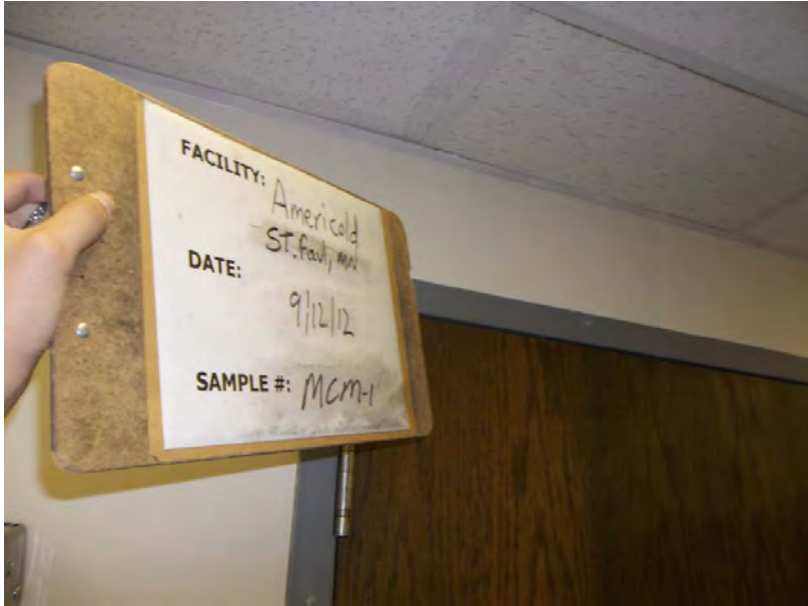
MCM-1

2' X 4' CEILING TILE, FISSURES AND PINHOLES

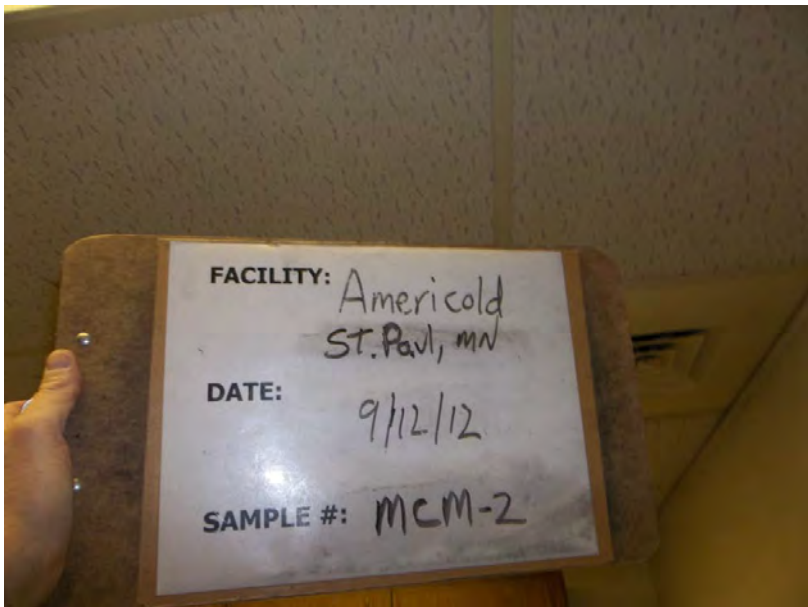
MCM-2

2' X 4' CEILING TILE, FISSURES AND PINHOLES

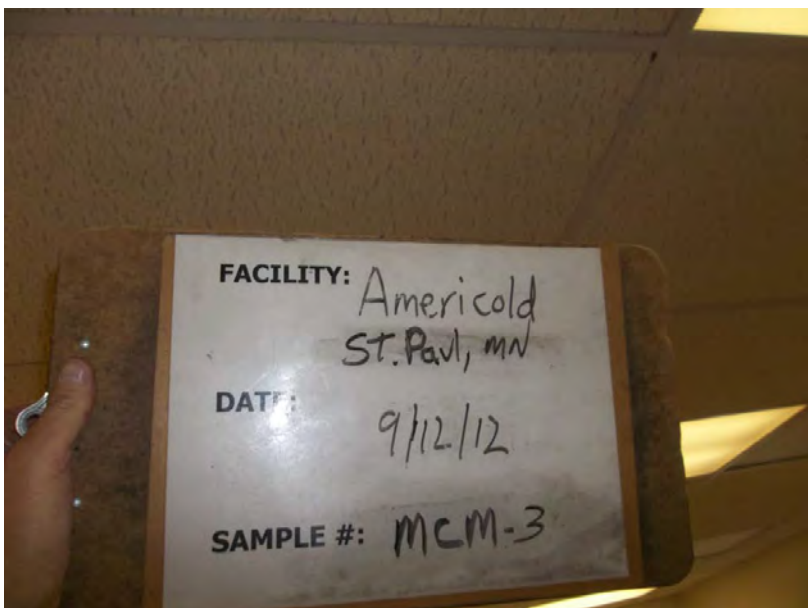
MCM-3

2' X 4' CEILING TILE, FISSURES AND PINHOLES
