548 Minnehaha Ave, St. Paul, MN

Structural Observations and Report

September 20, 2022

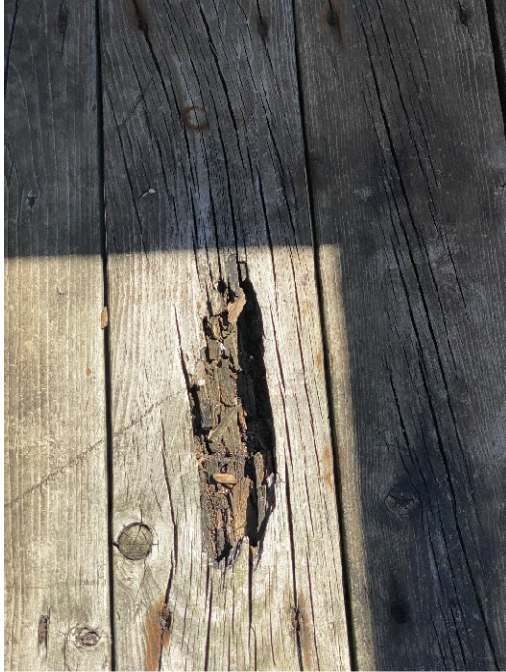
Overall, the condition of the fire escape is poor with many deteriorated and split members. Handrails are loose, several floor boards are deteriorated, and attachments to the house are split and deteriorated.

Example of deteriorated floor board

Recommendation: based on the amount of work needed to bring the fire escape within compliance we recommend it be removed and replaced with an engineered, code compliant, fire escape. This will likely require new framing members, foundations, bracing, and attachments to the home. An architect may be needed to address the egress requirements such as width of the stairs, tread rise and run and landing size. Additionally, the configuration of railings and other miscellaneous guarding will need to be determined.

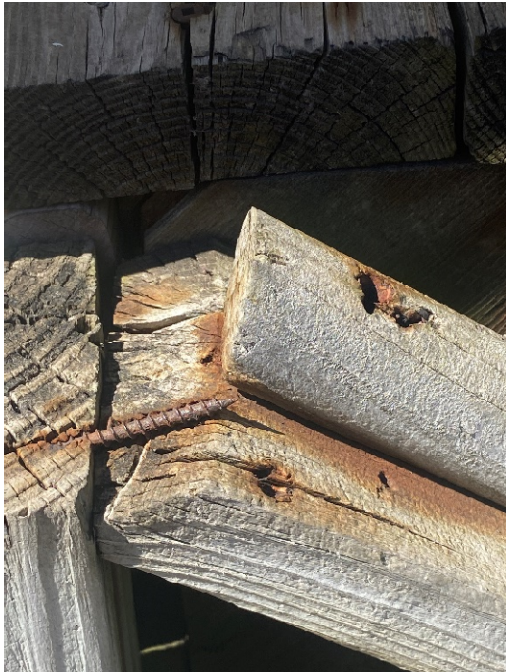
Example of split and loose hand rail

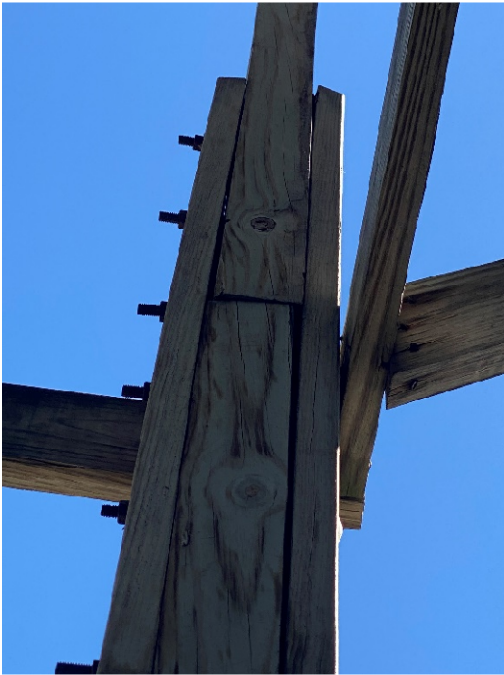
Generally, the quality of construction is also poor. Members are attached without light gage clips, bases, or hangers and the attachment to the home is by screws through the siding.

One of many poorly constructed connections.

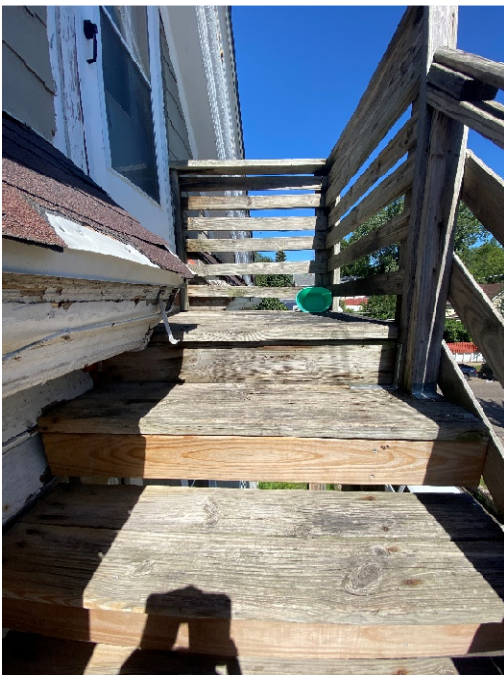
The fire escape serves an attic space and as a path of egress may not conform to the many aspects required under the building. This should be further reviewed by the building official or an architect.

Access through this area is constricted and may not conform to the building code.
