August 18, 2022

Mark Younghans
Submitted by email: younghans86@ymail.com

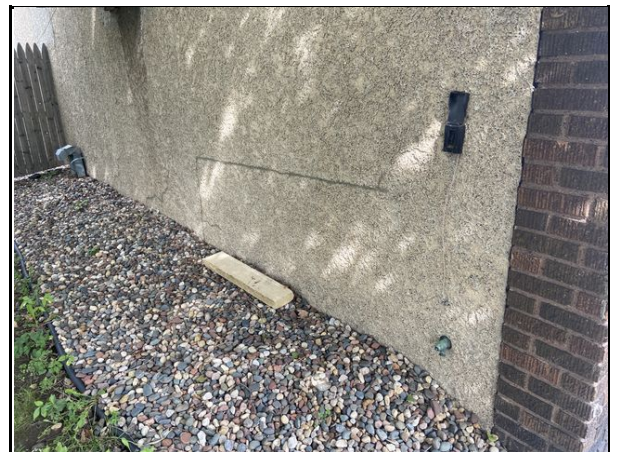
4 No structural issues noted with stucco siding on south side of building.

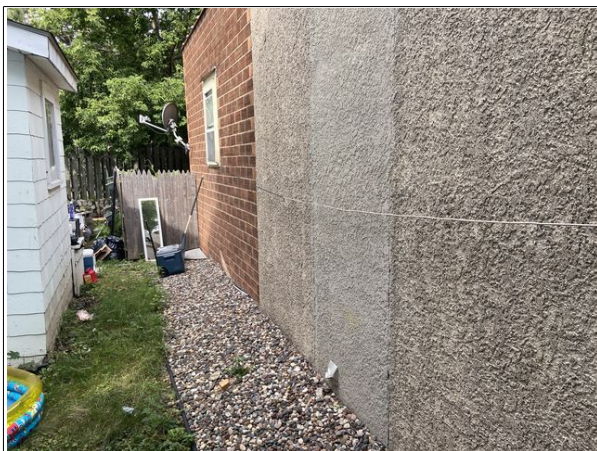
5 No structural issues noted with exterior of building.

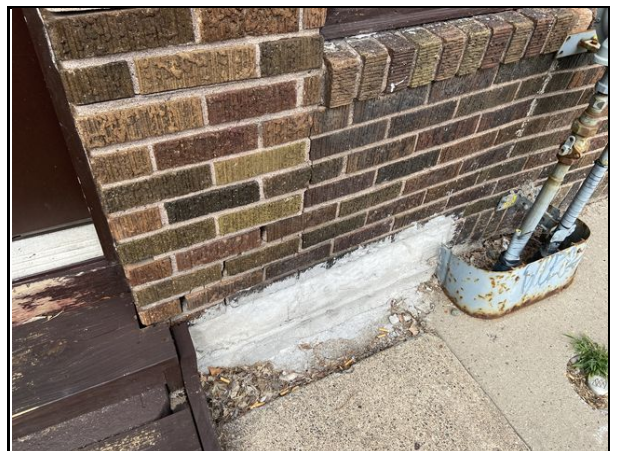
6 Cracks in brick fascia noted near gas line on east side of building.

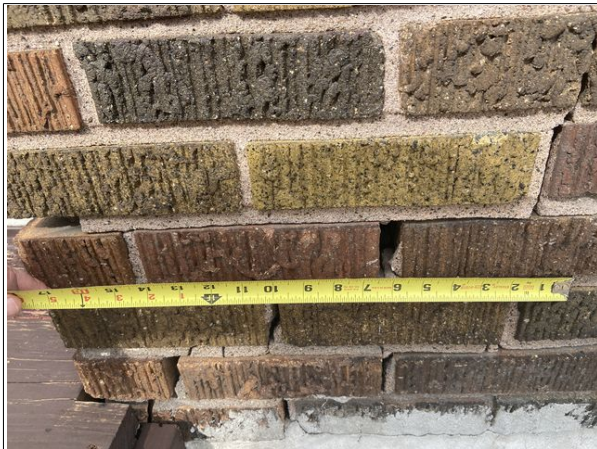
7 Cracks in brick fascia noted near gas line on east side of building. Not a structural concern.

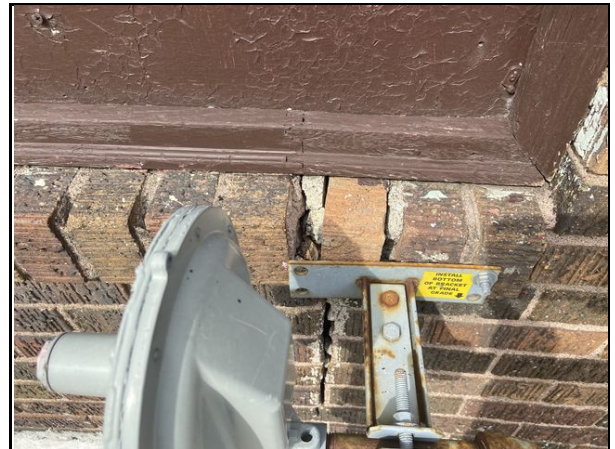
8 Cracks in brick fascia noted near gas line on east side of building. Not a structural concern.

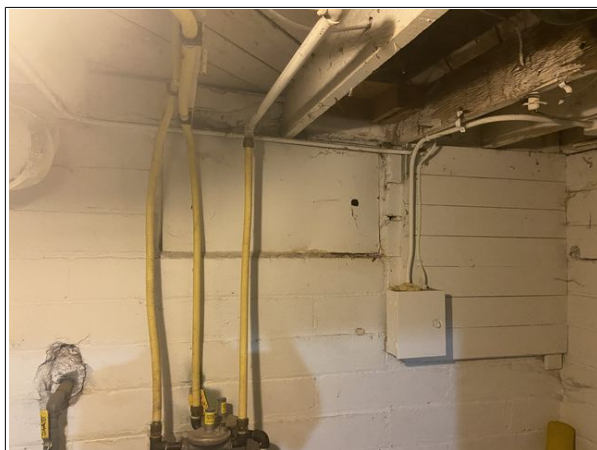
9 No structural issues noted at eastern foundation walls in basement.

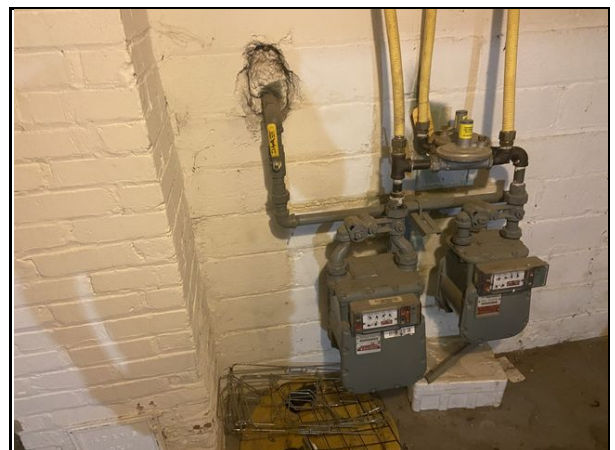
10 No structural issues noted at eastern foundation walls in basement.

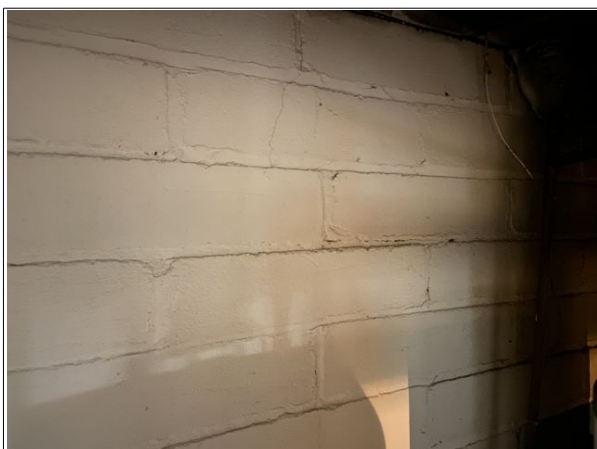
11 No structural issues noted at eastern foundation walls in basement.

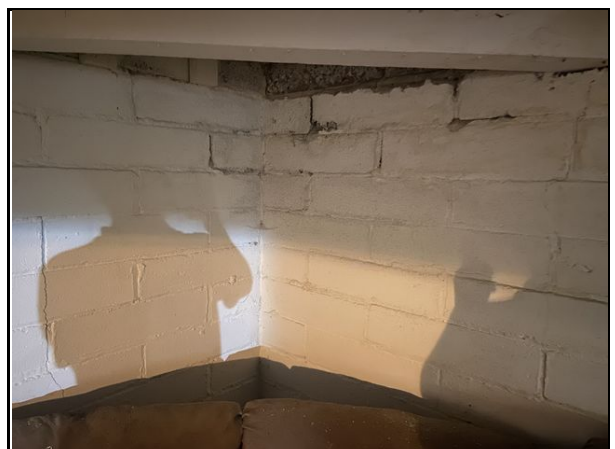
12 Minor cracking at northeast corner of basement not a structural concern.

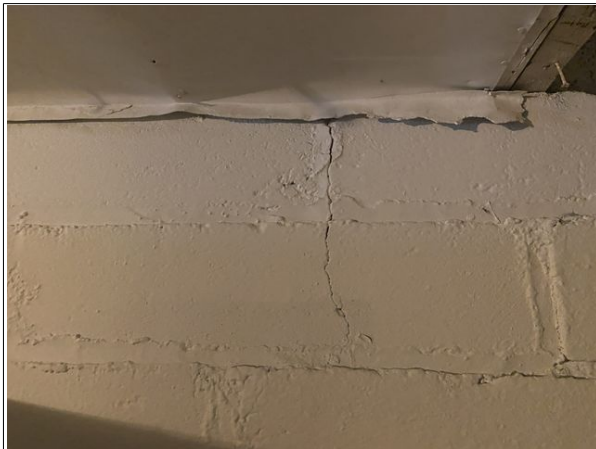
13 Minor crack in eastern basement foundation wall noted. Not a structural concern.

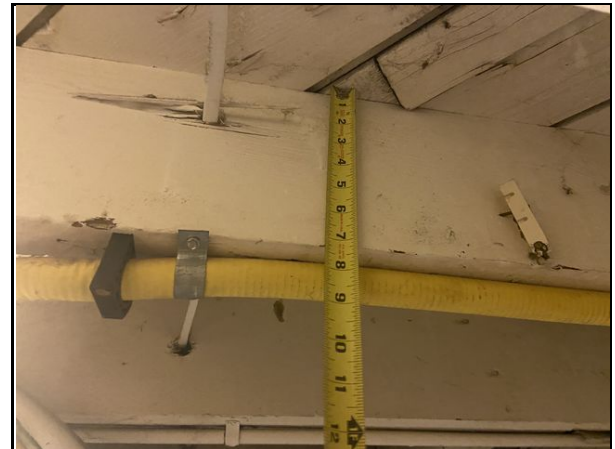
14 First floor joists in overall good condition.

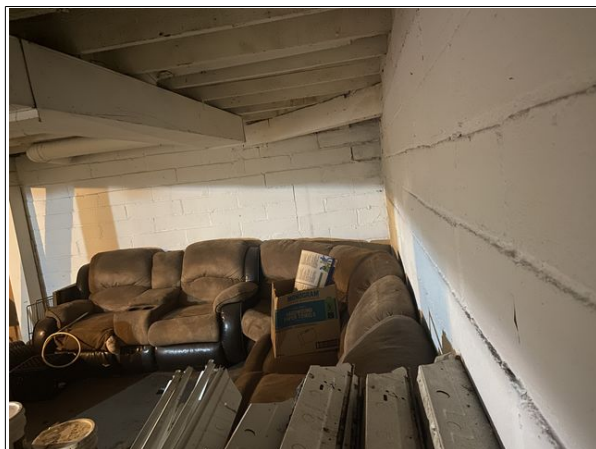
15 No structurally significant displacement noted in eastern foundation wall in basement.

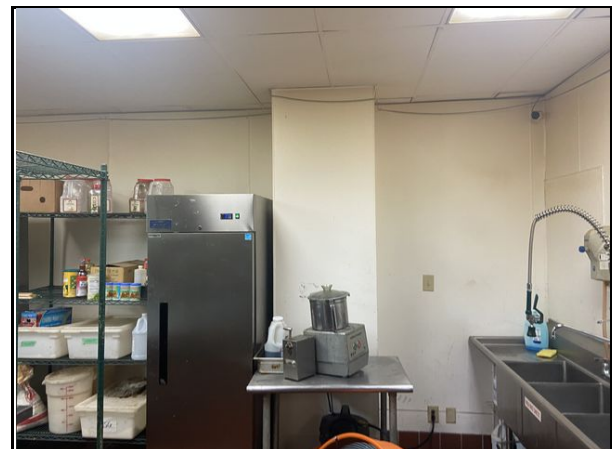
16 No structural issues noted in visible portions of eastern wall of building.

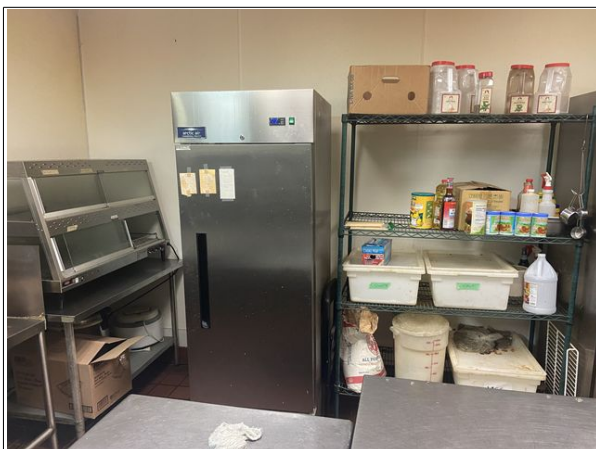
17 No structural issues noted in visible portions of eastern wall of building.

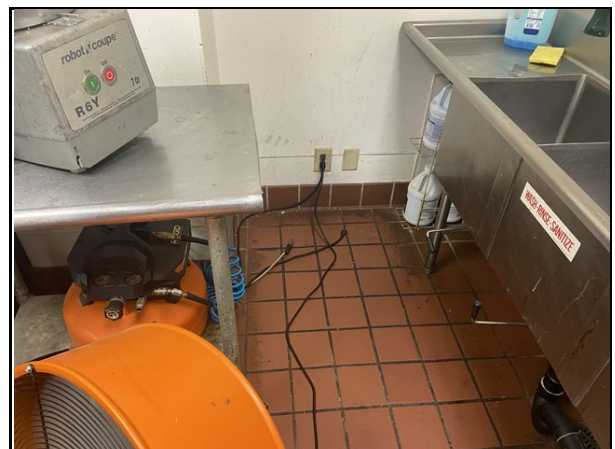
18 No structural issues noted in visible portions of eastern wall of building.

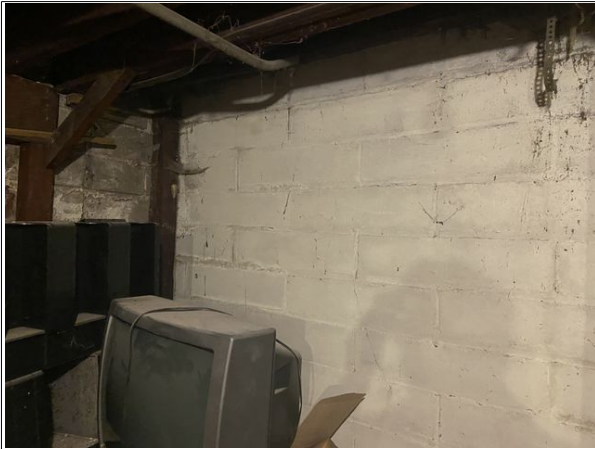
19 No structural issues noted in eastern foundation wall

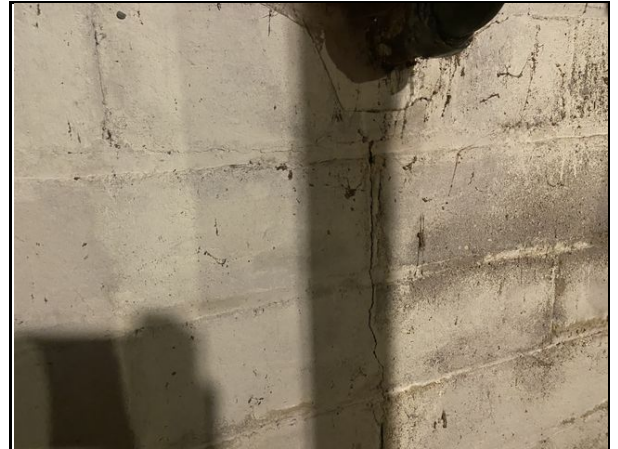
20 Minor crack in eastern basement foundation wall noted. Not a structural concern.

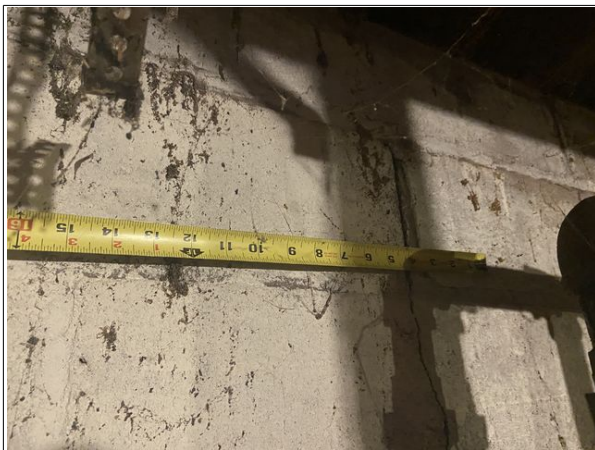
21 Minor crack in eastern basement foundation wall noted. Not a structural concern.

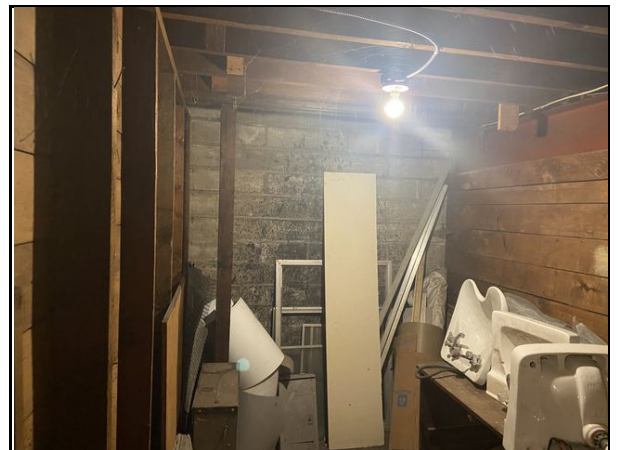
22 No structural issues noted in eastern foundation wall.

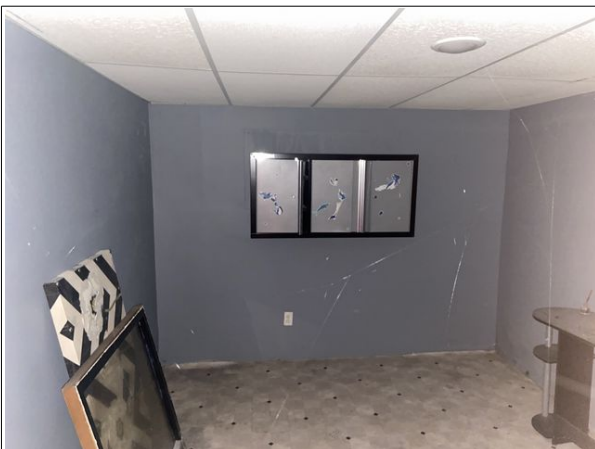
23 No structural issues noted in finished portions of basement.

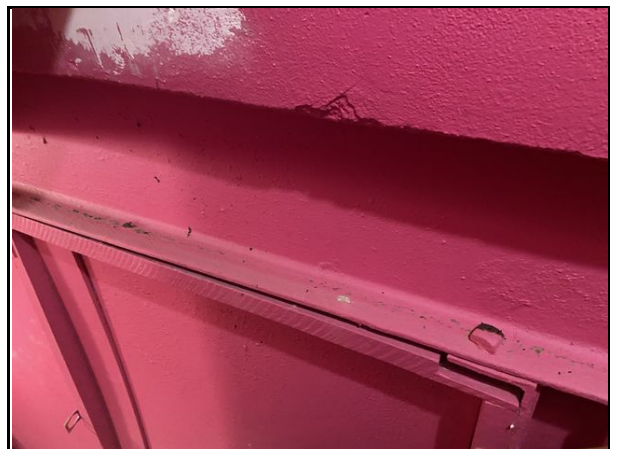
24 Existing framing in basement in good condition.
