September 13, 2021

RE: Request for Appeal: Fire Inspection Correction Notice 35410
Versacold USA LLC /Americold
240 Chester Street
Saint Paul, MN

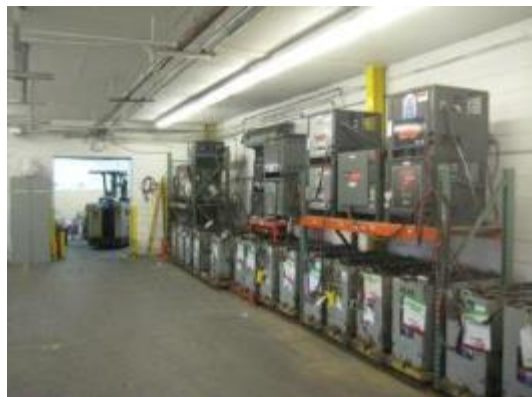
13-03 **Forklift Charging – Ventilation.** Install ventilation over the forklift charging area in accordance with one of the following:

- Provide continuous ventilation over the forklift chargers either with hoods over the chargers similar to the Brooklyn Park facility, or with ventilation located at the ceiling level of the room.
- Provide ventilation over the forklift chargers either with hoods over the chargers similar to the Brooklyn Park facility, or with ventilation located at the ceiling level of the room that is interlocked to hydrogen detection at the ceiling that would activate the ventilation if hydrogen were detected.

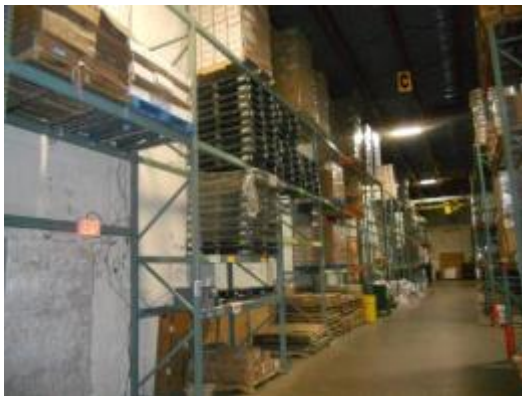
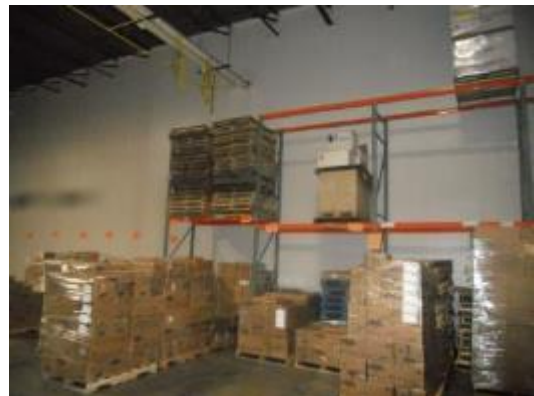
- 16-01 **Idle Pallets Stored in Racks.** The several stacks of idle pallets in the 240 Building freezer warehouse area should be removed from the storage racks. The idle pallets should be stored on the floor outside of the racks to maximum 6 ft. high.

Comments: Idle pallets stored in racks create a severe fire exposure hazard. Pallets should be stored on the floor outside of the racks to reduce the fire exposure in this non-sprinkler protected facility.

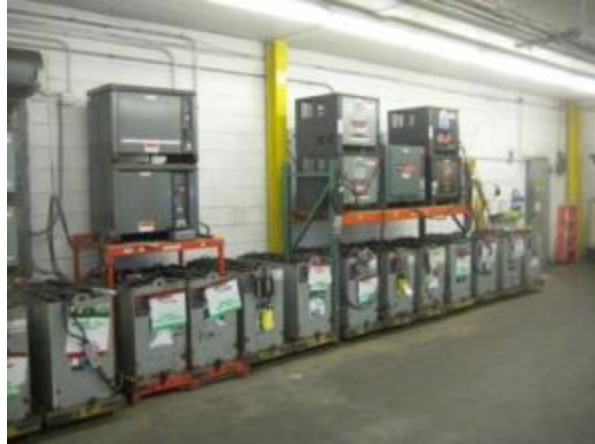
Forklift Battery Charging: The forklift battery charging area is located on the West Dock. There is no mechanical ventilation present. (To be installed in 2016.)

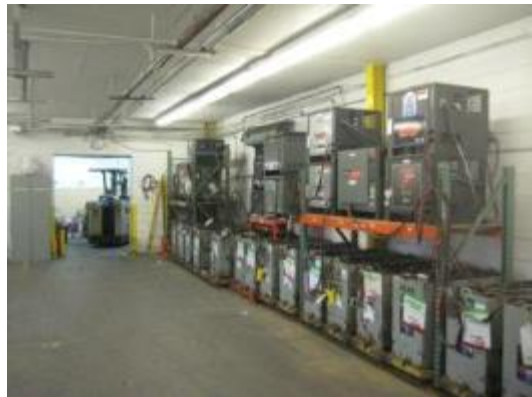
13-03 **Forklift Charging – Ventilation.** Install ventilation over the forklift charging area in accordance with one of the following:

- Provide continuous ventilation over the forklift chargers either with hoods over the chargers similar to the Brooklyn Park facility, or with ventilation located at the ceiling level of the room.
- Provide ventilation over the forklift chargers either with hoods over the chargers similar to the Brooklyn Park facility, or with ventilation located at the ceiling level of the room that is interlocked to hydrogen detection at the ceiling that would activate the ventilation if hydrogen were detected.

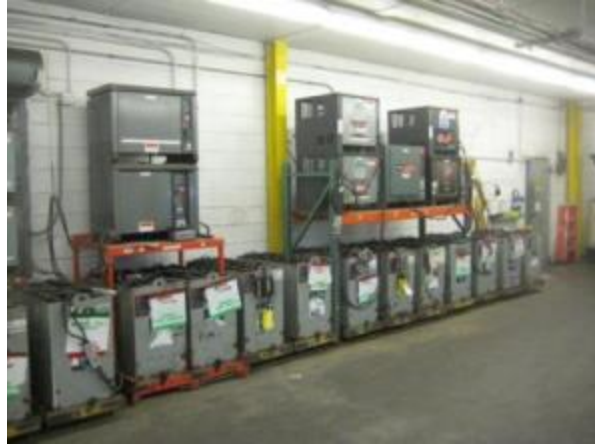
Forklift Battery Charging: The forklift battery charging area is located on the West Dock. There is no mechanical ventilation present. A hydrogen detector has been installed above the equipment in this area. There are plans to install a wall ventilation fan that will be interlocked with the detector in 2018.

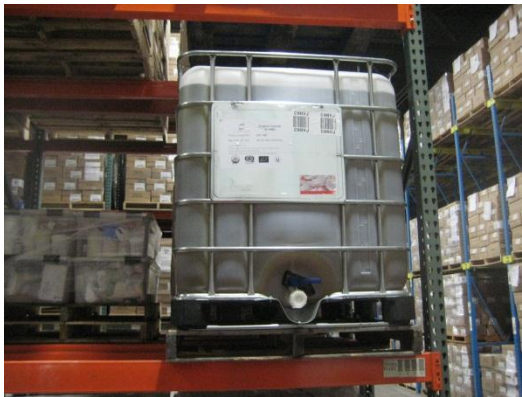
Canola Oil Tote in Rack – 2nd Tier

- Store in a detached building at least 50 ft. away from the main buildings.
- Store detached portable flammable liquid storage building that is UL Listed and/or FM Approved.
- Store inside the main building in an area that is fire isolated from the remainder of the building by at least 2 hour fire rated construction and is provided with spill containment capable of containing the entire contents of all containers.

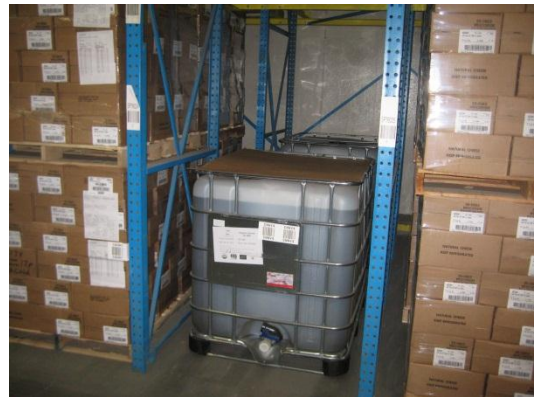
Canola Oil Totes in Rack

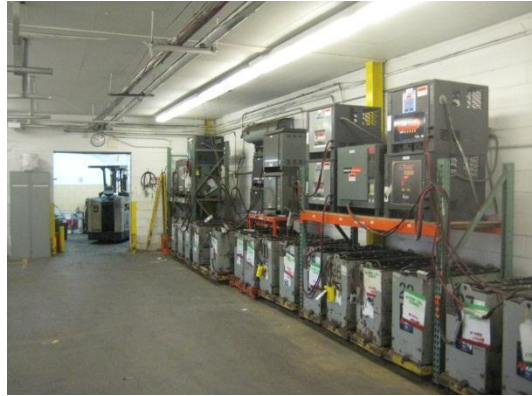
- 13-03 **Forklift Charging – Ventilation.** Install ventilation over the forklift charging area in accordance with one of the following:

- Provide continuous ventilation over the forklift chargers either with hoods over the chargers similar to the Brooklyn Park facility, or with ventilation located at the ceiling level of the room.
- Provide ventilation over the forklift chargers either with hoods over the chargers similar to the Brooklyn Park facility, or with ventilation located at the ceiling level of the room that is interlocked to hydrogen detection at the ceiling that would activate the ventilation if hydrogen were detected.

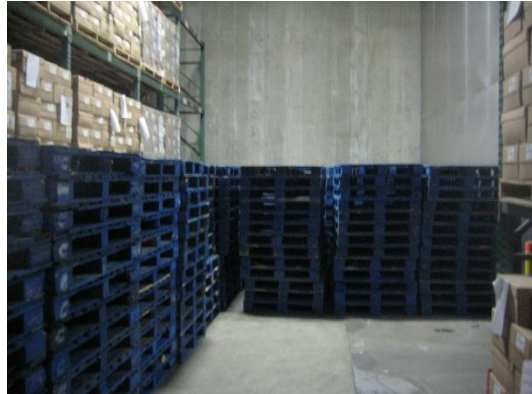
The idle wood pallets have been removed from the racks and stored on the floor no higher than 6 ft.

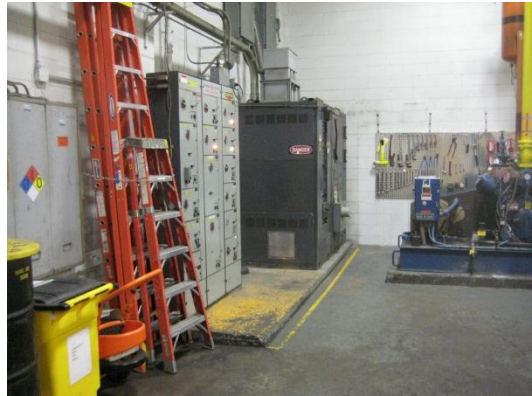
M10-01 Maintain 36-inch clearance around electrical switchgear. Various materials were noted stored adjacent to MCC switchgear in Engine Room 1. To be done.

This recommendation has been completed by moving all combustibles 36 inches or more from the electrical panels.

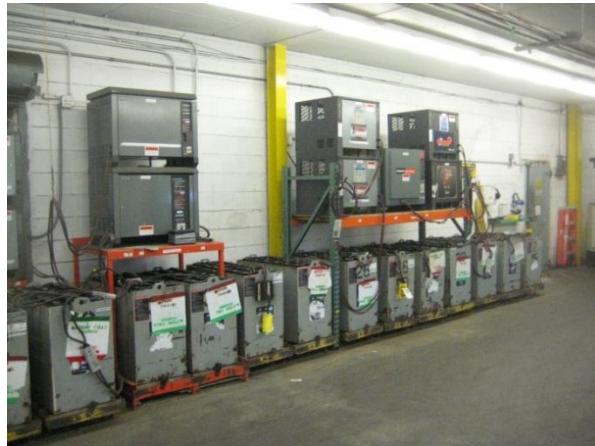
Forklift Battery Charging: The forklift battery charging area is located on the West Dock. There is no ventilation and this needs to be addressed.
