# **Comprehensive Inspections**

# **SUMMARY REPORT**

**Inspection Address:** 132 Western Ave S, St Paul, MN 55102

**Inspection Date:** 10/23/2018 Start: 2:00 pm

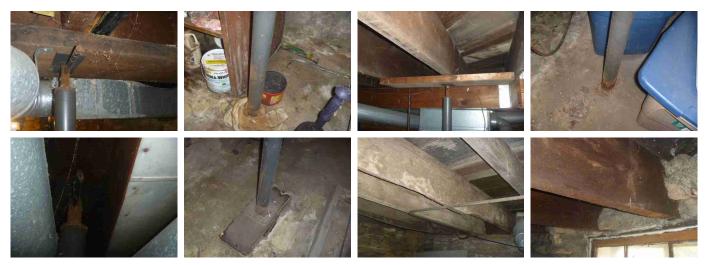
The columns and beams are in acceptable condition.

Note: There are multiple steel adjustable support posts installed to add support to the existing structure.

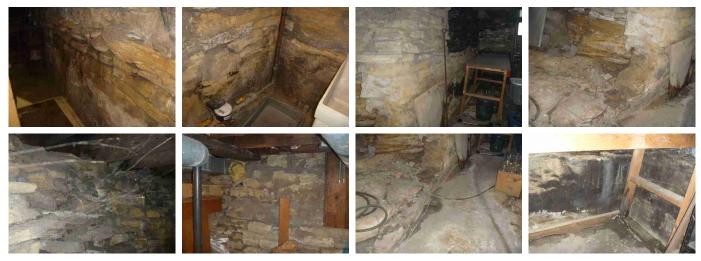
Stacked & Unreinforced Walls

This is an older foundation that includes stacked and un reinforced stone walls. These are significantly more seismically vulnerable than modern concrete stem walls, and can include a sand-lime mortar mix that deteriorates more rapidly than most modern concrete mixes. These foundations can be difficult and costly to retrofit. Therefore, you should consult a structural engineer or a foundation contractor, because this issue could affect your evaluation of the property.

Note: The joints have areas of aging and softening and there is evidence of moisture intrusion and wall modifications. Maintenance and modifications is advised.

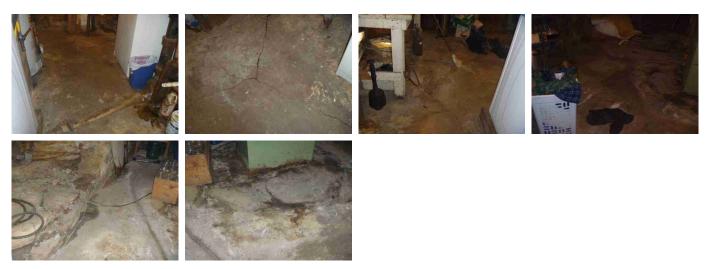
The basement floor is older and is in acceptable condition with typical settling, shrinkage, or curing cracks.

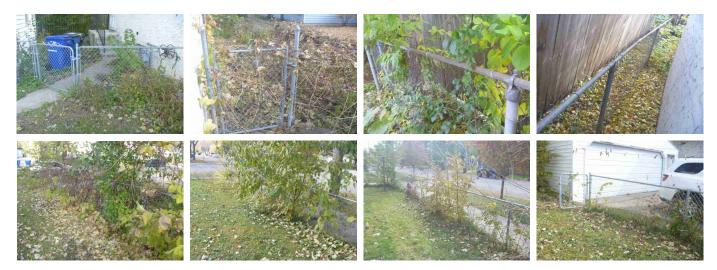
### The fences and gates are serviceable but have damage commensurate with their age - Continued

The fences and gates are serviceable, but have damage commensurate with their age.

Note: Portions of the fences are obscured by foliage or other material, which prevents a thorough inspection.

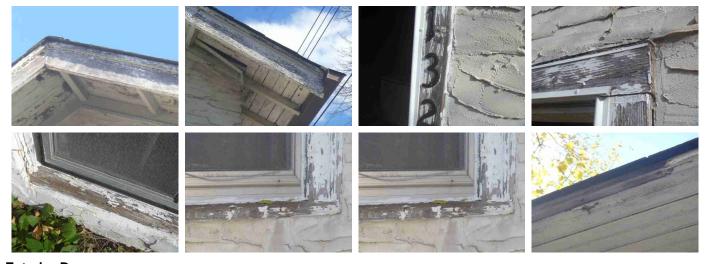
The fascia board and trim and soffits are in poor condition and need repairs and paint maintenance. See sample pictures in full report.

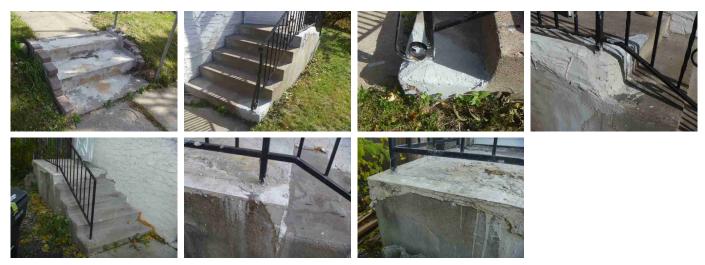
The steps have been repaired and are functional but have cosmetic deficiencies.

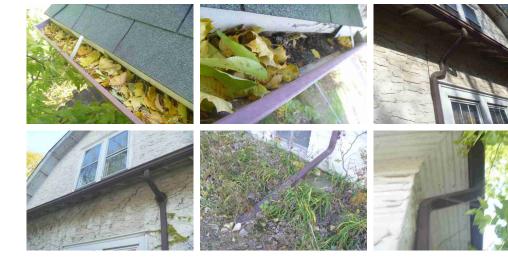
The gutters need to be cleaned and serviced to drain properly. See sample pictures in full report. Note: Some downspout's extensions are missing or need to be reconnected or redirected or serviced. See sample pictures in full report.

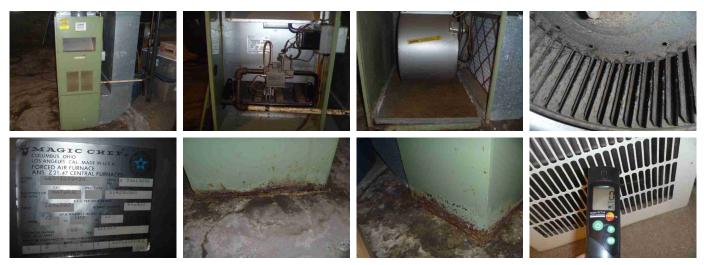
Central heat is provided by a 37 year old furnace located in the lower level.

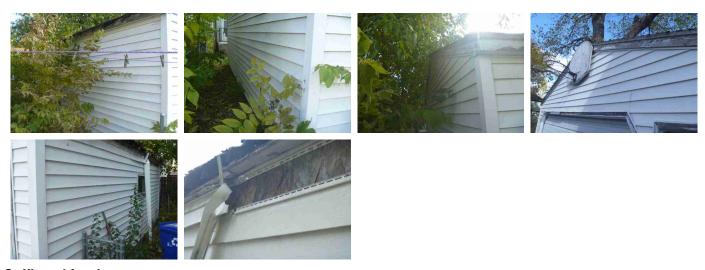
The vinyl siding is has missing panels and needs repairs. See pictures in full report. Note: There are missing flashing on the doors and windows which need to be installed.
