July 23, 2023

I am writing to respectfully request that the Department of Safety and Inspections (DSI) grant me the certificate of occupancy to my 733 Fairview Ave. N., Saint Paul Home for the reasons I will illustrate.

Re: 733 Fairview Ave N  
File#: 14 325587 VB2

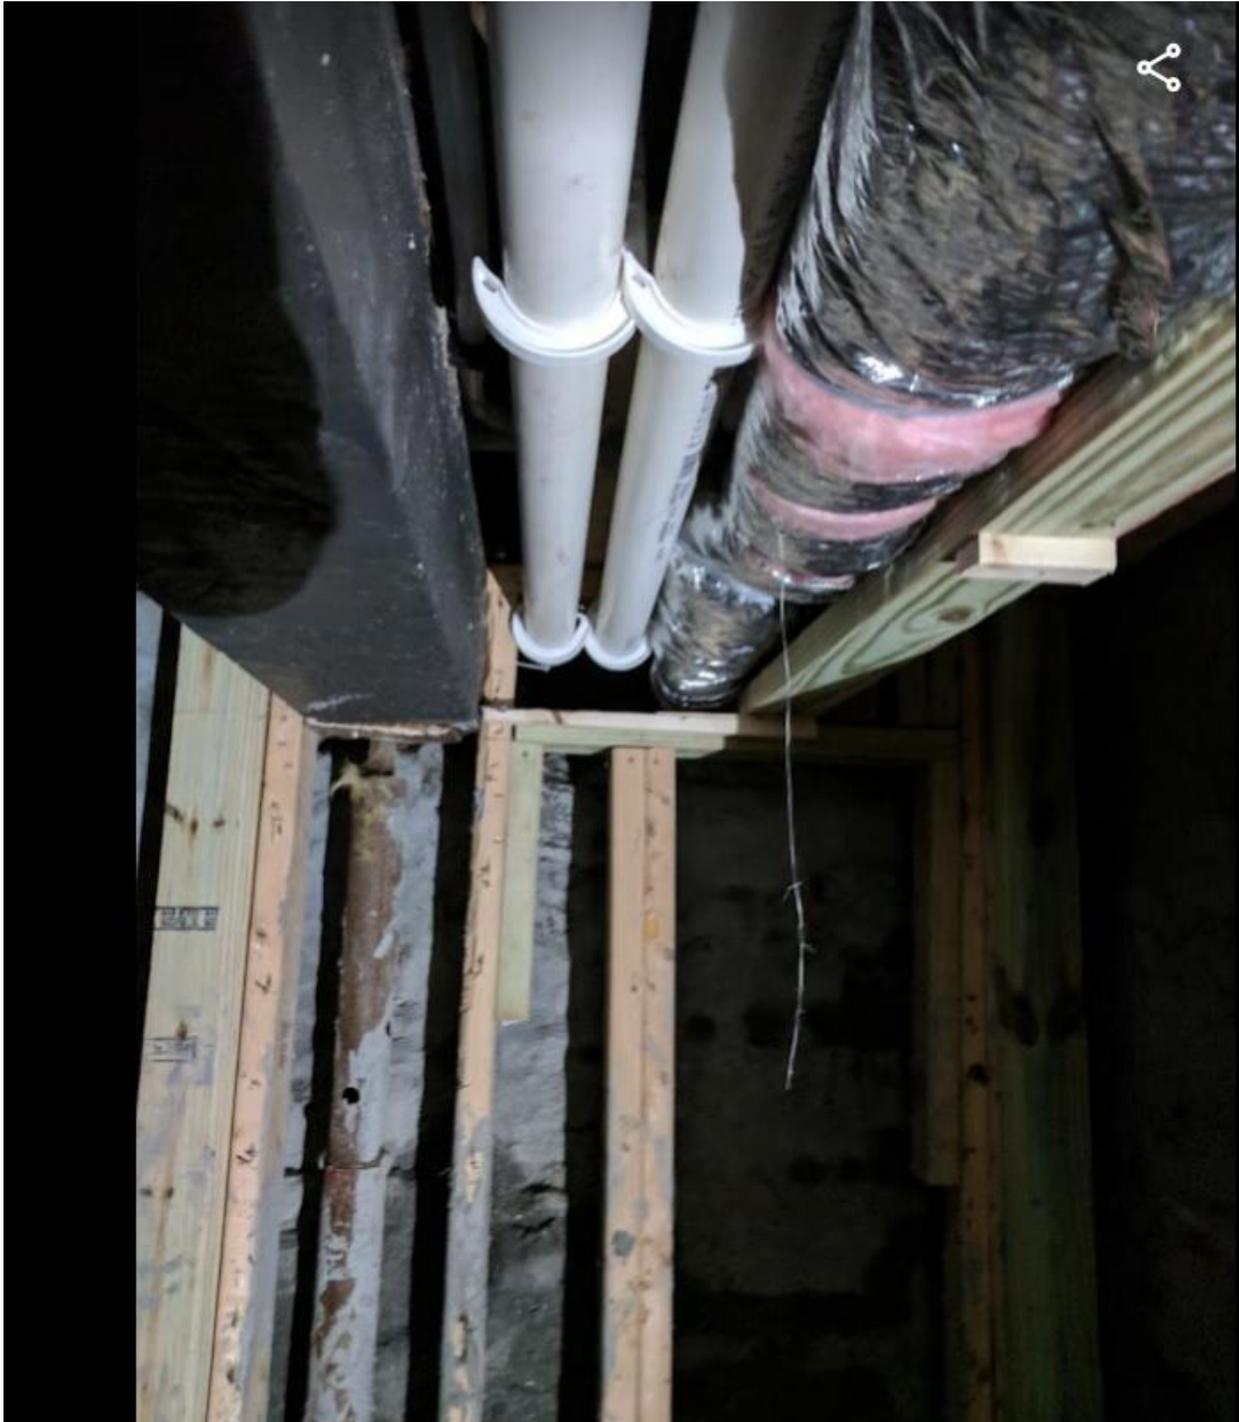
2015

The aforementioned is duplicitous because the following photo of the (white) PVC water heater gas vent piping is precisely what the Plumbing Inspector, Jim Kaufer observed in 2015. As such, there is no need to destroy and open a finished ceiling and walls so you can see the piping again. There were no issues with these gas venting pipes at that time, and accordingly, there should not be any new issues today.

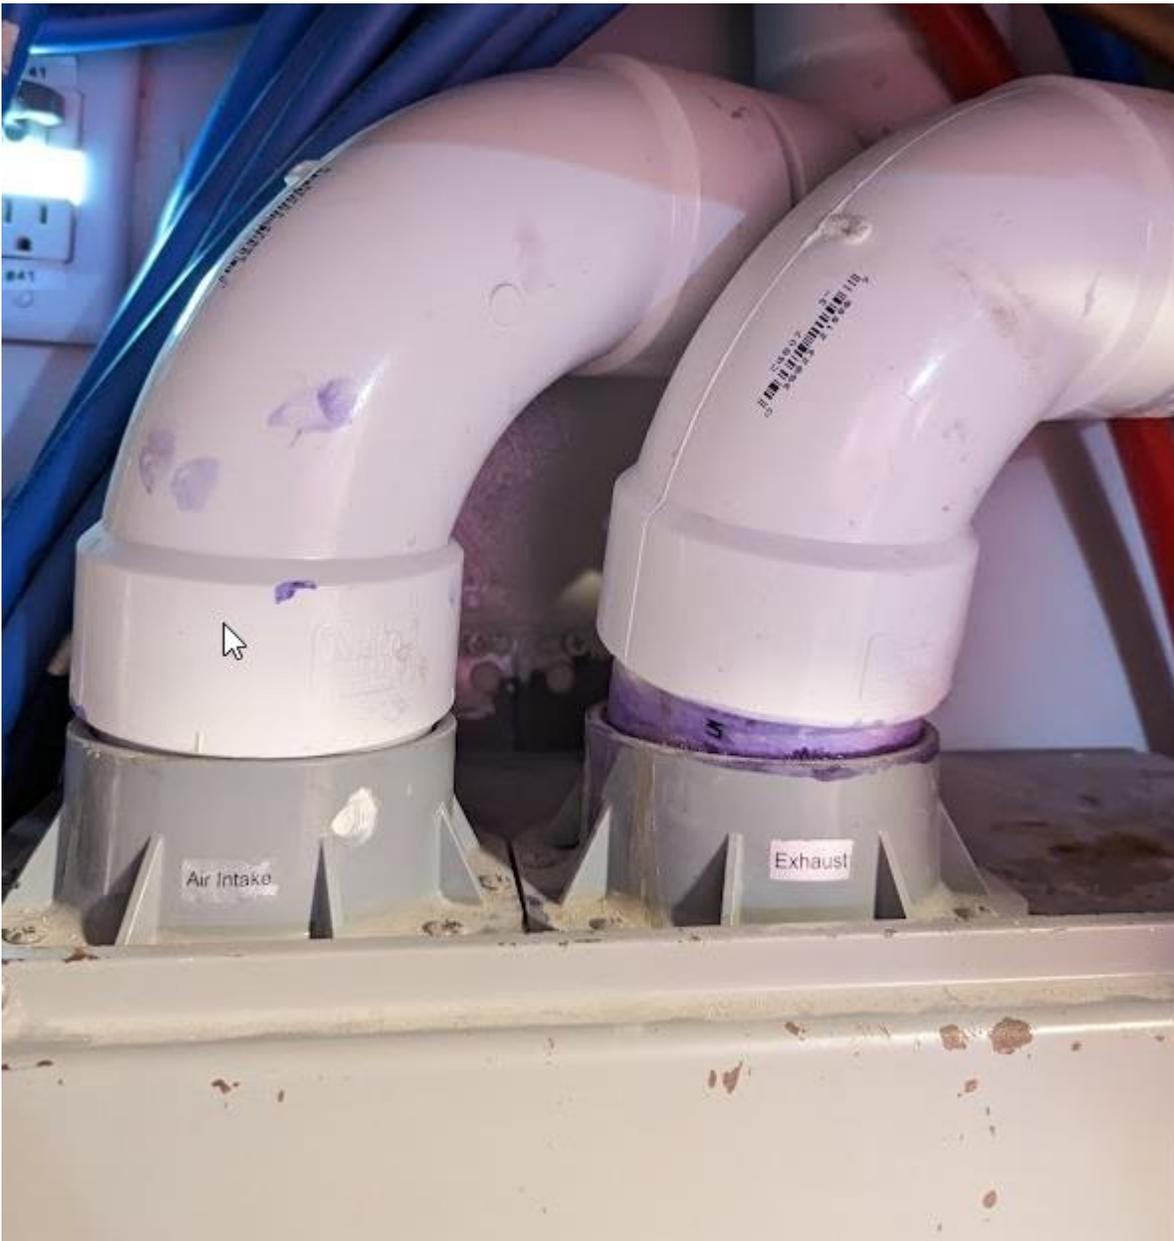
**Water Heater Mounted to wall**

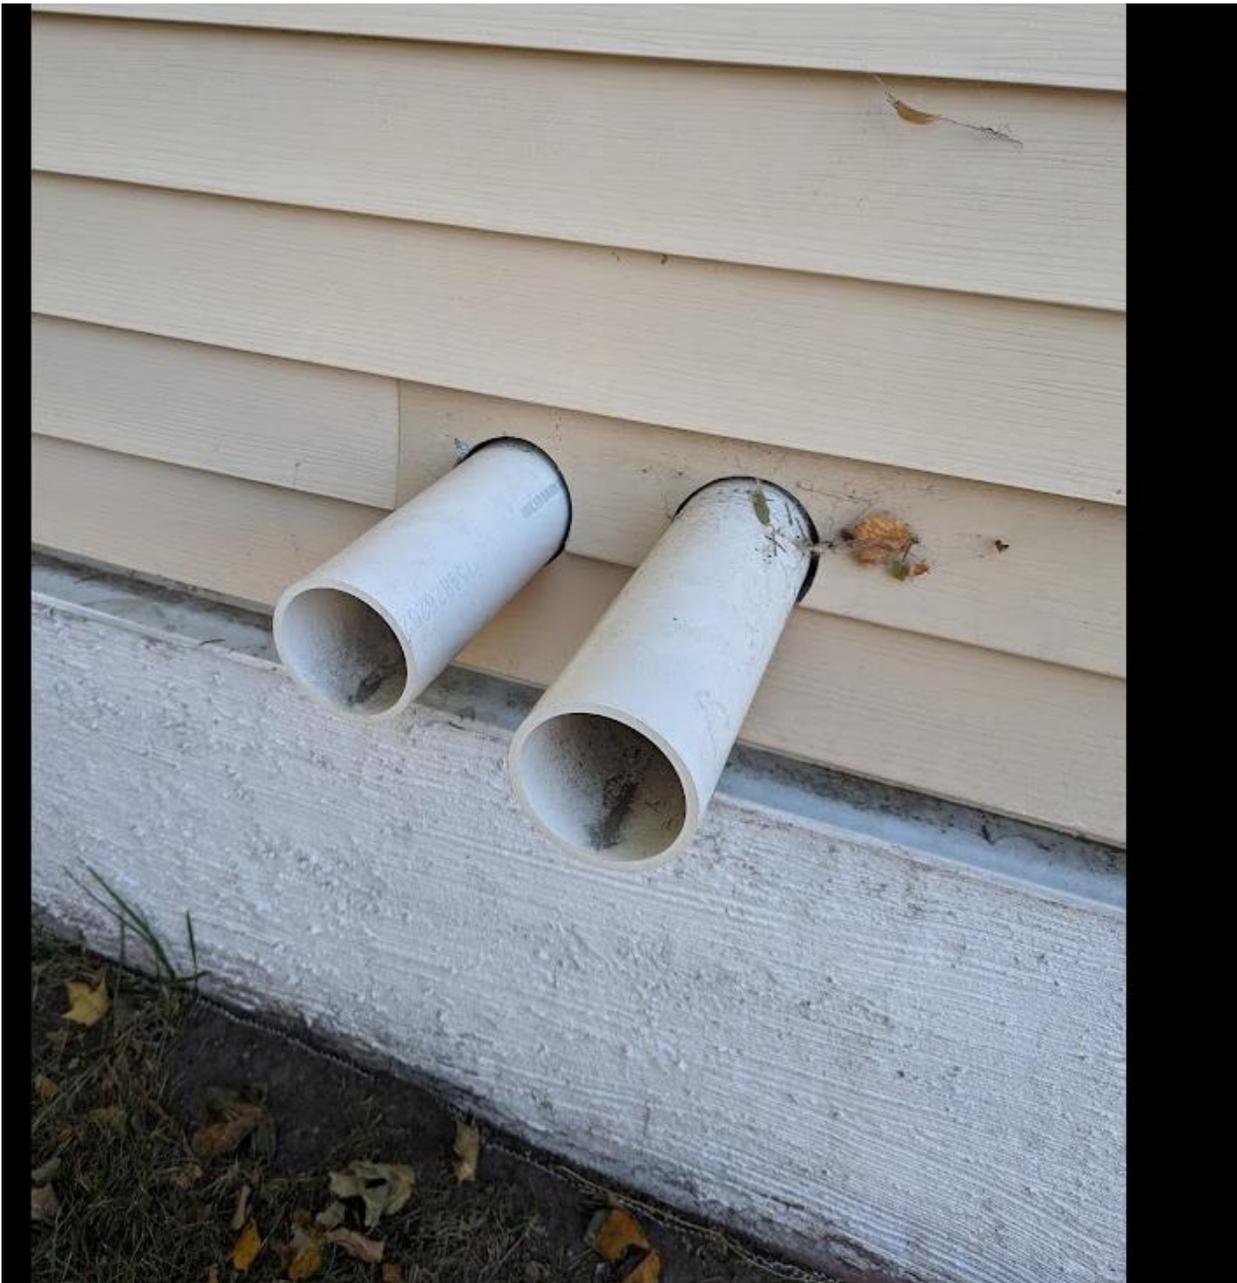
2015-2021

6. Basement – Water Heater –(MFGC 503) Install the water heater gas venting to code.

Comment #6 about the venting, addresses the above photo where the outside venting did not have elbows (turns) attached. Again, they were purposefully left off because at the time we were in the process of repairing siding on the outside of the home and it was counterproductive to attach (glue) the elbows and then cut them to remove them prior to attaching new long siding pieces. It is precisely why the inspector made this comment: **“Install the water heater gas venting to code.”**

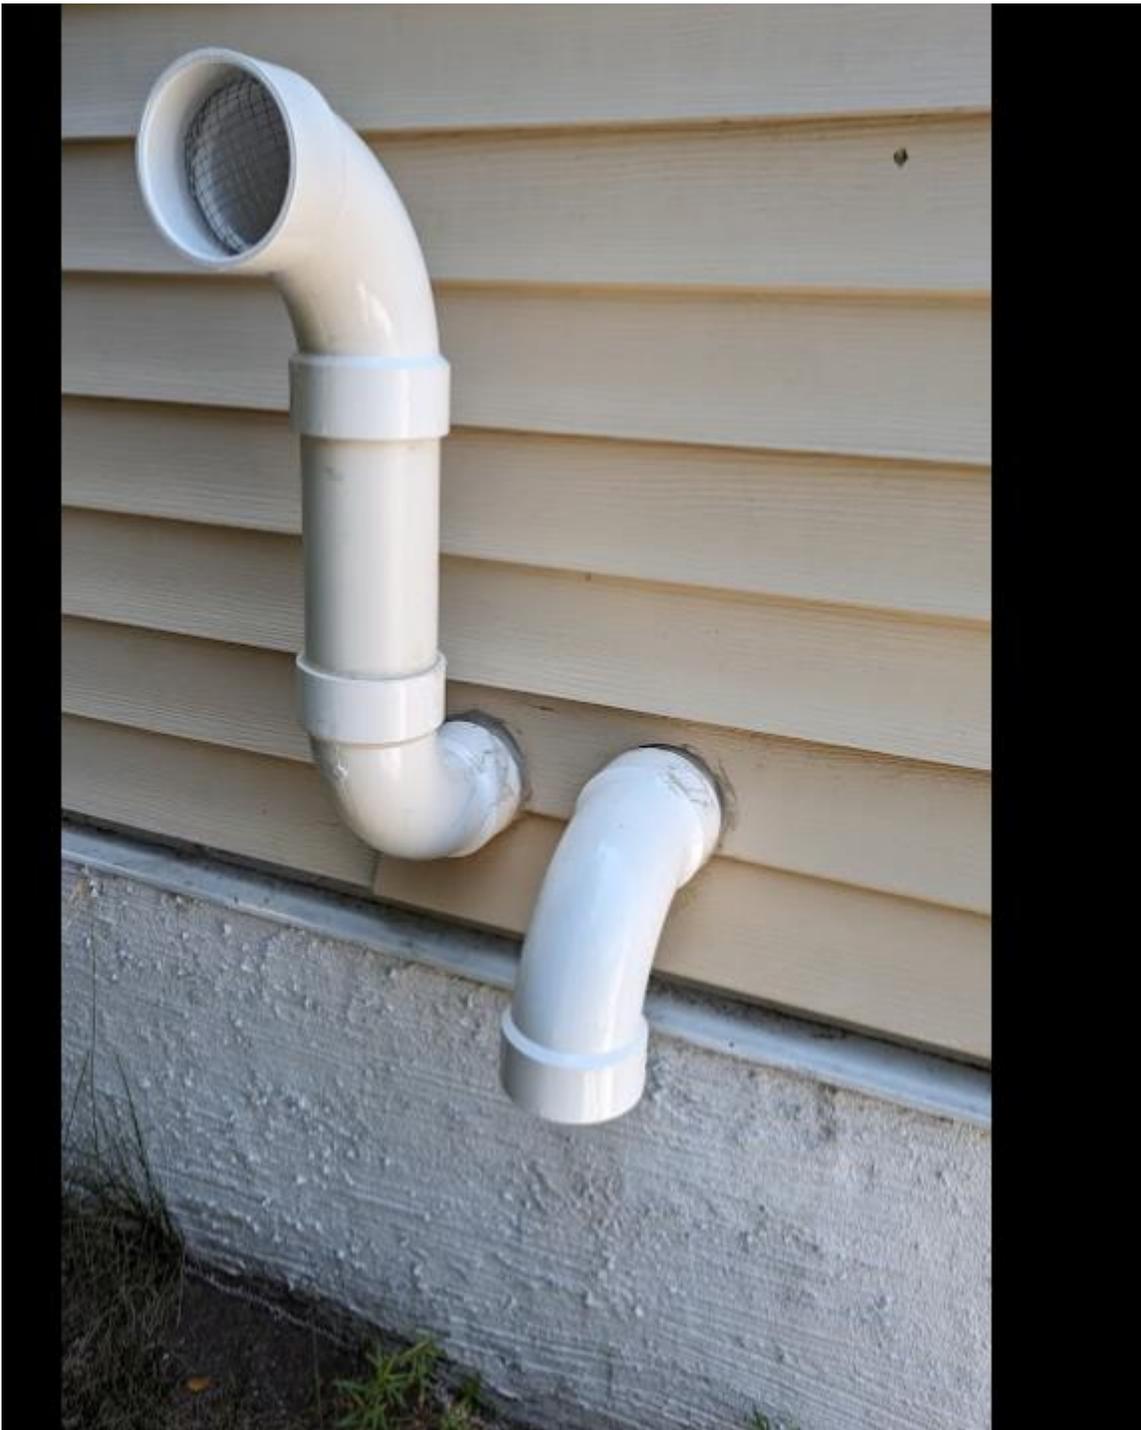
**March 2023**

The aforementioned was corrected and the elbows were secured, but that does not warrant a new directive in 2023 for the Plumbing Inspector, Jim Kaufer, who has already seen and inspected the PVC gas venting pipes in 2015 – to require the homeowner to open up the sheetrock of an already finished basement for the inspector to re-inspect what he already himself inspected and passed in 2015-2016. It should be noted, still, into the first half of 2021, the basement ceilings remained open (not sheetrocked) and the gas venting was still exposed and visible. Thus, for the homeowner to now be required as of June 2023 for **“The walls/ceiling will need to be opened**

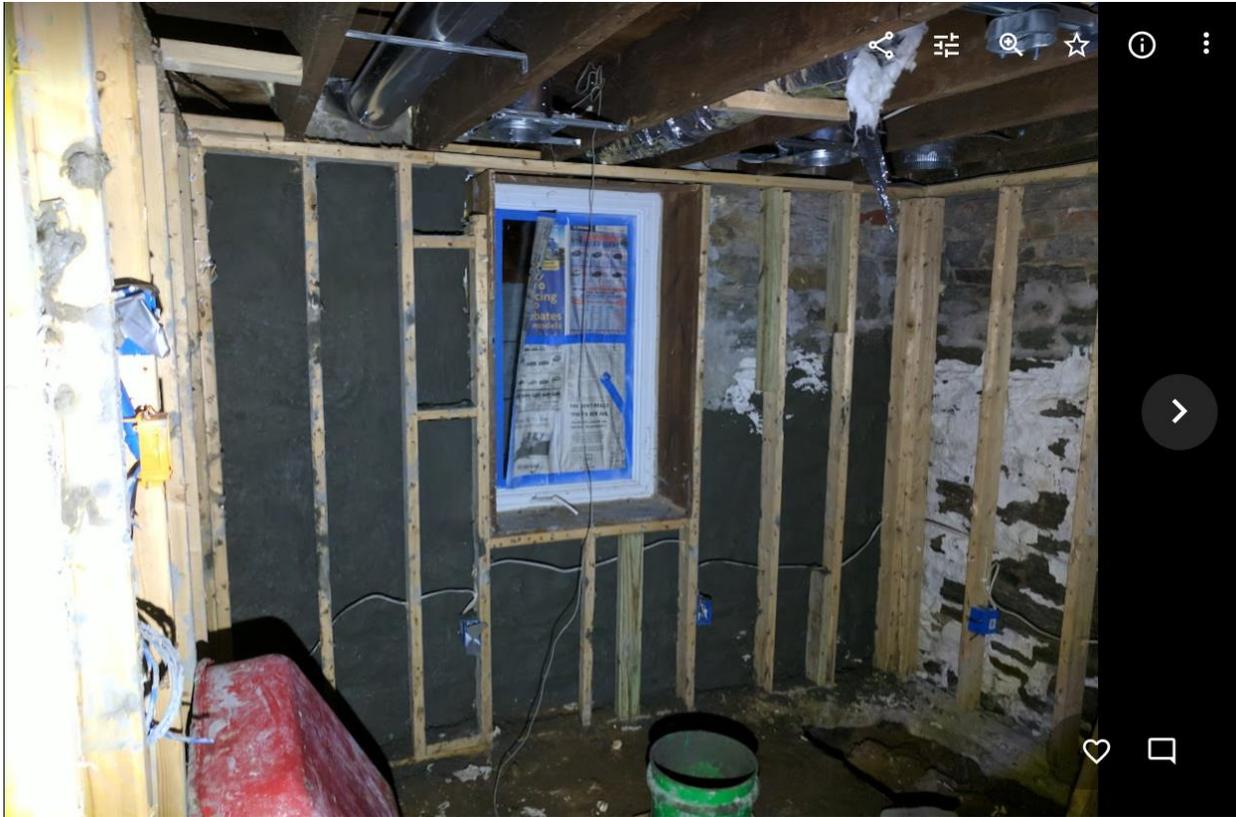
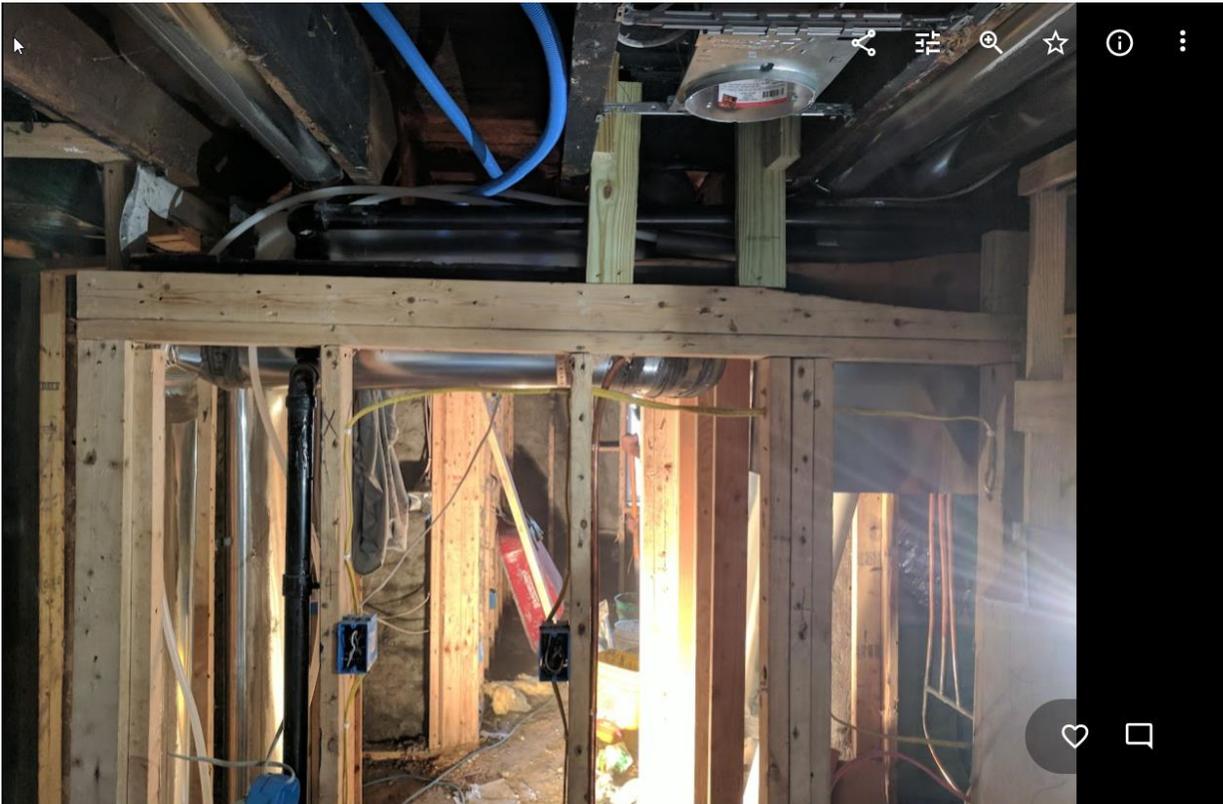
To this end, just like the white PVC gas venting piping in the walls and ceiling, the AC/HVAC Venting ductwork is also visible in these photos and appropriately, was also inspected – **but by a different** Heating Inspector, Erik Witt, **and not the June 2023 inspector**. The only comment about the new ductwork in 2021 is mentioned in #5: “Clean all supply and return ducts.” Accordingly, it is unnecessary that in 2023, the Warm Air Inspector, Chris Wiskur (a

different inspector than even the previous two inspectors), alleges that the “ducts were installed and covered up without permit or inspection”. This is patently untrue, sloppy, and if he had reviewed the previous two reports, possibly requested in bad faith. Irrespective, the demand would be extremely onerous to the homeowner, is unwarranted and redundant. The work was done years earlier as is visible in the photos, with a permit and the work inspected years earlier, soon after the work was completed.
