Project Location:

Project Name: Protectowire System Replacement

The Americold facility located at 240 Chester Street, St. Paul, Minnesota was inspected for asbestos containing materials. The materials found to contain asbestos are listed below:

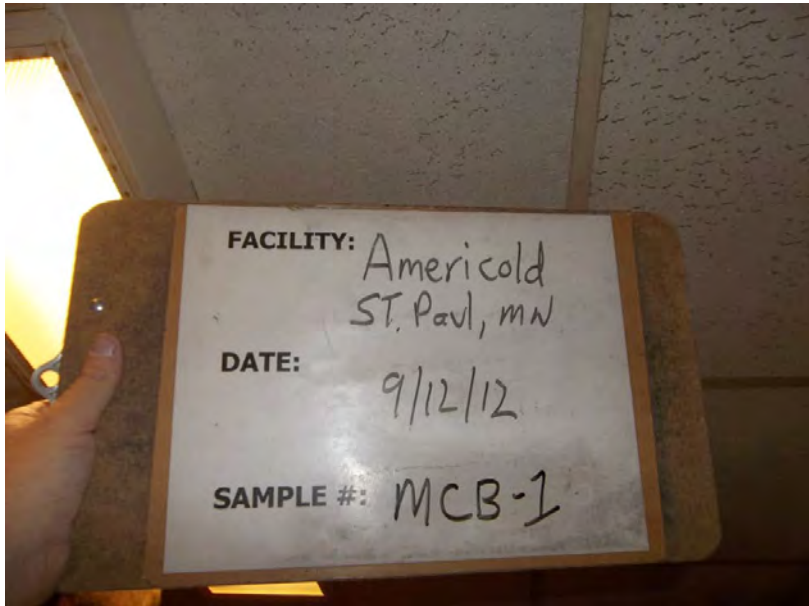
MCB-1

MCB – 2' X 2' ceiling tile, fissures and pinholes, located in the north dock office contains 3% chrysotile asbestos as analyzed by Polarized Light Microscopy. This miscellaneous material was friable and in good condition at the time of sampling.

2' X 2' CEILING TILE, FISSURES AND
PINHOLES

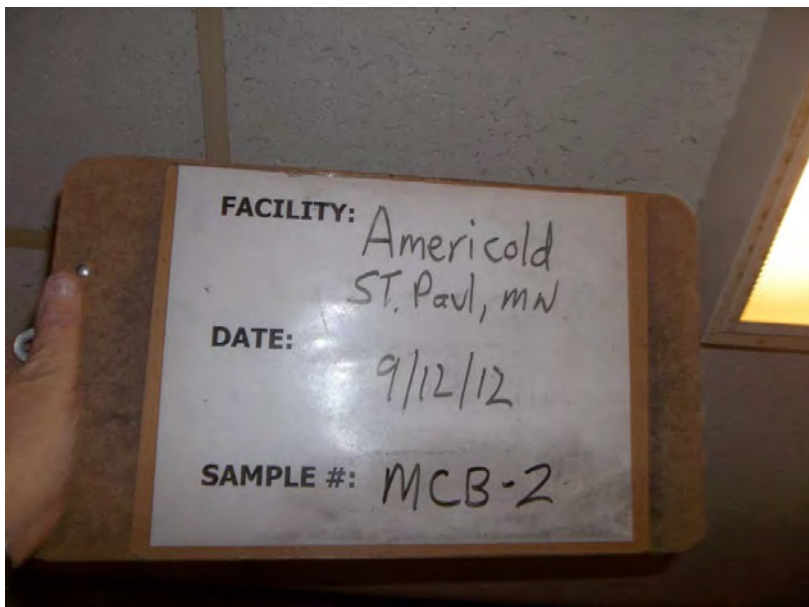
MCB-2

2' X 2' CEILING TILE, FISSURES AND
PINHOLES

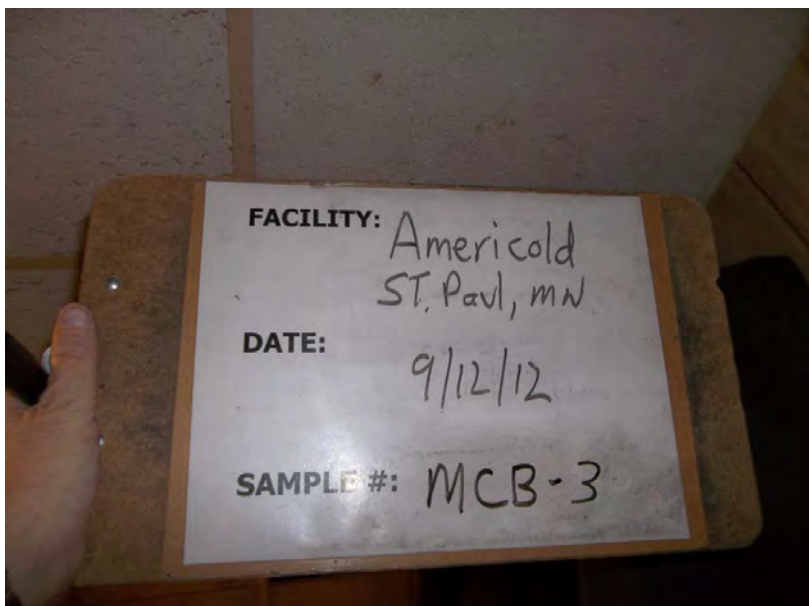
MCB-3

2' X 2' CEILING TILE, FISSURES AND
PINHOLES
