September 13, 2021

RE: Request for Appeal: Fire Inspection Correction Notice 35410  
Versacold USA LLC /Americold  
240 Chester Street  
Saint Paul, MN

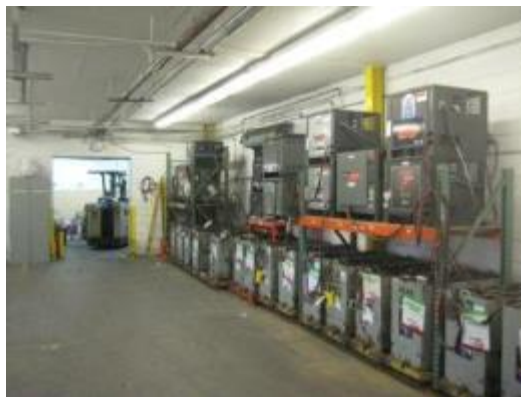
- 13-03 **Forklift Charging – Ventilation.** Install ventilation over the forklift charging area in accordance with one of the following:

*Comments:* In case of a battery overcharge or other potential electrical fault, charging batteries can emit hydrogen gas, which can be highly flammable and explosive is sufficient concentration. The flammable limits of hydrogen are 4% to 75% by volume. Therefore, ventilation should be provided to remove any emissions of hydrogen gas from the batteries.

- Provide continuous ventilation over the forklift chargers either with hoods over the chargers similar to the Brooklyn Park facility, or with ventilation located at the ceiling level of the room.
- Provide ventilation over the forklift chargers either with hoods over the chargers similar to the Brooklyn Park facility, or with ventilation located at the ceiling level of the room that is interlocked to hydrogen detection at the ceiling that would activate the ventilation if hydrogen were detected.

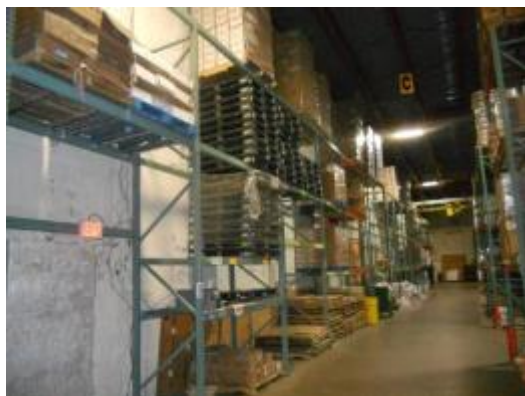
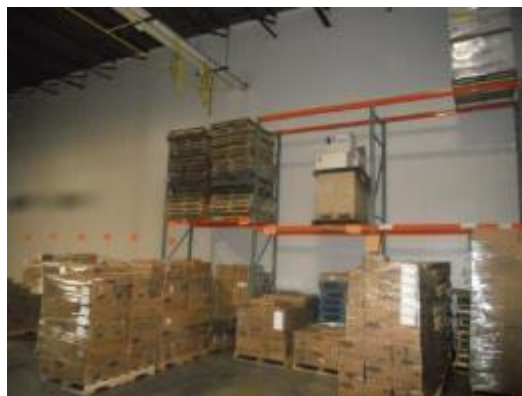
- 16-01 **Idle Pallets Stored in Racks.** The several stacks of idle pallets in the 240 Building freezer warehouse area should be removed from the storage racks. The idle pallets should be stored on the floor outside of the racks to maximum 6 ft. high.

*Comments:* Idle pallets stored in racks create a severe fire exposure hazard. Pallets should be stored on the floor outside of the racks to reduce the fire exposure in this non-sprinkler protected facility.

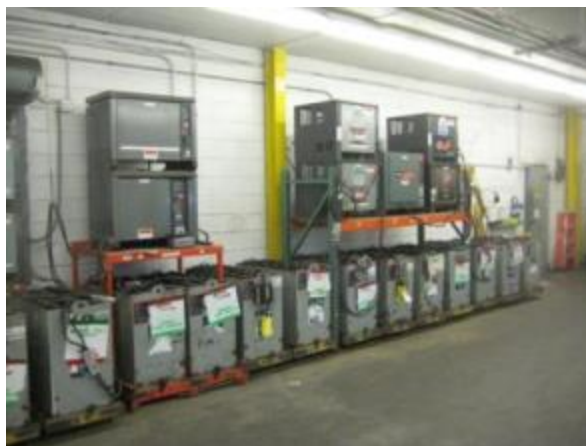
**Forklift Battery Charging:** The forklift battery charging area is located on the West Dock. There is no mechanical ventilation present. (To be installed in 2016.)

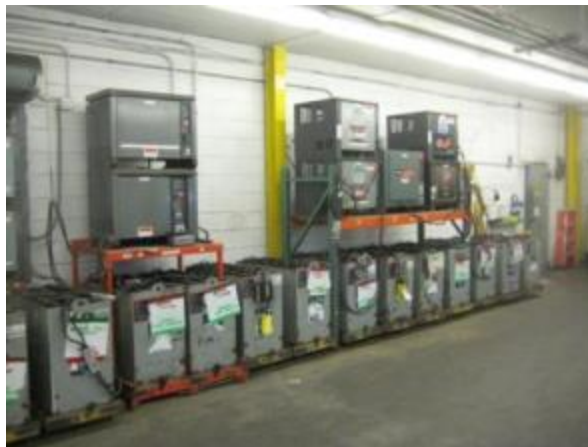
**Forklift Battery Charging:** The forklift battery charging area is located on the West Dock. There is no mechanical ventilation present. A hydrogen detector has been installed above the equipment in this area. There are plans to install a wall ventilation fan that will be interlocked with the detector in 2018.

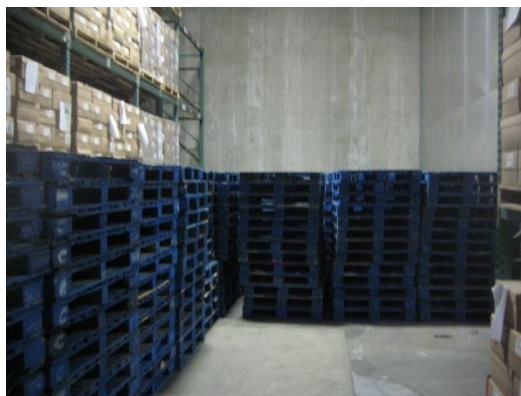
The idle wood pallets have been removed from the racks and stored on the floor no higher than 6 ft.

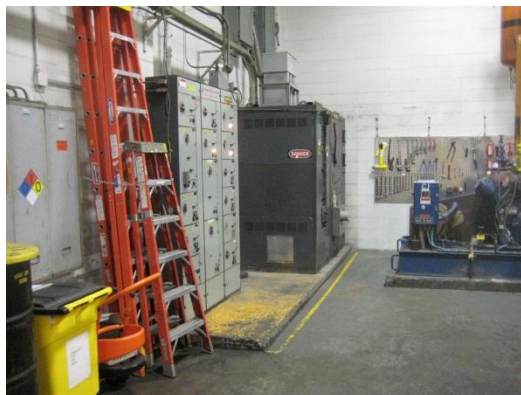
- M10-01 Maintain 36-inch clearance around electrical switchgear. Various materials were noted stored adjacent to MCC switchgear in Engine Room 1. To be done.

This recommendation has been completed by moving all combustibles 36 inches or more from the electrical panels.

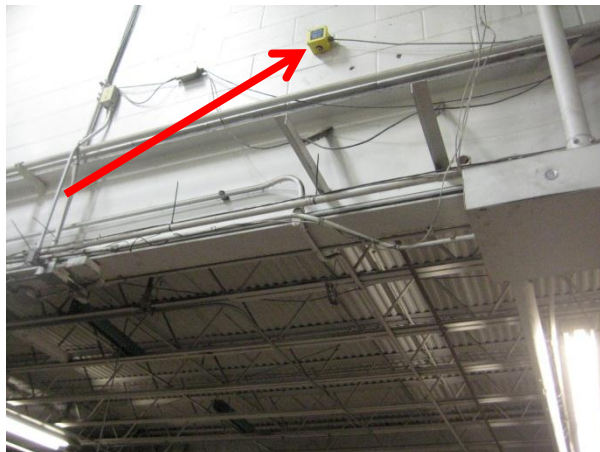
- Raising the existing ammonia detection to the ceiling level versus the current 5 to 12 ft. above the floor in most areas as ammonia is lighter than air.

- Add additional detectors in both engine rooms as both currently only have the one detector.

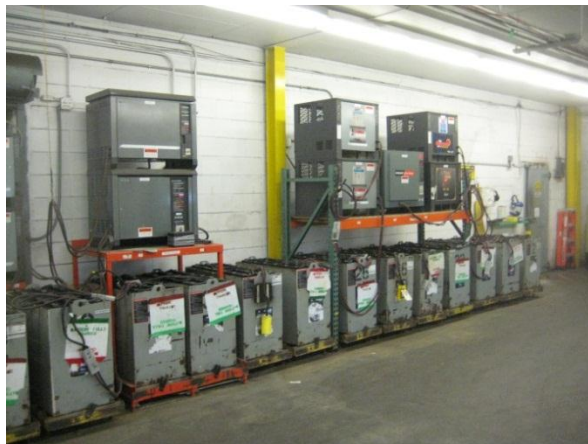
**Forklift Battery Charging:** The forklift battery charging area is located on the West Dock. There is no ventilation and this needs to be addressed.
