## **AEDS / Little Africa Building**

Structural Damage Assessment

Steel Roof Trusses/ CMU Walls

May 6, 2022

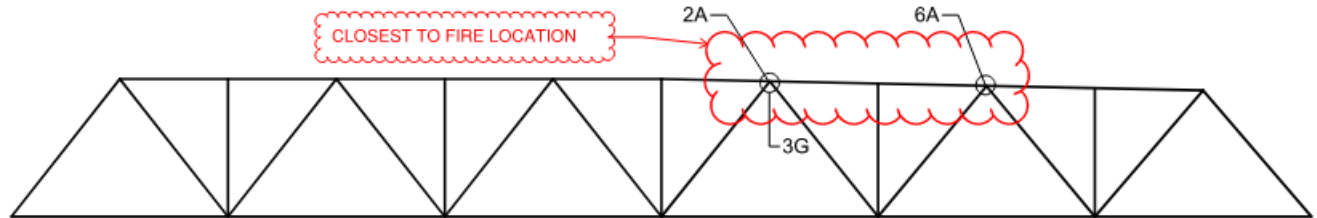
### T1 DIAGRAM

The long span roof trusses are constructed of steel angles and plates. The top and bottom chord and diagonal members are double angles. All connection points are made with gusset plates that are typically riveted and then bolted at construction splice points. Relative to the attached truss diagram, the T1 truss, located adjacent to the mezzanine, was closest to the fire with the T2 truss being nearby on the edge of the fire. The T3 truss was farther away and a sample was taken of the angles to act as the control sample for comparison. The diagram provided shows the layout of each truss and the location of the test samples. Samples 2 and 3 were observed to be closest to the center of the fire. The attached test results provide the data for each sample. Photos 1 & 2 are representative of the truss configuration.

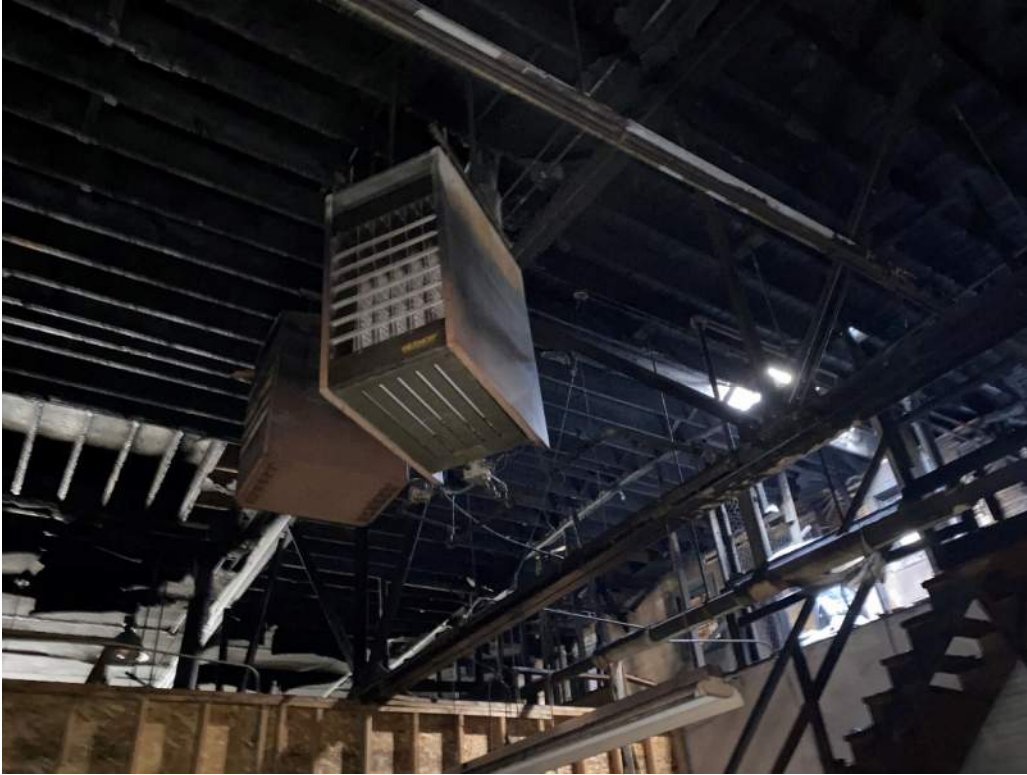
**PHOTO #1: View of T1 truss near file location.**

The conclusion of the steel testing report is that the steel roof trusses were not exposed to the fire long enough to cause any damage. The steel trusses can be reused in place when the wood framing is replaced. During the demolition process of removing the damaged wood framing, the lateral stability of the trusses should be maintained. Temporary lateral bracing may be required during the construction process.

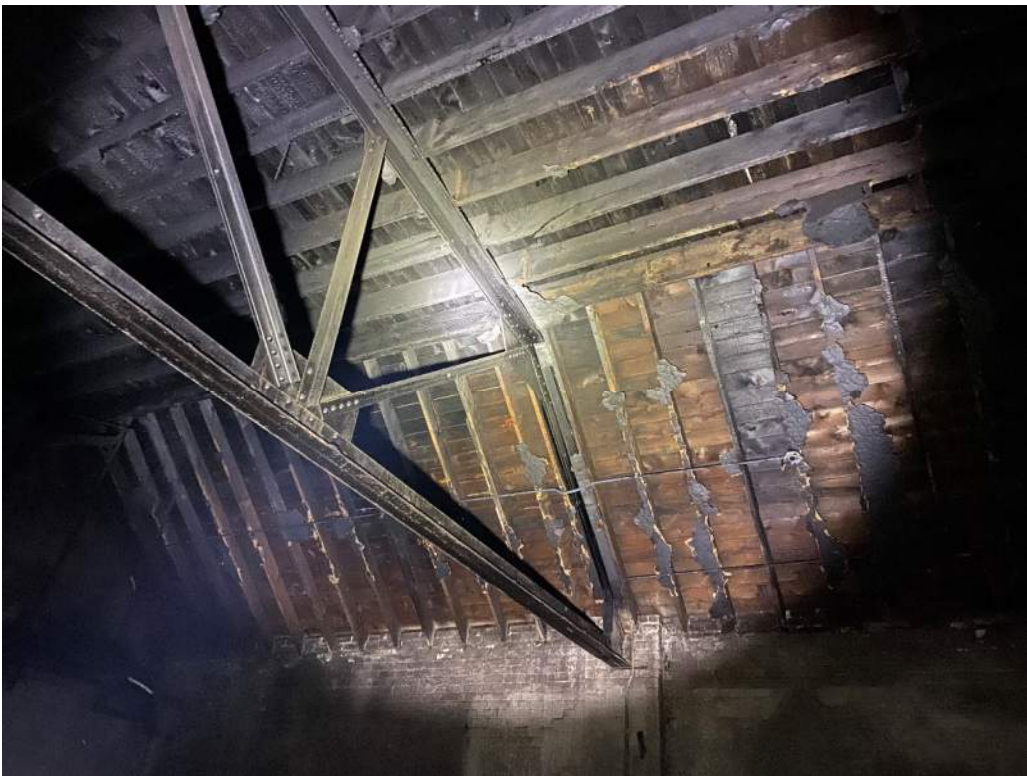
**PHOTO #2: View of north end of T1 truss.**

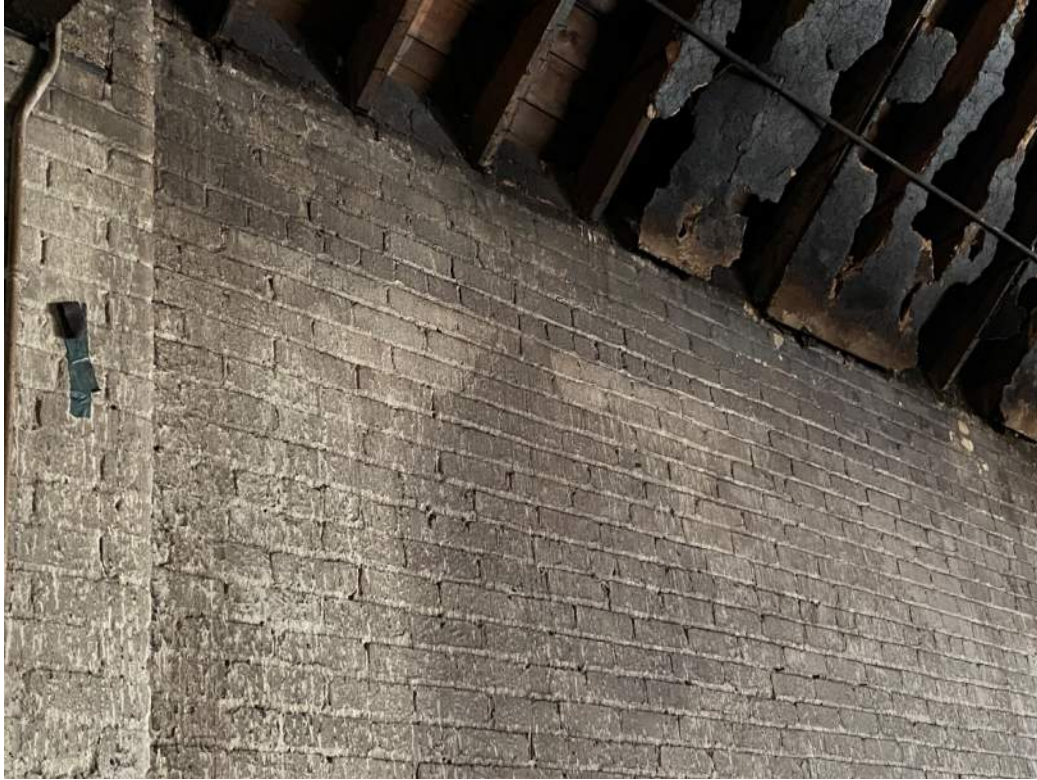
The masonry wall adjacent to the fire was also reviewed. From visual observations it was readily apparent that the primary heat of the fire did not reach the north wall which was closest to the fire. The wall is painted and there were not any indications of paint bubbling on the surface. The wall appears to be dirty from smoke exposure which is typical for fire conditions like this. See Photos 3 & 4 for visual reference.

**PHOTO #3: View of North Wall at T1 support column.**

The masonry walls adjacent to the fire also appear to be in relatively good condition as they were not damaged in the fire. However, there may be some repairs necessary for future occupancy that are more visible on the exterior of the building that are related to water damage issues. These conditions are not part of this report but should be considered for the proposed upgrades to the property.

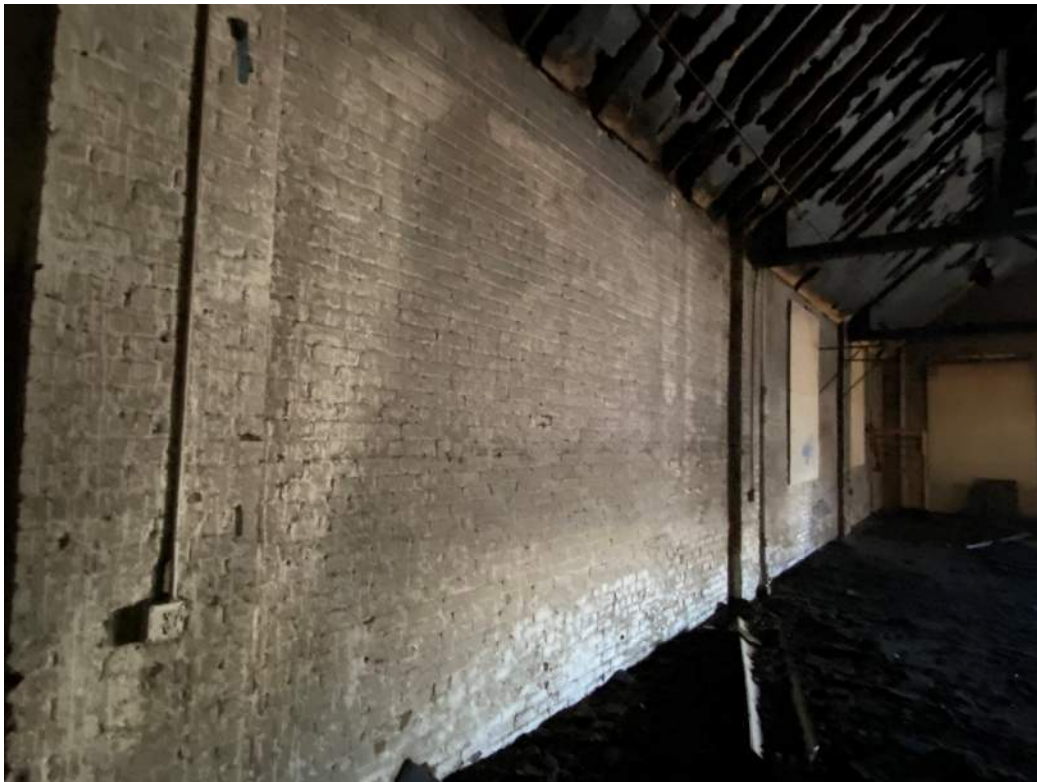
**PHOTO #4: View of North wall closest to fire location**
