PARKING RAMP EVALUATION REPORT

Best Western Plus Como Park Hotel Parking Ramp
1015 Bandana Boulevard East
Saint Paul, Minnesota 55105

Encompass Project #: 22-8144-000

January 3, 2023

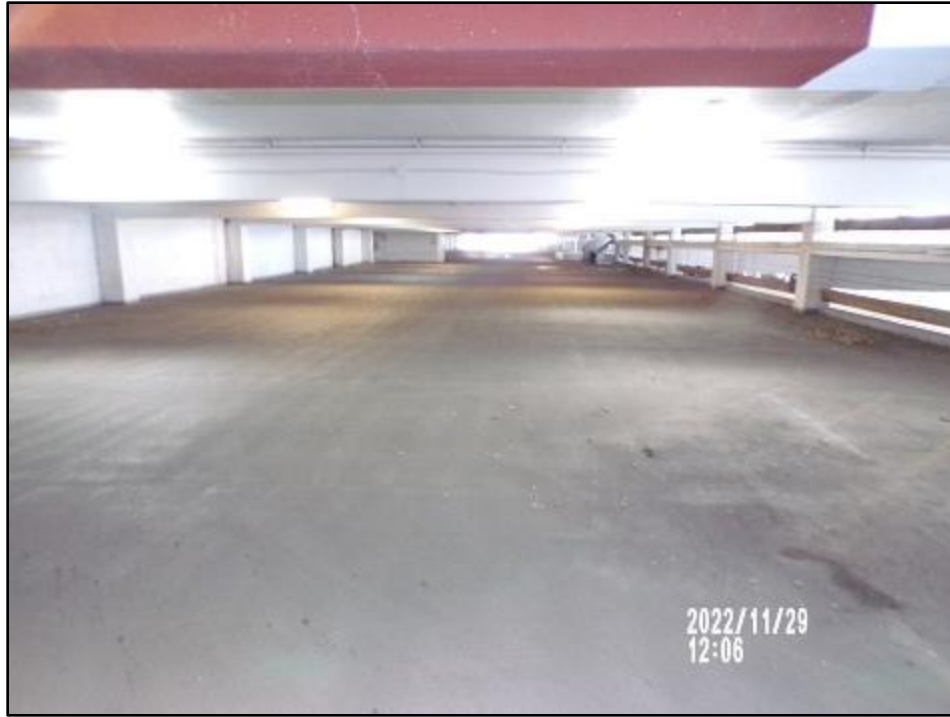
Level 2 looking south

2.3.2.1 Deteriorated traffic coating was observed on level 2 with large tears and missing sections found. The detailing near expansion joints was found to be in the worst condition.

2.3.4.1 The visible traffic coating on Level 2 was in poor condition and the Google aerial image of Level 3.5 shows a severely deteriorated traffic coating present.

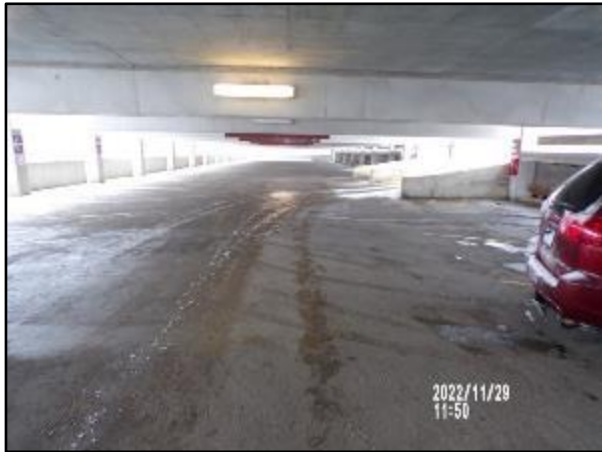
Level 2.5

2.3.2.3 The PT slab surfaces had varying levels of roughness with the first covered level (level 2.5) having aggregate pops (pockmarks in the slab) with a higher occurrence of pop outs near the ramps.

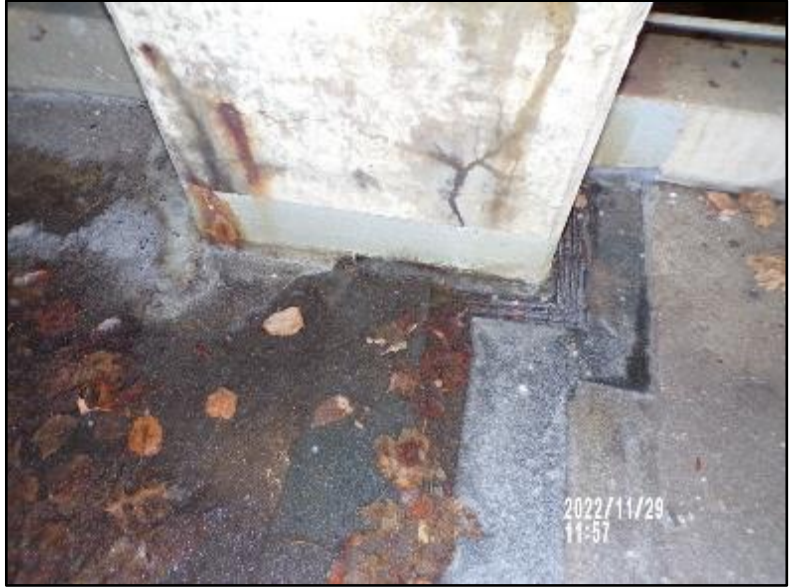
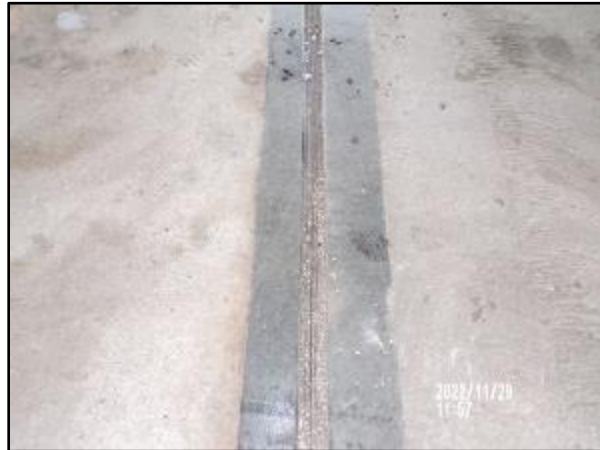
Expansion Joint Top

2.4.1.2 The expansion joints in poor condition had visible tears and debonding of the top horizontal wings (legs) at various points along the joint.

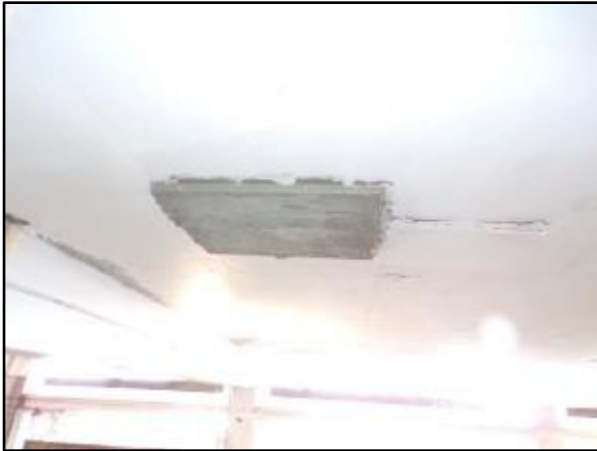
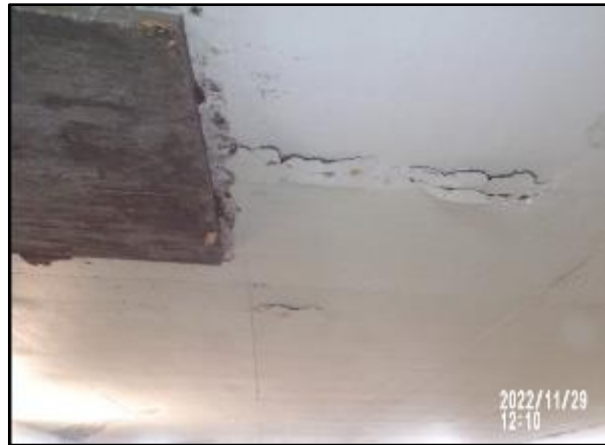
2.5.6.1 One location had several concrete patches that extended 1-2 inches below the formed bottom surface of the slab.

Left: Previous bottom of slab patch was formed lower than original bottom of slab. Right – Continued spalling next to patch.

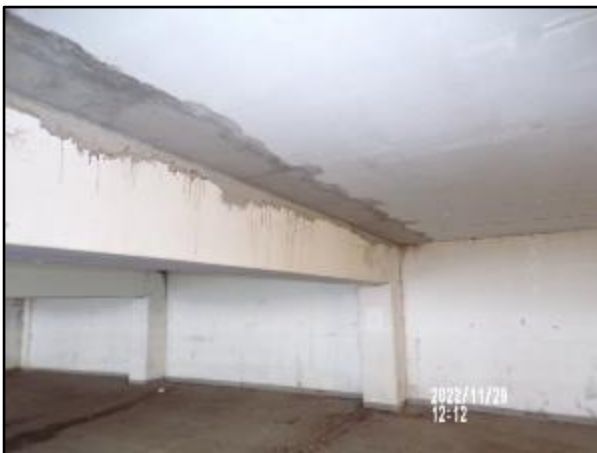
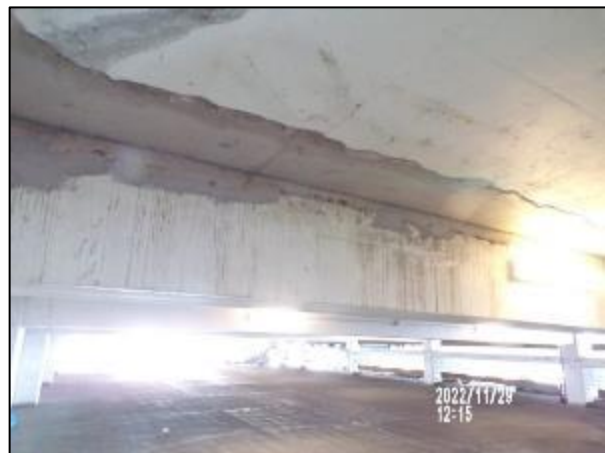
Previous patch full length of beams.

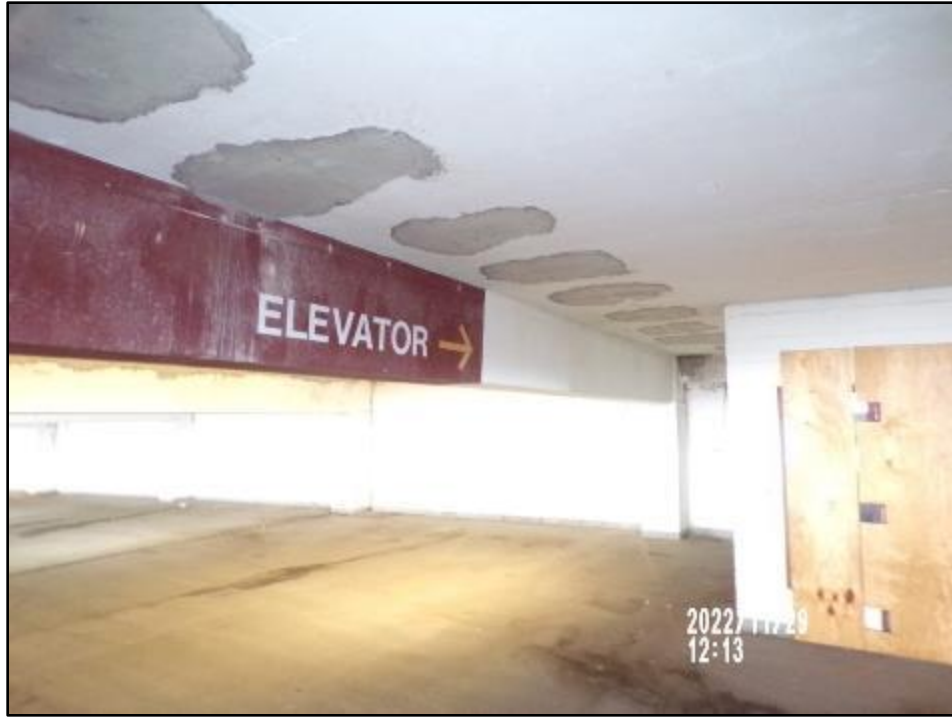
2.5.5 Locations on Levels 1.5 and 2.5 had four uniformly spaced holes drilled through the entire depth of the PT slab.

2.5.5.2 Some locations had threaded rods with square washers and nuts in the holes while other locations were open.

Previous bollard through bolt patching under Level 3.

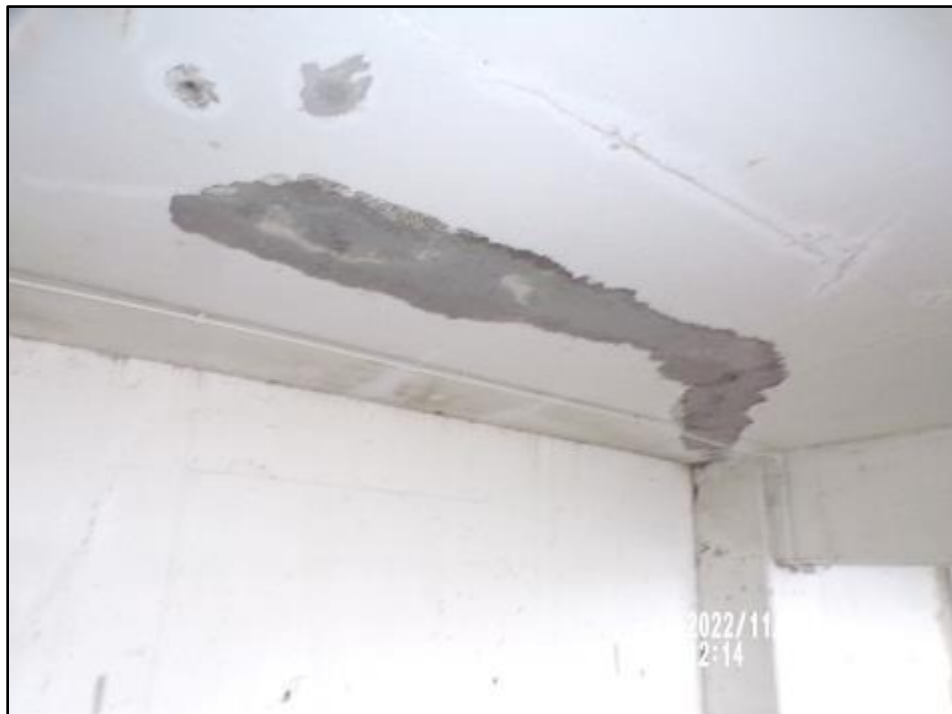
Bottom of slab cracks intersecting beam-column connection at foundation wall.

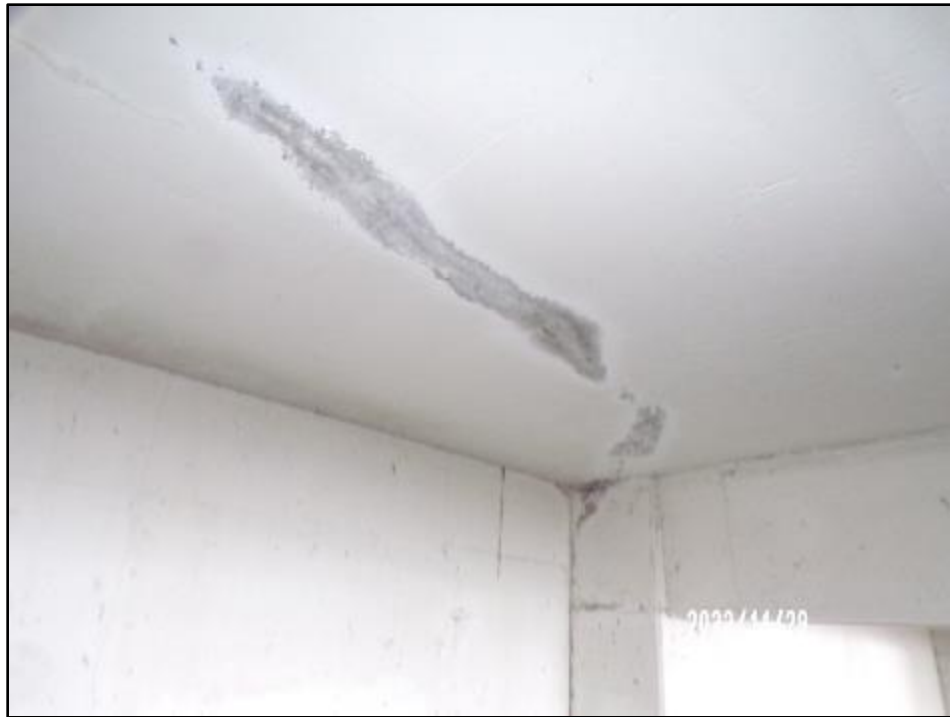
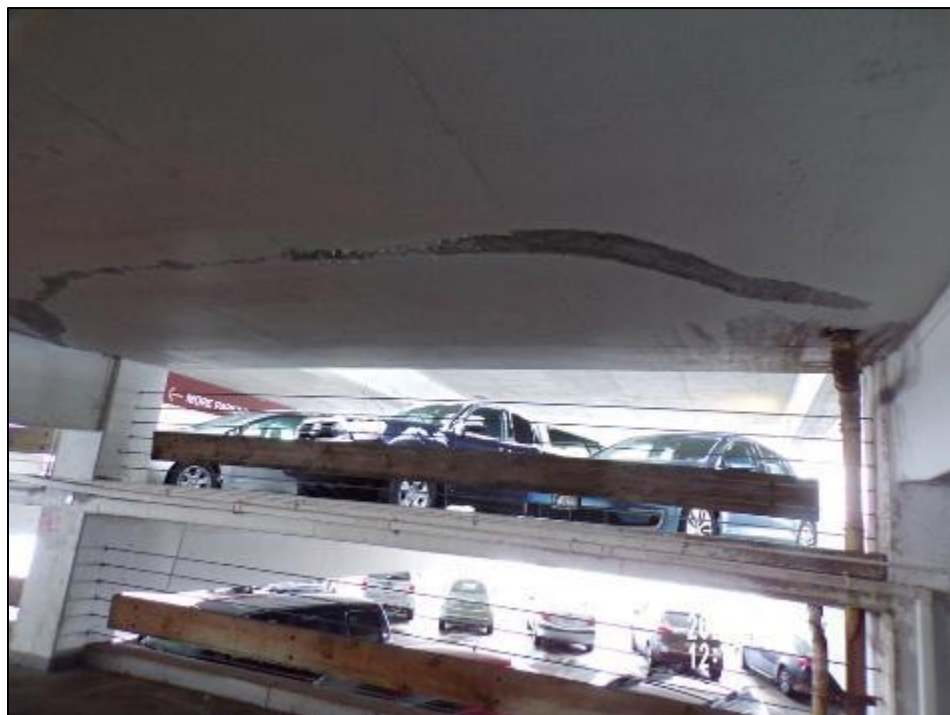
Bottom of slab cracks intersecting beam-column connection at foundation wall.

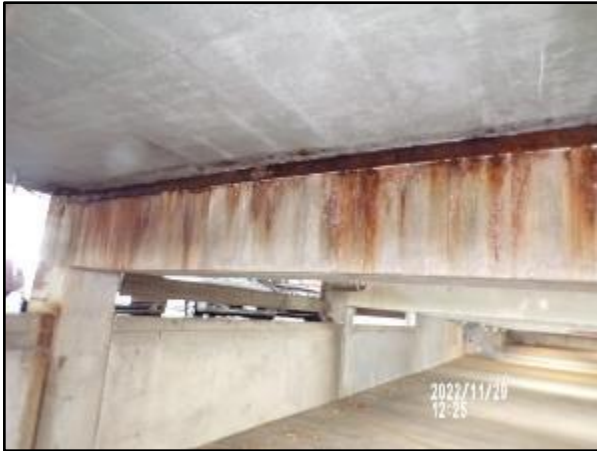
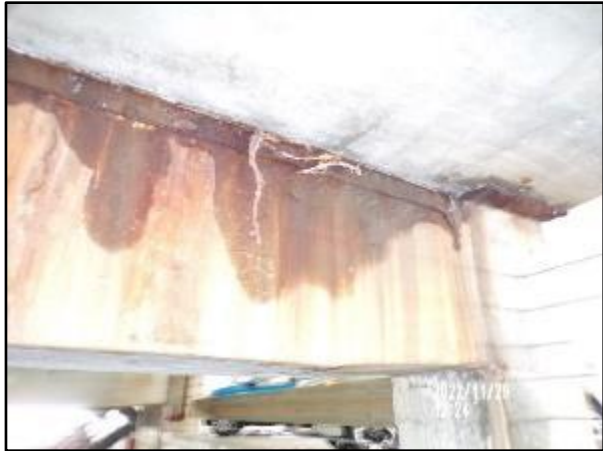
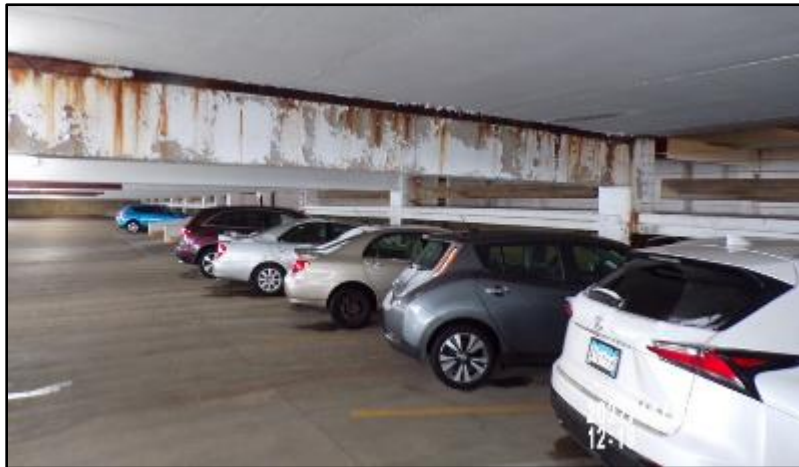
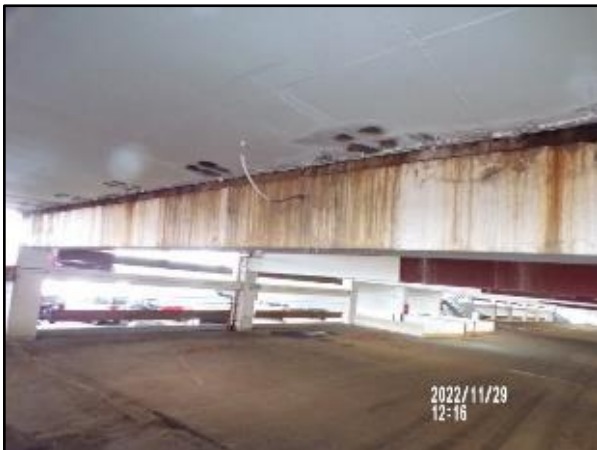
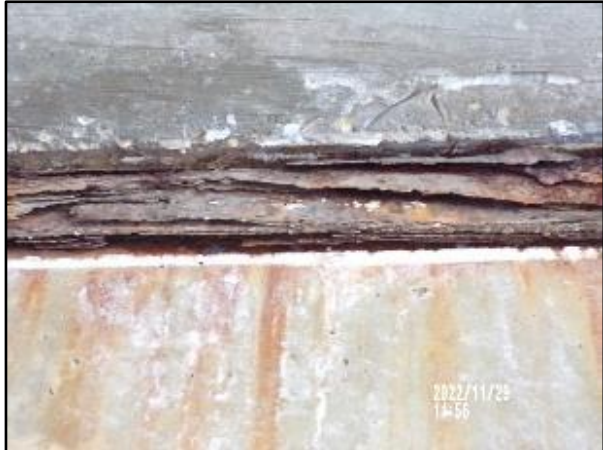
Expansion Joint Bottom

2.6.1 Extensive and severe steel corrosion was present at the steel members, either plates or angles, that were integral in the expansion joint system. The steel angle or bent plate sitting on a PT beam ledge was to allow for a sliding slab condition. The angle is severely corroded all locations.

2.6.1.1 The vertical down leg of the steel angle is completely deteriorated and nonfunctional.

2.6.2 Water intrusion was noted at all expansion joints on bottom of the slabs and beams.

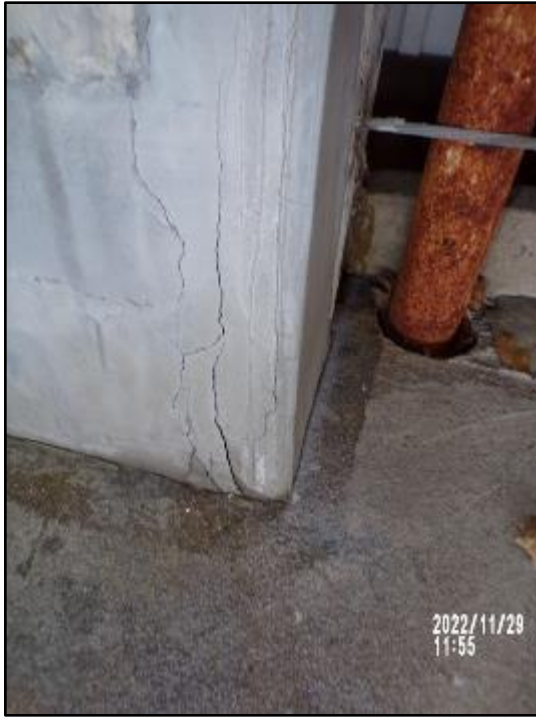
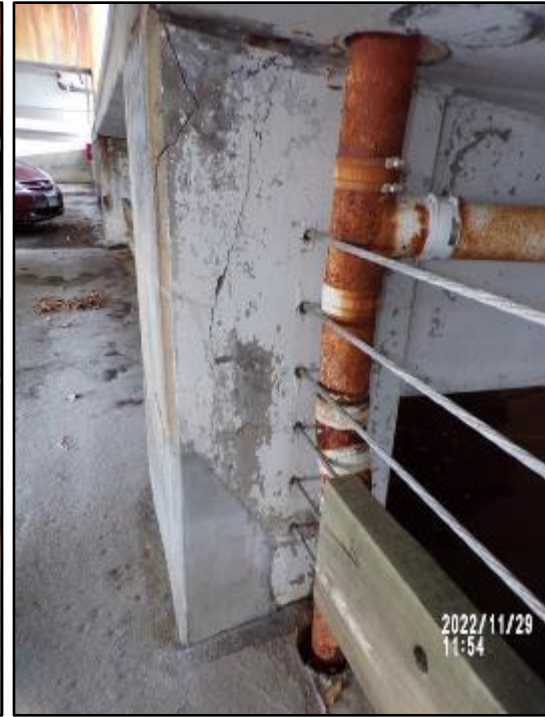
- 2.7.5 Previous repairs were observed on some columns (not painted or coated like all other columns).
 - 2.7.5.1 Previous repairs were cracking and spalling, similar to the original columns.

Level 2.5 previous column base patching starting to re crack

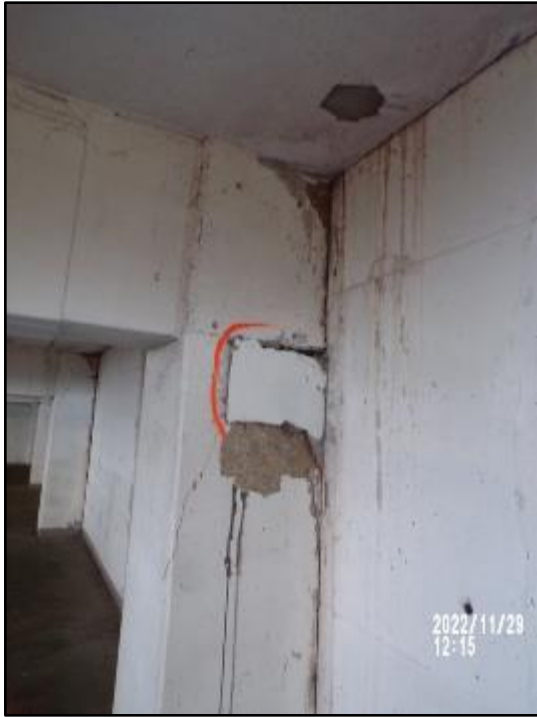
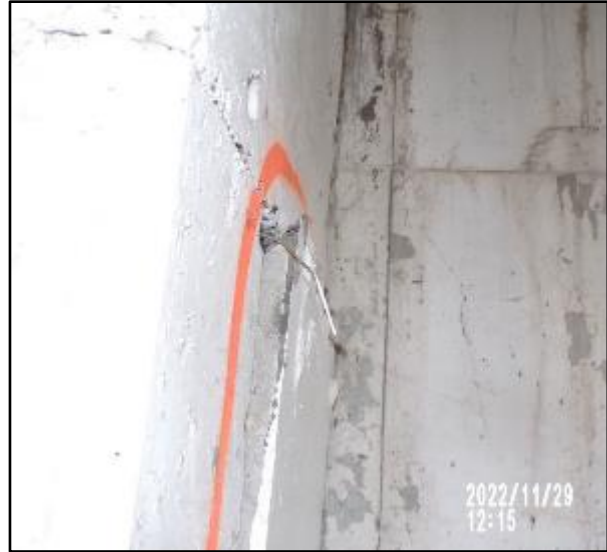
Column spall below beam at east foundation wall

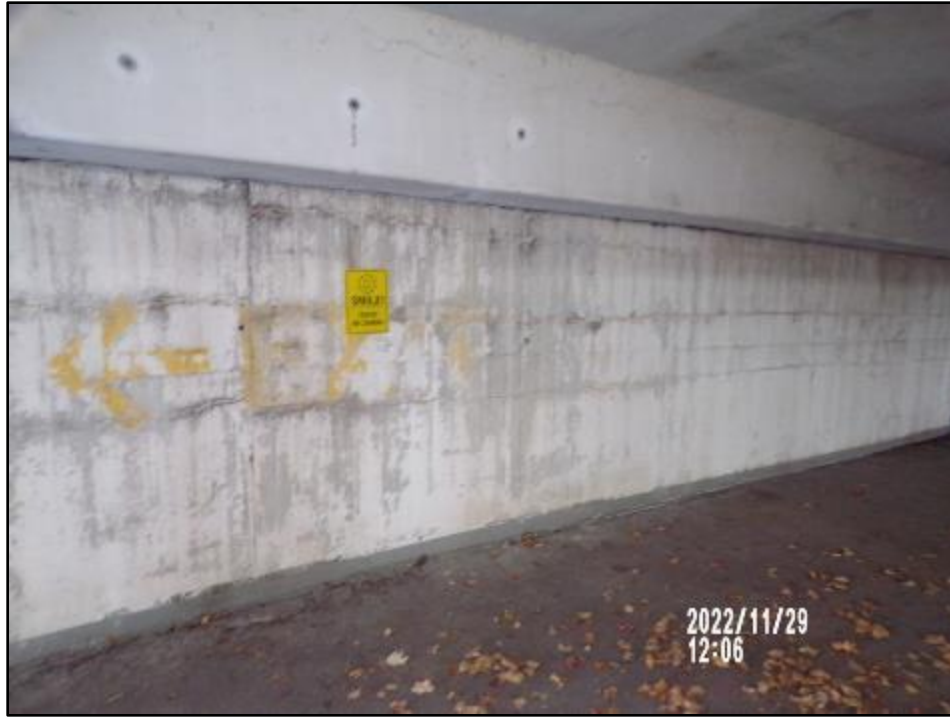
North foundation wall

- 2.8.1 Foundation walls were in good condition with some cracks and spalls noted.
- 2.8.2 Cracks did not appear to have water intrusion present and were less than 1/16th of an inch wide.
- 2.8.3 Exposed rebar observed at isolated spalls was corroded and not epoxy coated.
- 2.8.4 Vertical shrinkage cracks were noted on most exterior walls.

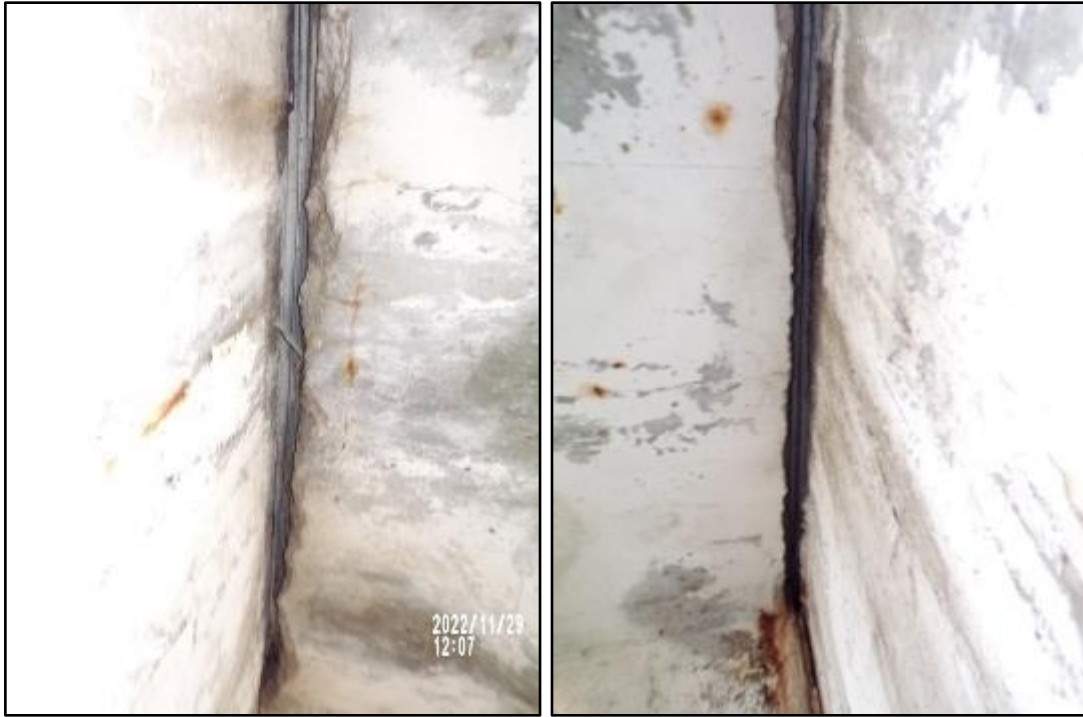
Level 3 Expansion Joint between Grid C east foundation wall on left and PT slab on right.
Photo taken on Level 2

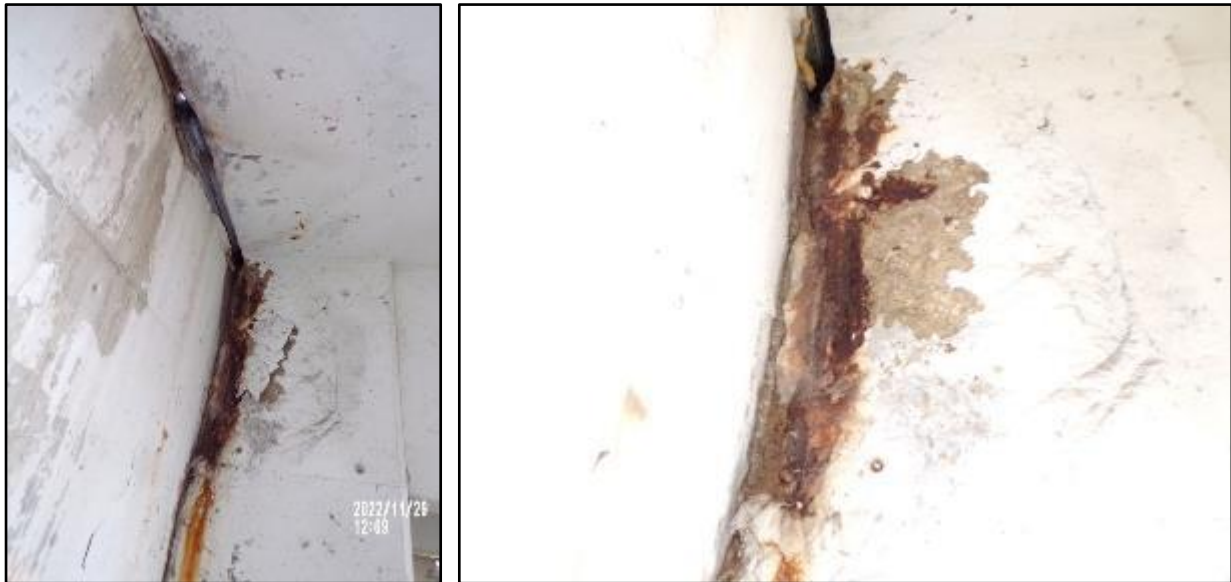
Loose concrete spall (left) removed (right)

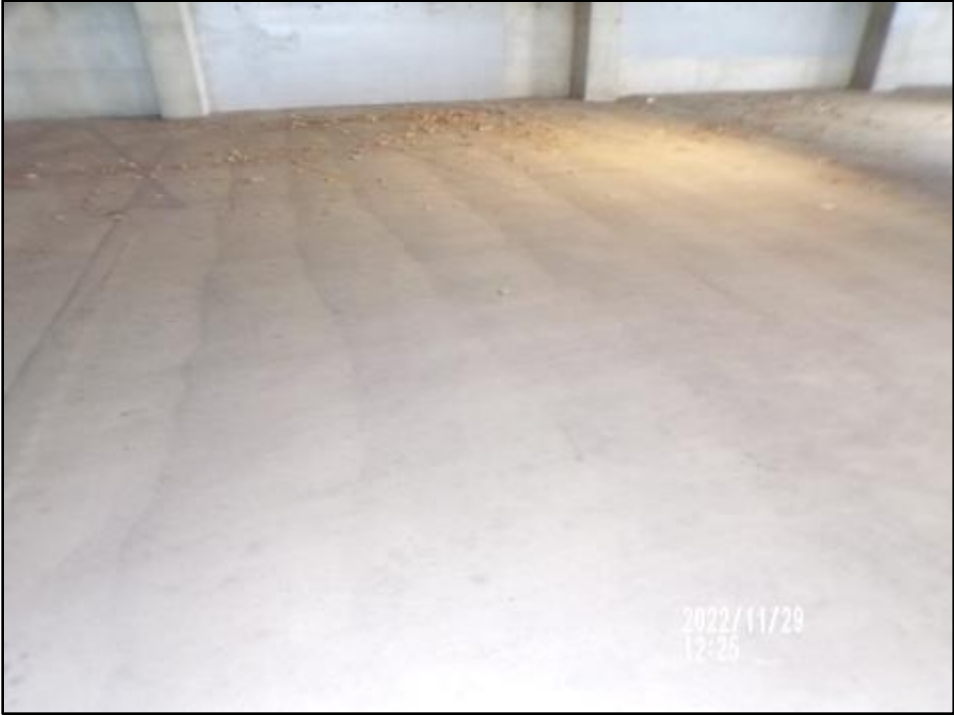
Level 1 slab on grade east side

- 2.9.1 The slabs on grade are in good condition with minimal cracking or settling noted.
- 2.9.2 Most of the cracking and settling occurred at the column/slab intersection point.
- 2.9.3 The finish on the slab on grade was a rough nonslip texture and appears to be original from finishing of the concrete.

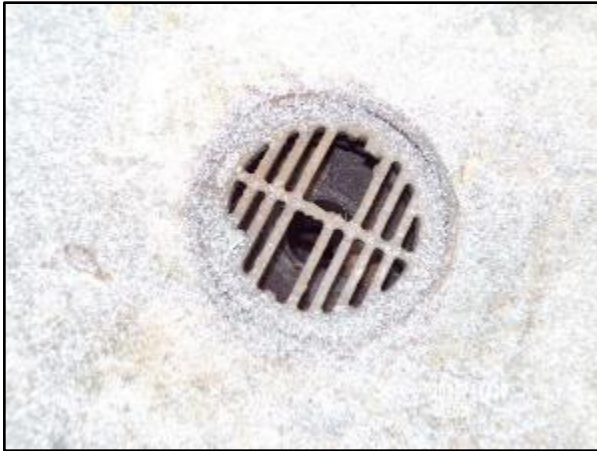
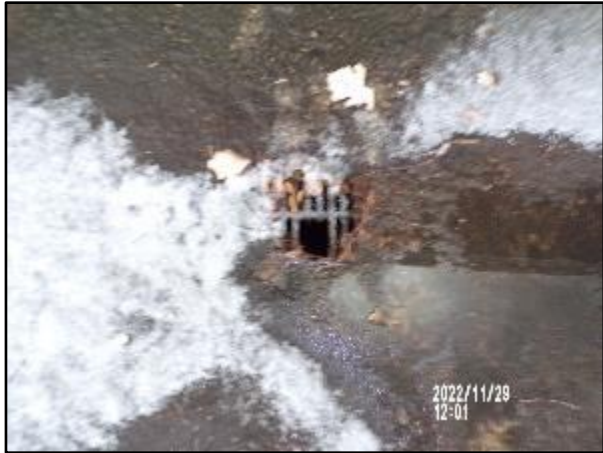
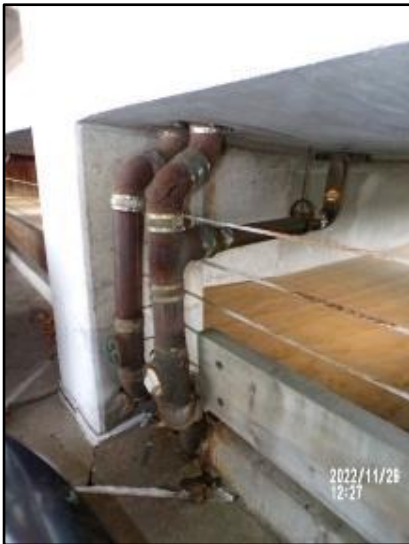
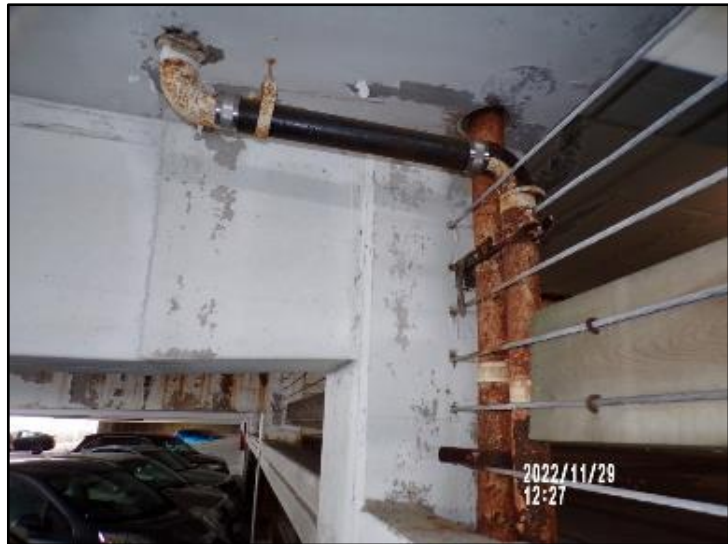
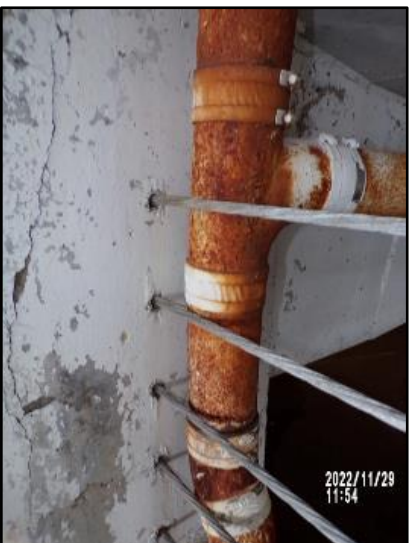
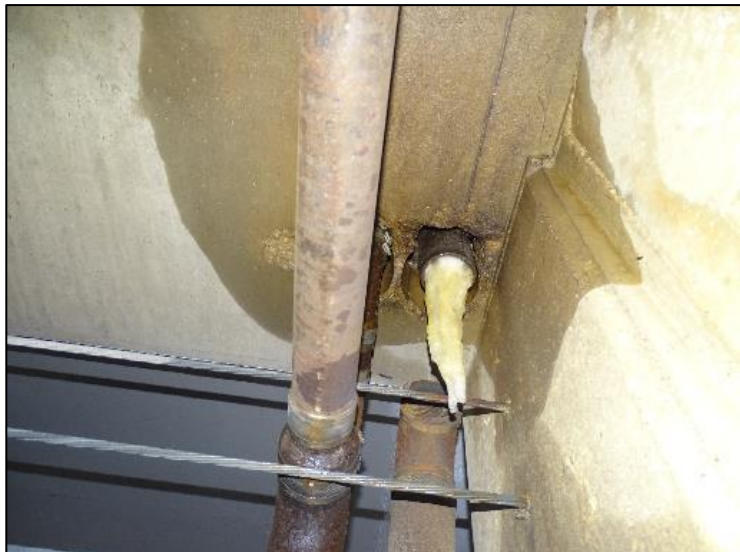
Slotted Drain Covers and Cast Iron Pipe Corrosion

- 2.10.1 The cast iron or ductile steel drainpipes are in poor condition with corrosion and evidence of water leaks at the fittings.
- 2.10.2 Some locations were missing portions of the pipe.
- 2.10.3 The drain covers were generally in good condition with only minor corrosion and damage observed.

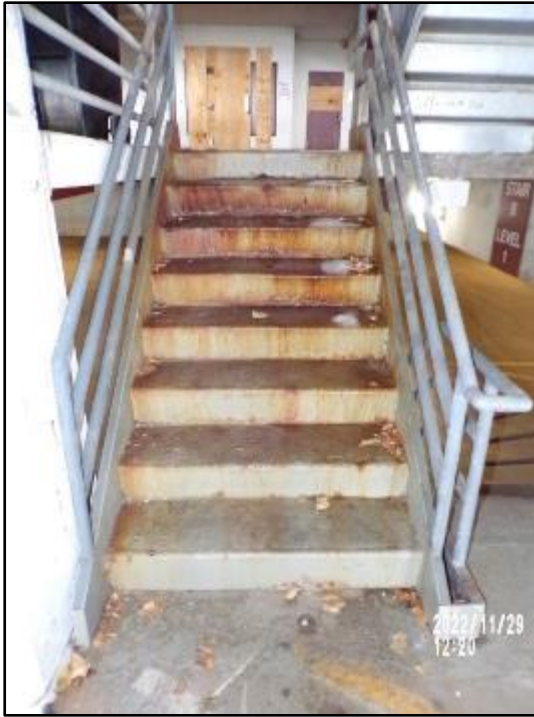
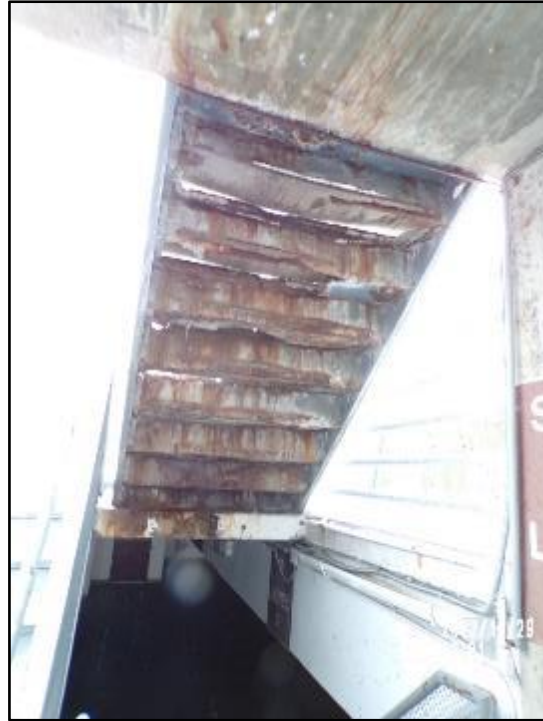
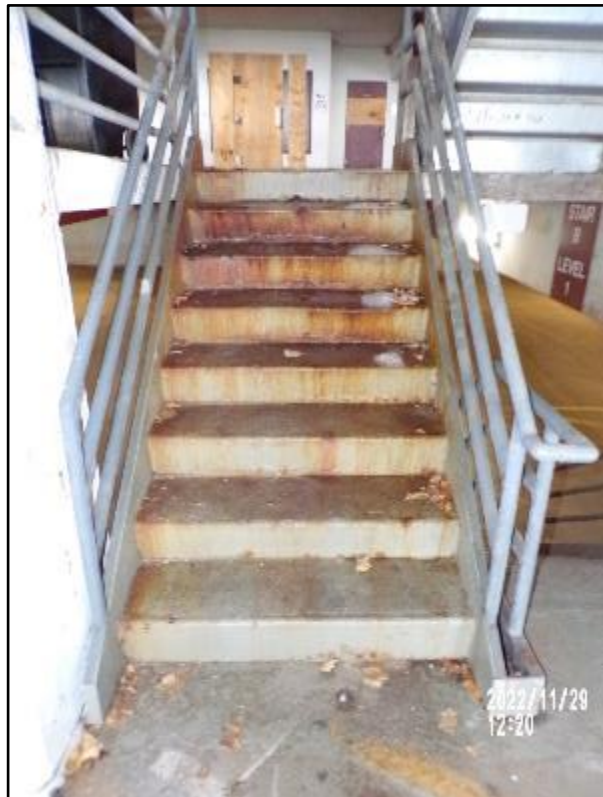
Metal Stairs

- 2.12.1 The metal stairs at the top levels of the parking ramp were in significantly corroded condition with some steel riser pan forms disintegrated and the filler concrete in the pan was missing.
- 2.12.2 These stairs had plywood placed over the damaged risers trying to make them accessible and able to be used.
- 2.12.3 The remaining stairs down to the lower levels were in varied condition but all of the stairs present showed signs of moderate to significant corrosion, water intrusion through them, and varied levels of deterioration of the concrete and/or metal structure.

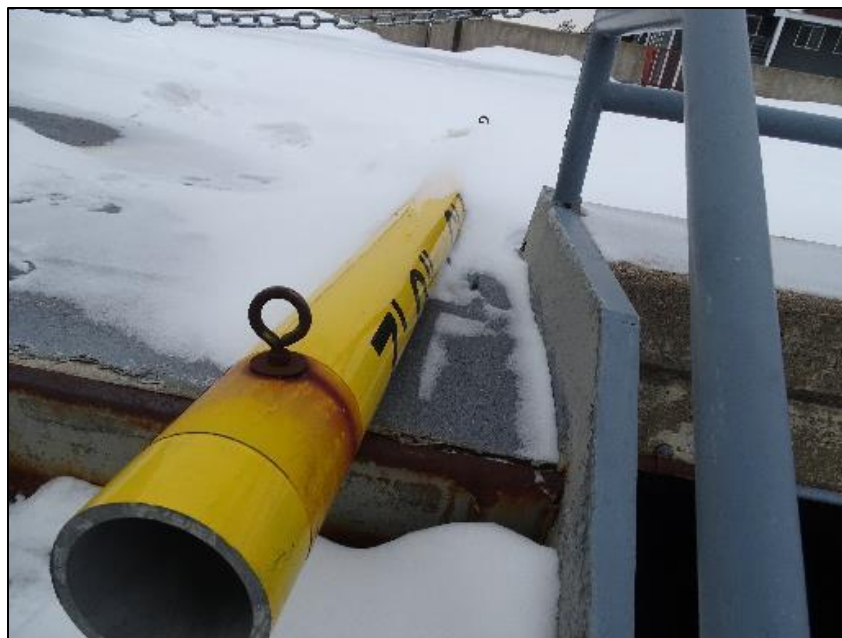
Height warning bar not installed
