# 548 Minnehaha Ave, St. Paul, MN

## Structural Observations and Report

September 20, 2022

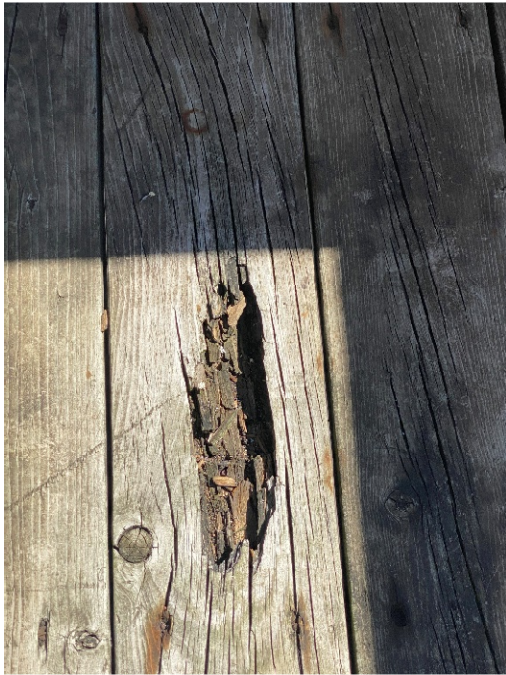
Example of deteriorated  
floor board

**Recommendation:** based on the amount of work needed to bring the fire escape within compliance we recommend it be removed and replaced with an engineered, code compliant, fire escape. This will likely require new framing members, foundations, bracing, and attachments to the home. An architect may be needed to address the egress requirements such as width of the stairs, tread rise and run and landing size. Additionally, the configuration of railings and other miscellaneous guarding will need to be determined.

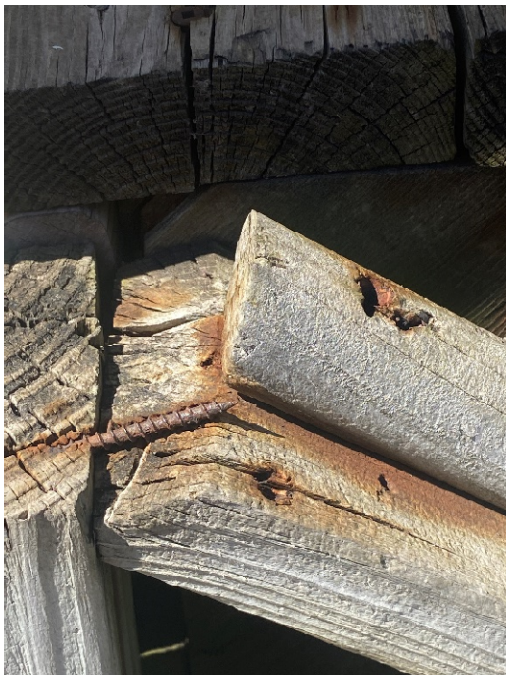
Example of split and  
loose hand rail

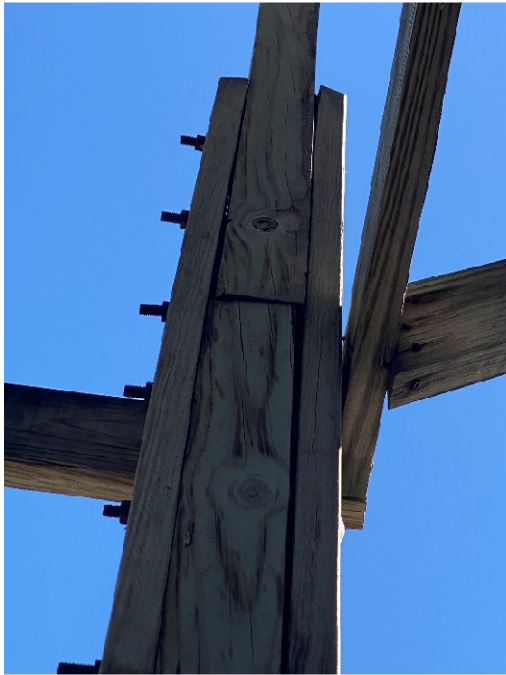
Generally, the quality of construction is also poor. Members are attached without light gage clips, bases, or hangers and the attachment to the home is by screws through the siding.

One of many poorly constructed connections.

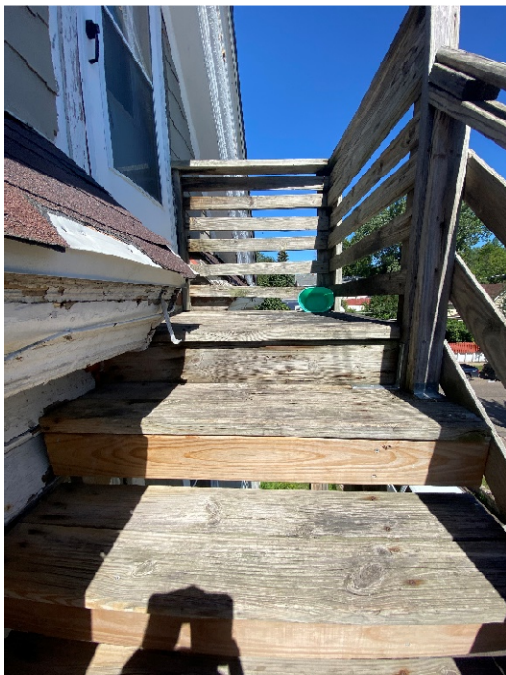
The fire escape serves an attic space and as a path of egress may not conform to the many aspects required under the building. This should be further reviewed by the building official or an architect.

Access through this area is constricted and may not conform to the building code.
