September 13, 2021

RE: Request for Appeal: Fire Inspection Correction Notice 35410
Versacold USA LLC /Americold
240 Chester Street
Saint Paul, MN

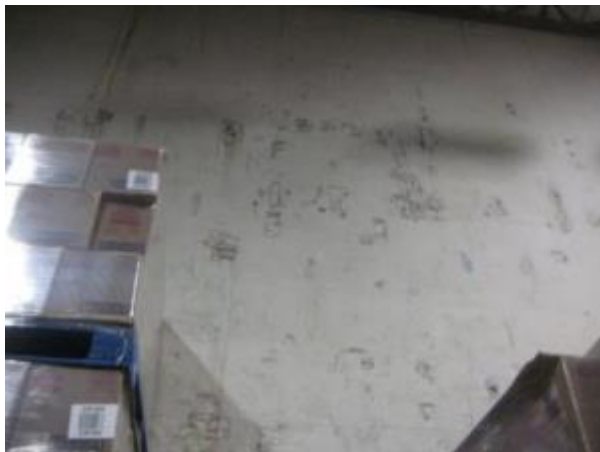
Freezer Wall – Exposed Expanded Polystyrene

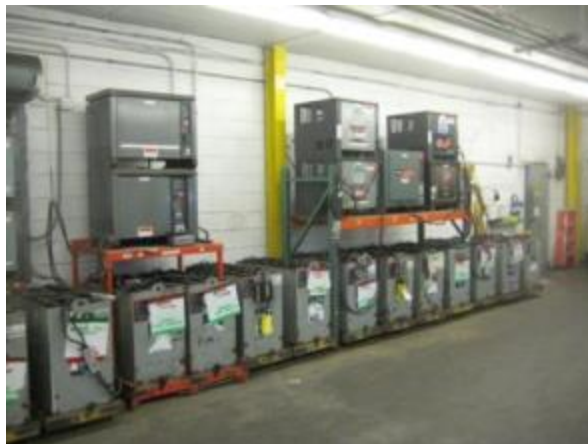
Forklift Battery Charging: The forklift battery charging area is located on the West Dock. There is no mechanical ventilation present. (To be installed in 2016.)

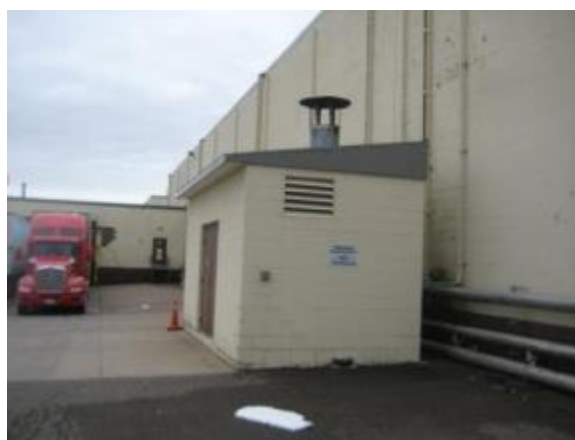
Boilers: There is a small natural gas fired hot water heating boiler located in a detached Boiler Building along the east wall of the 240 Building. This boiler used to be used to heat glycol that was circulated in a heating loop contained in the floors of the 240 Building freezers. However, this boiler is no longer used as it was found that the floors could be heated adequately by just circulating the glycol through the loop using one of two glycol pumps. But, the boiler is still fully connected and could be used.

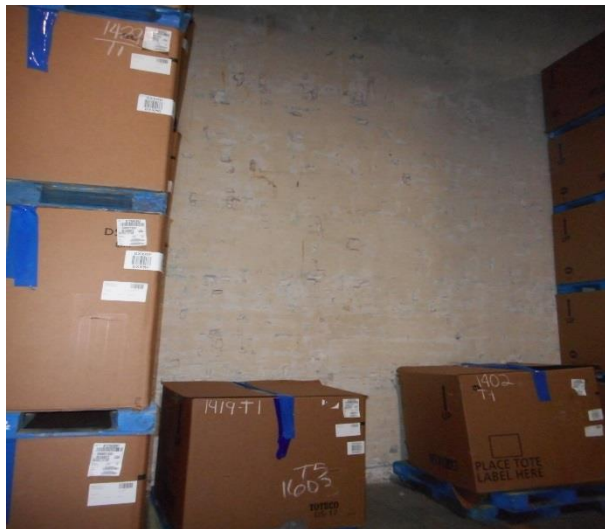
240 Building Freezer Wall – Exposed Expanded Polystyrene

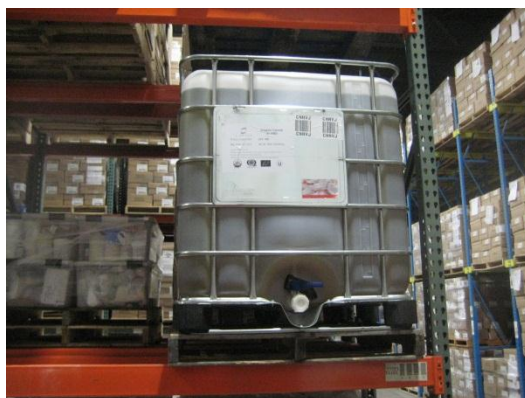
Canola Oil Tote in Rack – 2nd Tier

- Store in a detached building at least 50 ft. away from the main buildings.
- Store detached portable flammable liquid storage building that is UL Listed and/or FM Approved.
- Store inside the main building in an area that is fire isolated from the remainder of the building by at least 2 hour fire rated construction and is provided with spill containment capable of containing the entire contents of all containers.

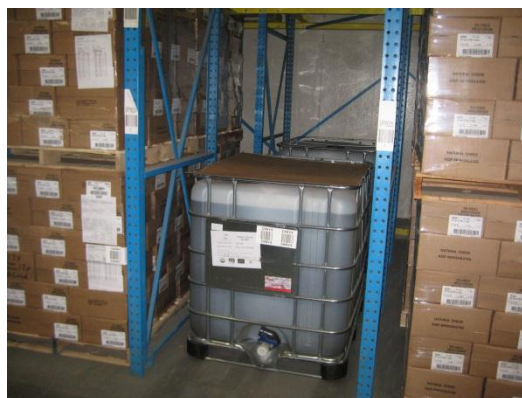
Canola Oil Totes in Rack

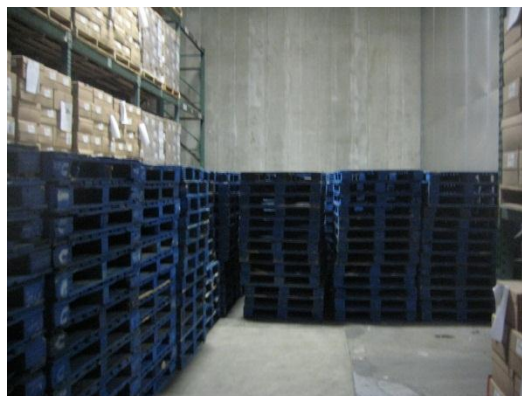
The idle wood pallets have been removed from the racks and stored on the floor no higher than 6 ft.

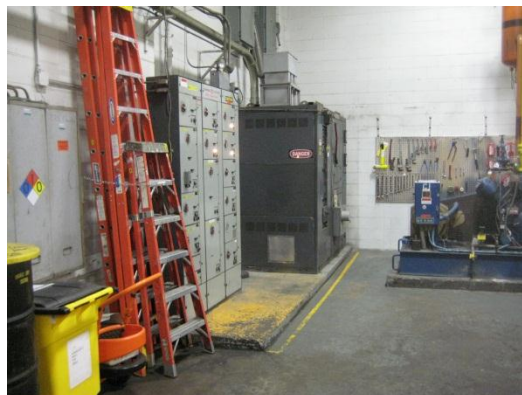
- M10-01 Maintain 36-inch clearance around electrical switchgear. Various materials were noted stored adjacent to MCC switchgear in Engine Room 1. To be done.

This recommendation has been completed by moving all combustibles 36 inches or more from the electrical panels.

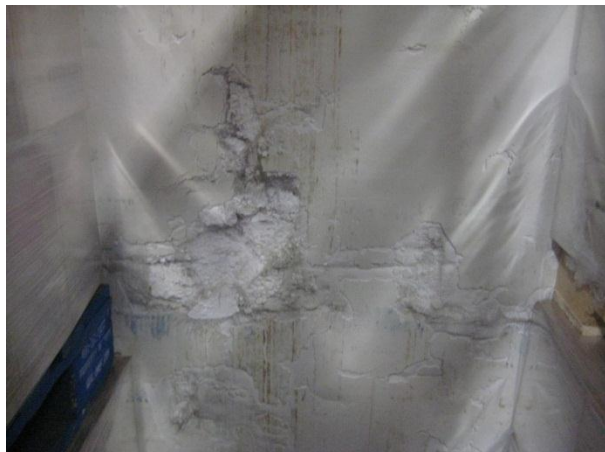
**Freezer Wall – Exposed Expanded Polystyrene**

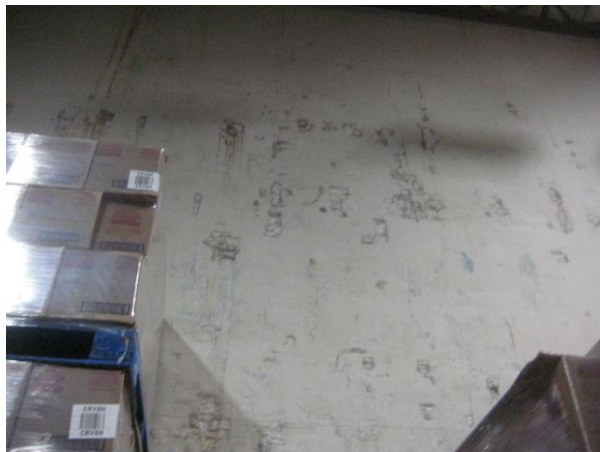
**Freezer Wall – Exposed Expanded Polystyrene**

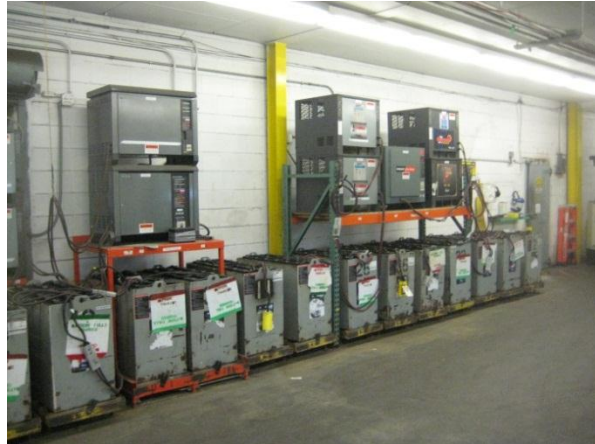
Forklift Battery Charging: The forklift battery charging area is located on the West Dock. There is no ventilation and this needs to be addressed.
