**Appeal of the Department Determination for  
934, 938, & 942 Ashland Avenue**

**Appellants' Exhibit 1**

## **Expert Report of John Trostle**

### **Violations of the Covenant of Habitability, Including Conditions that are Hazardous for Tenants' Health and Safety, at 934/938/942 Ashland Avenue**

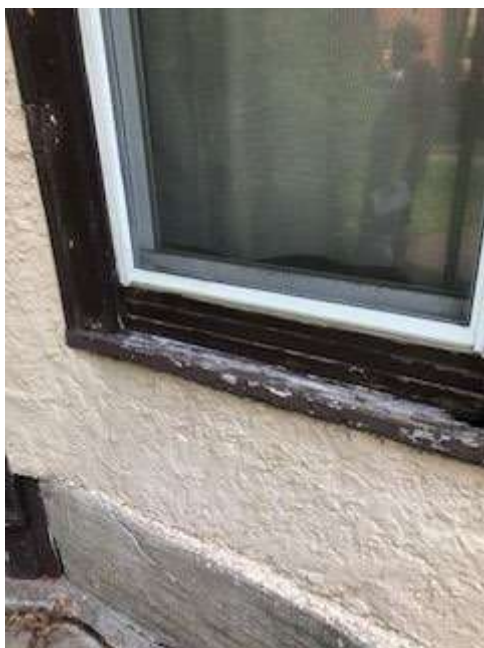
All three building exteriors have areas of wood rot and peeling paint in the siding as well as the wood trim at the doors and windows (see pictures 1-4, below). The gaps at the wood trim and casings cause ongoing water penetration and have contributed to the visible damage in the walls and ceiling cavities (as evidenced by conditions like wall cracks and bulging ceilings—examples of which are documented in pictures 26-28 later in this report). These gaps also present the significant danger of mold developing, or having already developed, in wall and ceiling cavities at common areas and tenant units, which may not yet be visible at the surface. Furthermore, there are gaps present at some upper eaves to the buildings where metal fascia has pulled away from the bottom edge of the roofing.

3: Rotting/peeling exterior trim

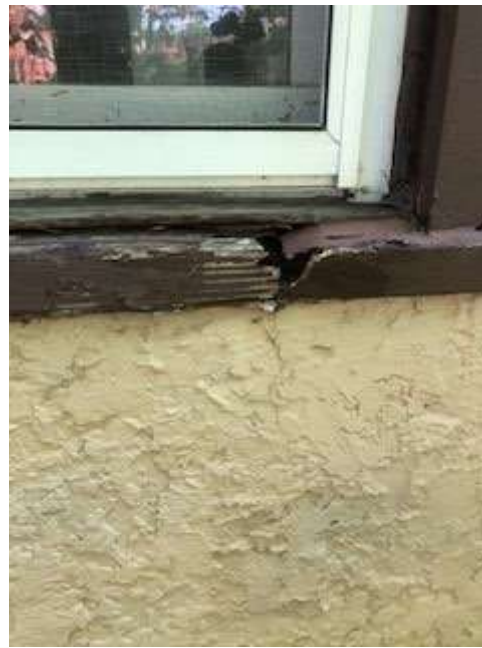
4: Rotting/peeling exterior trim and cavity

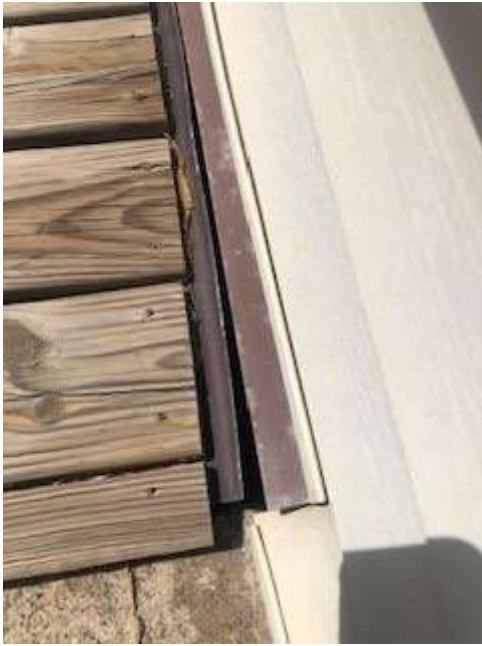
Additionally, Building #938 features a rear stairway that has a broken step, loose handrail, damaged stringer support, and separation at the entrance to the adjoining unit. Building #942 features another rear wooden balcony that is extremely wobbly and separating at the adjoining unit entry. See pictures 5-7 for examples of these conditions. A video of the condition of Building #942 balcony is included with this appeal as “Trostyle: shaking upper rear balcony video.”

5: Wooden balcony separating from siding

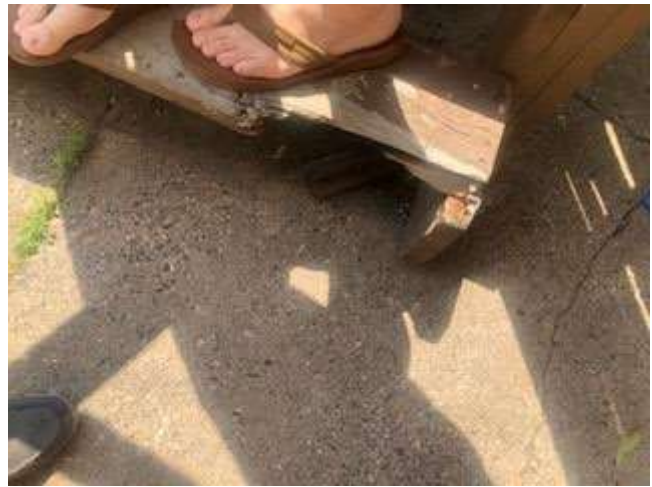
6: Broken step at rear stairs to unit entry

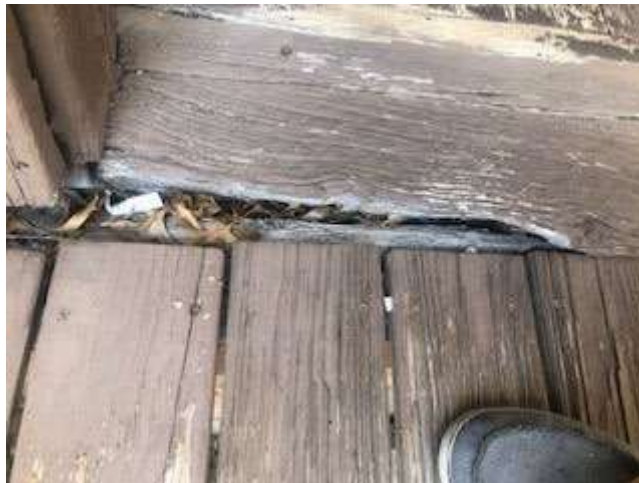
7: Cracked wood at top step for rear stairs to unit entry

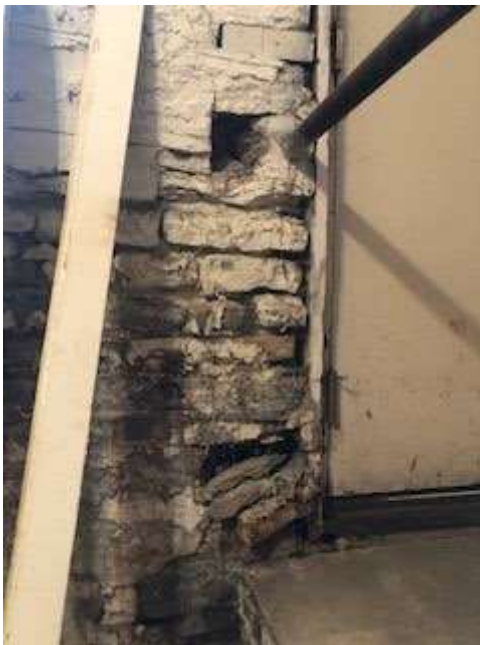
The foundations of each of the three buildings comprising the Ashland Apartments are stone, with some areas of concrete block. My inspection revealed significant wear and large openings at the stone foundations and parge coats (see pictures 8-11). Because the stone contains lime, the mortar joints tend to deteriorate over the many decades after the buildings were constructed, and simply repairing the visible worn mortar areas will likely not completely correct the water infiltration issues. This is due to the visible damage at the concrete step pathways between buildings and mortar wear not presently exposed (see pictures 13-14).

8: Settling and holes in foundation

I strongly recommend that the foundations of all three buildings be evaluated by a contractor specializing in foundation and structural issues. It is clear that the buildings are actively settling and a patchwork approach to the repairs to the foundation and concrete steps between buildings will not correct the water infiltration problems. Importantly, the foundation settling poses a risk to tenants through its perpetuation of existing issues like water seepage causing flooding and mold, cracks in walls and ceilings, and uneven floors. Picture 12, below, demonstrates the flooding that regularly occurs during rainstorms in the basement of Building #934 (in the storage area serving Unit 5) due to the severe foundation issues.

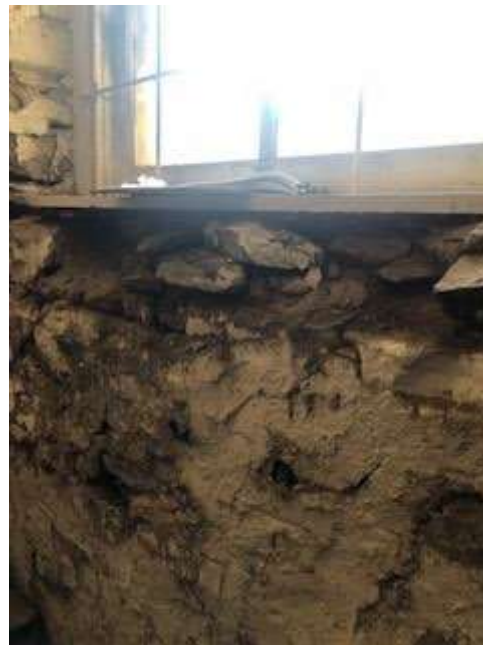
9: Deteriorating foundation at basement window

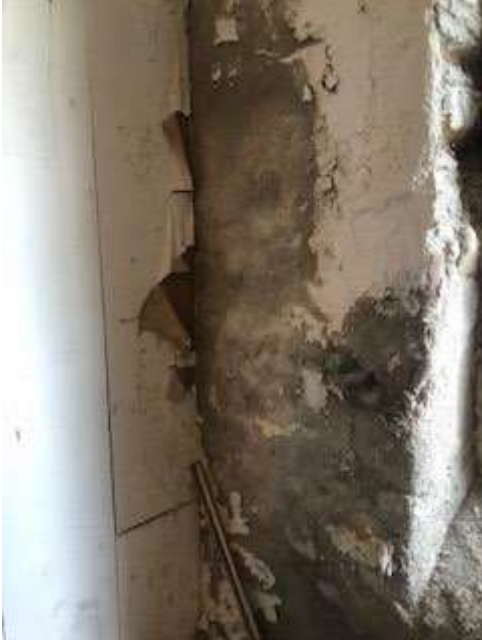
10: Flaking paint and worn foundation

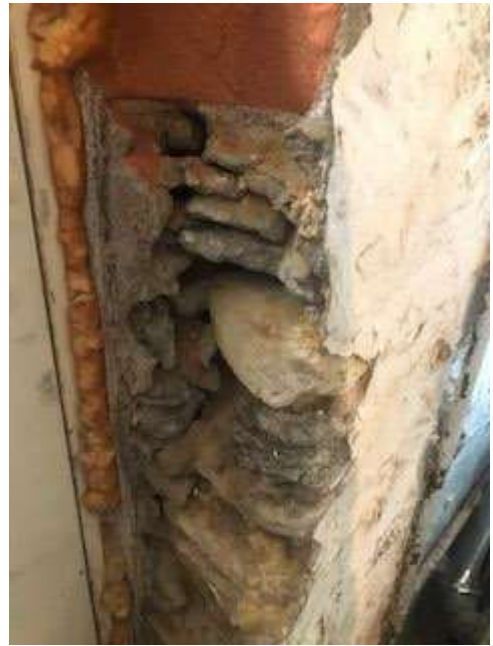
11: Settling foundation with holes

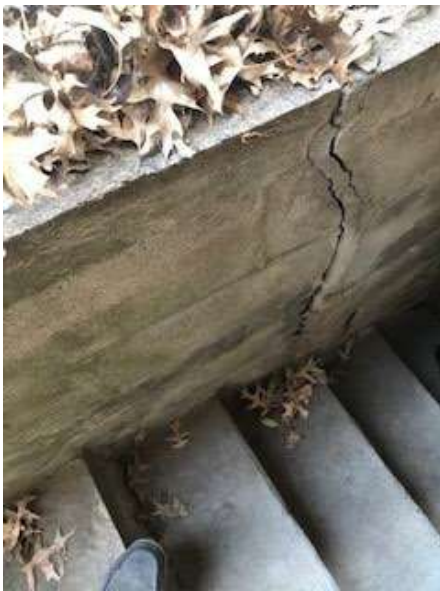
Cracks, damage, and gaps at wall joints to exterior concrete steps are contributing to water infiltration (see pictures 13-15).

13: Cracks at concrete steps to Unit 5

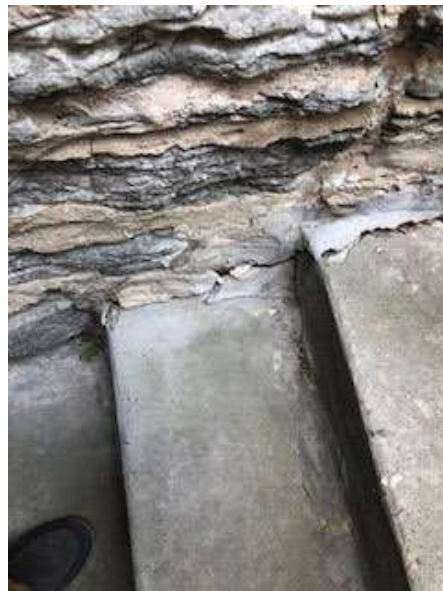
14: Mortar gaps at concrete steps to Unit 5

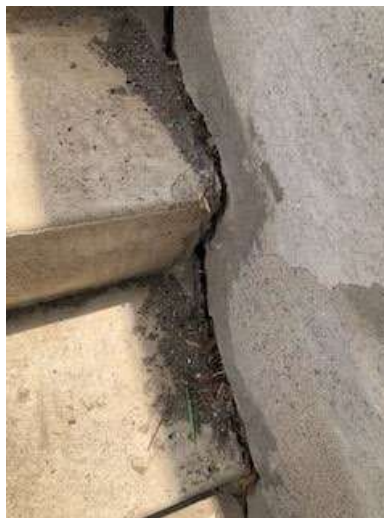
15: Mortar gaps at concrete steps to Unit 5

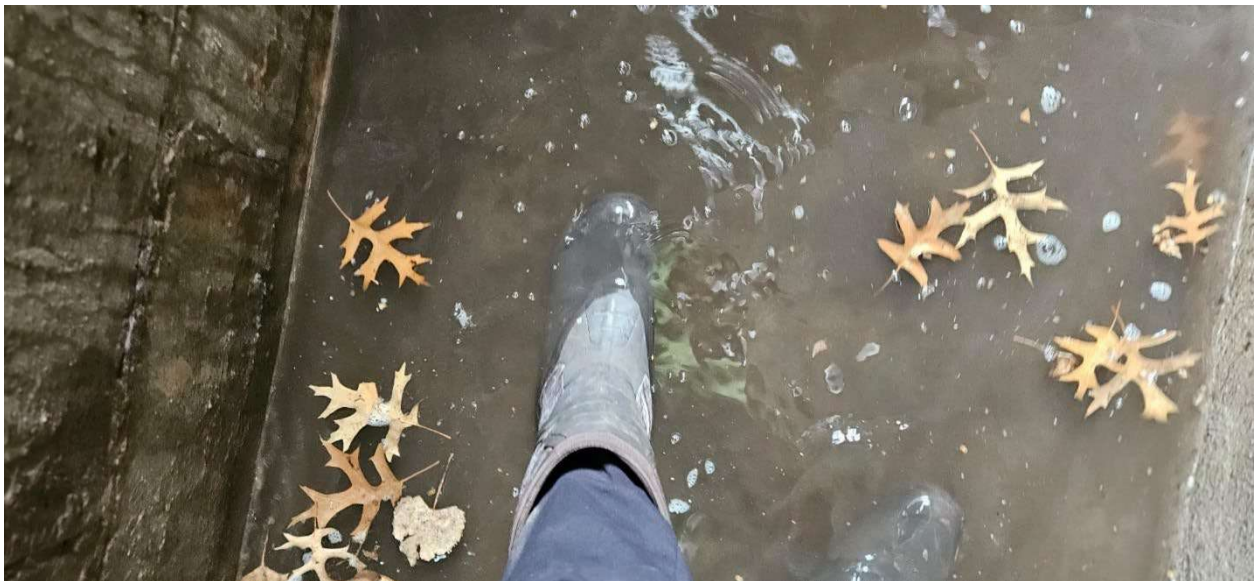
As shown in pictures 16-17, the entryway to Unit 5 in Building #934 (the basement unit) experiences upwards of several inches of flooding during rainstorms due to the infiltration of water through the foundation and cracks in the steps, as well as the lack of drainage at the base of the steps. Picture 16 illustrates the active streams of water coming through gaps in the wall and pooling at the entryway. This flooding—along with the subsequent standing water at the unit entry and the water infiltration into the unit, causing mold and flooring damage—constitutes a danger to tenants and visitors' health and safety, including children who are present in the basement unit.

17: Several inches of water from flooding at entry to Unit 5  
(photograph taken by Mr. Cornell on June 16, 2025)

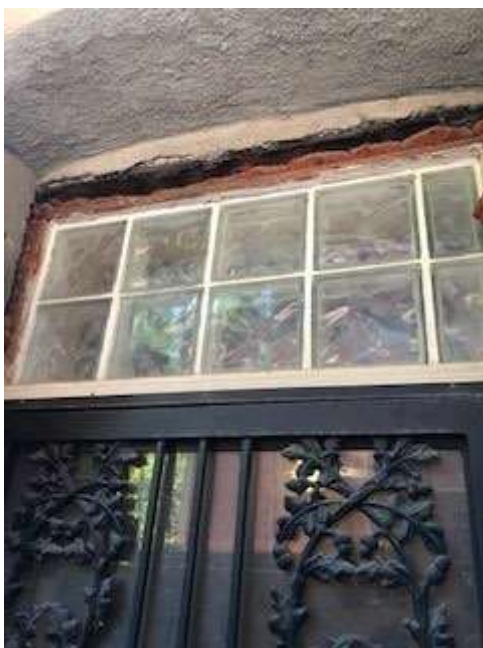
Due to settling, the exterior door to the laundry room and several individual units with primary doors to the exterior have gaps which must be corrected to seal properly (see picture 18).

18: Gaps at glass above exterior door to Unit 5

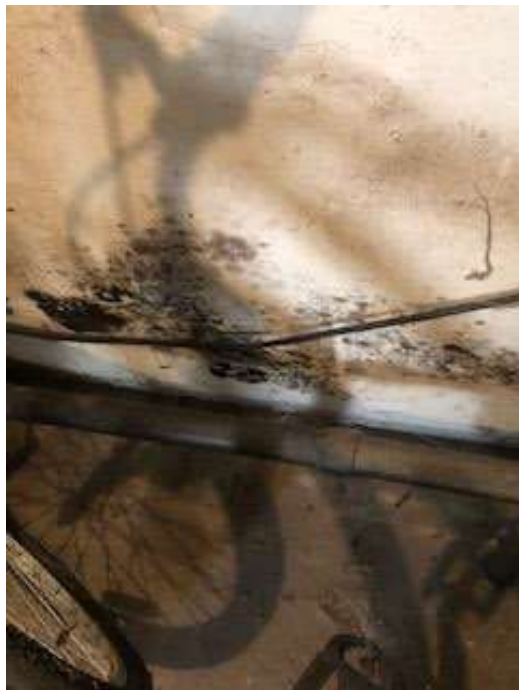
In the laundry room within Building #942, which serves all tenants, there exist highly concerning areas of mold spotting (see pictures 19-20). This appears to be black mold, which poses

a severe threat to tenants' safety when they are using the laundry room and breathing in spores present in the air. In addition to the mold, the walls of the laundry room are otherwise damaged and stained. These are plainly dangerous conditions and some of the most concerning within the buildings.

19: Mold at laundry room walls

With specific regard to the mold issue, it is my professional opinion that the Ashland Apartments will remain in their current dangerous condition without moisture/mold testing in all exterior wall cavities as well as significant abatement efforts for all visible mold in tenant units and common areas like the laundry rooms. I do not believe that this pervasive issue will be resolved without such property-wide efforts by a qualified professional.

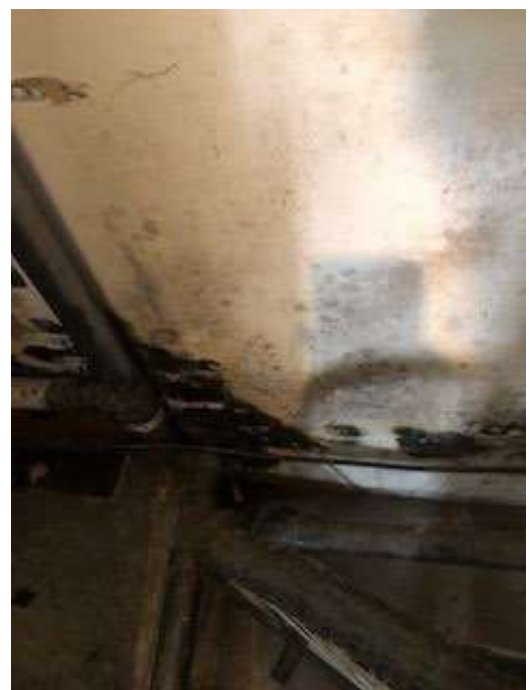
20: Mold at laundry room walls

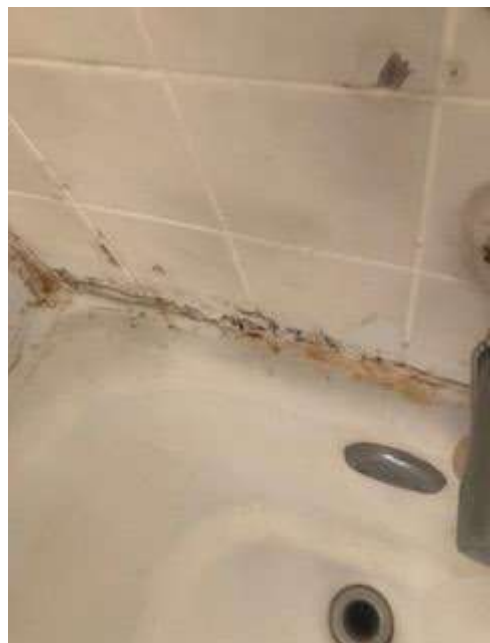
Tenant units accessed in all buildings have various problems related to their walls and ceilings. For one, I observed multiple instances of mold inside units, including on baseboards and in unit showers (see pictures 23-26). There are also many settling cracks and bulging within units, likely due to the buildings' foundation problems (see pictures 27-29). I observed other instances of neglect like peeling paint and staining. I also discovered loose wall panels in tenant units in areas like behind the stove, in bedroom closets, and in shower tubs.

24: Mold and deterioration in unit shower

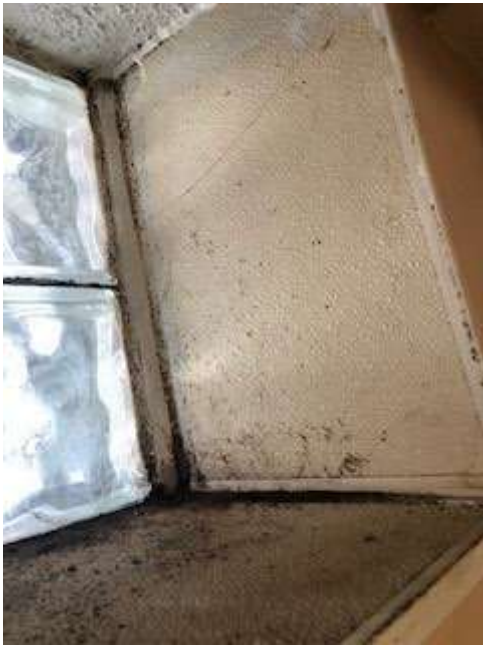
25: Mold at glass block window in unit shower

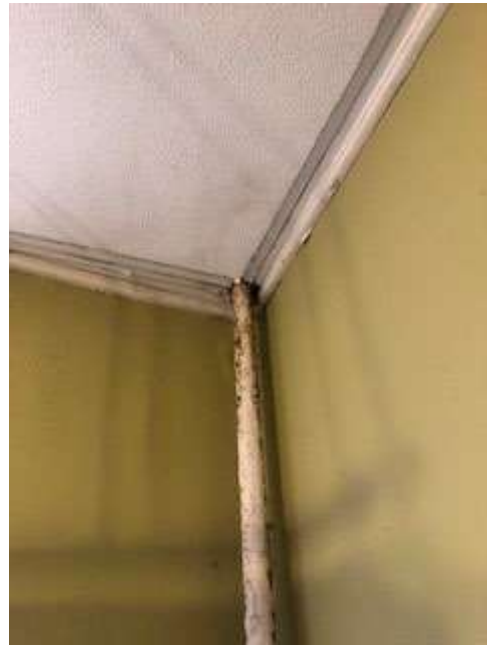
26: Mold/rust on exposed pipe

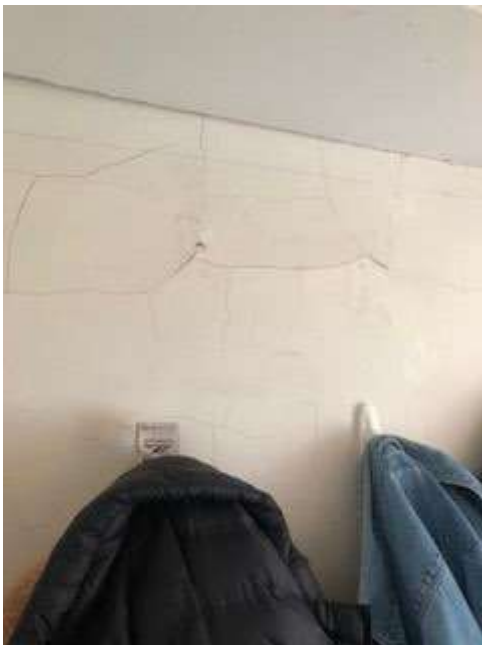
27: Wall cracks in tenant unit

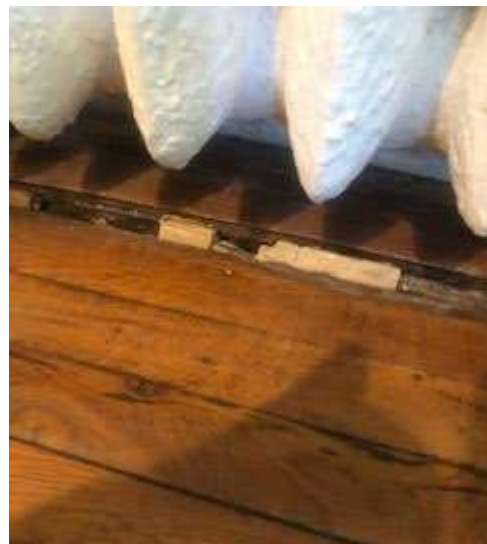
My inspection revealed problems with the flooring in all observable units. Specifically, I found flooring that was significantly damaged, settled, cracked, or completely missing in some corners (see pictures 30-32). There are also instances of shoddy repairs using duct tape (see picture 33), and loose hardwood flooring in all units. Additionally, there are loose and damaged kitchen floor tiles present in Unit 6 within Building #938.

31: Crack in floor under radiator in tenant unit

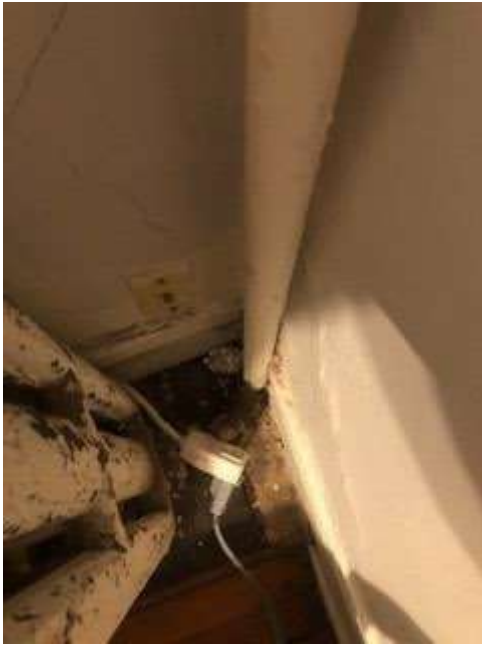
32: Missing flooring in tenant unit

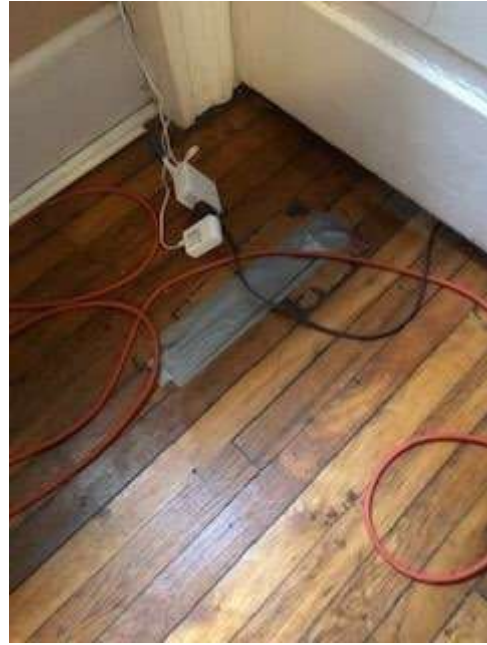
33: Tape to repair flooring in tenant unit

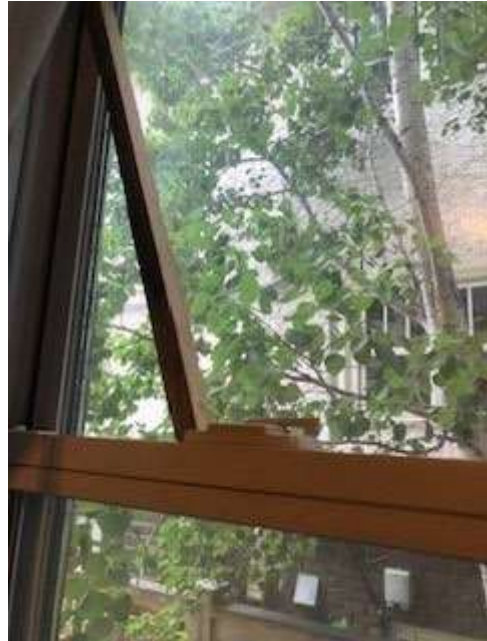
In Unit 11 within Building #942, the upper sash of a living room window is slipping (see picture 34). This means that the upper portion of the window is unable to stay up and closed, and this tenant has had to wedge a wooden post in the window to ensure that it remains closed. I observed other units where tenants have had to use wooden posts to keep their windows closed, such as Unit 9 within Building #942 in which the upper sashes of the bedroom windows are slipping (see picture 35). Additionally, the upper sashes of windows in the living room and kitchen are sagging in Unit 1 in Building #934, though the tenant has not used posts to keep them up.

35: Tenant window held up by wooden post

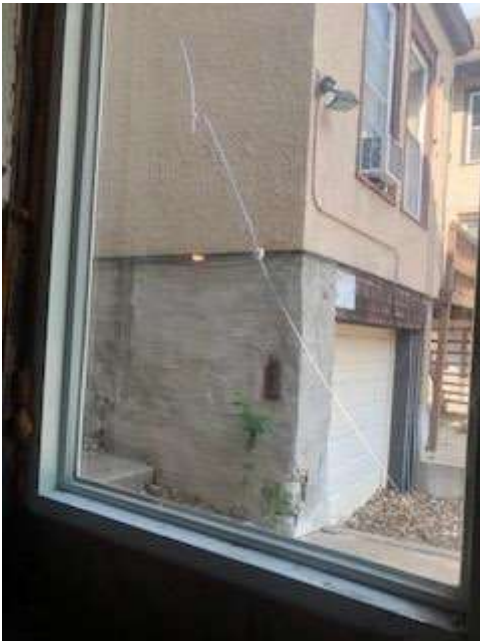
In Unit 6 within Building #938, the living room window glass is cracked and the rear bedroom windows have damaged tilt pins. The laundry room window in Building #942 is also cracked with a small hole that indicates an apparent BB-gun shot or similar incident (see picture 36). In Unit 10 within Building #942, the kitchen includes one window with a large hole in the broken glass (see picture 37), as well as another window with an upper sash that slams down and will not stay closed.

36: Cracked window in laundry room

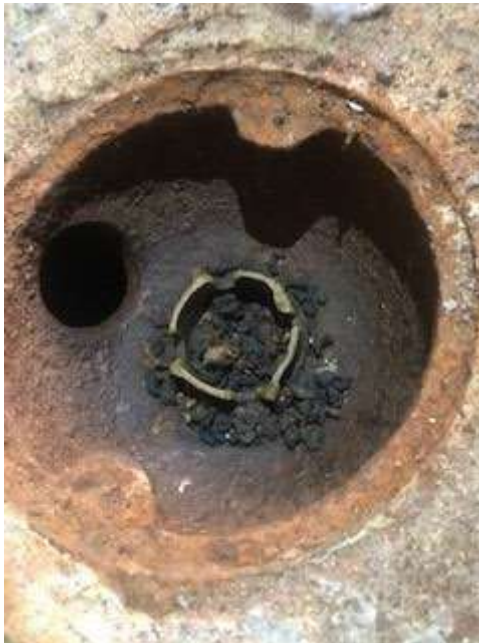
The floor drain in the basement area of Building #934 (which serves as a storage and gym area for Unit 5, seen above with flooding in picture 12) has another clogged floor drain with missing clean-out plug (see picture 40). Again, the lack of a clean-out plug allows sewer gas and smells to enter the space, posing a risk to the health of the Unit 5 tenant who regularly uses this area and has children. I also observed an uncapped plumbing vent pipe sealed with a rag in this room.

40: Unit 5 storage area floor drain missing clean-out plug

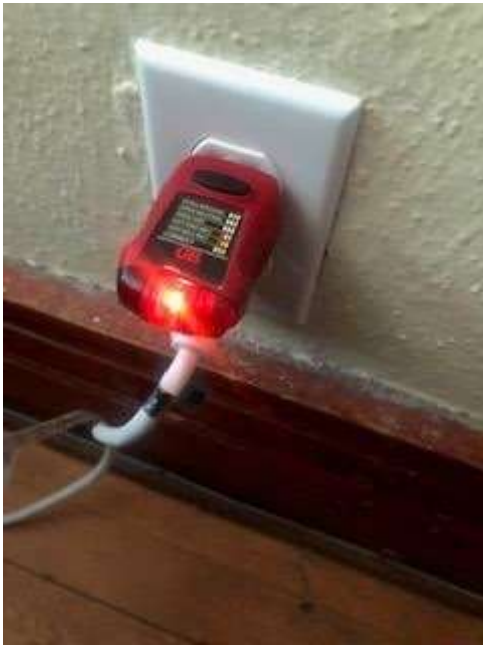
In the laundry room and other basement spaces open to tenants, I observed missing covers at electrical boxes, resulting in exposed wires (see pictures 41-42). In Unit 11 within Building #942, there are open ground 3-prongs at the electrical receptacles in the living room, front bedroom and dining room, which can pose a risk of electrical shock to tenants and damage to electrical appliances (see picture 43). Unit 11 also requires smoke and carbon monoxide detectors in the hallway. In Unit 9 within Building #942, the living room fan light severely wobbles when the fan is running, and is missing a globe cover (see picture 44). Many lights within tenant units have missing covers and globes (pictures 44-45).

43: Testing unit showing open ground outlet

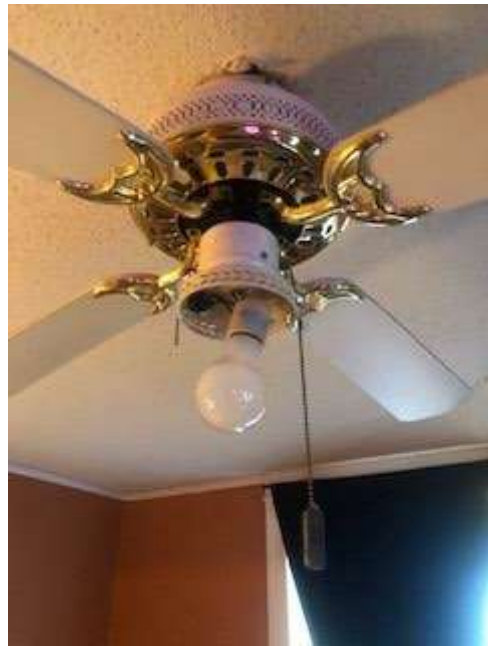
44: Wobbly fan in tenant unit w/o cover

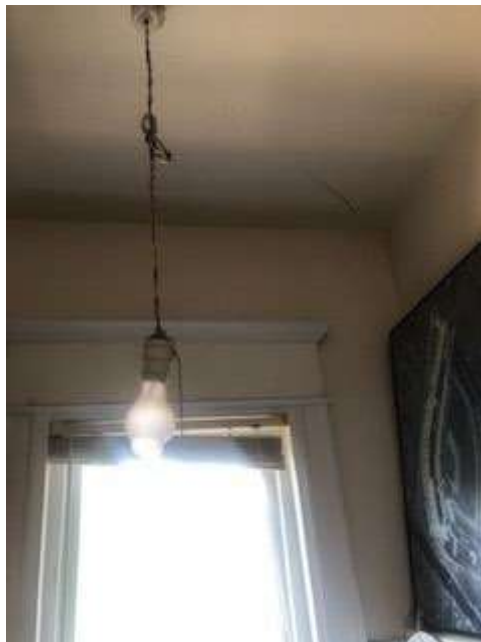
45: Light in tenant unit w/o cover
