**DONAN**<sup>®</sup>

**CLAIM NUMBER: 007483705-004  
DONAN PROJECT NUMBER: 32-21010031-0**

**JANUARY 29, 2021**

On January 26, 2021, a study was made on the duplex unit at the above-referenced address. The purpose of the study was to determine the extent of structural damage from a fire and provide repair recommendations. Mr. Sergey Tkach of Lifetime Builders, LLC, a representative of the owner, was present to point out areas of concern and to provide firsthand information. This letter, with the enclosed photographs, is the report of my findings and conclusions.

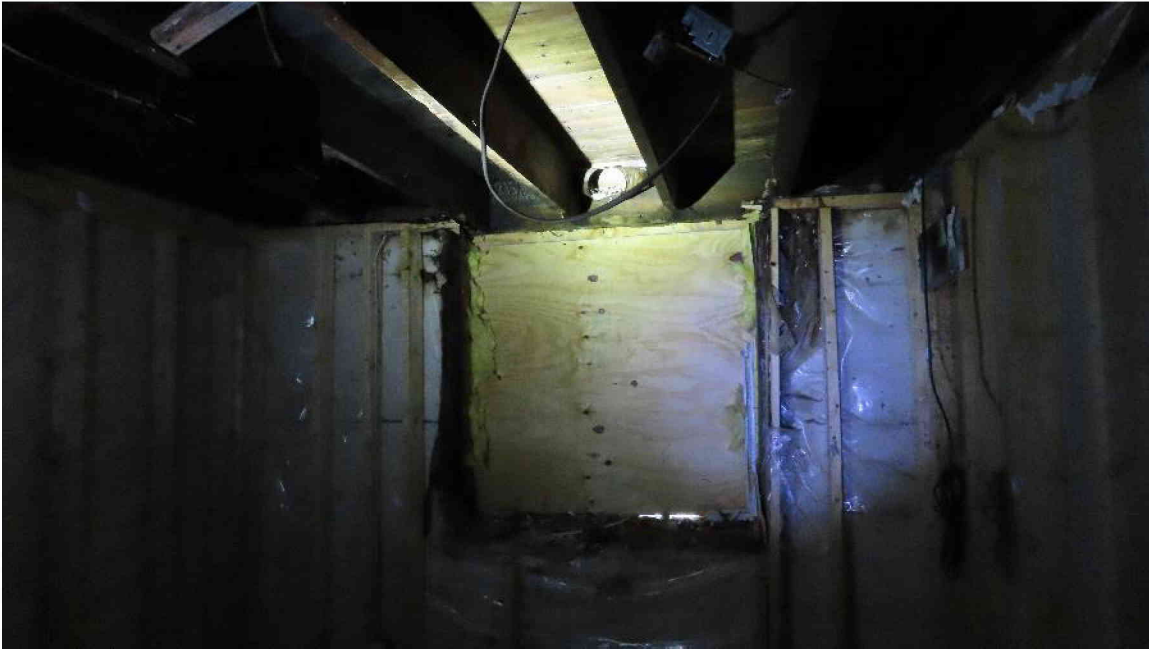
The reported source of the fire is in the northwest basement bedroom. The window on the north wall is boarded up, and the window header is missing (Photographs 5 and 6). Five exposed floor joists and floor decking near the window are charred and soot-stained (Photograph 7).

Photograph 5: Boarded up window in the northwest basement bedroom.

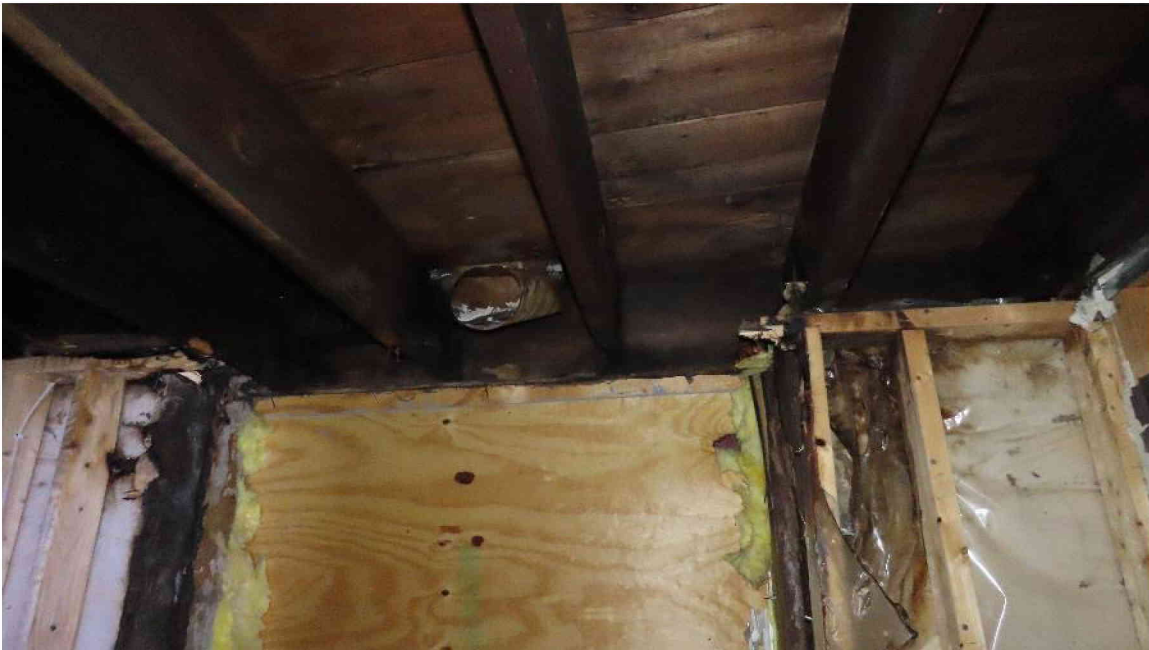
Charred floor joists and floor decking is at the northwest basement bedroom ceiling. The basement window header is missing. Soot and smoke-stained wood framing are at the north wall of the basement. The floor joists and decking and the window framing in the northwest basement bedroom are structurally damaged from the fire.

Photograph 6: Window header is missing.

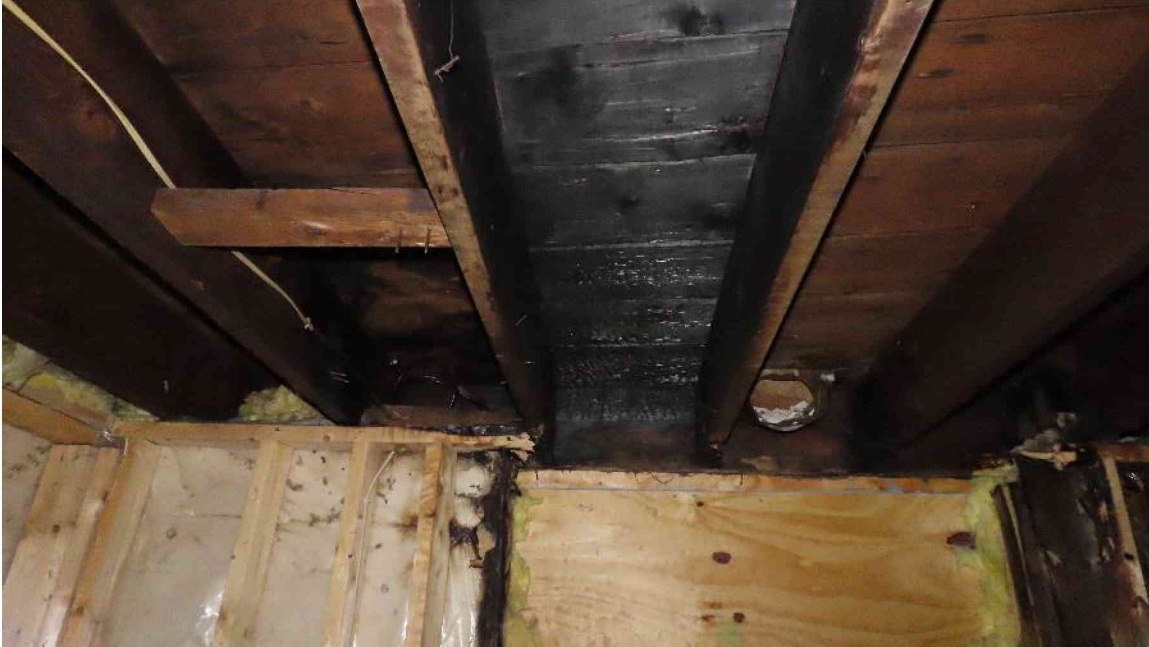
Photograph 7: Charred floor joists and decking at the northwest basement bedroom.

The charred floor joists and decking at the northwest basement bedroom and the charred wall sheathing at the north door require replacement. The kitchen floor joists with saw cuts can be reinforced by “sistering” to restore pre-loss structural strength.<sup>2</sup> Other non-structurally damaged smoke and soot-stained framing can be cleaned or replaced to mitigate the odor. Additional drywall may need to be removed from the north wall for thorough cleaning and odor mitigation.

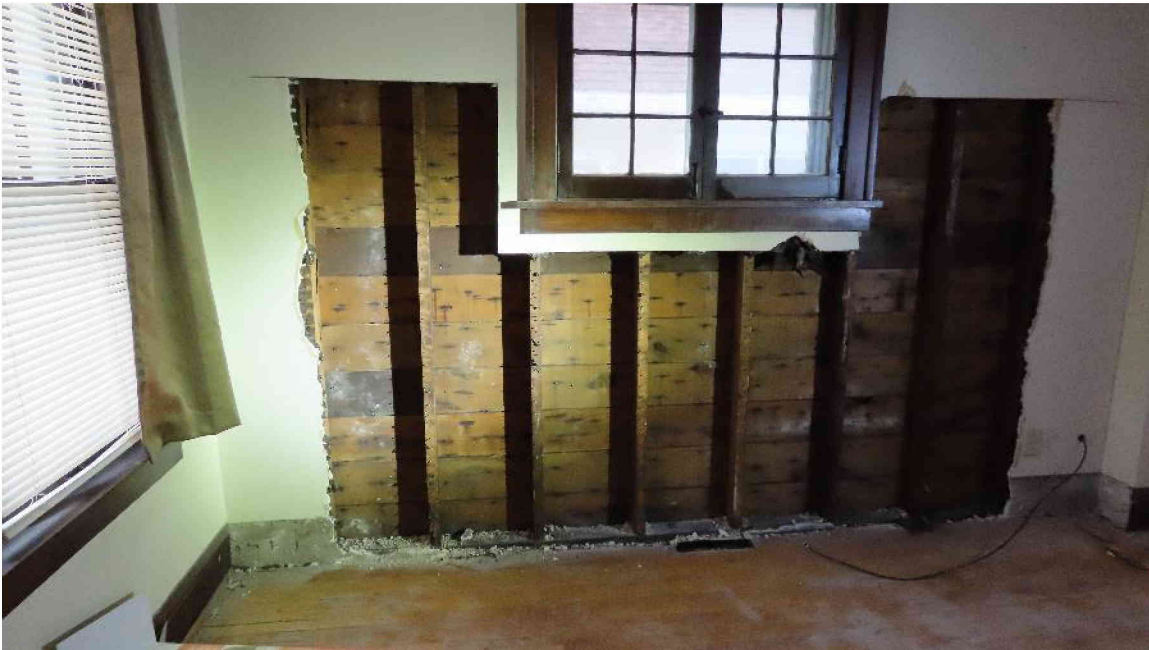
The living room is at the northwest corner of the first level. Drywall has been removed from the north wall in the living room, revealing soot-stained framing (Photograph 8 and 9). The dining room is east of the living room. Drywall has been removed from the wall below the window on the north wall of the dining room, revealing soot-stained framing (Photographs 10 and 11). The framing in the living room and dining room is not charred.

Photograph 8: Drywall removed from the north wall of the living room.

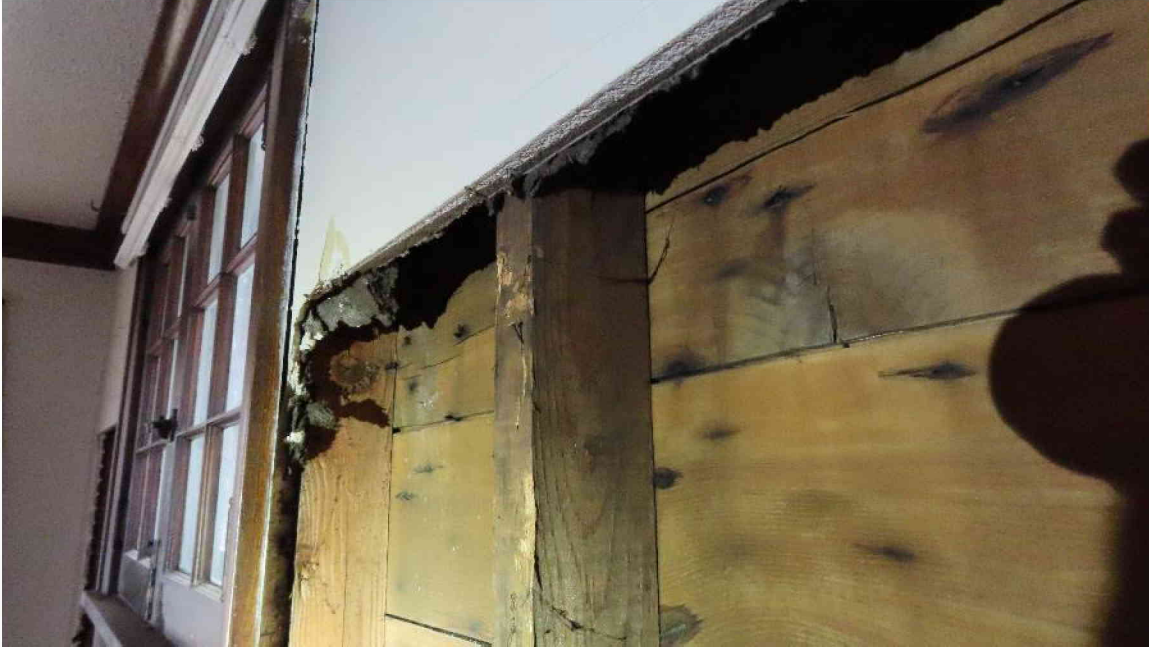
The exposed framing on the north wall in the living room and dining room are soot and smoke stained but are free of char. The exposed floor joists in the kitchen are free of char. No char, soot, or smoke stains are on the rafters in the

Photograph 9: Soot stained wall framing.

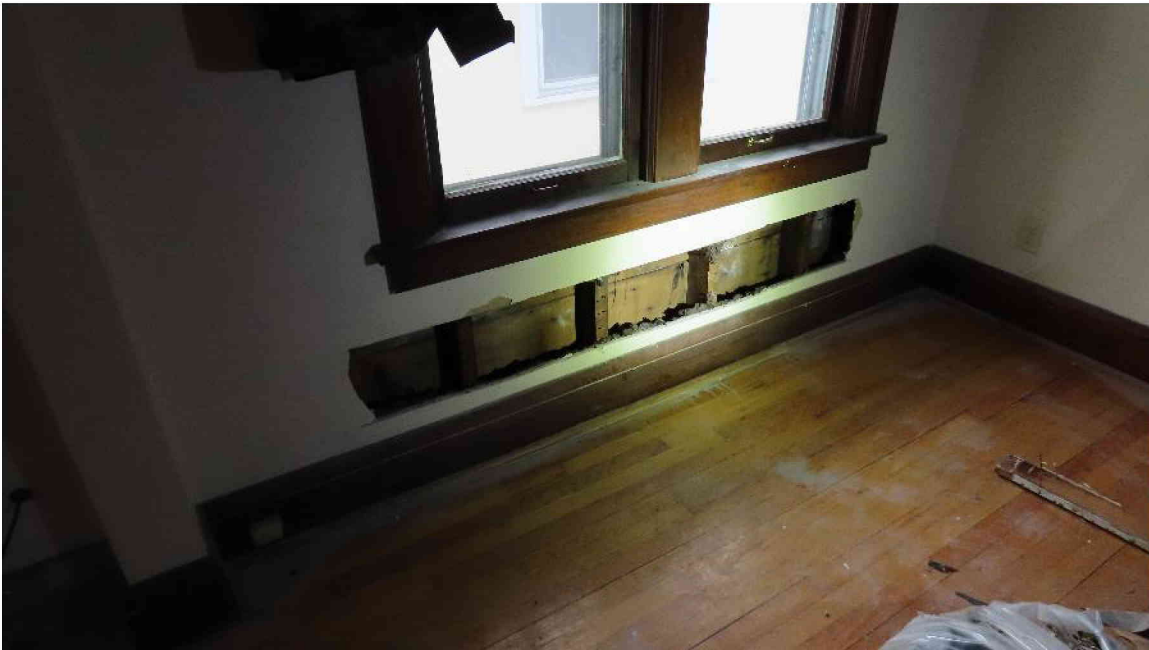
Photograph 10: Drywall removed from the north wall under the dining room window.

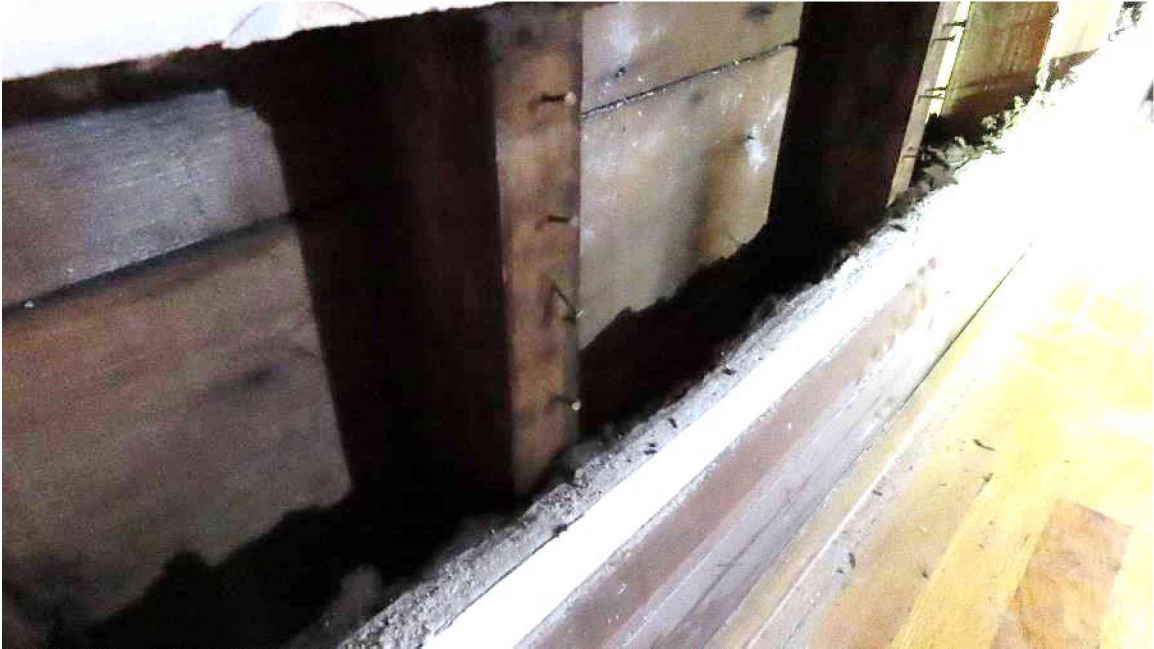
Photograph 11: Soot stained wall framing.

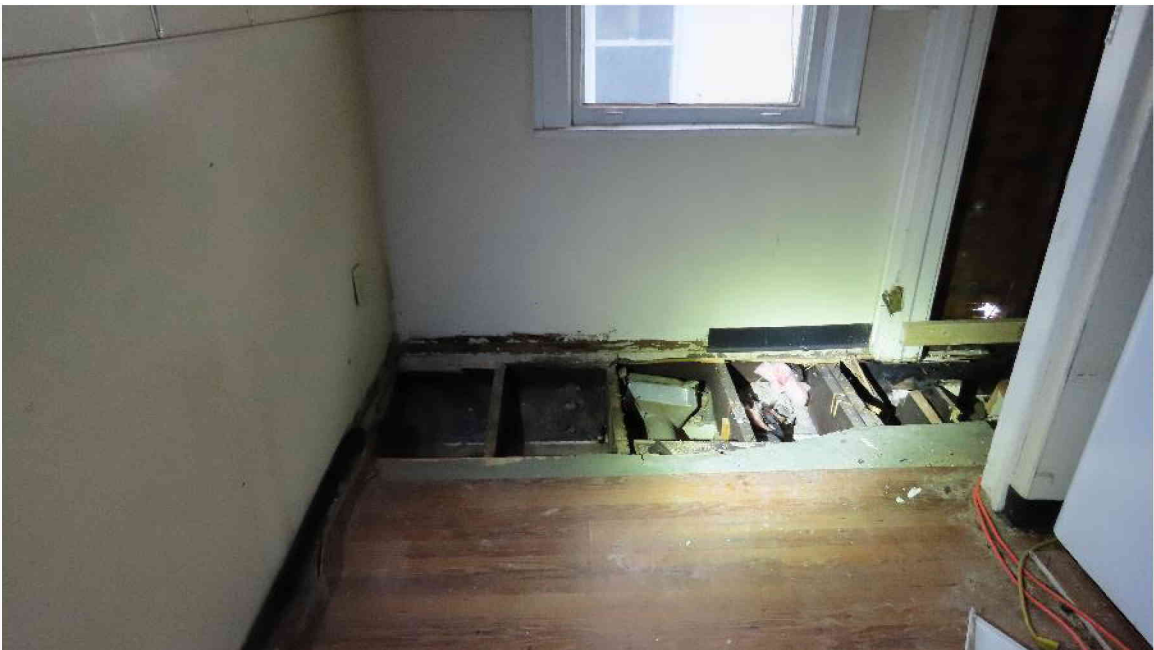
Wood flooring has been removed from the kitchen floor at the north wall (Photograph 12). Saw cuts with sharp edges are in the exposed floor joists (Photograph 13). Charred wall sheathing is at the soot-stained CMU block near the north door (Photograph 14 and 15).

Photograph 12: Floor removed from the kitchen at the north wall.

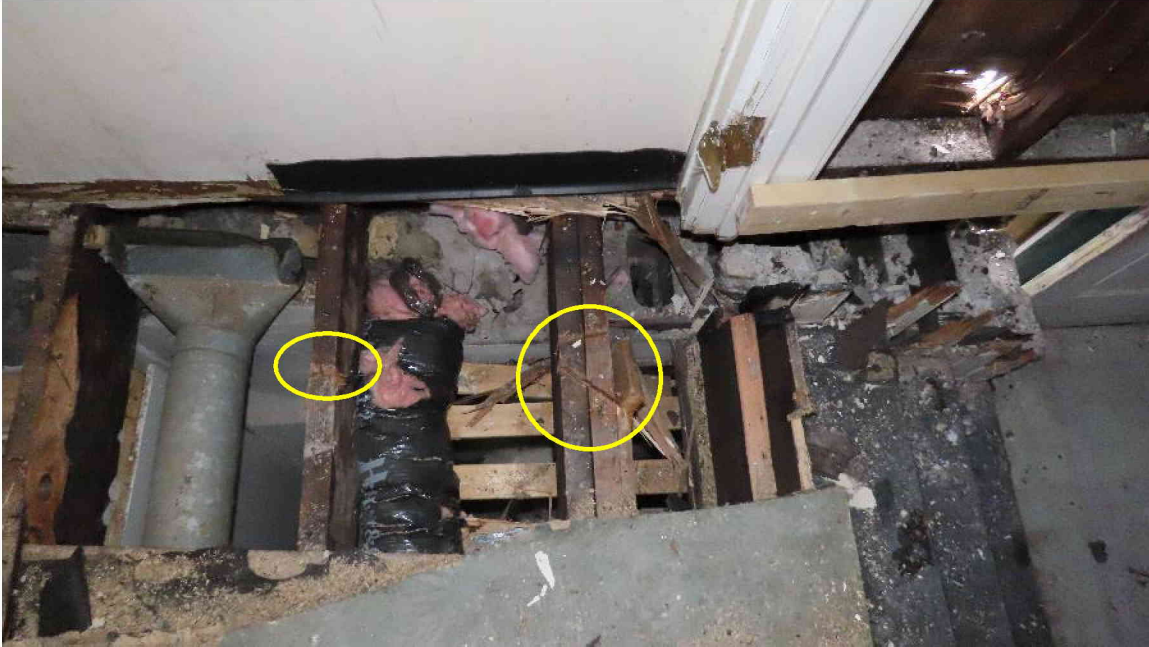
Saw cuts, from activities during extinguishing the fire have structurally damaged the floor joists in the kitchen. An area of the north exterior wall sheathing, at the boarded-up door at the stairway, is charred. Exterior wall sheathing by the north door is damaged by fire.

Photograph 13: Sawcut in floor joists.

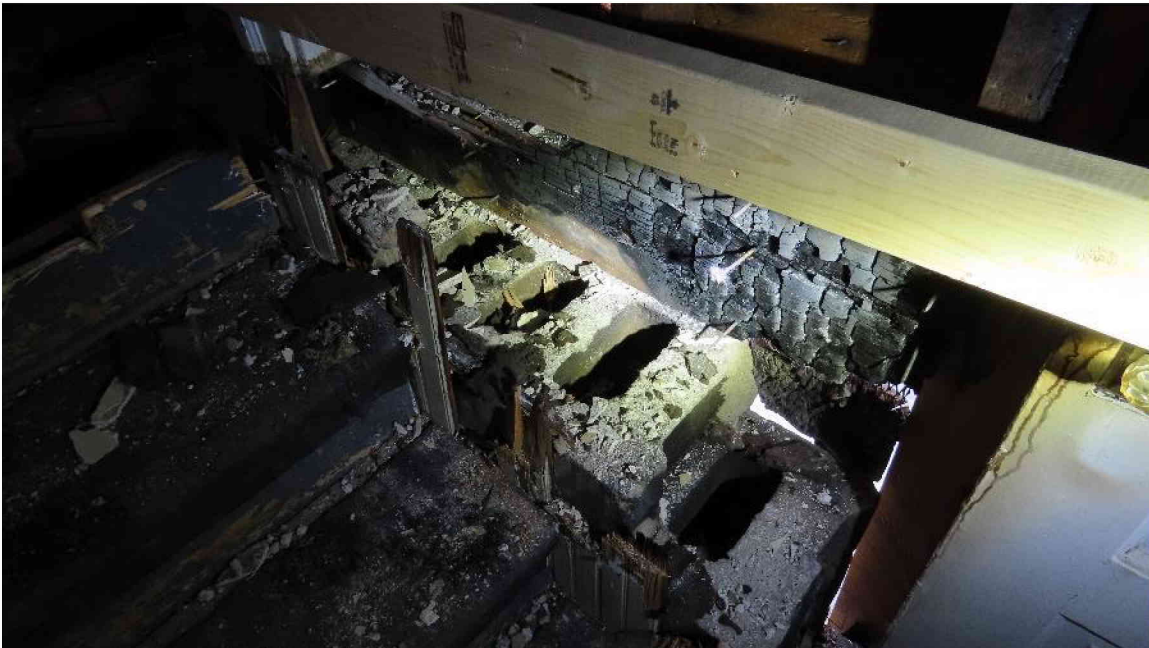
Photograph 14: Charred wall sheathing at the north door.

By the north door, the damaged wall sheathing requires replacement, and the holes in the stucco should be patched and painted. The soot stains on the north wall can be cleaned by pressure washing.

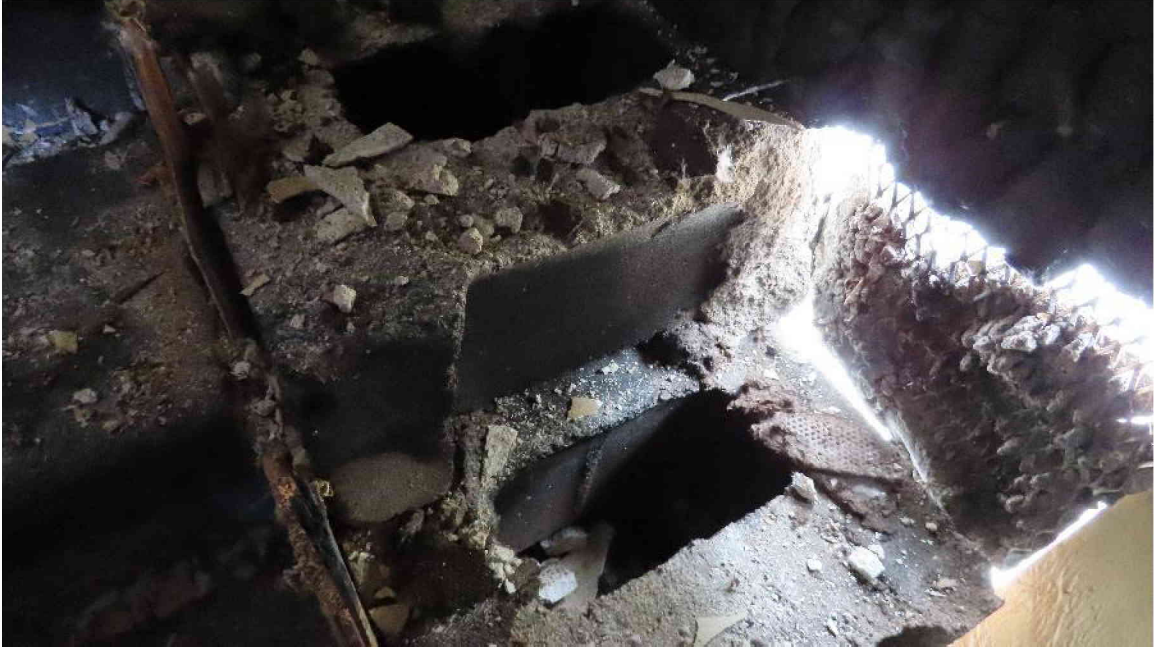
Photograph 15: Soot stained CMU block.

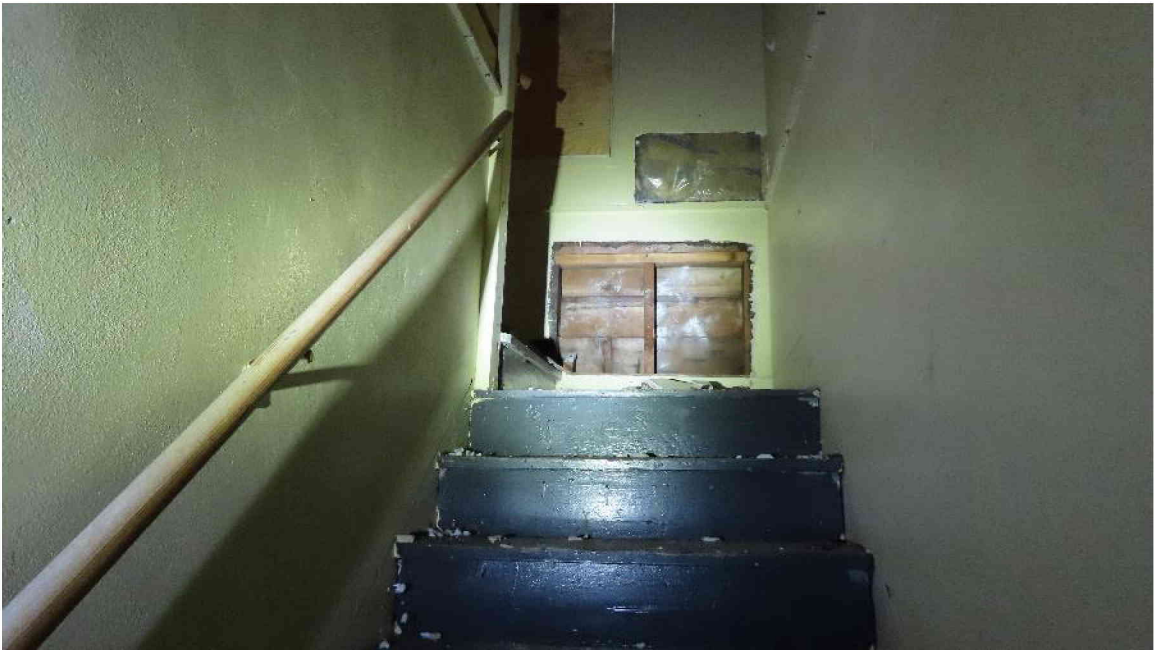
Sections of drywall have been removed from the north wall of the upper-level bedroom, and one of the two windows is boarded up (Photographs 16 and 17). Drip stains are on the exposed rafters and roof decking in the attic (Photograph 18). The rafters and roof decking are free of soot stains.

Photograph 16: Drywall removed from the north wall at the upper level.

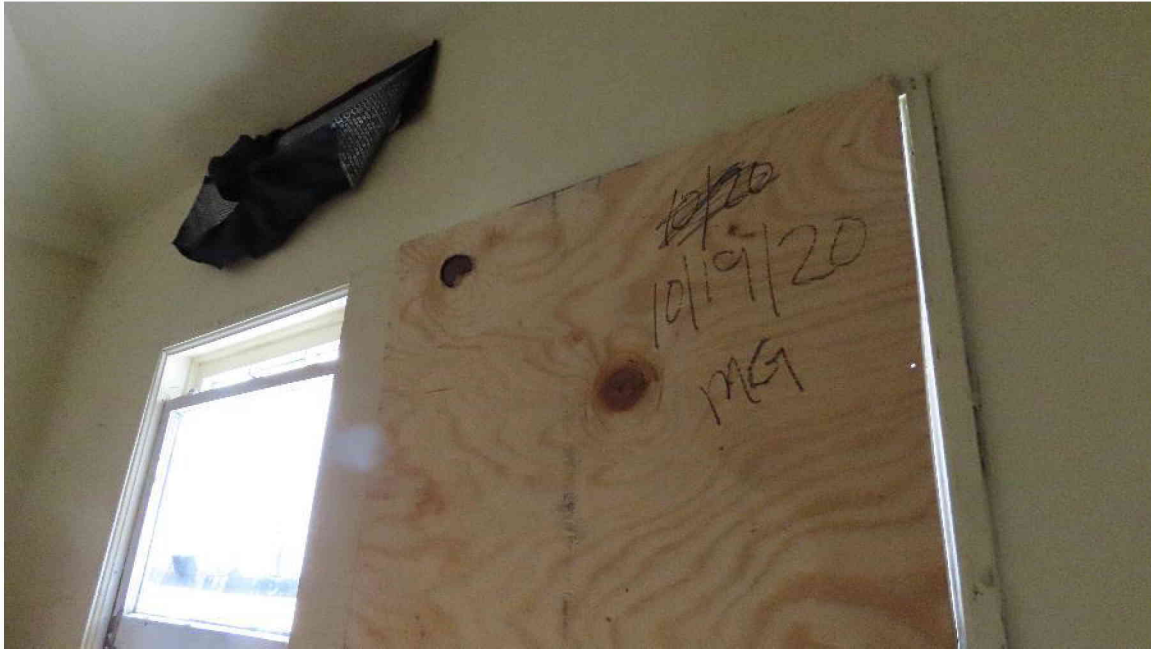
Photograph 17: Boarded up north window in the upper-level bedroom.

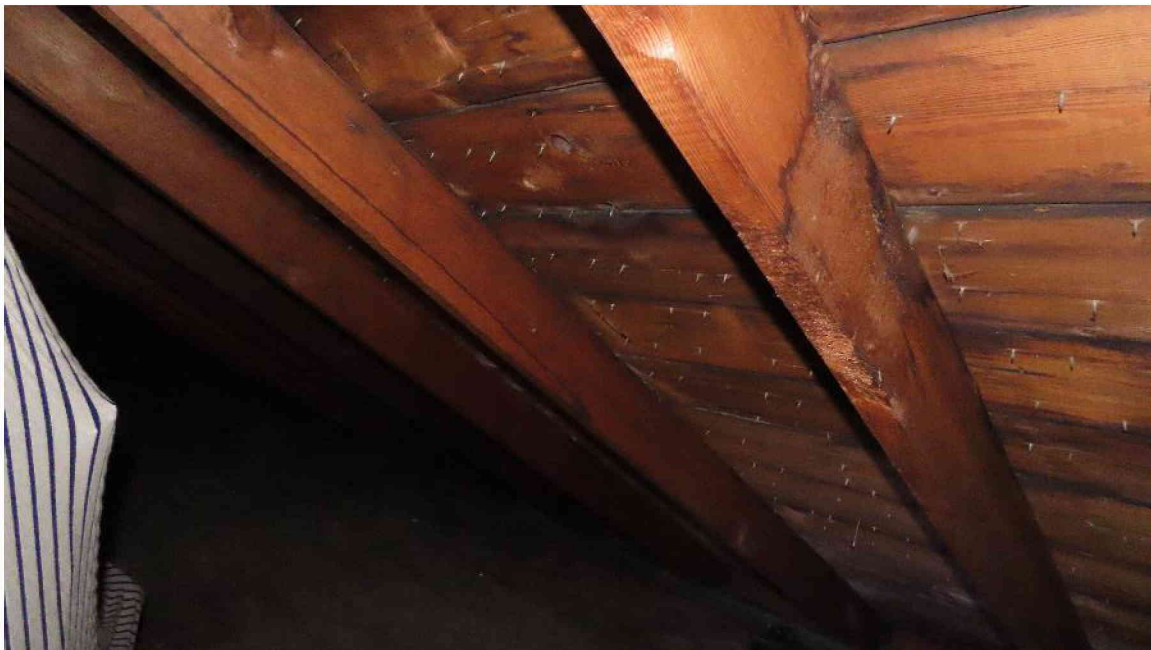
attic. The lack of charring indicates that the members are not damaged from the fire.

Photograph 18: Exposed north roof slope rafters in the attic.

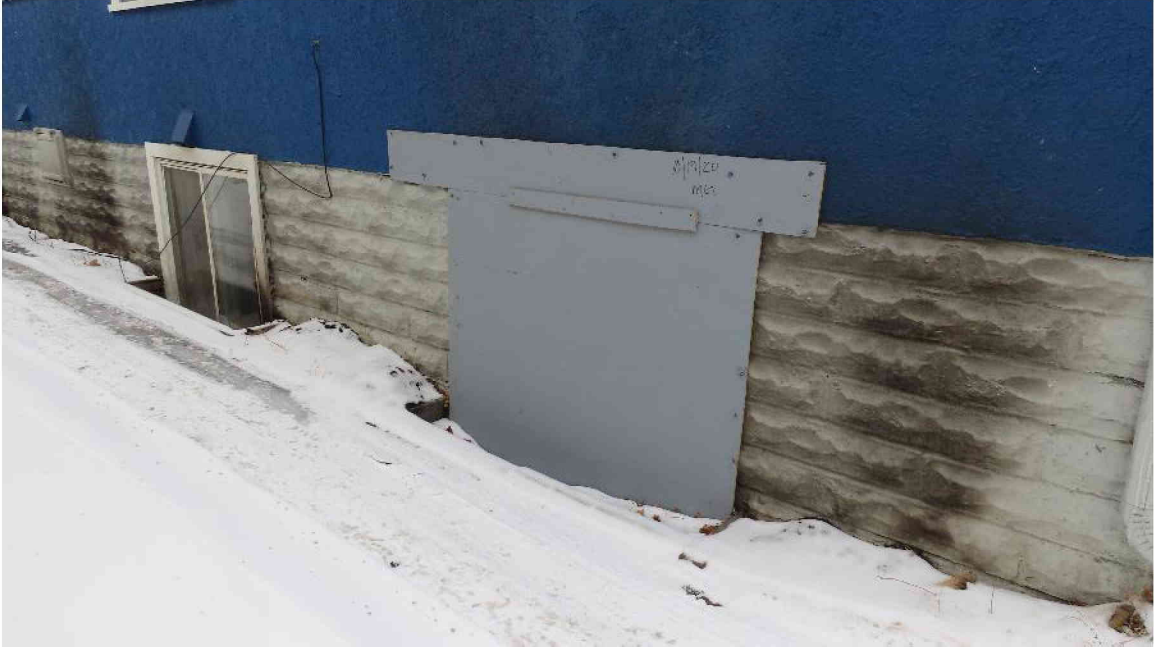
Multiple vertical patterns of soot stains are on the north exterior wall (Photograph 19 and 20). Holes with clean, sharp edges are in the stucco by the boarded-up door on the north exterior wall (Photographs 21).

Vertical smoke stains are on the north exterior wall stucco, originating from multiple locations at the ground level and projecting upward. Damaged stucco is at the north door, consistent with forced entry by the fire department or others.

Photograph 19: Soot stained exterior walls at boarded up window on the north wall.

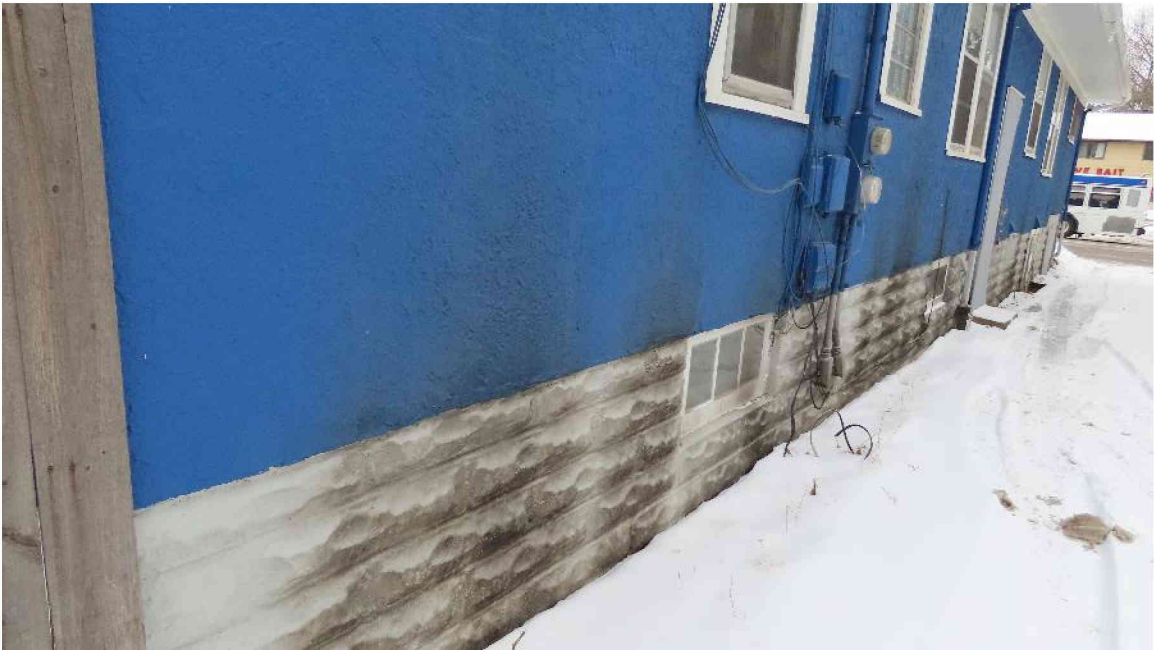
Photograph 20: Soot stains on the north wall.

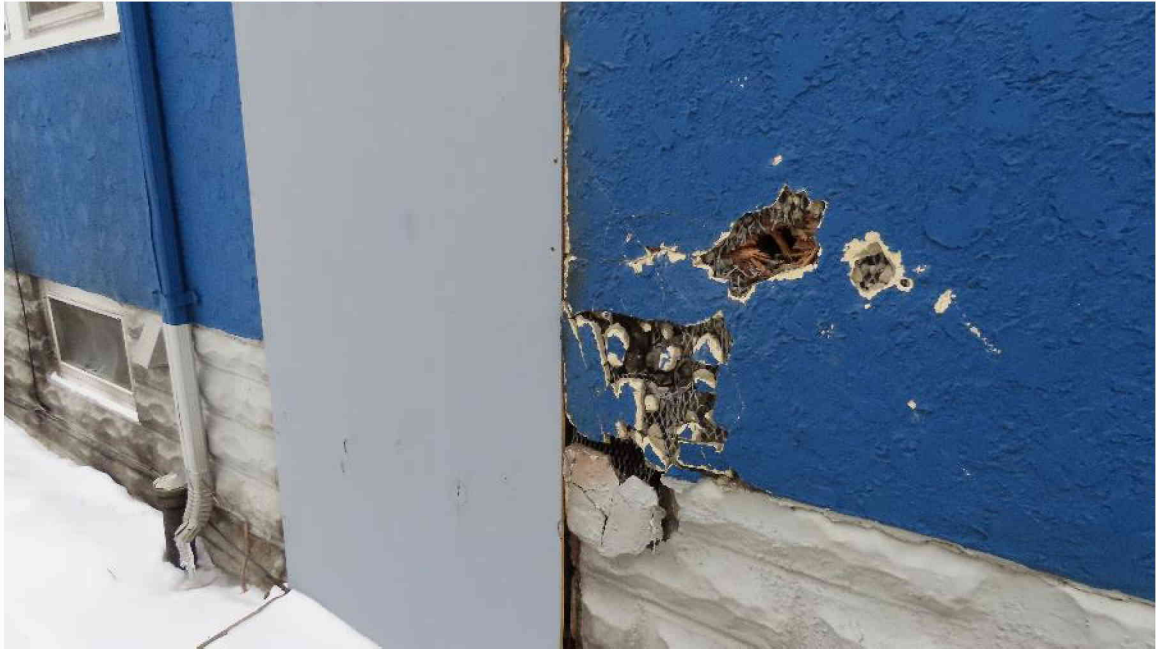
Photograph 21: Holes in stucco at the boarded-up door.
