**Appeal of the Department Determination for  
934, 938, & 942 Ashland Avenue**

Expert Report of John Trostle

### **Violations of the Covenant of Habitability, Including Conditions that are Hazardous for Tenants' Health and Safety, at 934/938/942 Ashland Avenue**

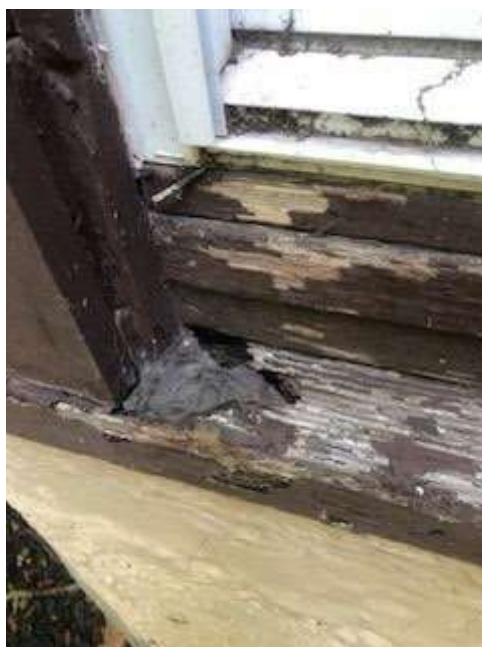
All three building exteriors have areas of wood rot and peeling paint in the siding as well as the wood trim at the doors and windows (see pictures 1-4, below). The gaps at the wood trim and casings cause ongoing water penetration and have contributed to the visible damage in the walls and ceiling cavities (as evidenced by conditions like wall cracks and bulging ceilings—examples of which are documented in pictures 26-28 later in this report). These gaps also present the significant danger of mold developing, or having already developed, in wall and ceiling cavities at common areas and tenant units, which may not yet be visible at the surface. Furthermore, there are gaps present at some upper eaves to the buildings where metal fascia has pulled away from the bottom edge of the roofing.

As for the peeling paint at the stucco, siding, and trim, this represents a danger due to the likelihood that it is lead-based paint. I understand that the three buildings were constructed in 1904, and thus there is a presumption that lead-based paint was used. The peeling flakes of presumed lead-based paint on the exterior of the Ashland Apartments pose a health risk.

1: Rotting/peeling exterior trim

2: Rotting/peeling exterior trim and cavity

3: Rotting/peeling exterior trim

4: Rotting/peeling exterior trim and cavity

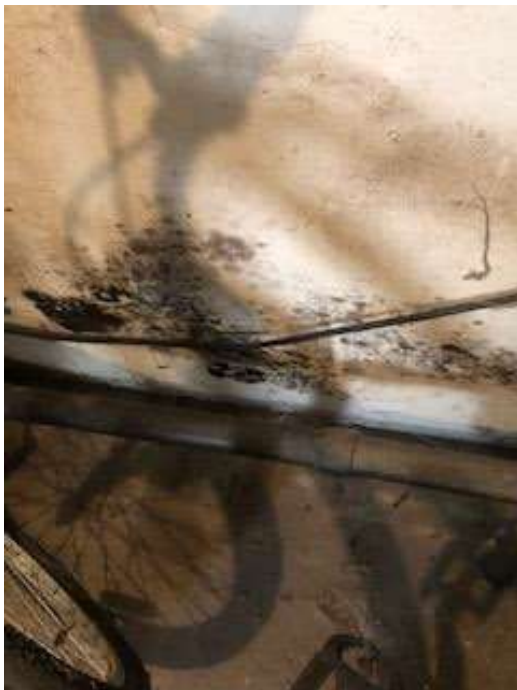
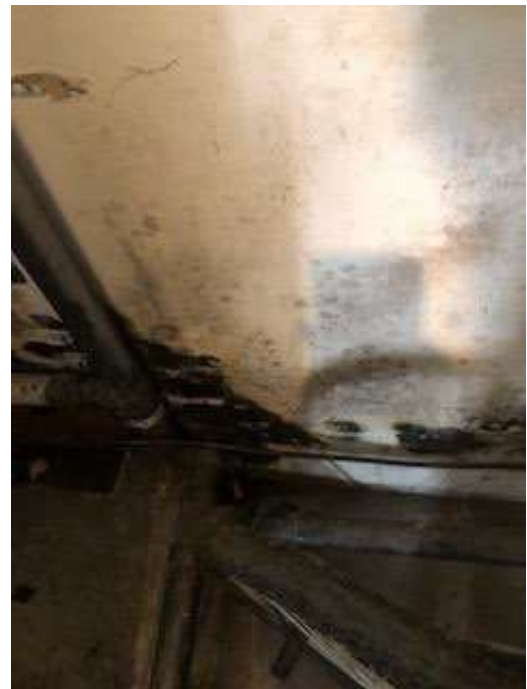
In the laundry room within Building #942, which serves all tenants, there exist highly concerning areas of mold spotting (see pictures 19-20). This appears to be black mold, which poses

a severe threat to tenants' safety when they are using the laundry room and breathing in spores present in the air. In addition to the mold, the walls of the laundry room are otherwise damaged and stained. These are plainly dangerous conditions and some of the most concerning within the buildings.

19: Mold at laundry room walls

20: Mold at laundry room walls

With specific regard to the mold issue, it is my professional opinion that the Ashland Apartments will remain in their current dangerous condition without moisture/mold testing in all exterior wall cavities as well as significant abatement efforts for all visible mold in tenant units and common areas like the laundry rooms. I do not believe that this pervasive issue will be resolved without such property-wide efforts by a qualified professional.

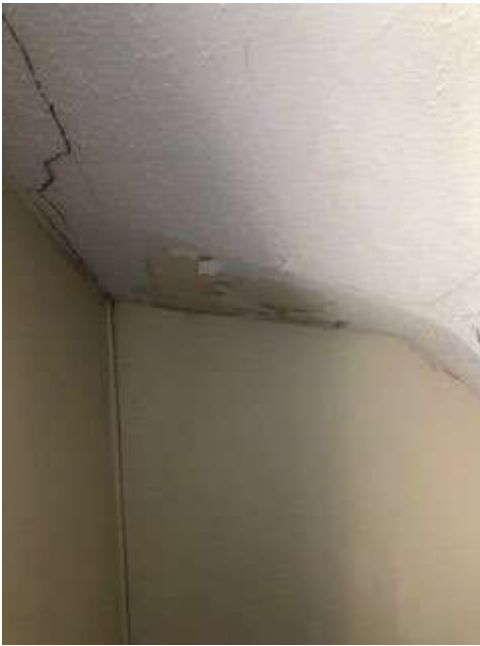
In other common areas, I observed bulging and cracking of various walls and ceilings in the halls and stairways (see picture 21). There is also general damage, staining, and paint wear in these areas that have been left unrepaired (see picture 22). The holes such as that shown in picture 21 may allow rodents and other pests to enter the building.

21: Ceiling flaking and cracking in hallway

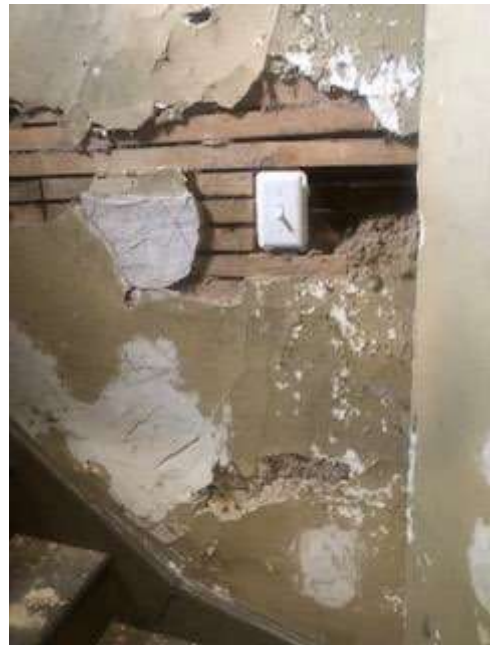
22: Wall deterioration at stairway

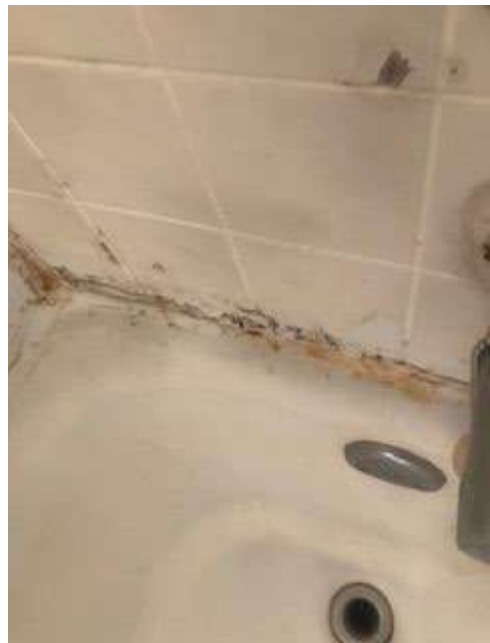
Tenant units accessed in all buildings have various problems related to their walls and ceilings. For one, I observed multiple instances of mold inside units, including on baseboards and in unit showers (see pictures 23-26). There are also many settling cracks and bulging within units, likely due to the buildings' foundation problems (see pictures 27-29). I observed other instances of neglect like peeling paint and staining. I also discovered loose wall panels in tenant units in areas like behind the stove, in bedroom closets, and in shower tubs.

23: Mold/rot at baseboards and flooring

24: Mold and deterioration in unit shower

25: Mold at glass block window in unit shower

26: Mold/rust on exposed pipe

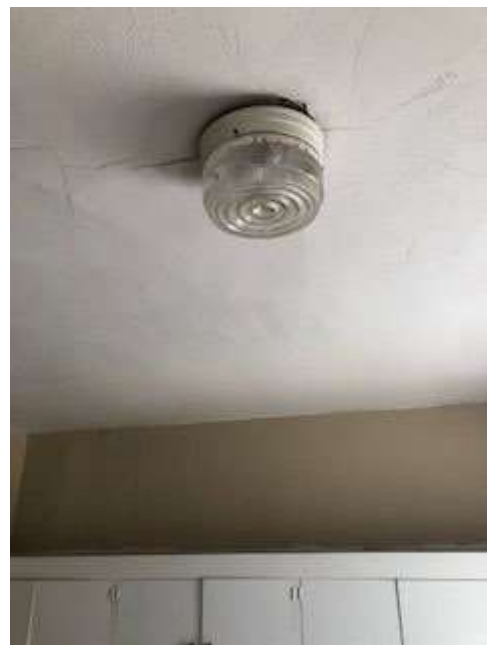
27: Wall cracks in tenant unit

28: Cracking near light fixture in tenant unit

29: Wall cracks in tenant unit

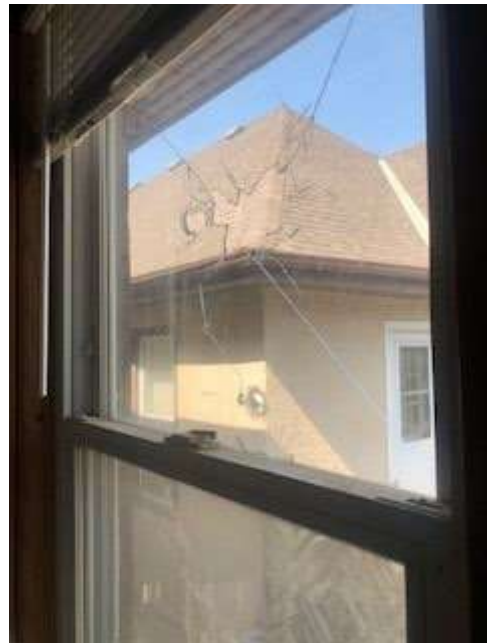
In Unit 6 within Building #938, the living room window glass is cracked and the rear bedroom windows have damaged tilt pins. The laundry room window in Building #942 is also cracked with a small hole that indicates an apparent BB-gun shot or similar incident (see picture 36). In Unit 10 within Building #942, the kitchen includes one window with a large hole in the broken glass (see picture 37), as well as another window with an upper sash that slams down and will not stay closed.

37: Hole in tenant window

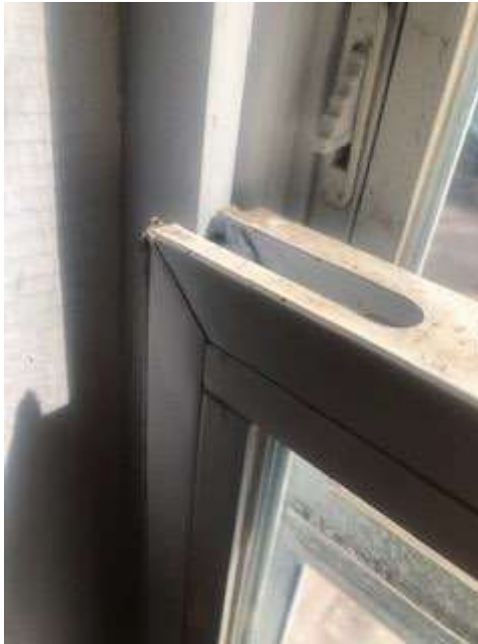
As a general matter, living room and bedroom windows in tenant units across the three buildings include slipping sashes and missing screens. Units also include windows that are off their tracks and do not seal properly (see picture 38).

38: Tenant window off track

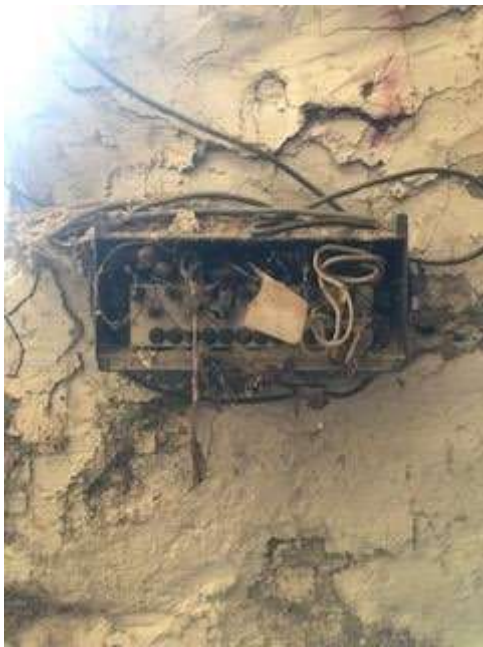
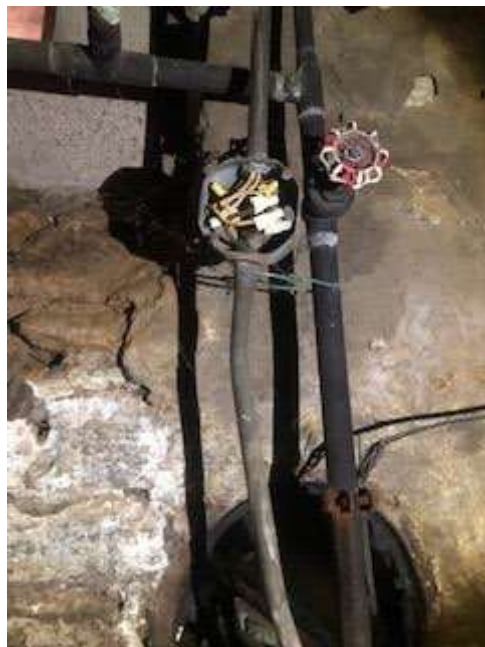
In the laundry room and other basement spaces open to tenants, I observed missing covers at electrical boxes, resulting in exposed wires (see pictures 41-42). In Unit 11 within Building #942, there are open ground 3-prongs at the electrical receptacles in the living room, front bedroom and dining room, which can pose a risk of electrical shock to tenants and damage to electrical appliances (see picture 43). Unit 11 also requires smoke and carbon monoxide detectors in the hallway. In Unit 9 within Building #942, the living room fan light severely wobbles when the fan is running, and is missing a globe cover (see picture 44). Many lights within tenant units have missing covers and globes (pictures 44-45).

41: Electrical box missing cover

42: Electrical box missing cover

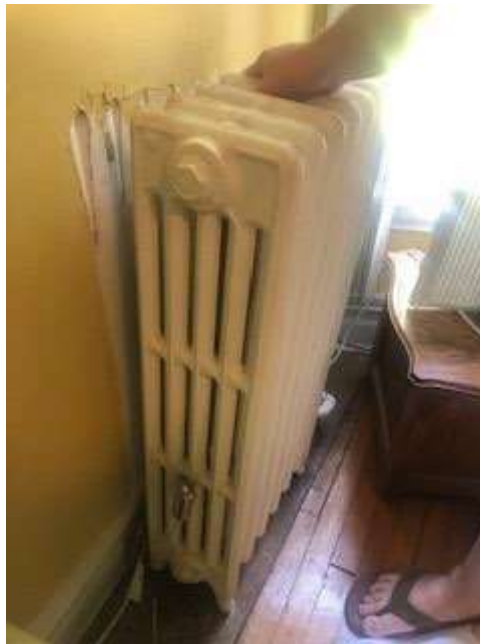
The final area in which I found noncompliance with general habitability standards is the heating of the three buildings comprising the Ashland Apartments. The boiler units show no indication of regular servicing. I also observed numerous loose radiators, including one shown below in the living room of Unit 6 within Building #938 (see picture 46).

46: Loose radiator in tenant unit
