**Appeal of the Department Determination for  
934, 938, & 942 Ashland Avenue**

**Appellants' Exhibit 1**

## **Expert Report of John Trostle**

### **Violations of the Covenant of Habitability, Including Conditions that are Hazardous for Tenants' Health and Safety, at 934/938/942 Ashland Avenue**

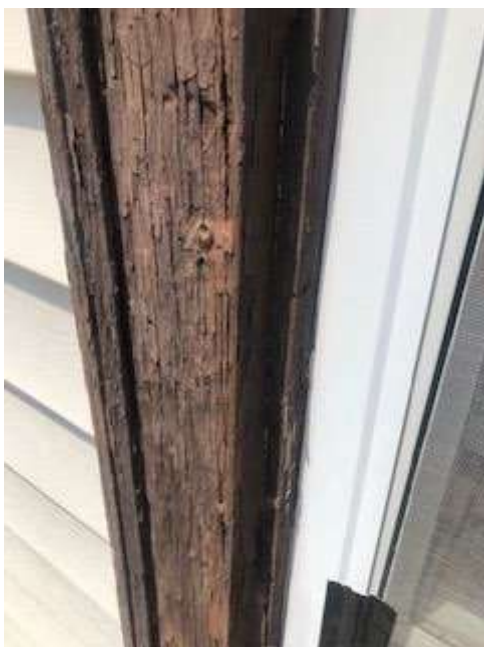
All three building exteriors have areas of wood rot and peeling paint in the siding as well as the wood trim at the doors and windows (see pictures 1-4, below). The gaps at the wood trim and casings cause ongoing water penetration and have contributed to the visible damage in the walls and ceiling cavities (as evidenced by conditions like wall cracks and bulging ceilings—examples of which are documented in pictures 26-28 later in this report). These gaps also present the significant danger of mold developing, or having already developed, in wall and ceiling cavities at common areas and tenant units, which may not yet be visible at the surface. Furthermore, there are gaps present at some upper eaves to the buildings where metal fascia has pulled away from the bottom edge of the roofing.

As for the peeling paint at the stucco, siding, and trim, this represents a danger due to the likelihood that it is lead-based paint. I understand that the three buildings were constructed in 1904, and thus there is a presumption that lead-based paint was used. The peeling flakes of presumed lead-based paint on the exterior of the Ashland Apartments pose a health risk.

1: Rotting/peeling exterior trim

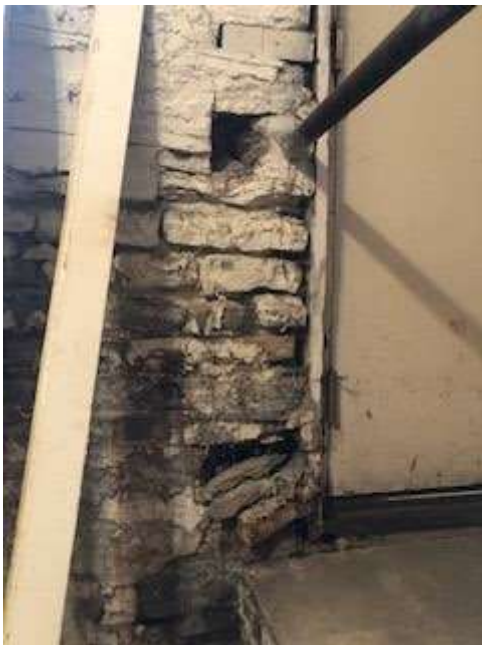
The foundations of each of the three buildings comprising the Ashland Apartments are stone, with some areas of concrete block. My inspection revealed significant wear and large openings at the stone foundations and parge coats (see pictures 8-11). Because the stone contains lime, the mortar joints tend to deteriorate over the many decades after the buildings were constructed, and simply repairing the visible worn mortar areas will likely not completely correct the water infiltration issues. This is due to the visible damage at the concrete step pathways between buildings and mortar wear not presently exposed (see pictures 13-14).

8: Settling and holes in foundation

I strongly recommend that the foundations of all three buildings be evaluated by a contractor specializing in foundation and structural issues. It is clear that the buildings are actively settling and a patchwork approach to the repairs to the foundation and concrete steps between buildings will not correct the water infiltration problems. Importantly, the foundation settling poses a risk to tenants through its perpetuation of existing issues like water seepage causing flooding and mold, cracks in walls and ceilings, and uneven floors. Picture 12, below, demonstrates the flooding that regularly occurs during rainstorms in the basement of Building #934 (in the storage area serving Unit 5) due to the severe foundation issues.

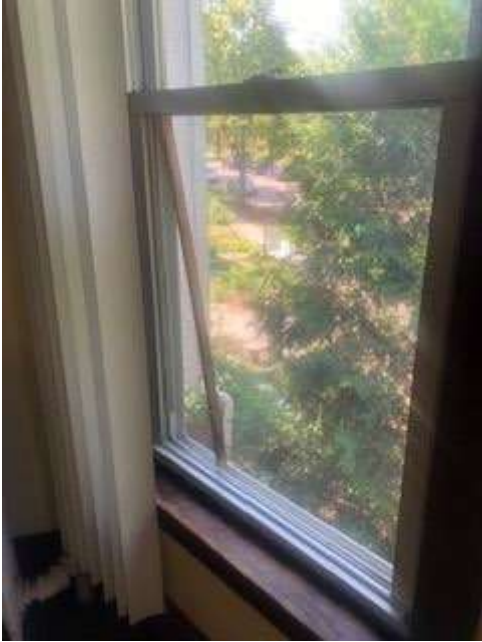
In Unit 11 within Building #942, the upper sash of a living room window is slipping (see picture 34). This means that the upper portion of the window is unable to stay up and closed, and this tenant has had to wedge a wooden post in the window to ensure that it remains closed. I observed other units where tenants have had to use wooden posts to keep their windows closed, such as Unit 9 within Building #942 in which the upper sashes of the bedroom windows are slipping (see picture 35). Additionally, the upper sashes of windows in the living room and kitchen are sagging in Unit 1 in Building #934, though the tenant has not used posts to keep them up.

34: Tenant window held up by wooden post

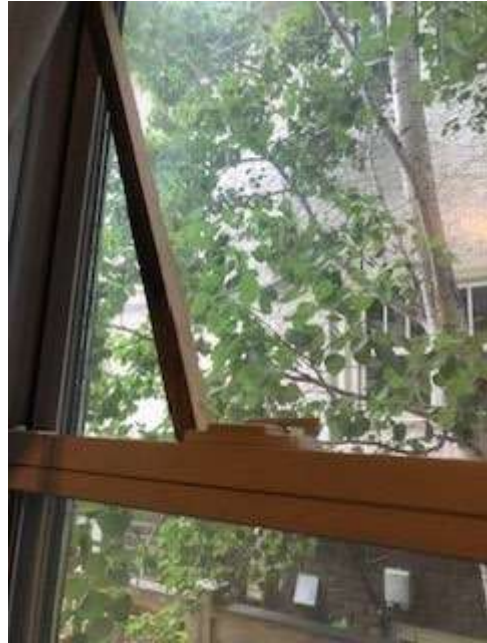
35: Tenant window held up by wooden post

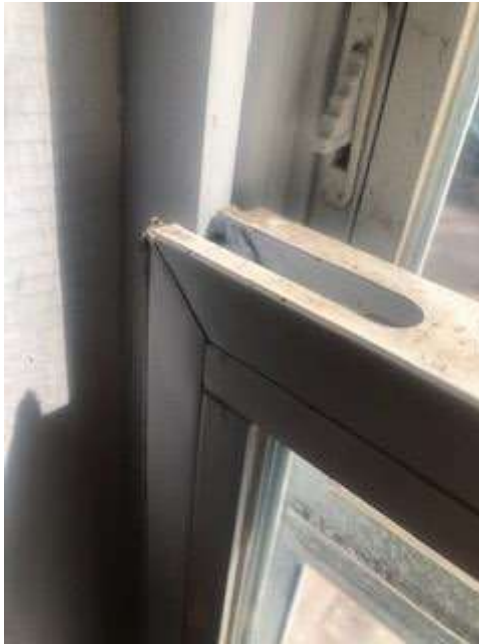
As a general matter, living room and bedroom windows in tenant units across the three buildings include slipping sashes and missing screens. Units also include windows that are off their tracks and do not seal properly (see picture 38).

38: Tenant window off track
