## HERITAGE PRESERVATION COMMISSION DESIGN REVIEW APPLICATION

RE: 716 Wilson Avenue Request for Demolition

Project No.: 15535.00  
Re: Structural Condition Review of the building at 716 Wilson Ave.

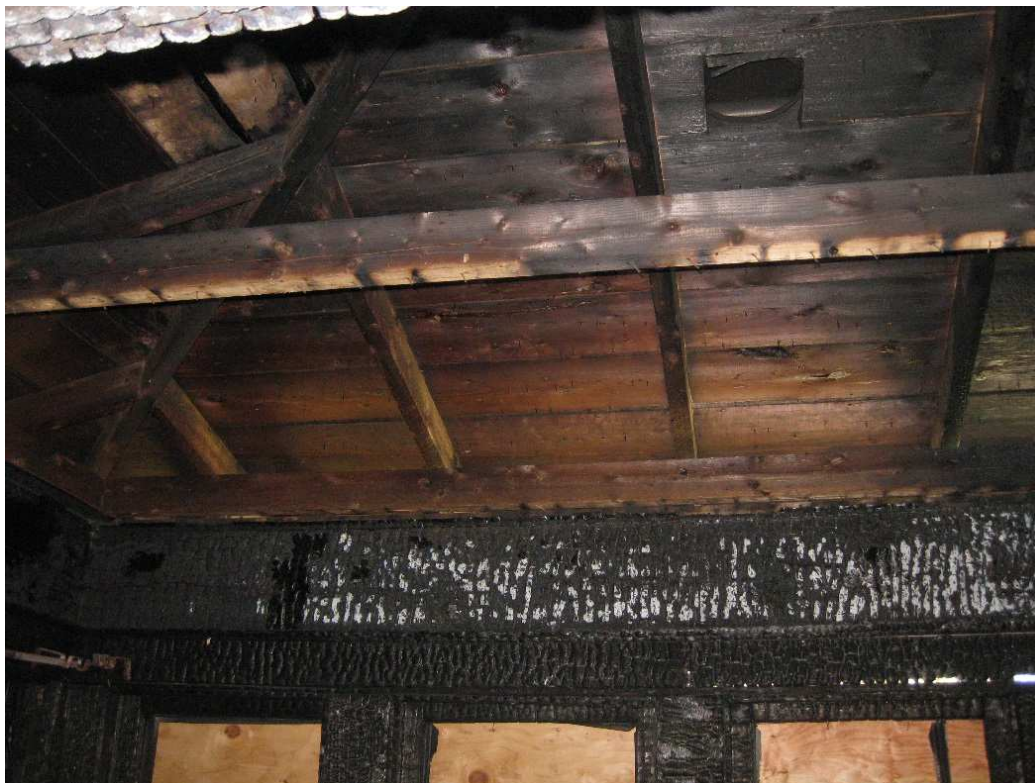
There is fire damage throughout the northeast end of the building, primarily the porch. Picture 1 and Picture 2 show the fire damage from within the home. The fire damage affected all of the beams that were visible in the front porch. It is also likely that the fire damaged more structural elements that were covered both in the porch and the main house. Fire damage can be seen on the finish throughout the building. Picture 3 shows the exterior elevation of the house at the north corner.

The fire damage to the structure in is mostly to the porch posts and lintels where the black char and ash is seen in Picture 1. Those members likely require replacement.

**Picture 1 – Front Porch Fire Damage**

Other members such as floor joists that are just darkened or slightly charred could be kept but would require soda blasting or some other procedure to remove the smoke smell.

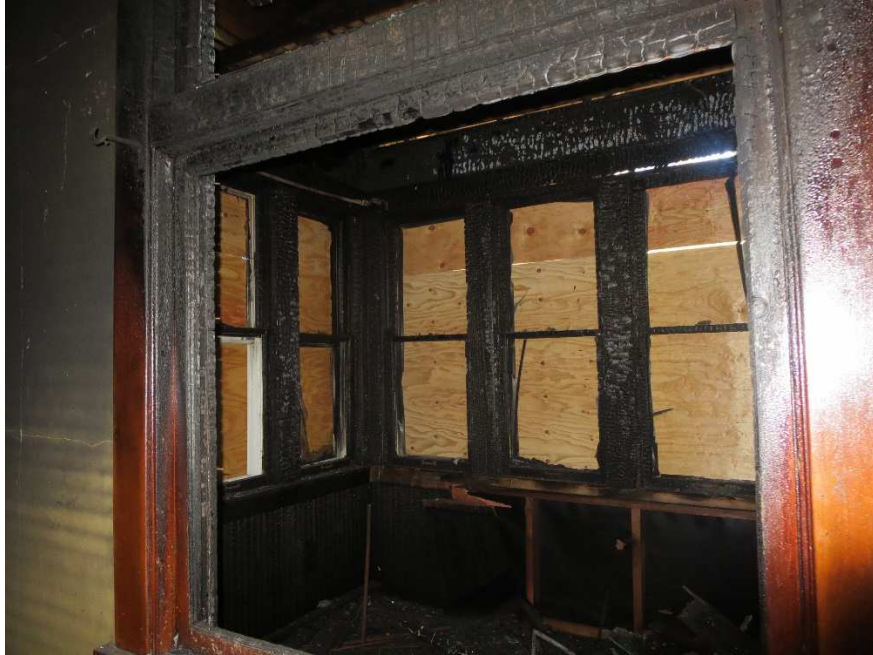
**Picture 2 – Front Porch Fire Damage**

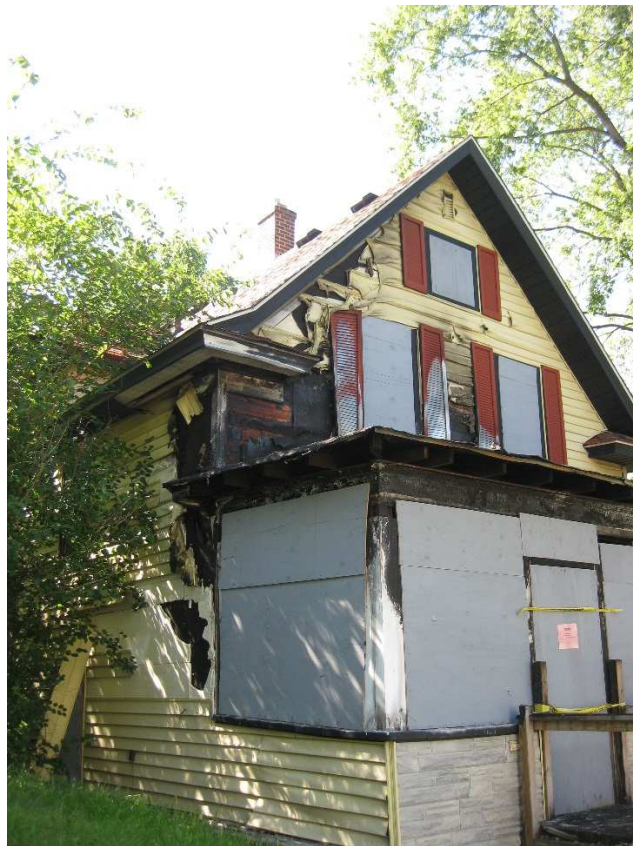
**Picture 3 – Fire Damage, Northeast Elevation**

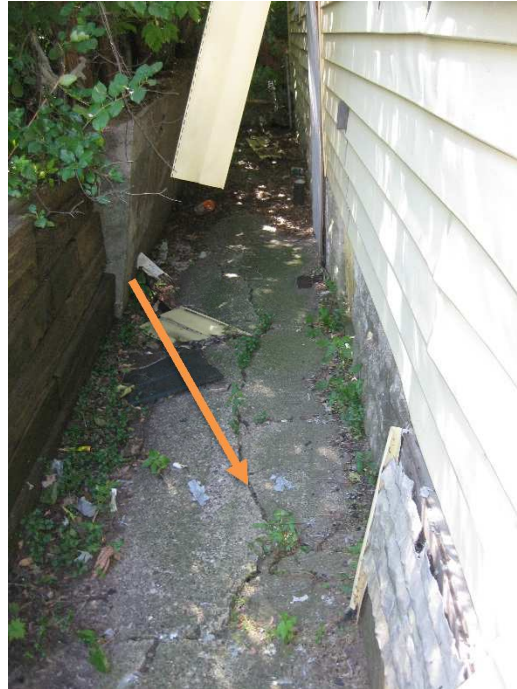
The exterior sidewalk of the northeast side of the house has a crack that runs through the center of it. The portion of the sidewalk closest to the house slopes down toward the foundation. The foundation of the porch is unknown. It is likely that the porch is settling, which is causing the soil to move and the crack to appear. Water drainage is also an issue. Due to the slope, water will drain towards the house. The water will infiltrate the basement through the foundation walls and likely cause damage to the walls over time. Picture 4 shows the crack at the northeast corner of the house.

**Picture 4 – Crack in Sidewalk at Northeast Corner**

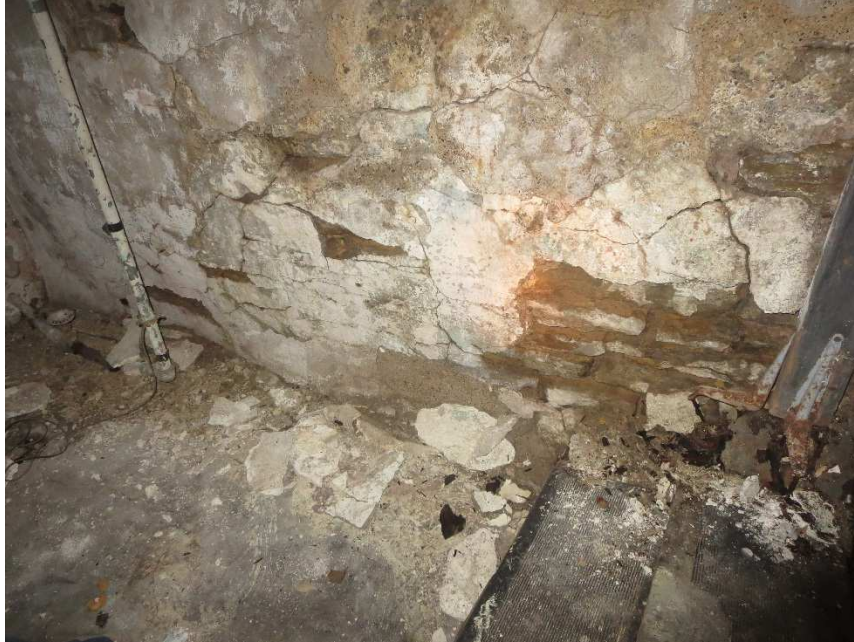
The interior sides of the foundation walls are in poor condition. There is cracking and spalling of the walls that can be seen throughout the basement. Picture 5 and Picture 6 show the faces of two of the foundation walls that are typical throughout the basement. The exterior of the foundation walls are also in need of repair. There are joints between the masonry units that are missing mortar. Picture 7 and Picture 8 show gaps between masonry units where mortar should be. The limestone walls are likely 16 to 20 inches thick so are not necessarily unsafe or insufficient, however they would require repairs.

**Picture 5 – Interior Foundation Wall**

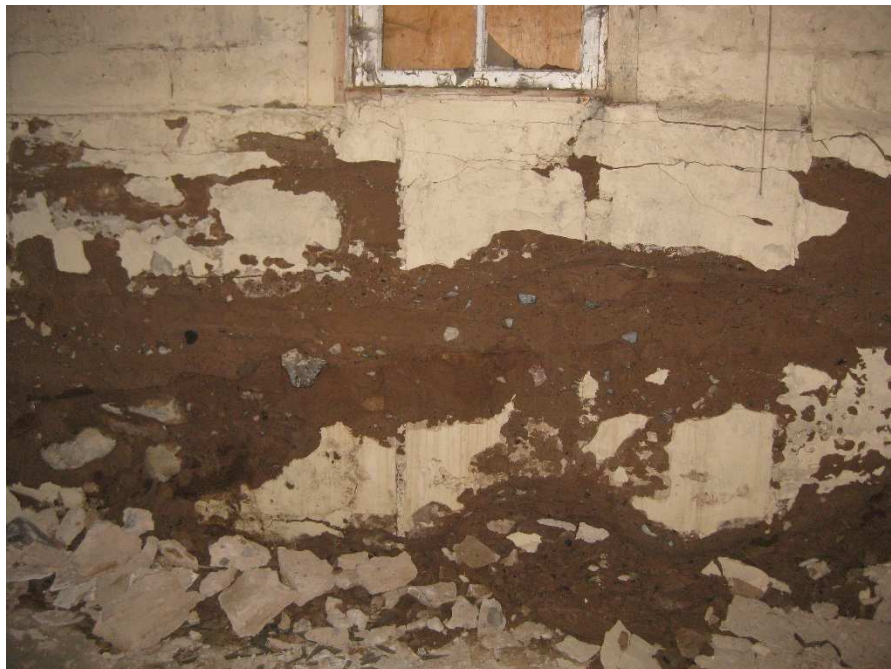
**Picture 6 – Interior Foundation Wall**

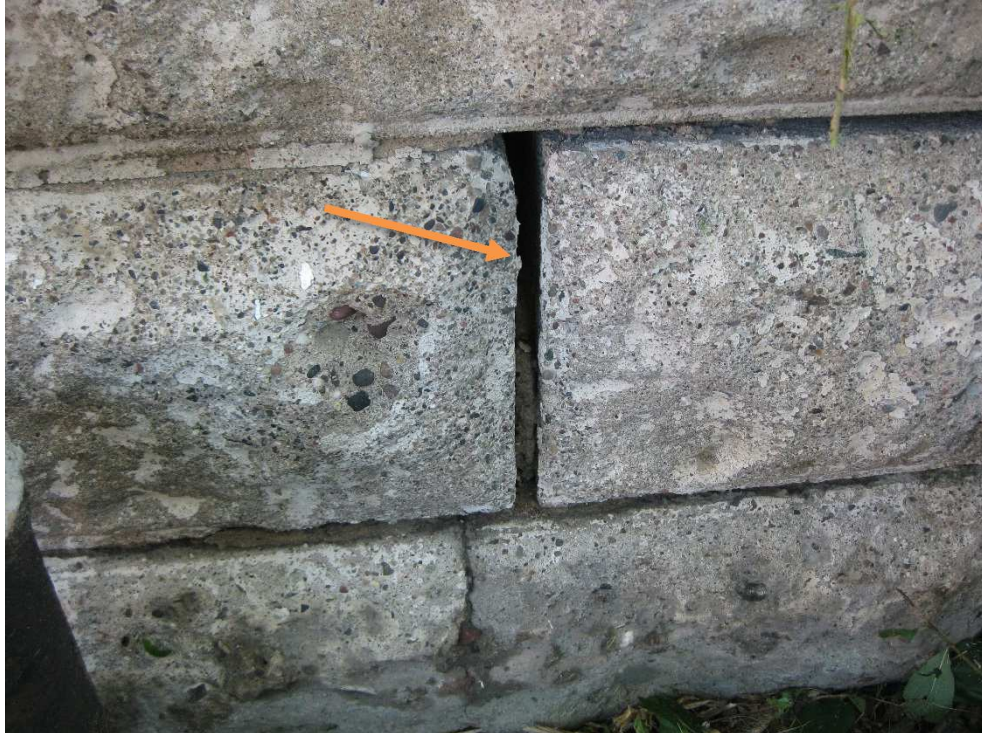
**Picture 7 – Exterior Foundation Walls**

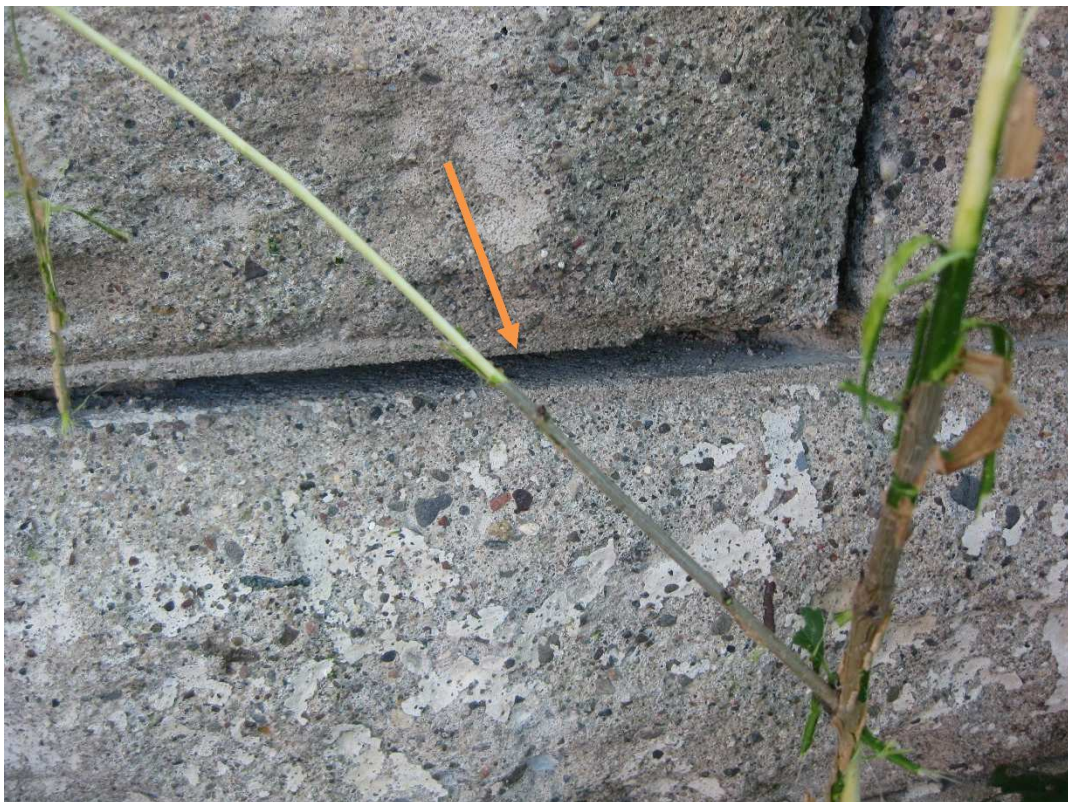
**Picture 8 – Exterior Foundation Walls**

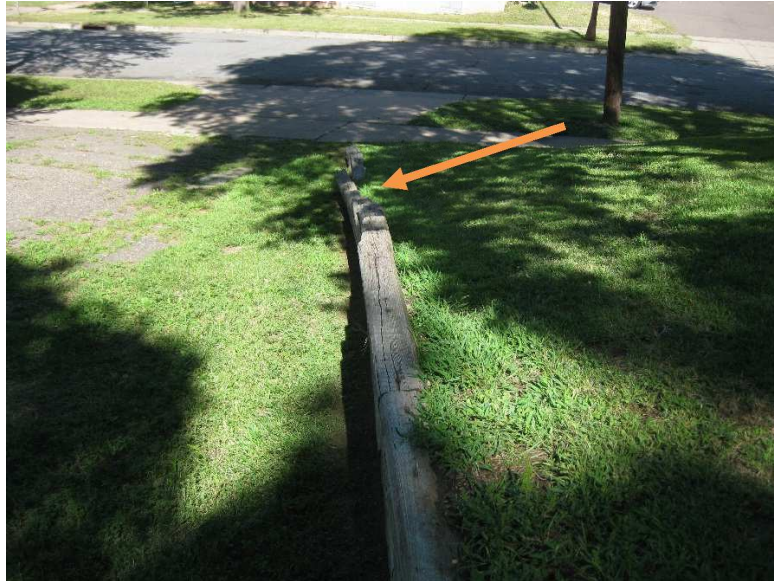
We observed issues with both of the retaining walls at the exterior of the house, they have essentially failed structurally. The timber retaining wall on the southwest side of the building is out of plumb. Along with that, some of the members of the timber wall are out of plane relative to each other. Picture 9 shows the wall with some of the members out of line. Picture 10 shows an up-close look at the end of the retaining wall and illustrates the displacement that has occurred between some of the members. Picture 11 is similar to Picture 9, but as seen from the opposite angle, the displacement of the wall as a whole can more easily be seen.

**Picture 9 – Timber Retaining Wall**

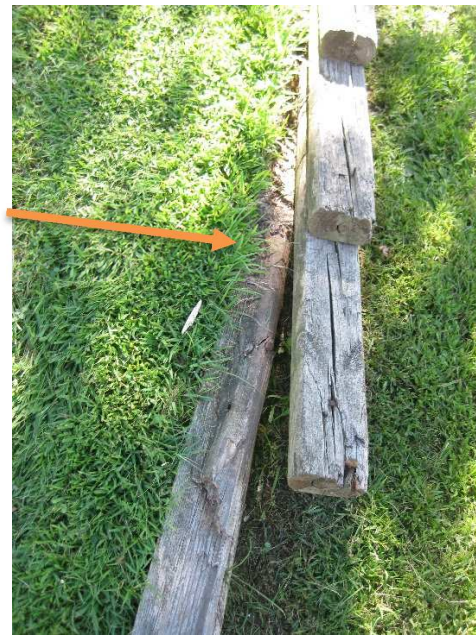
**Picture 10 – End of Timber Retaining Wall**

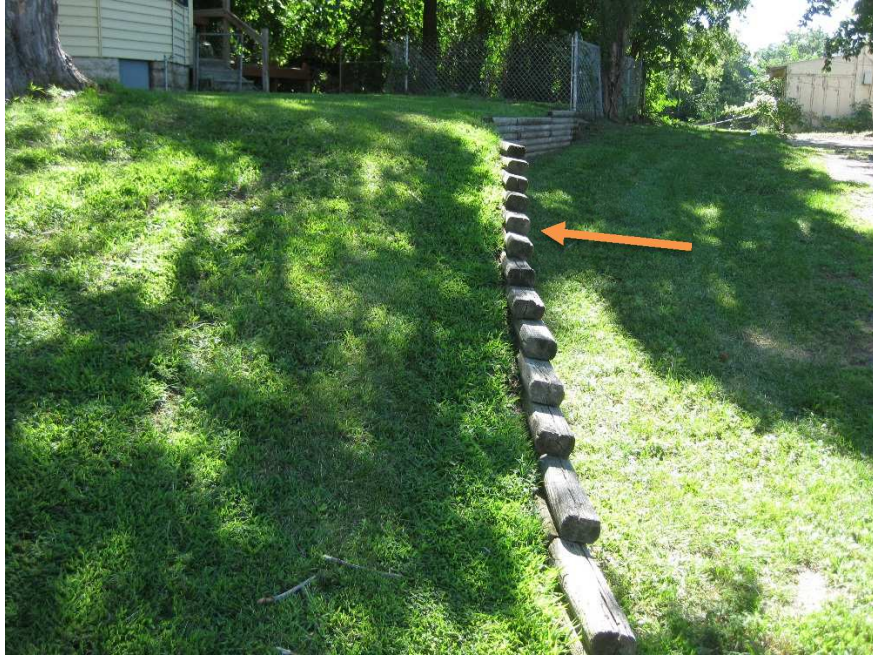
**Picture 11 – Timber Retaining Wall**

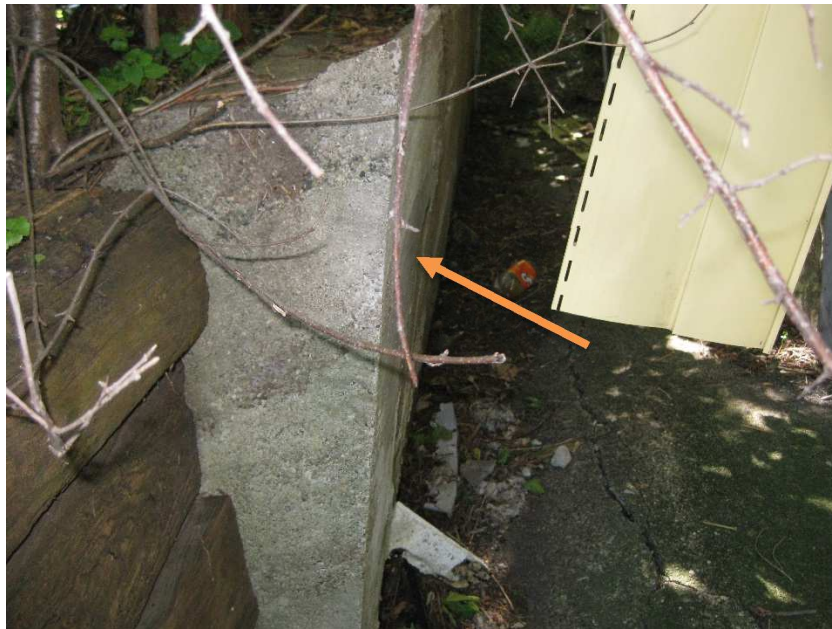
The concrete wall on the northeast of the house is also out of plumb. The wall itself appears to be sturdy, as evidenced by the lack of cracking or breaking, but its foundation has rotated. Picture 12 shows the wall out of plumb and the same wall can also be seen in Picture 4.

**Picture 12 – Rotated Foundation Wall**

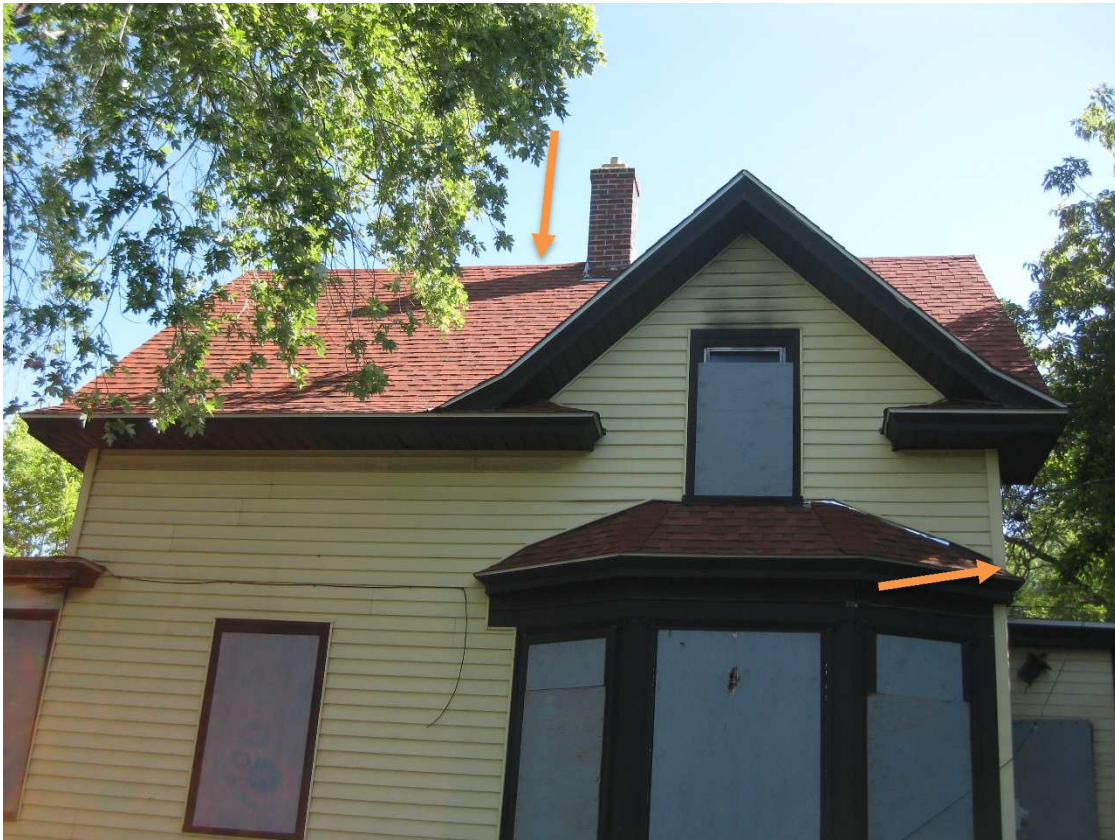
The roof and exterior walls, as observed from the outside, appeared to be in good condition. The roof was flat and there were no obvious problems. The exterior walls appeared to be plumb. Picture 13 shows one such roof and wall.

**Picture 13 – House Roof and Exterior Wall**
