PORT AUTHORITY OF THE CITY OF SAINT PAUL
[3M Main Plant Campus – Structurally Substandard Building Findings]

*Former St. Paul, MN 3M Campus
(Beacon Bluff Redevelopment)*

TIF Eligibility Assessment

Compass Rose No. STPPA003

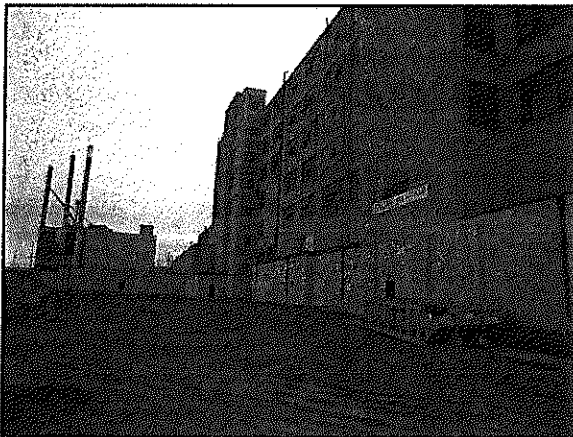
Overview

Defects in exterior building shell: Masonry foundation wall and brick show evidence of settlement cracks. Windows are broken and boarded. Height of structure is 2 stories higher than allowed by code.

Deficient in facilities for disabled: lack of maneuvering clearance and accessible features at stairs and entry, no passenger elevators, toilet and shower areas and not provided at every other floor.

Deficient in meeting Mechanical code: for building construction prior to 1989, mechanical systems do not provide sufficient number of air exchanges;

Deficient in meeting Electrical code: receptacle locations, receptacle types, and wiring are non-compliant with current building code.

Deficient interior enclosed stairway: rise/run dimensions, handrail height, grip, extensions and guardrails. Structure requires the addition of an enclosed stairway. Rated construction is inconsistent and no visual or audio alarms.

Chipped and/or damaged drywall in numerous locations. Flooring is damaged and inconsistent. Layout exhibits obsolescence.

Defects in exterior building shell: Window frames need paint, sills are in various stages of rotting paint peeling; roof leakage problem exists; water-damaged ceiling areas need to be replaced; aged and damaged exterior doors. Asbestos and lead hazards have not been identified but may be present.
