**Date:** June 12, 2015  
**File #:** 13 - 252825  
**Folder Name:** 1052 ROSS AVE  
**PIN:** 282922340015

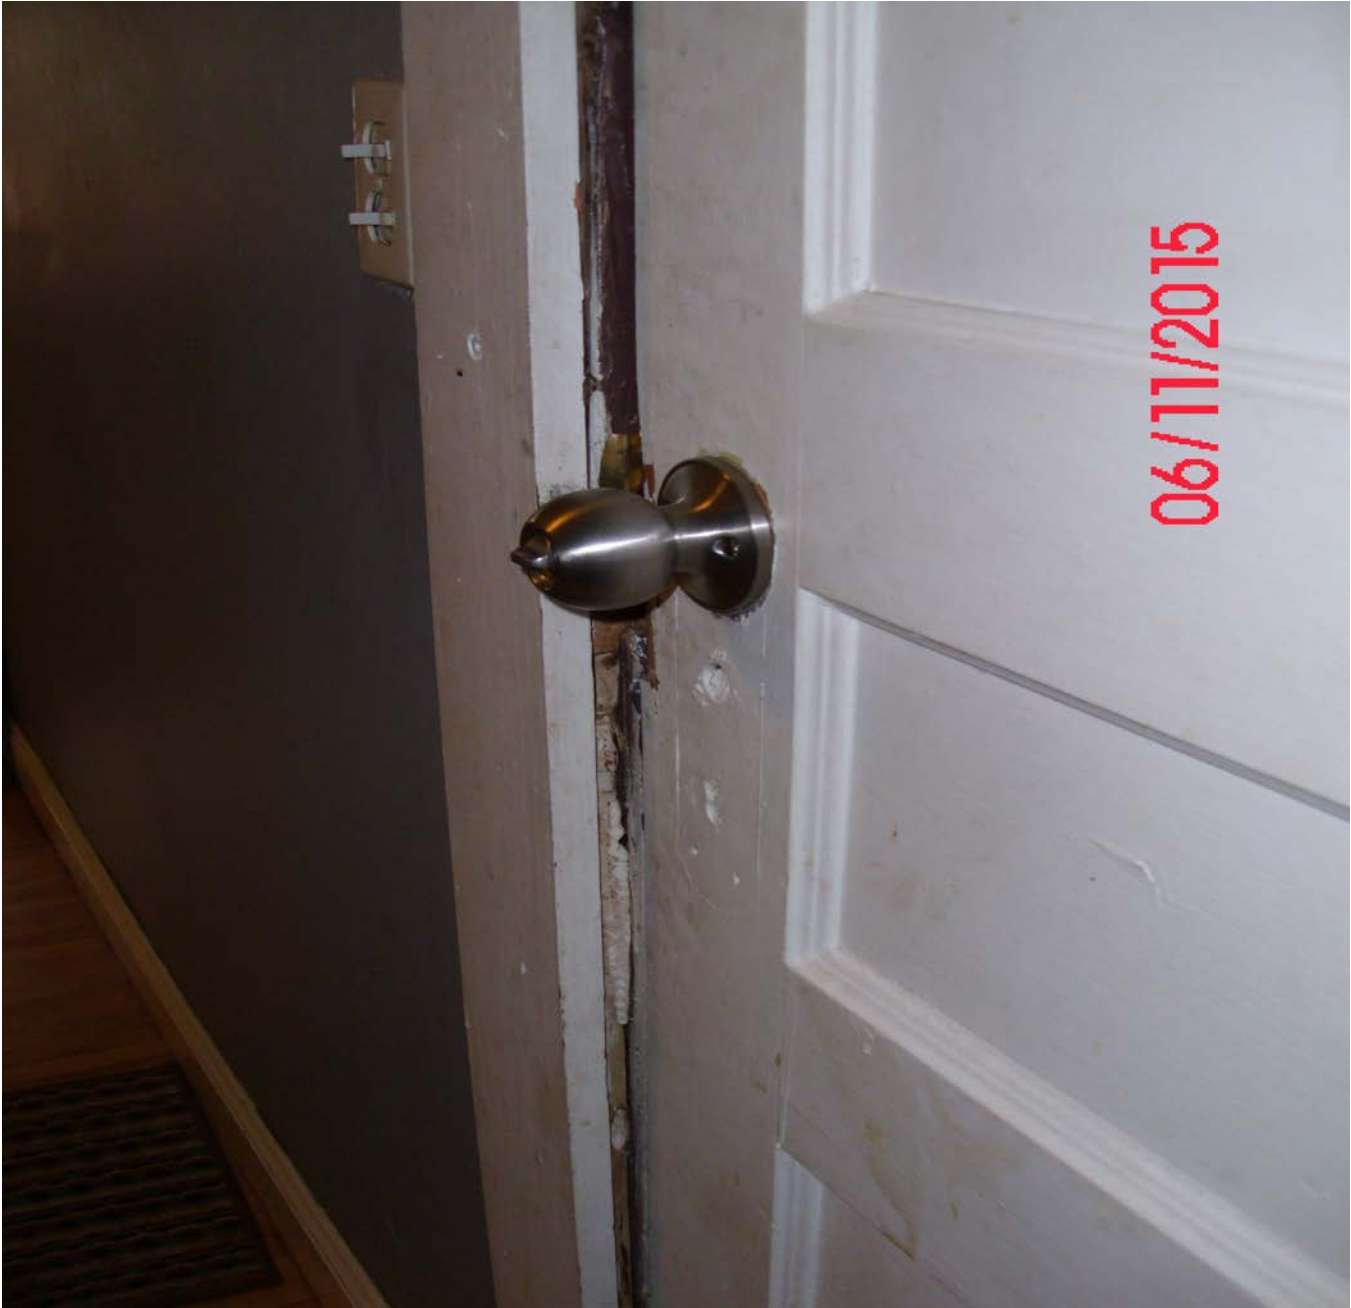
**Inside of entry door**  
**Frame assembly damaged and poor fit**  
**1 hour required assembly compromised**  
**20 minute door compromised**

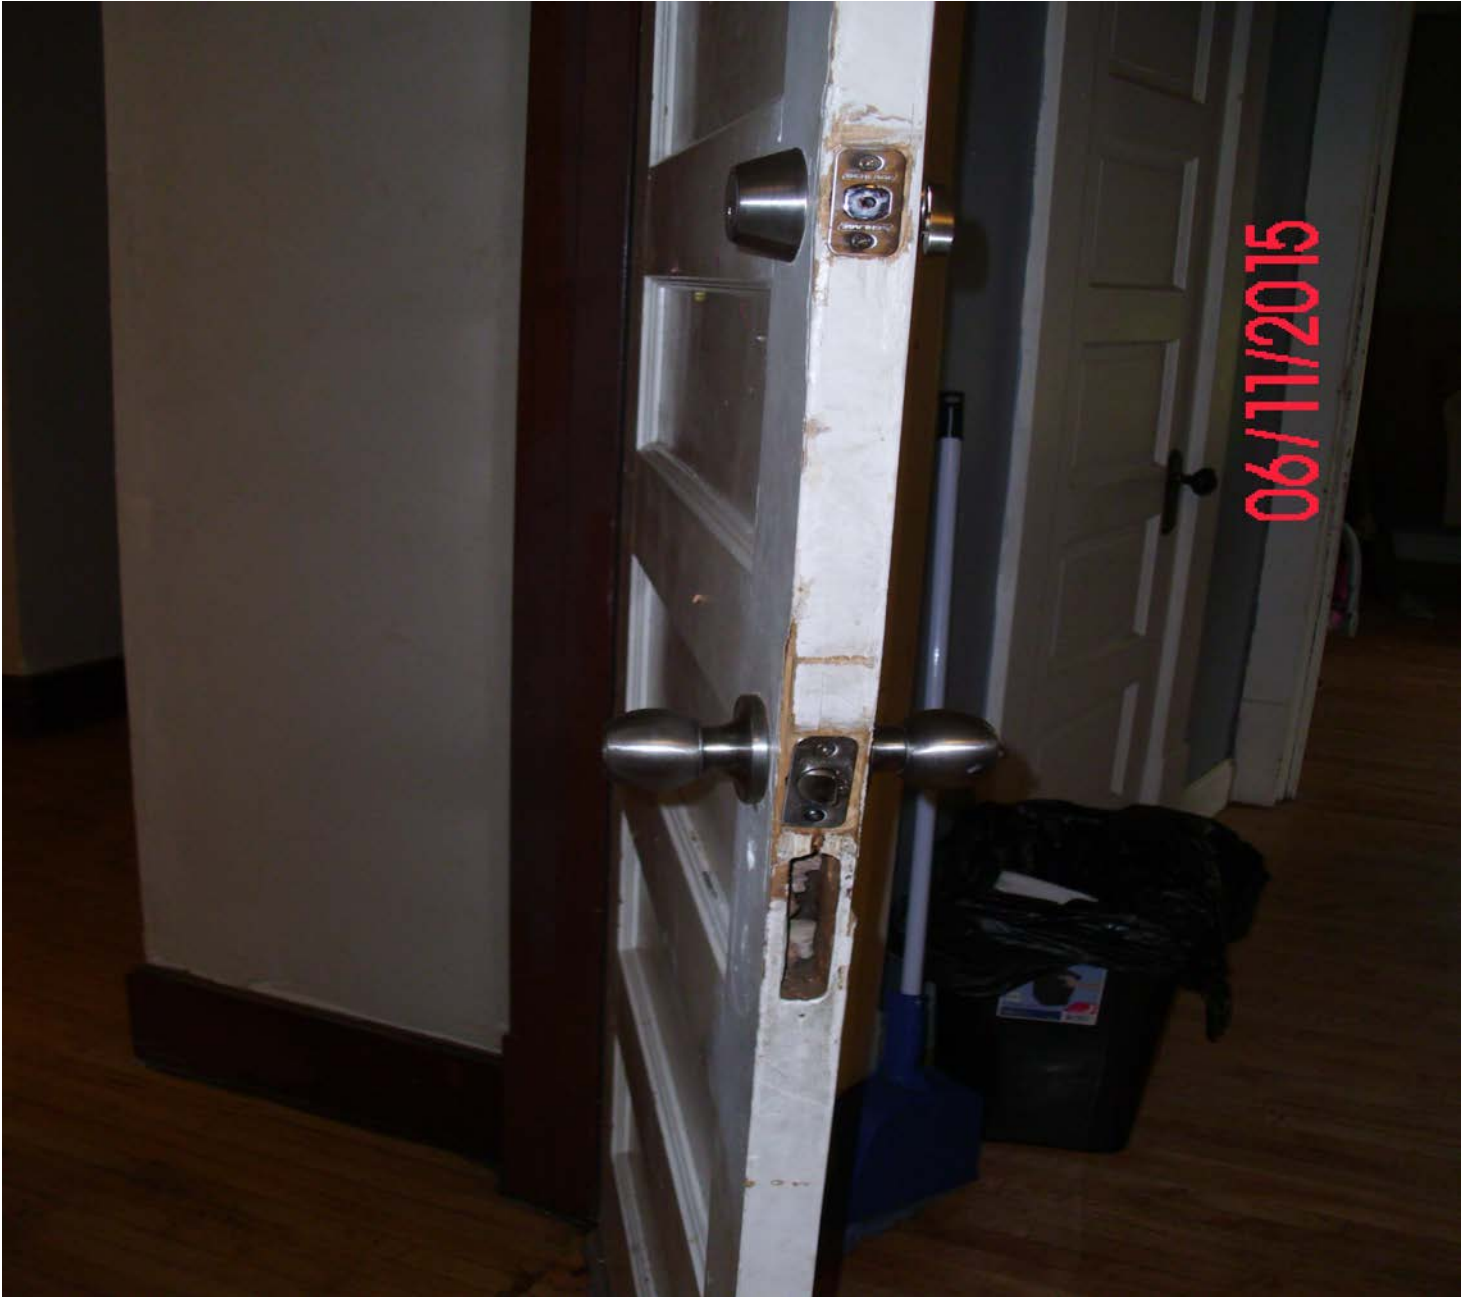
Continuation of first picture

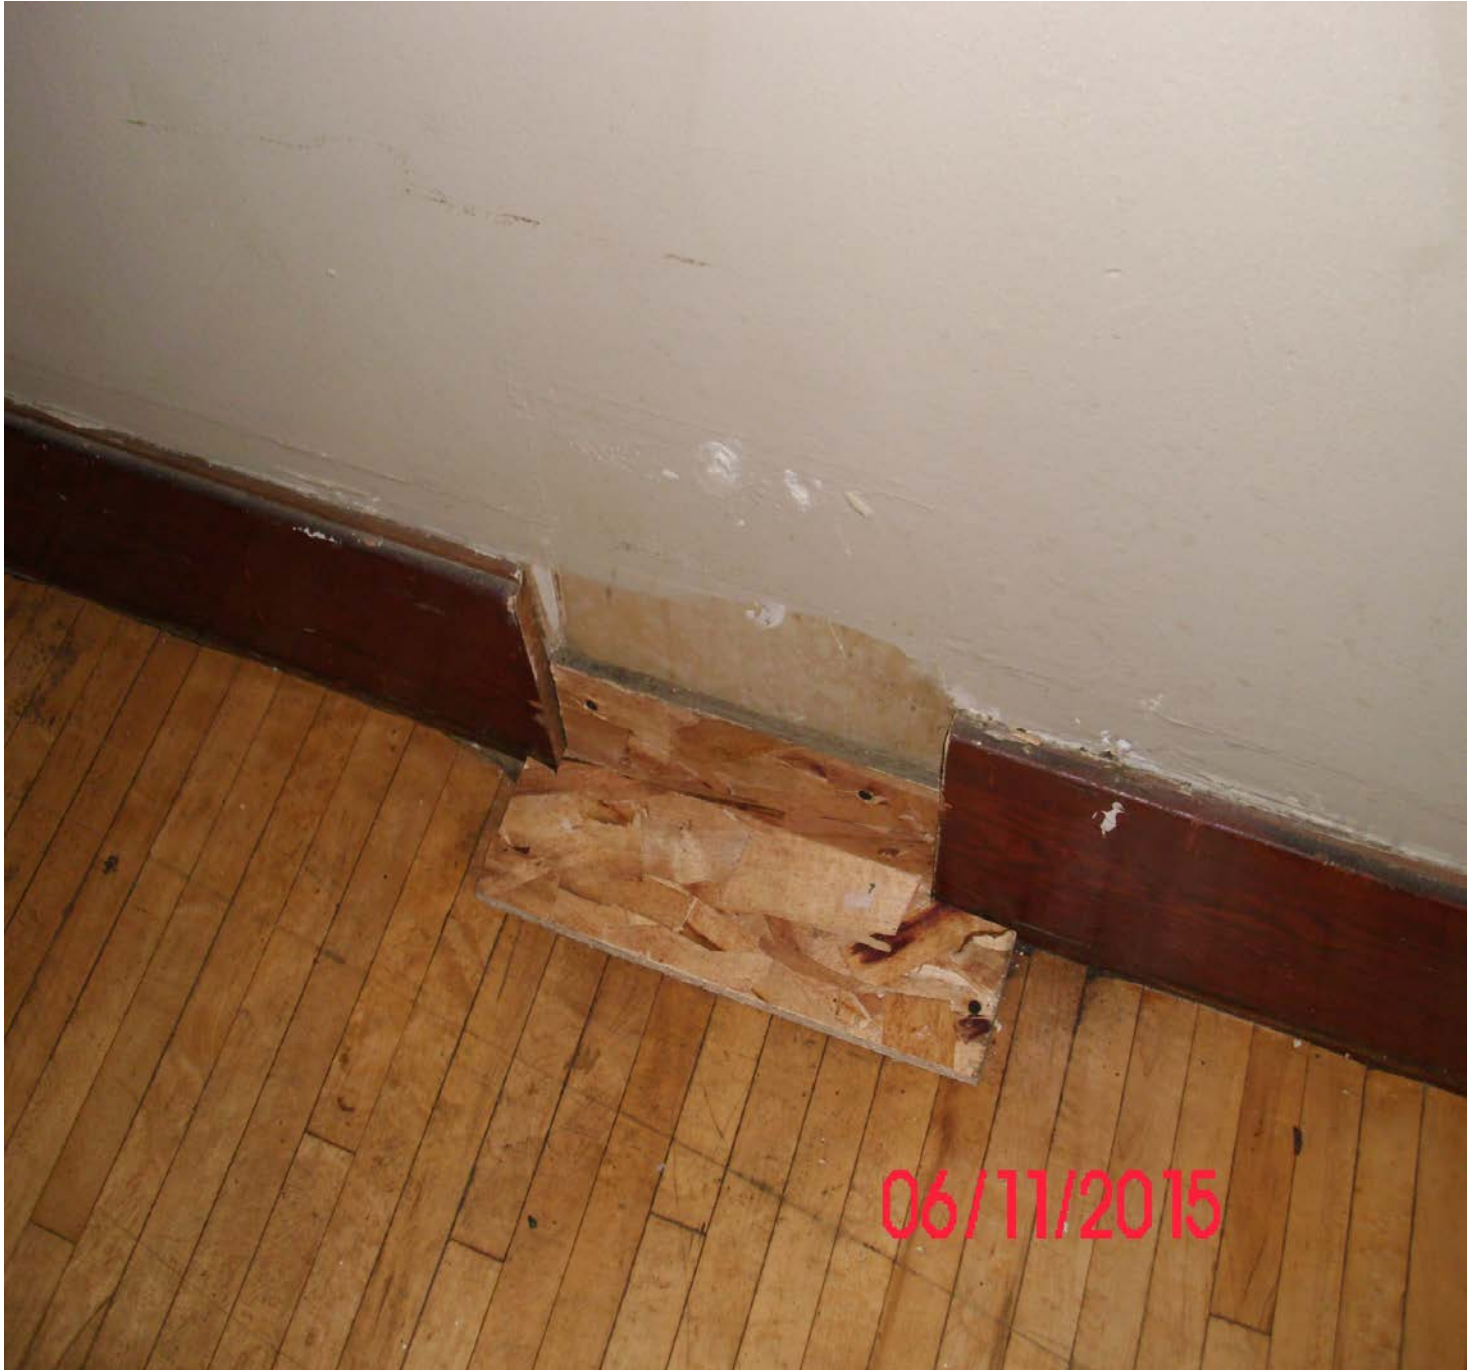
**2<sup>nd</sup> Floor corridor**

**Owner's repair for hole looking into the bathroom of a first floor unit**

**Does not meet one-hour separation requirements for materials or application**

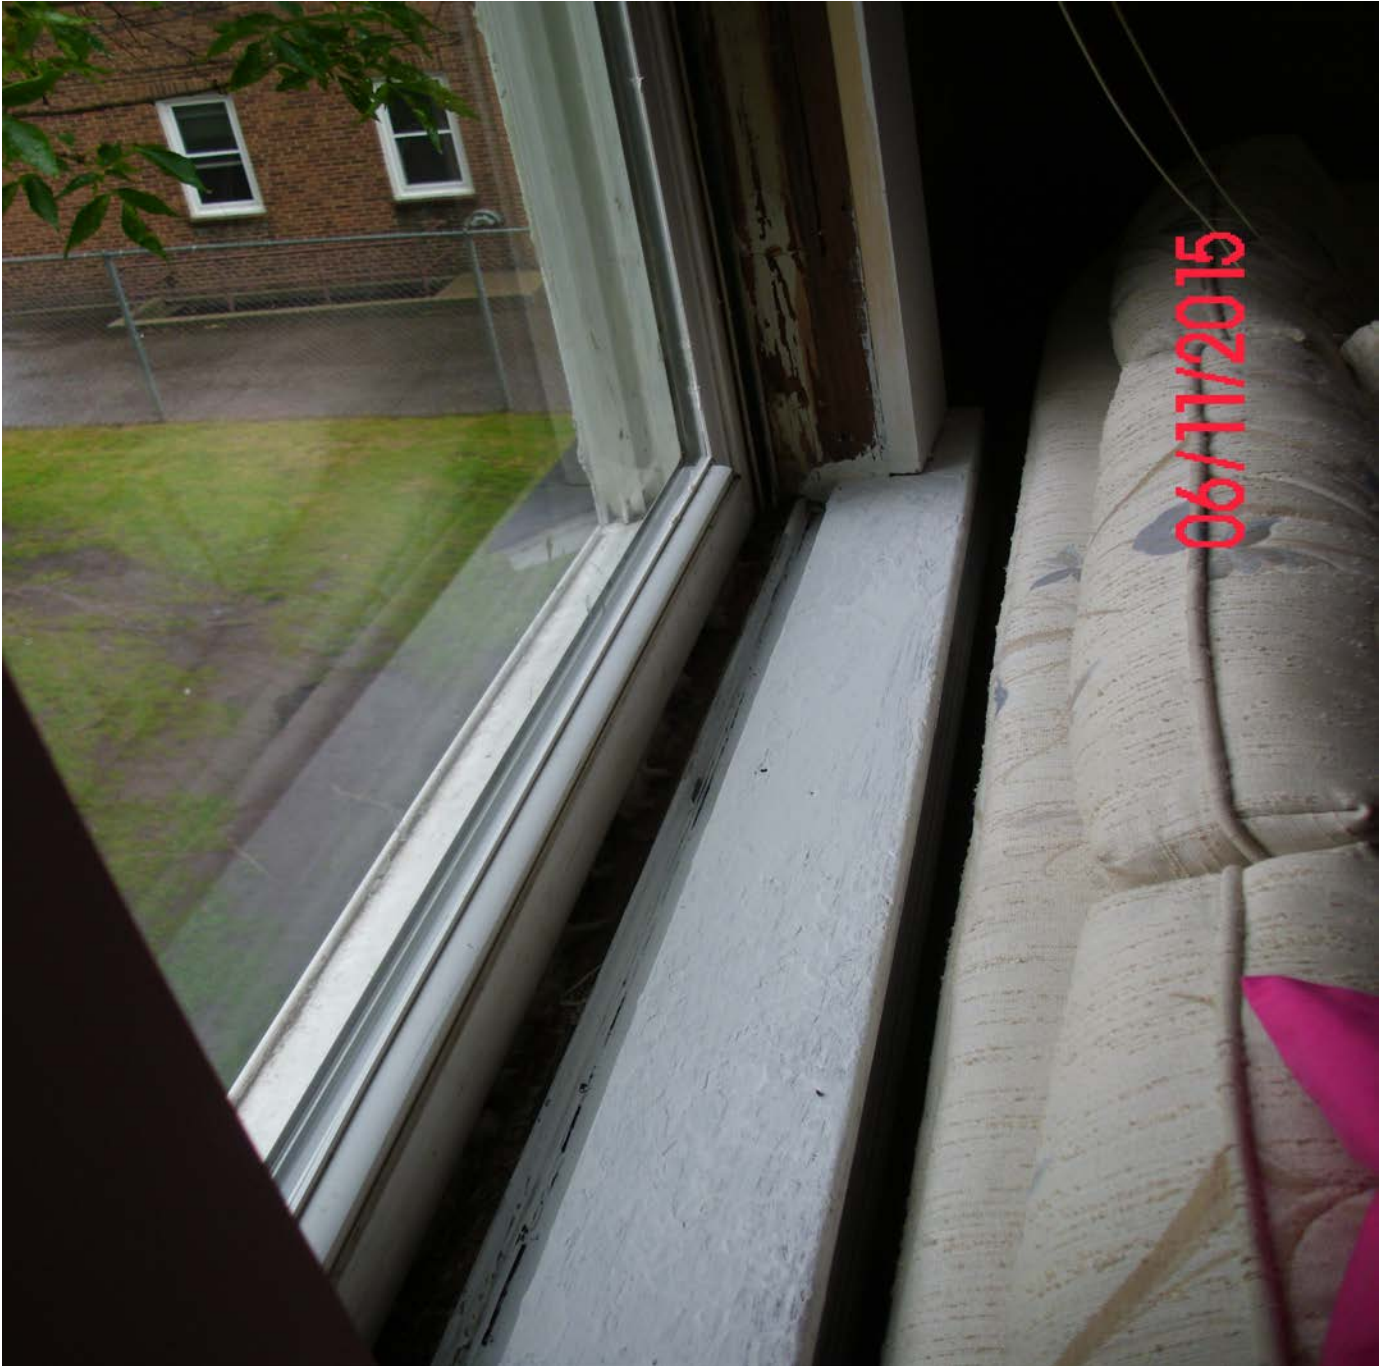
**Replacement window not finished. Insulation showing at lower sash/sill**

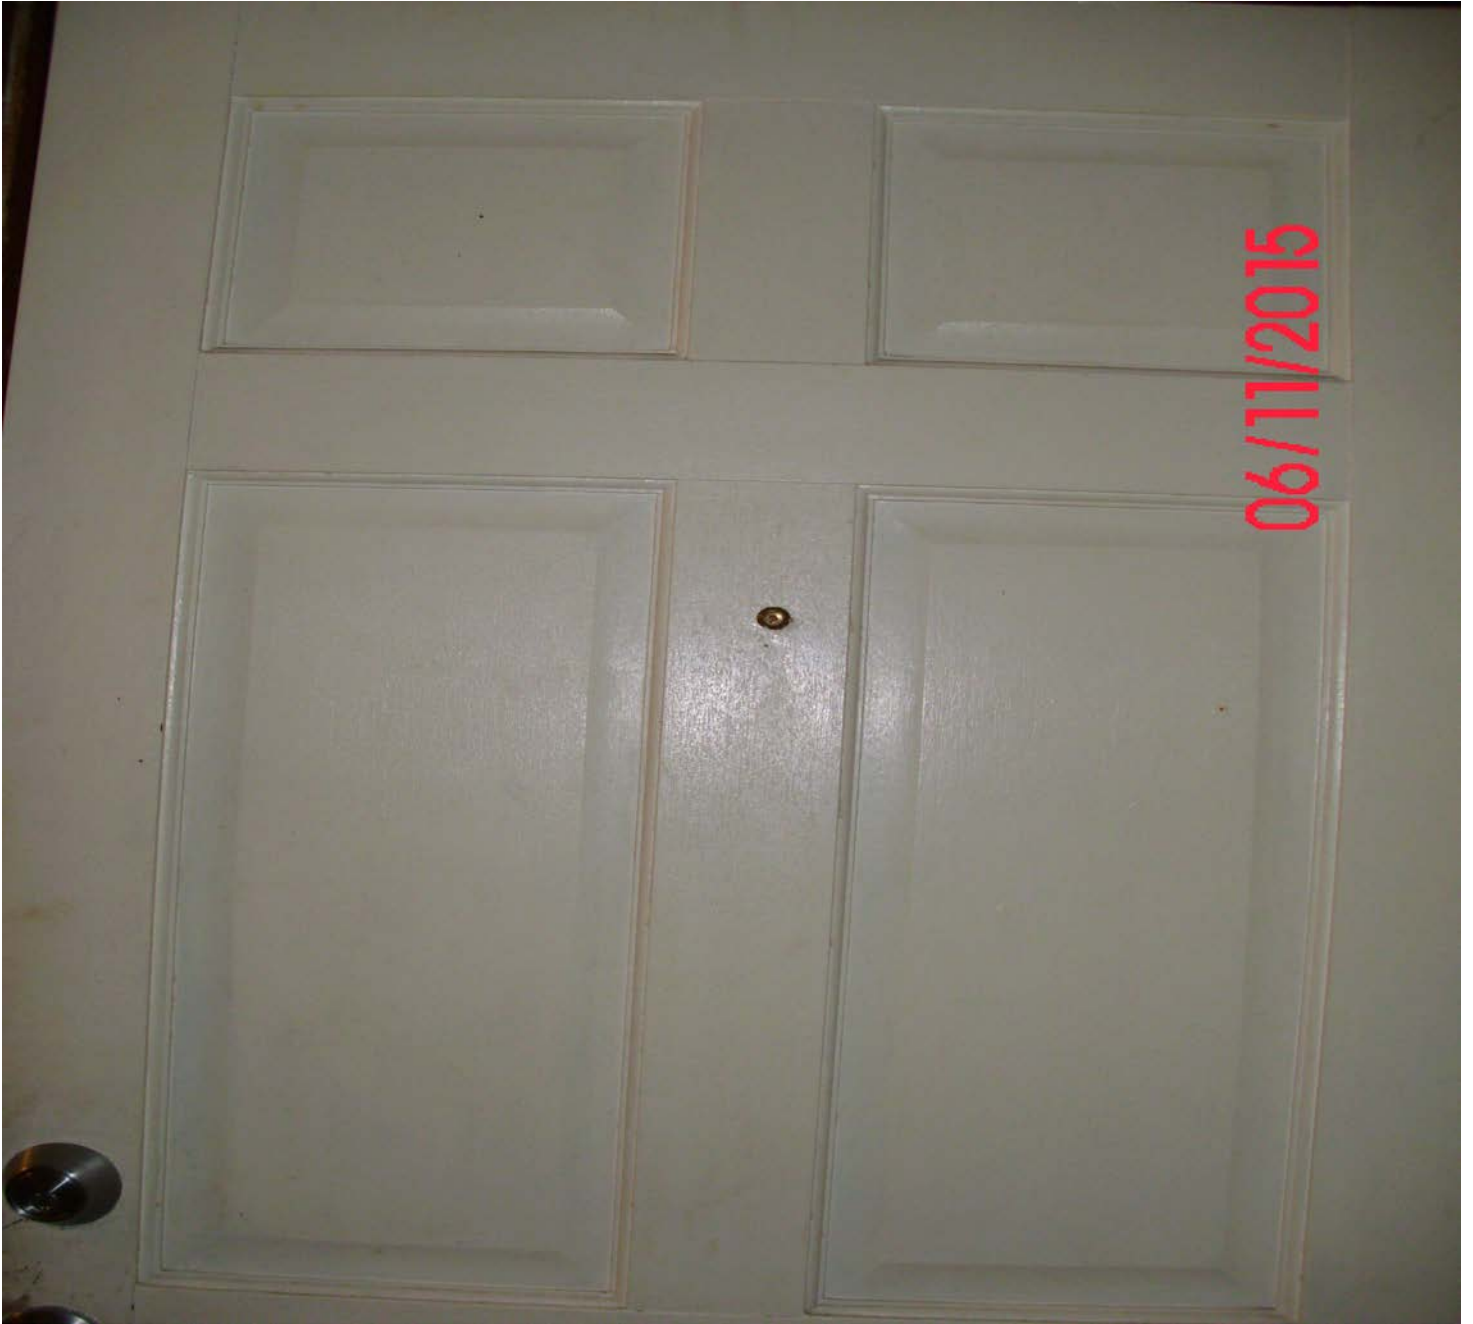
**Missing unit number**

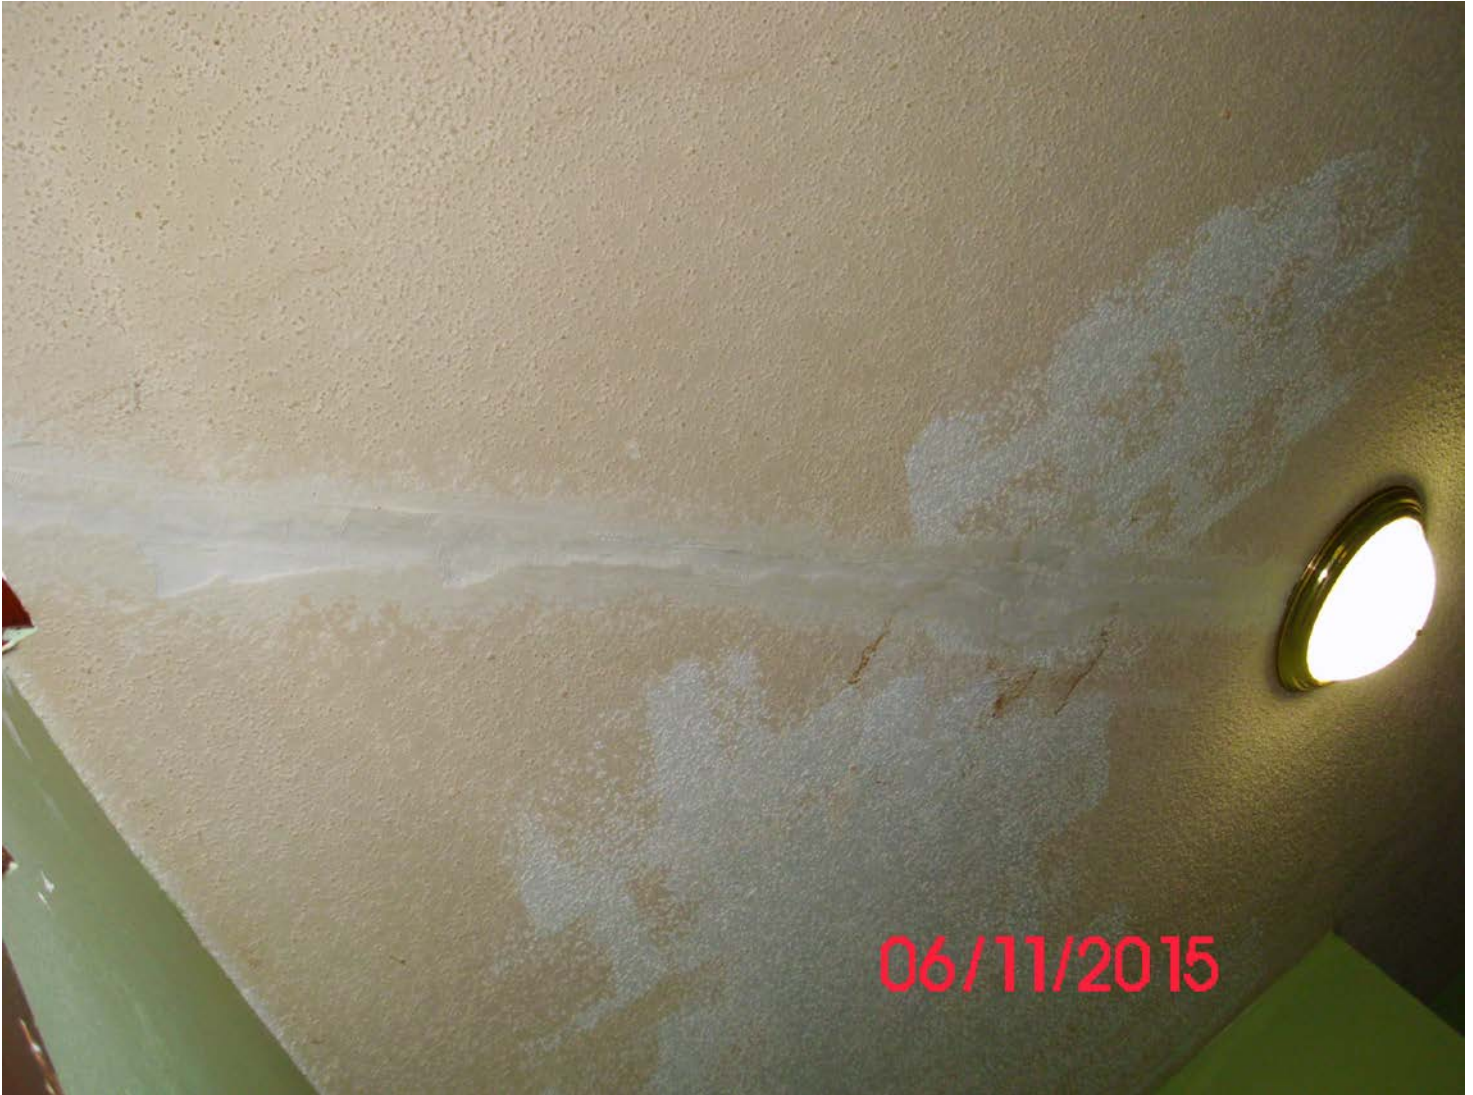
**Ceiling fixture had wiring running along the ceiling at previous inspection. Property owner rewired without a permit, running wiring above ceiling.**

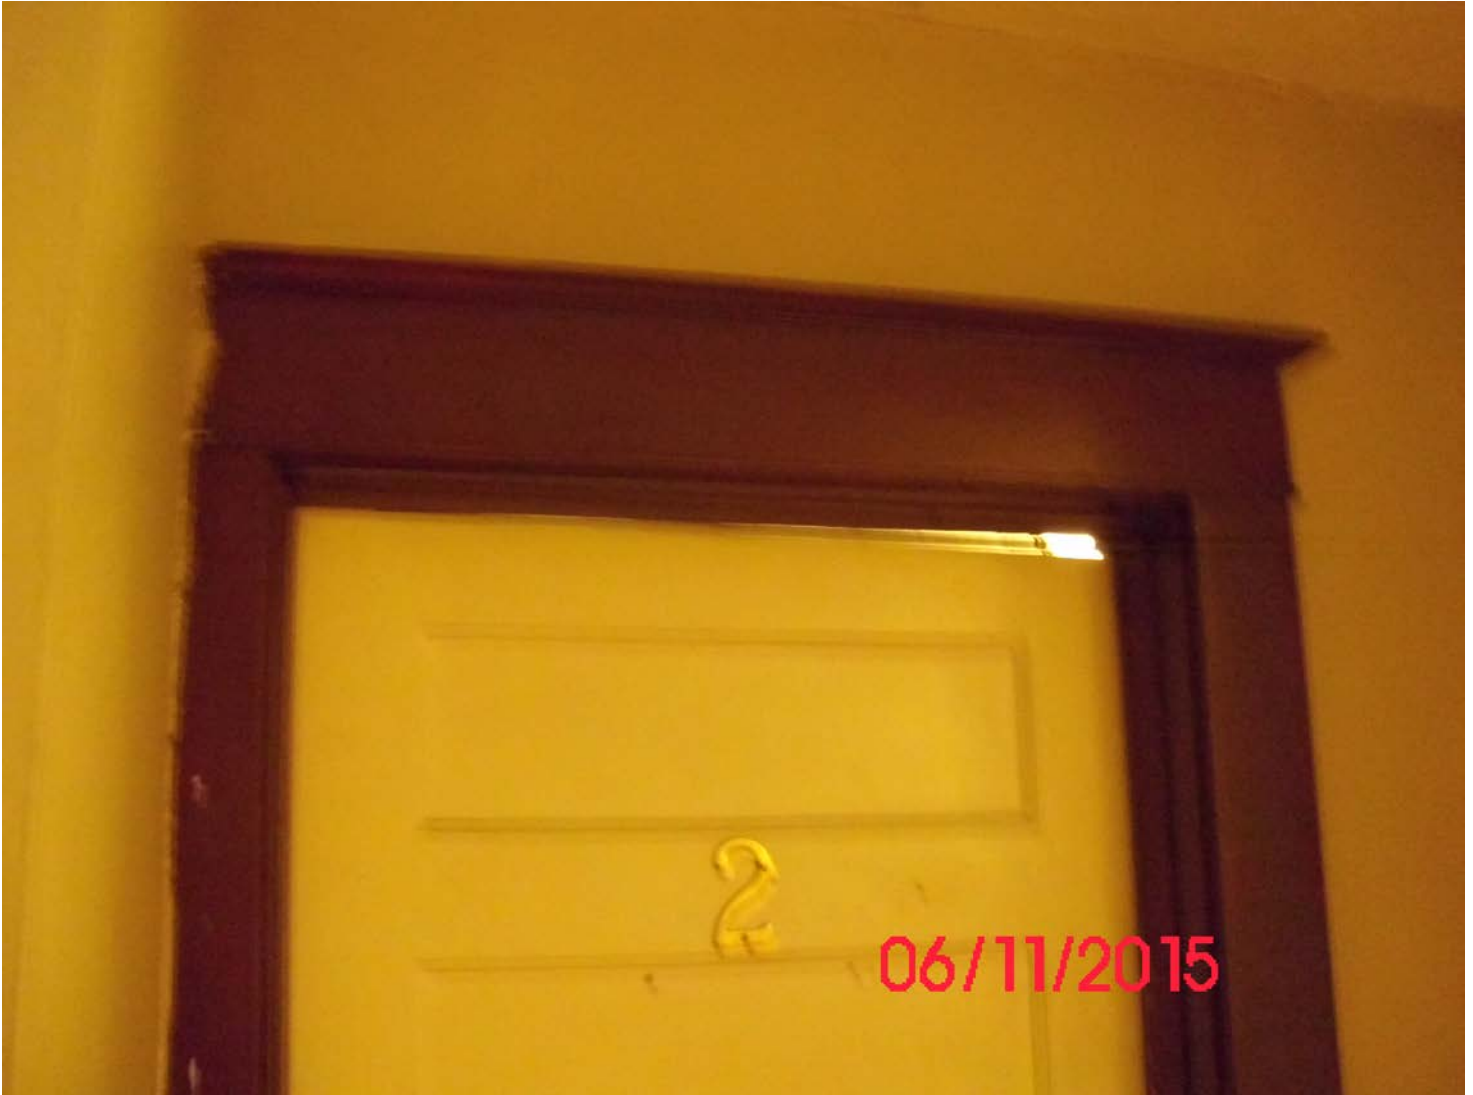
**Entry door does not fit in frame.**
