Photos taken by Angie Wiese, Supervisor of Commercial Section
1/6/2014

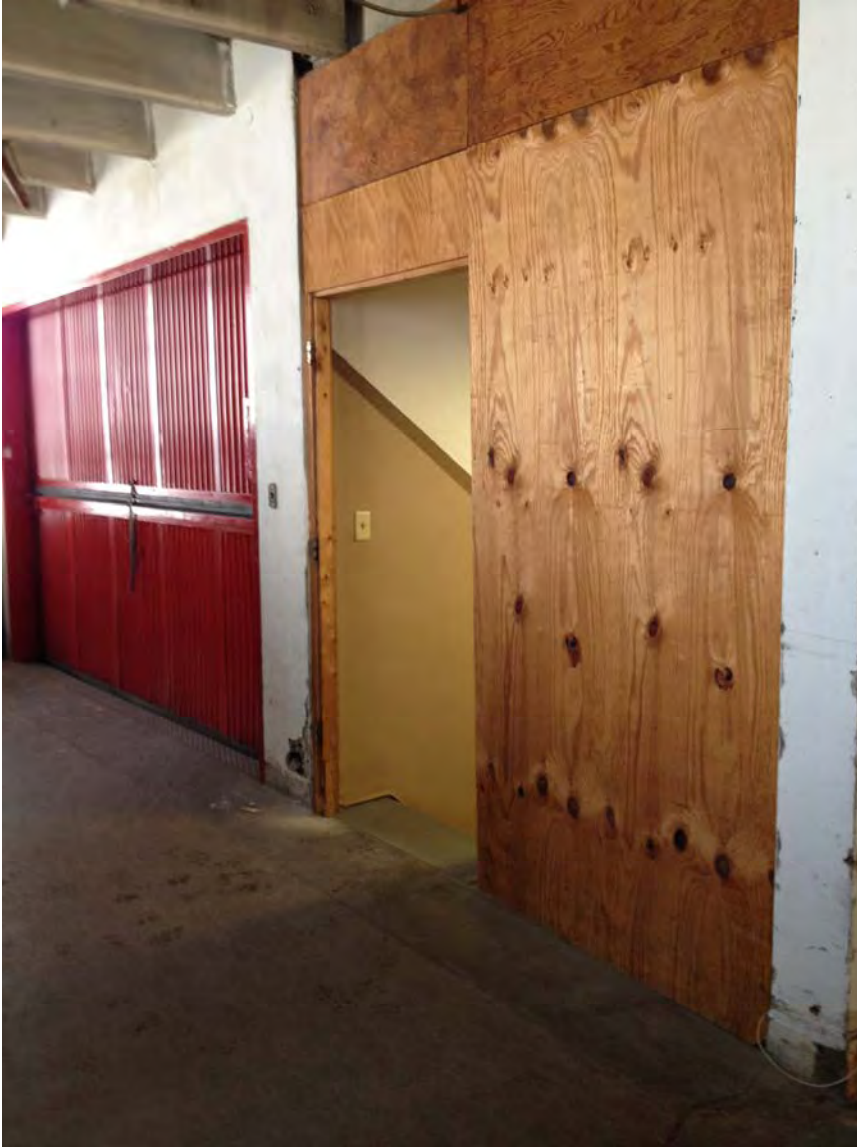
Opening at the 3rd floor. No door but evidence of a past plywood door and hasp locking arrangement. No landing on stair side where door opening is.

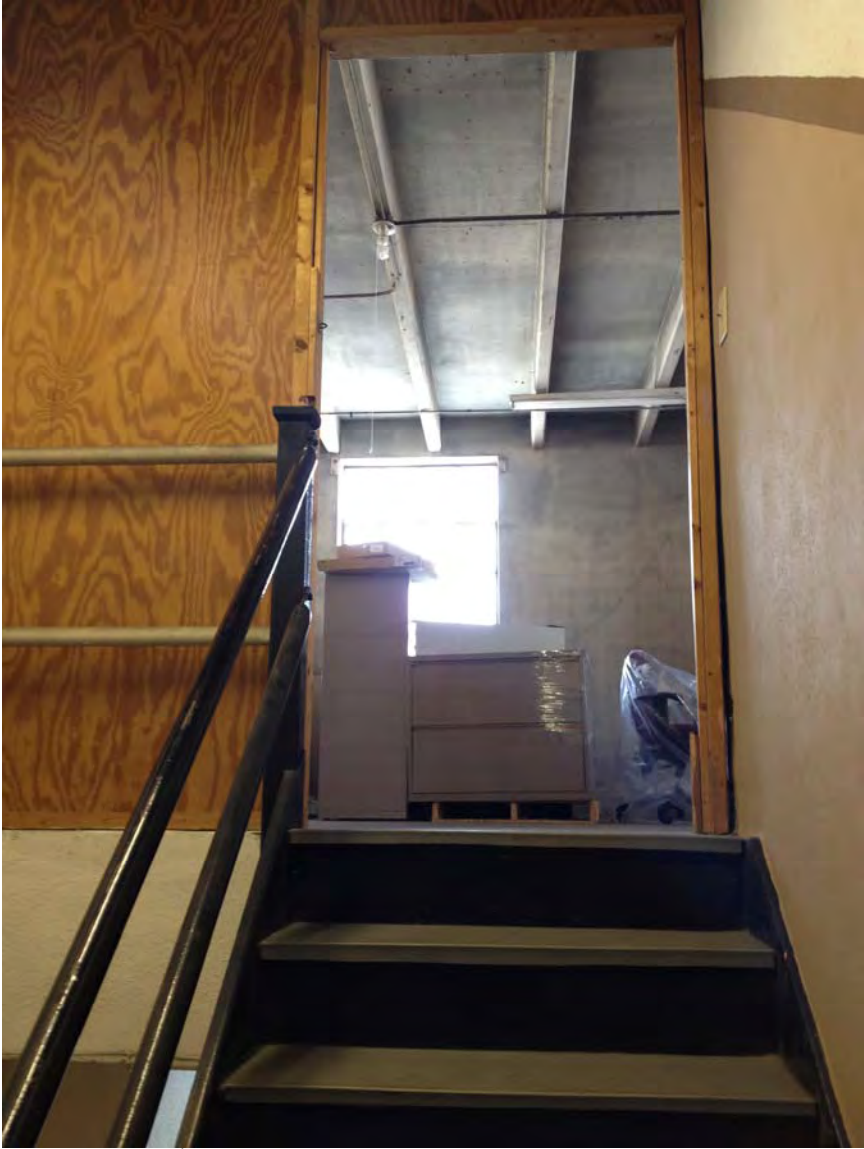
Opening at 3rd floor taken from stair side.

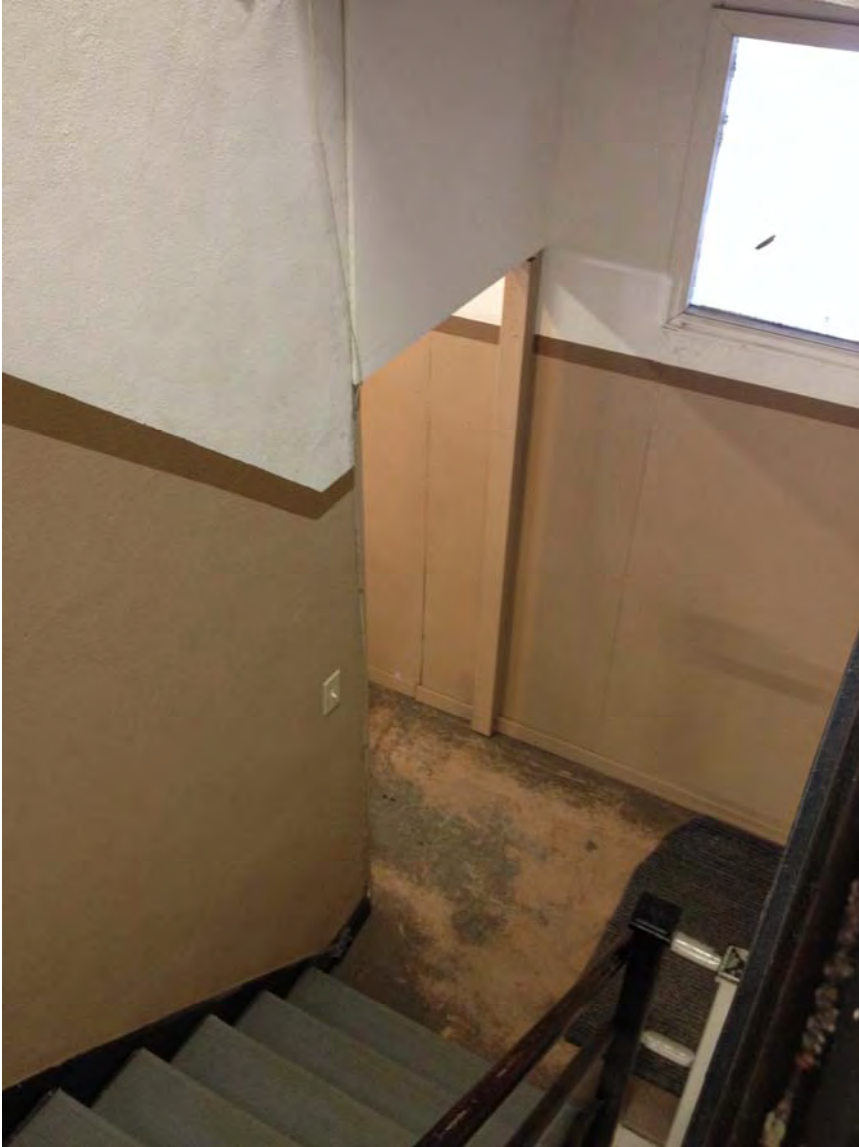
Opening at 2nd floor. No door but a landing on both sides of the opening.

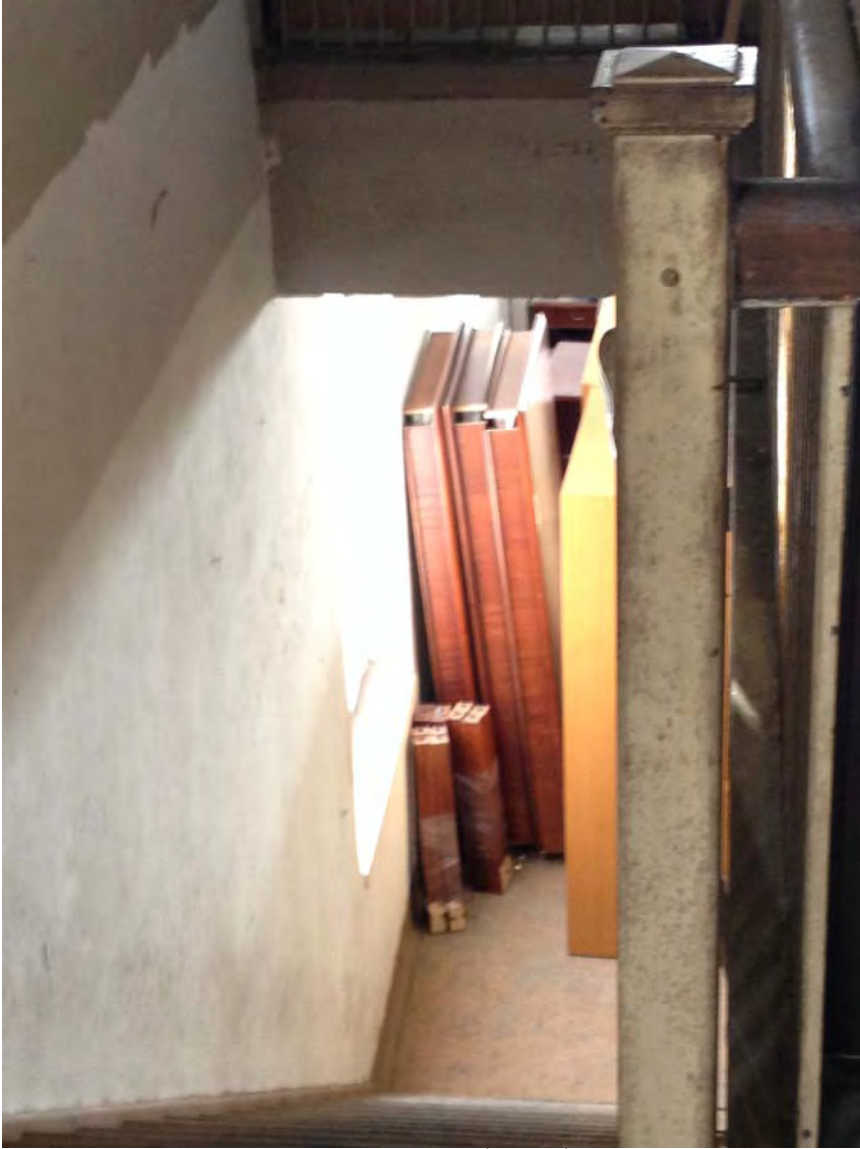
A second open stair that goes from 3rd to 2nd floor.

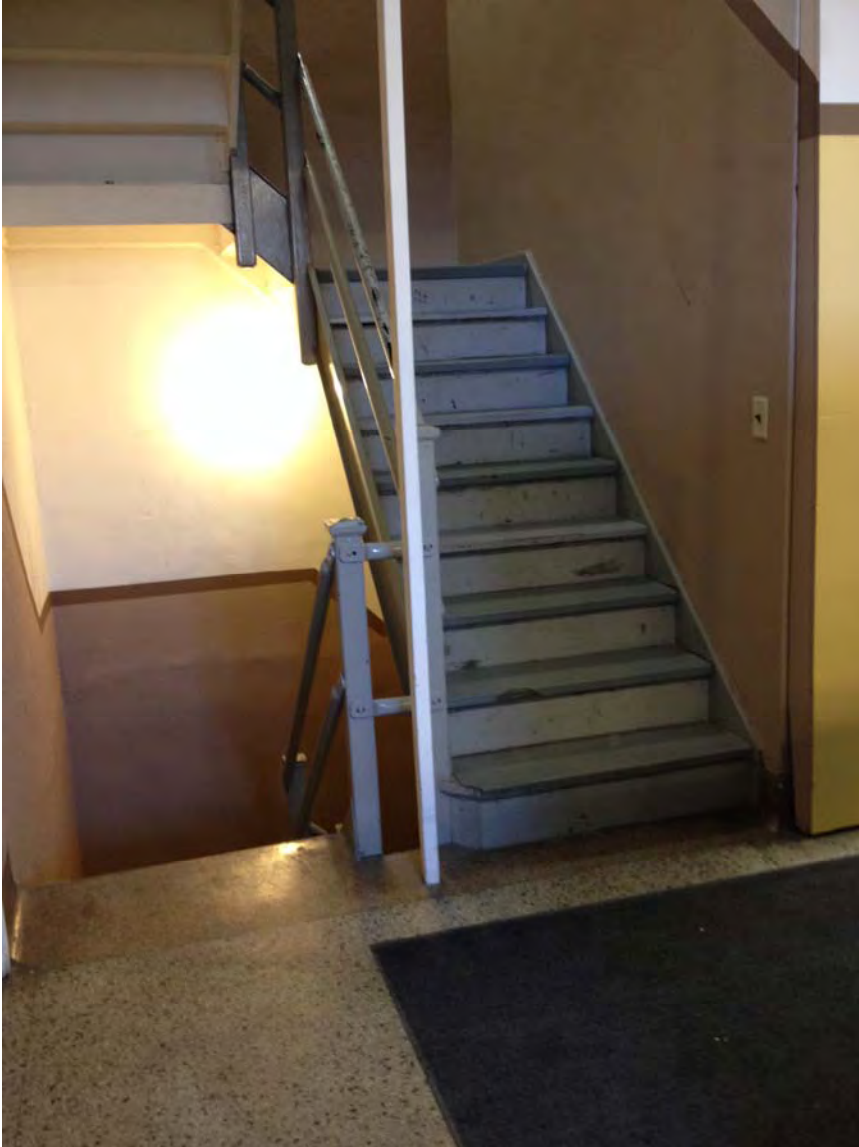
Opening at 1st floor. No landing or lobby area. Next picture is an enlargement of the bottom right of this picture.

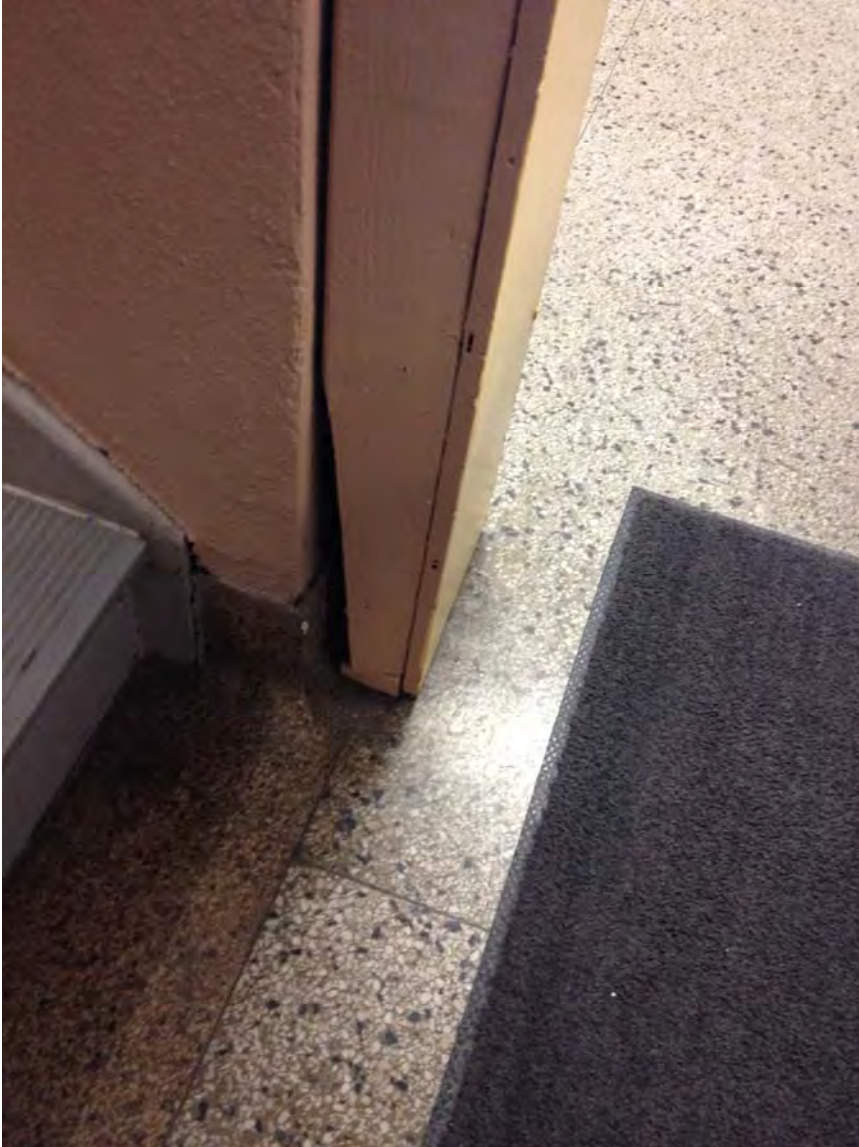
Enlargement of framing adjacent to plaster/terrazzo construction.

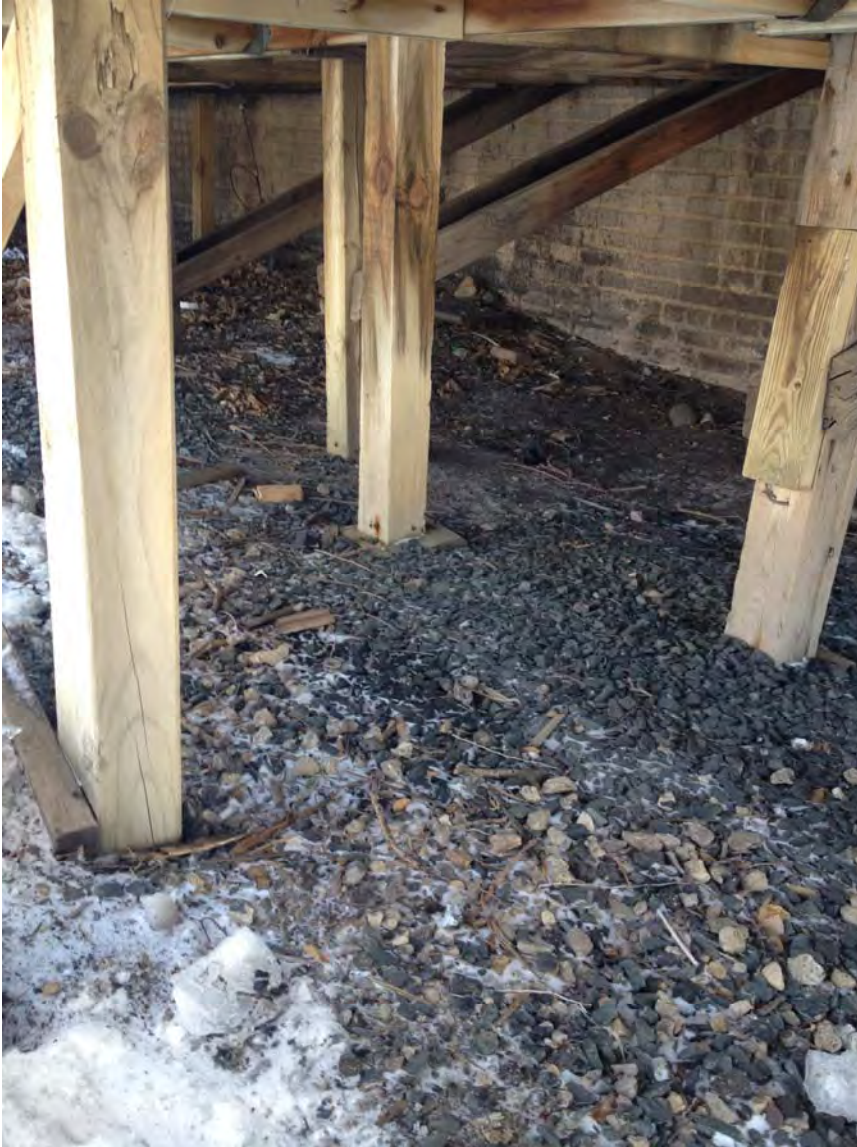
Structural elements of exterior loading dock which also serves as a means of egress from the building.

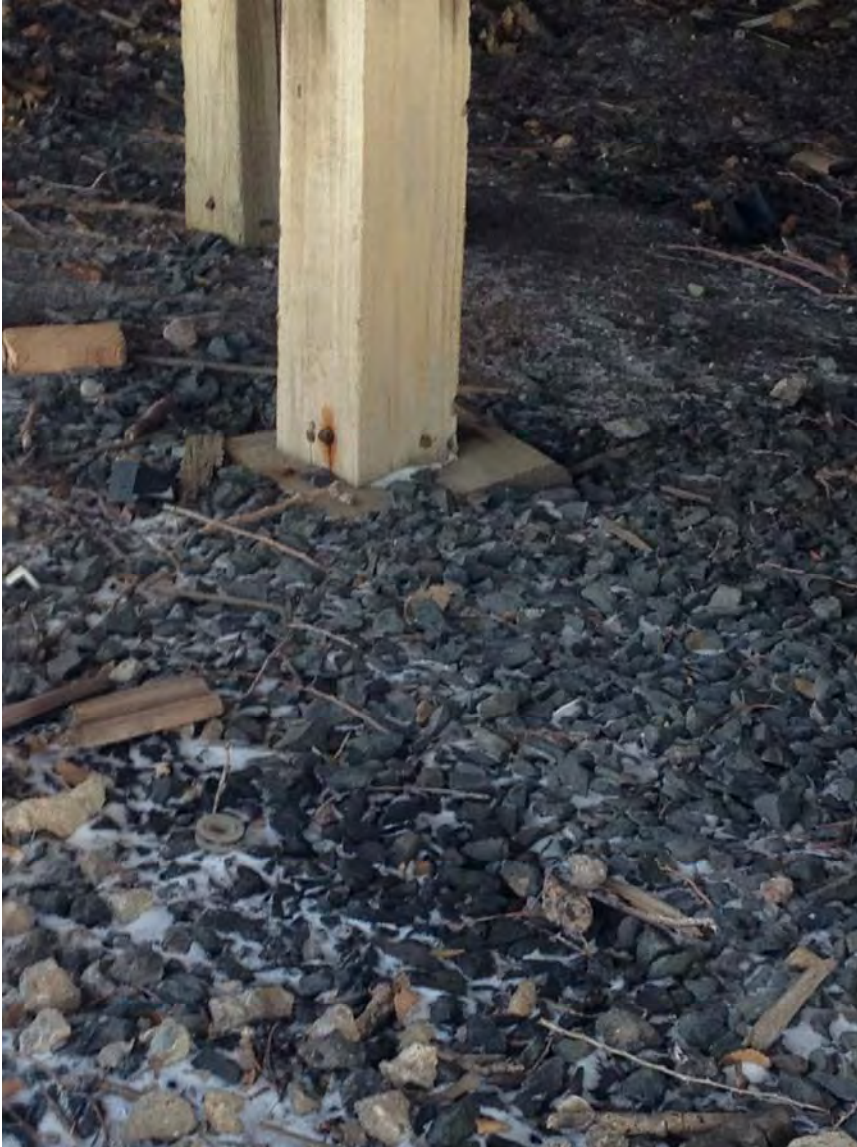
Enlargement showing the lack of footing.

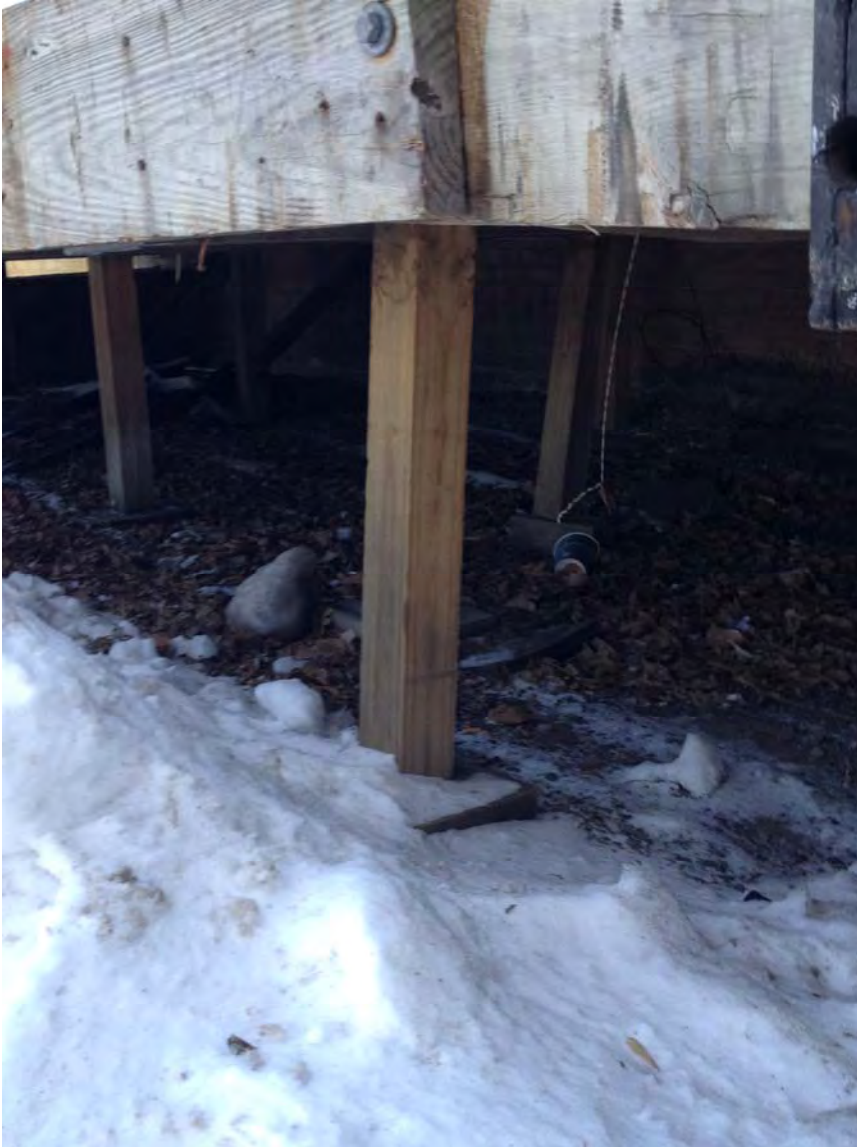
Structural elements of exterior loading dock which also serves as a means of egress from the building.

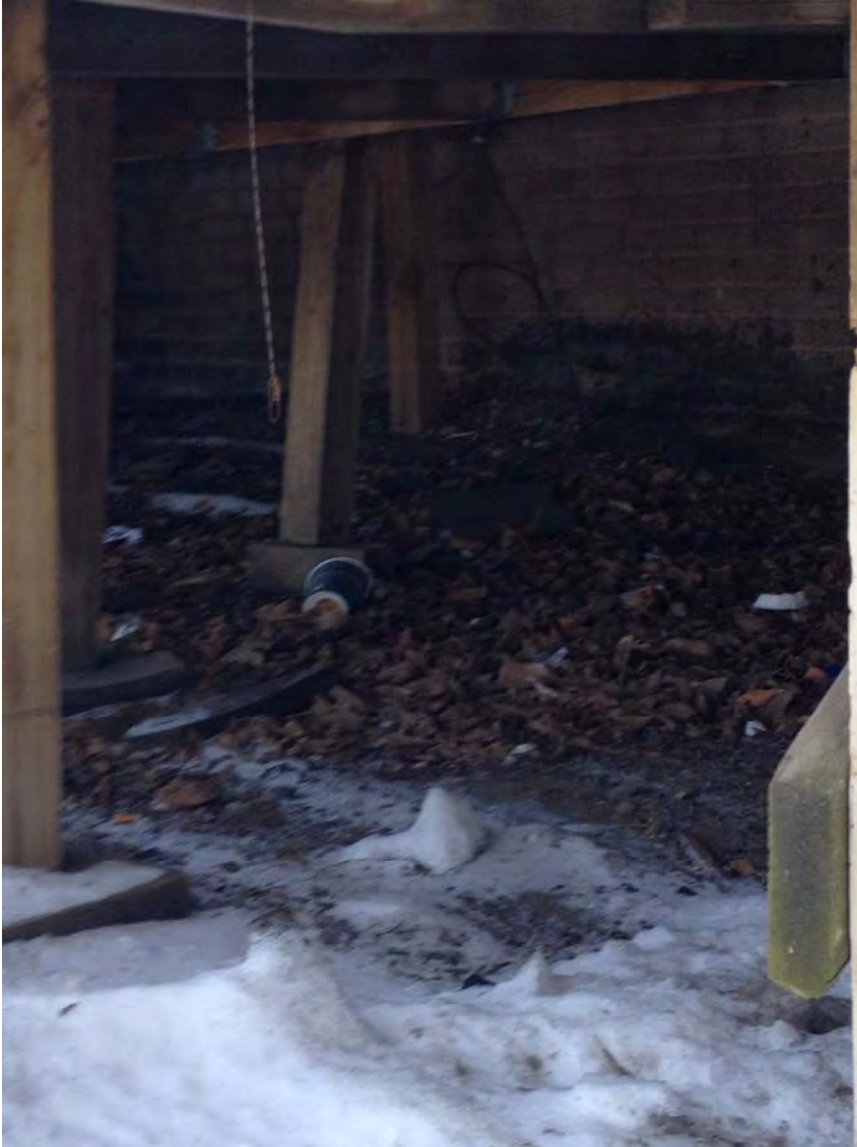
Enlargement showing one structural member out of plumb.
