February 10, 2016

RE: Foundation Assessment
956 Geranium Ave E
St. Paul, Minnesota

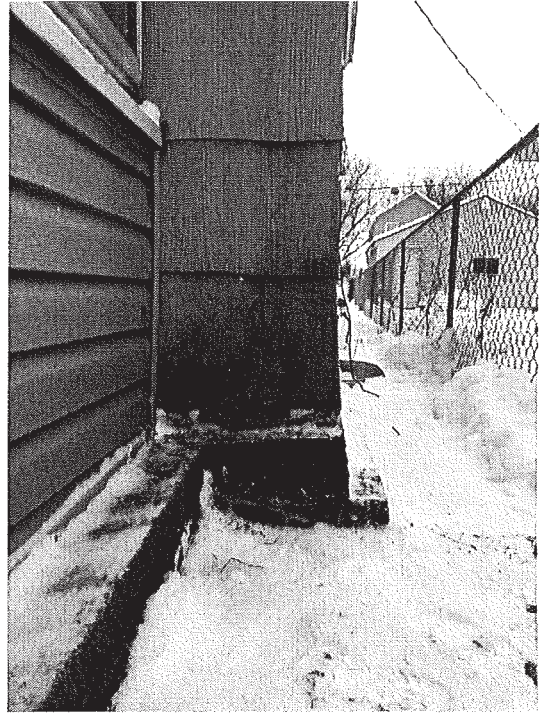
Along the perimeter of the house, a poured concrete ledge was visible, projecting out from the face of the exterior wall (see Photo 2). This ledge is a source of standing water which has been allowed to enter the rim joist and main floor framing members. The water intrusion appears to have resulted in damage/rot throughout the perimeter of the house (see Photo 3).

Photo 2 – Poured Concrete Ledge at Perimeter

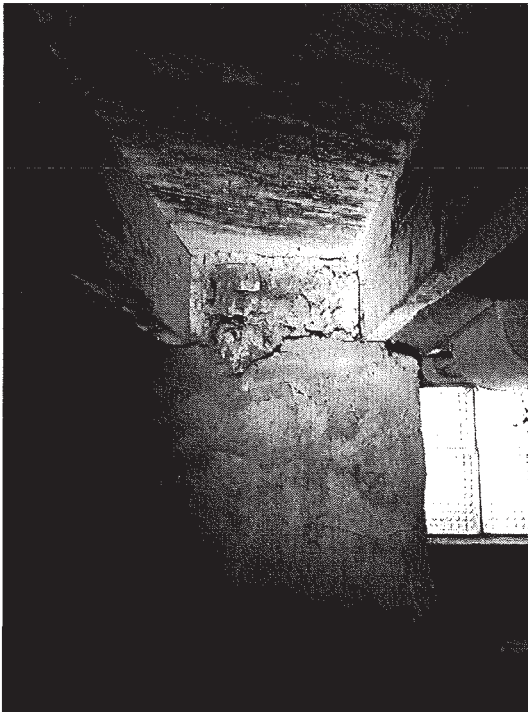
Photo 3 – Damaged/Rotted Wood Floor Joists

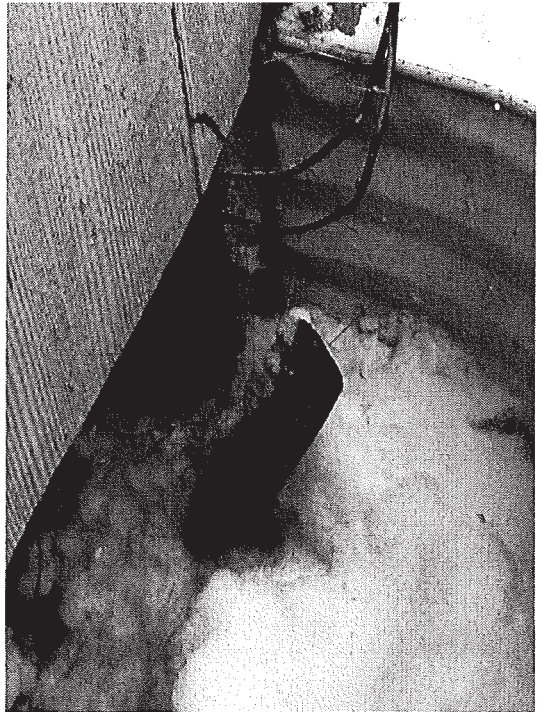
Other areas were noted as locations where water has been allowed to penetrate the foundation system. Poorly constructed window wells (see Photo 4), window sills located near exterior grade level (see Photo 5), and an exterior stair providing access to the lower level (see Photos 6 & 7) have all contributed to the moisture problem. In addition, the lower level stair structure did not appear to have adequate frost coverage at the foundation, so heave/settlement due to frost effects have also been an issue.

Photo 4 – Window Well with High Interior Grade Level

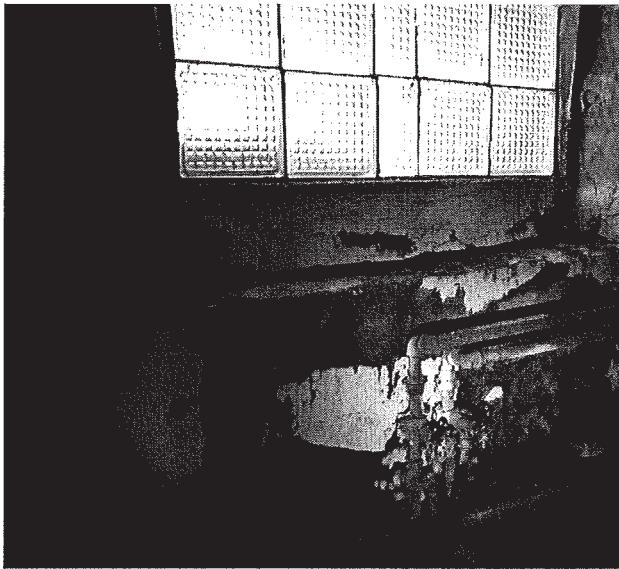
Photo 5 – Low Window Sill Allowing Moisture Infiltration

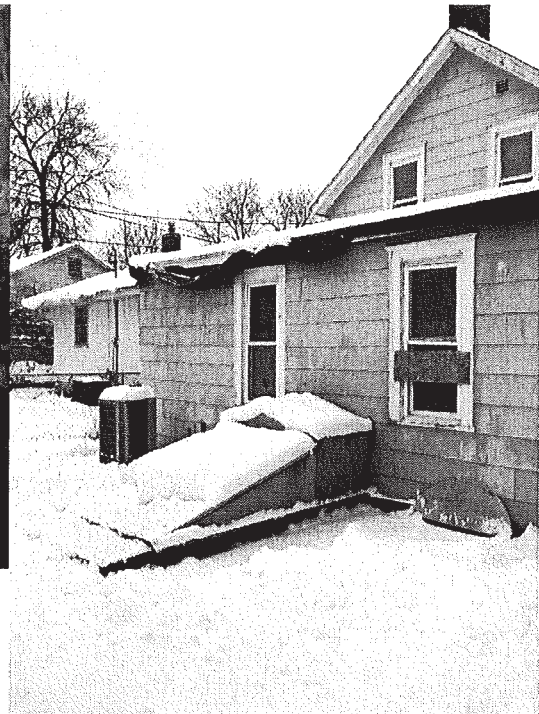
Photo 6 – Uninsulated, Unprotected Exterior Stair Access

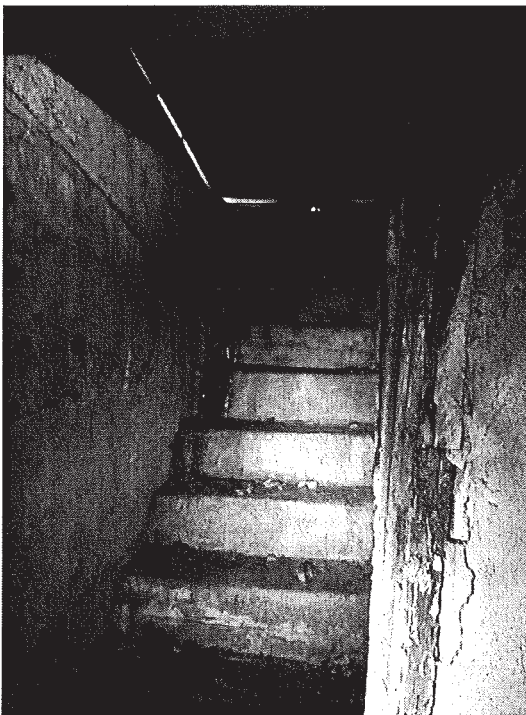
Photo 7 – Stair Access Allowing Moisture Infiltration

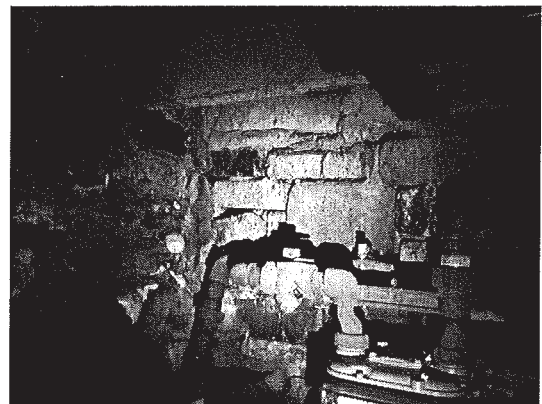
The majority of the existing stone foundation walls had been covered in a concrete/stucco parge coat, so identifying particular areas of deterioration was difficult. However, in locations where applying a finish was difficult, there are numerous signs of deterioration and settlement (see Photos 8 & 9).

Photo 8 – Cracked, Settling Stone/Brick Foundation Wall

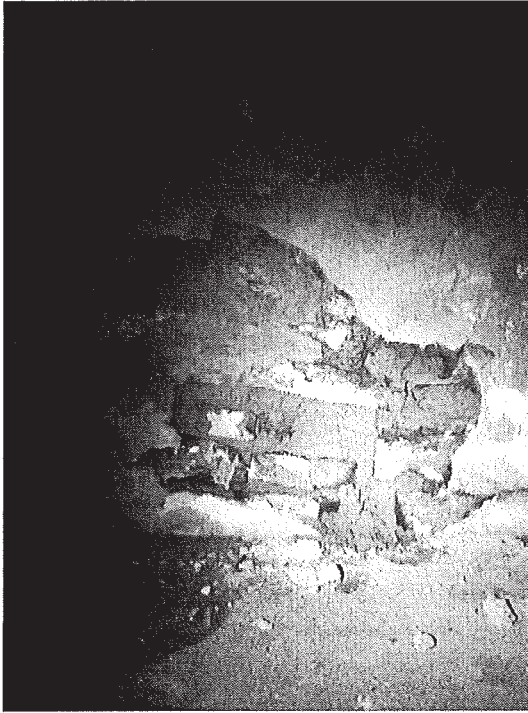
Photo 9 – Damaged Parge Coat and Crumbling Foundation Wall

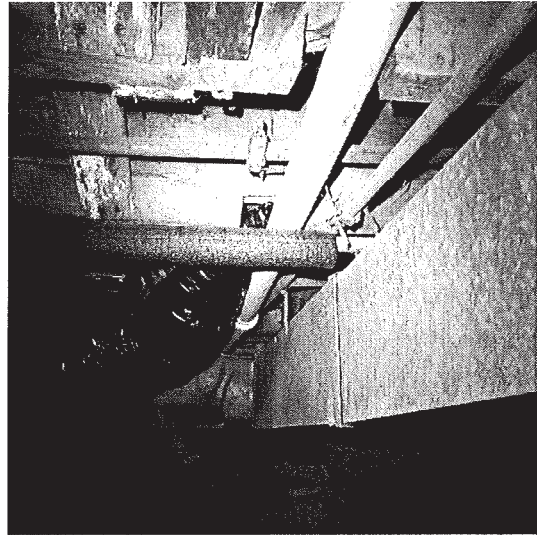
The main floor framing consisted of 2 x 8 floor joists, spaced at 16" o.c. In most areas, the joists were inadequately supported (no joist hangers, insufficient bearing length). Many of the headers over openings were undersized and in many cases, the joists were heavily notched or drilled (see Photos 10, 11 & 12), decreasing their load carrying capacity.

Photo 10 – Notched Floor Joists

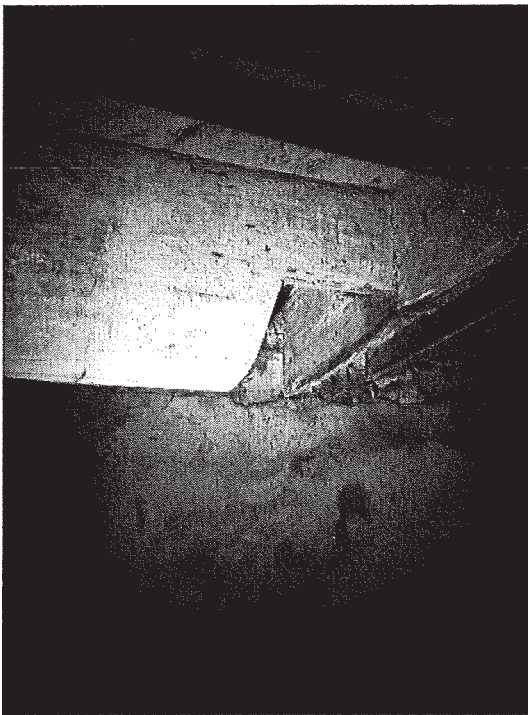
Photo 11 – Notched Floor Joist without Joist Hanger

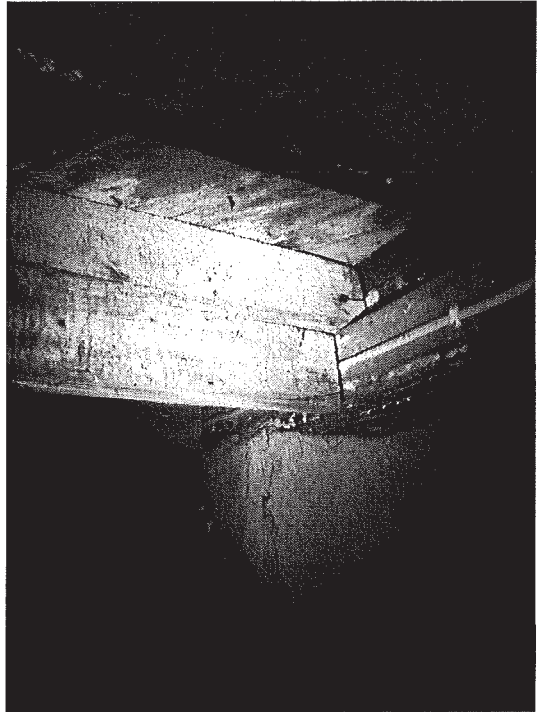
Photo 12 – Notch and Cracked Floor Joist
