Date: February 05, 2010 File #: 10 - 019633

Folder Name: 591 MACKUBIN ST PIN: 362923230004

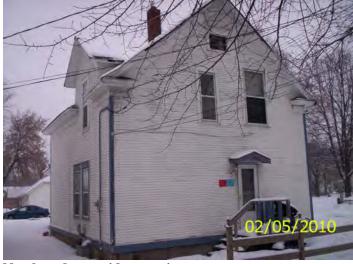
North and west sides, posting

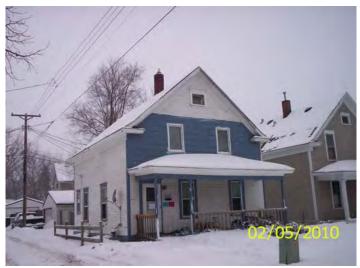
South and east sides, postings

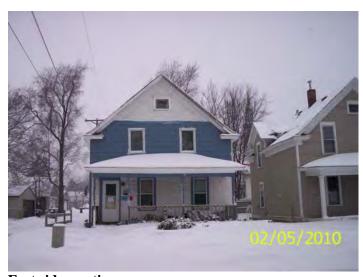
East side, postings

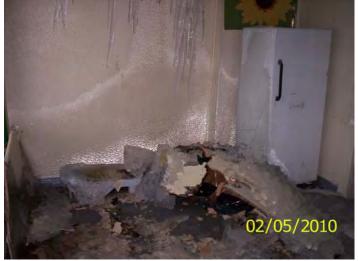
Kitchen, ice covered appliance, wall, floor

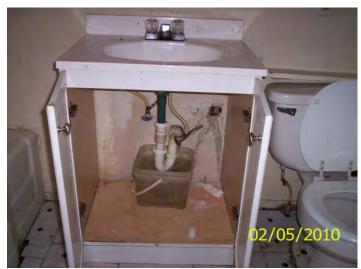
Improper trap repair, leaking

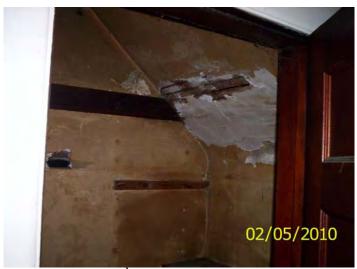
Damaged ceiling 2nd floor bathroom

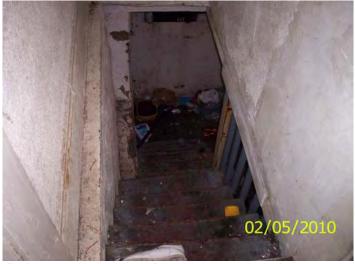
Stair way to basement, flooding, no hand rail

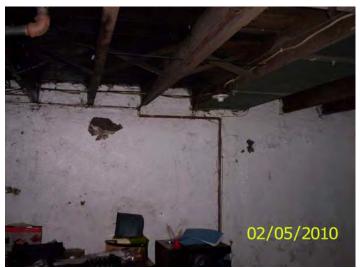
Bubbling, flaking paint

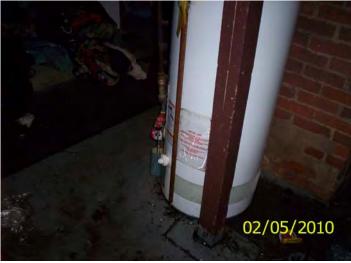
Improper post installation, improper spill tube, no handle on gas shut off

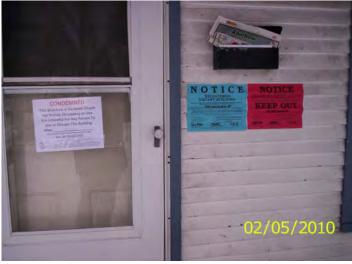
Front postings

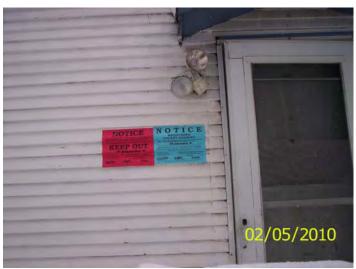
Rear posting
