INSPECTION REPORT – LICENSING

Inspection Date and Time: 11/5/2025 @ 2:00 p.m.

Business/DBA Name: The Commodore

Business Address: 79 Western Avenue North, Saint Paul, MN 55012

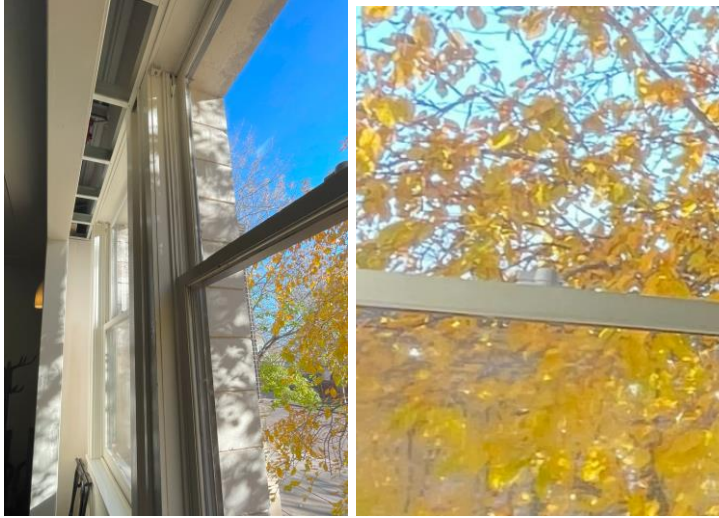
Condition #2:

Inspection Result: Non-Complaint and Compliant

Inspector Observations: Only primary windows were installed – no secondary “storm windows” existed. The windows appeared to be relatively new, in good condition and were equipped with locking mechanisms that prohibit opening without a key. This condition was imposed more than six months ago.

Summary of Mr. Rupp's comments: Locks have been installed, storm windows not needed based upon previous professional noise testing results.

“Install storm windows to reduce noise penetration on windows facing Holly Avenue, and install locking mechanisms to ensure these windows cannot be opened during events with music or entertainment, within six months.”

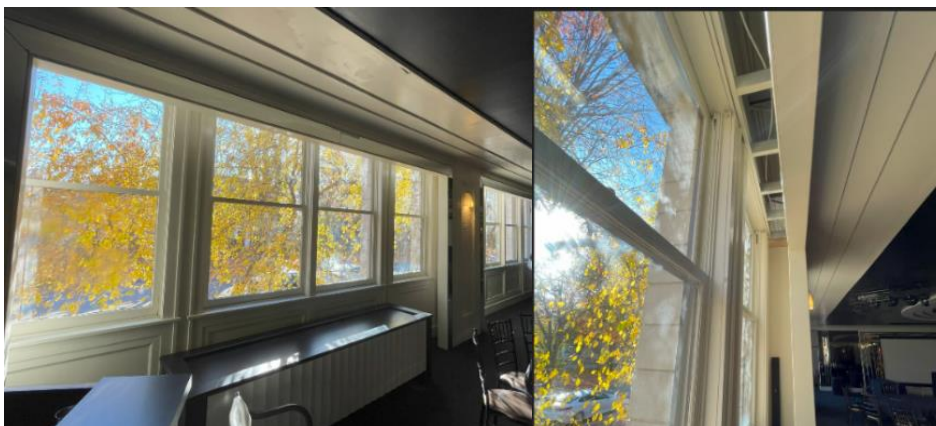
Condition #3:

Inspection Result: Non-Compliant

Inspector Observations: Windows were not equipped with drapes, shades, blinds, or any other type of window treatment. This condition was imposed more than six months ago.

Summary of Mr. Rupp’s Comments: Drapes not needed; cost \$30,000. No complaints of sound or light. If ever a complaint about light the Commodore would install blackout shades. Suggested this condition be changed to require compliance with Noise ordinance and if complaints are made, allow the Commodore to determine how to mitigate light and/or noise.

“Install drapery capable of absorbing sound, reducing sound penetration, and preventing strobe light penetration on windows facing Holly Avenue, within six months.”

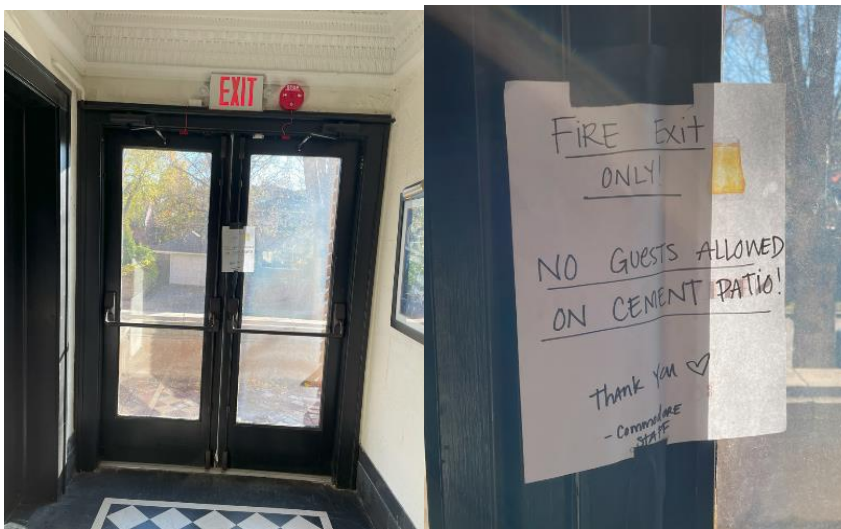
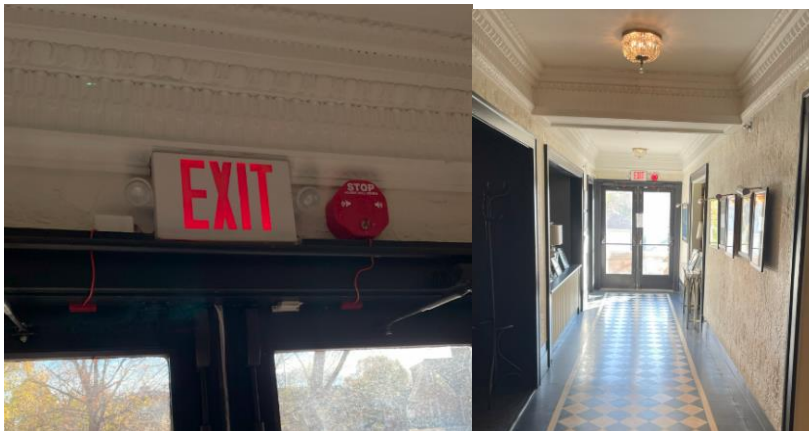
Condition #4:

Inspection Result: Compliant

Inspector Observation: South (Holly Avenue) door was equipped with crash bar and sounding device to alarm when opened. Basic hand-written sign posted noting door as a “Fire Exit Only”.

“Secure the south (Holly Avenue) door and install a crash bar and sounding device to ensure the door is used as an emergency exit only. This condition must be met immediately.”

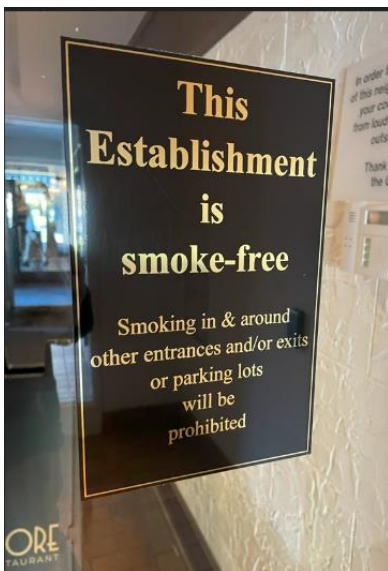
Condition #10:

Inspection Result: Non-Compliant and Compliant

Inspector Observation: Mr. Rupp was asked where the designated smoking area was and responded it was not necessary as the entire establishment is smoke free. No designated smoking area was determined to exist. Two (2) sizable signs were prominently displayed on each side of the main entrance to the establishment reading, “This Establishment is smoke-free Smoking in & around other entrances and/or exits or parking lots will be prohibited”

Summary of Mr. Rupp’s comments: Mr. Rupp explained that smoking was not allowed in or near the premises and customers who ask to smoke are directed by staff to do so on a public sidewalk.

“Designate a smoking area that is agreeable to the resident’s association. Smoking in and around other entrances and/or exits is prohibited.”

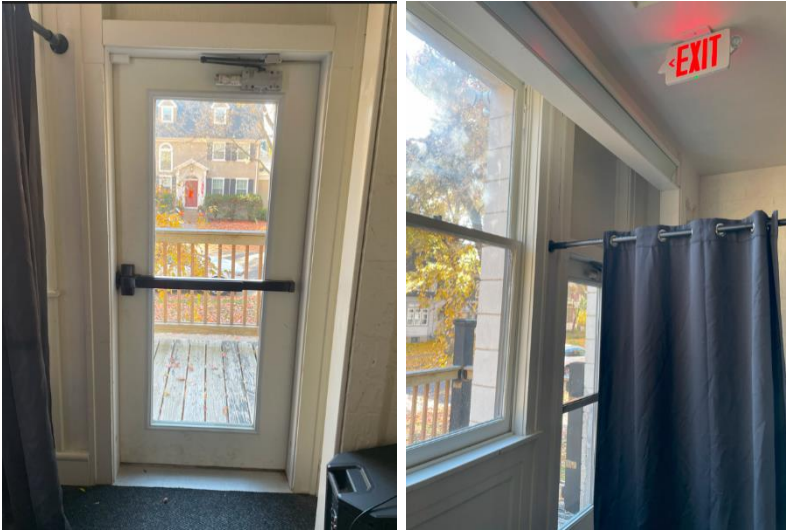
Additional Observation: A second door allowing access to Holly Avenue is located on the western-most side of the ballroom left of the stage that is not equipped with an alarm or designated as an emergency/fire exit. This door was apparently not part of the originally licensed premises and therefore not included in the original conditions to be designated as an alarmed emergency exit:
