**Limited Structural Engineering Services Report
511 Minnehaha Avenue East, St. Paul, Minnesota 55130
SRC Project No. SRC24-302
January 2, 2025
for
Jerry Brashier**

RE: Limited Structural Engineering Services Report
Building location: 511 Minnehaha Avenue East, St. Paul, Minnesota 55130
Via: Emailed this date.

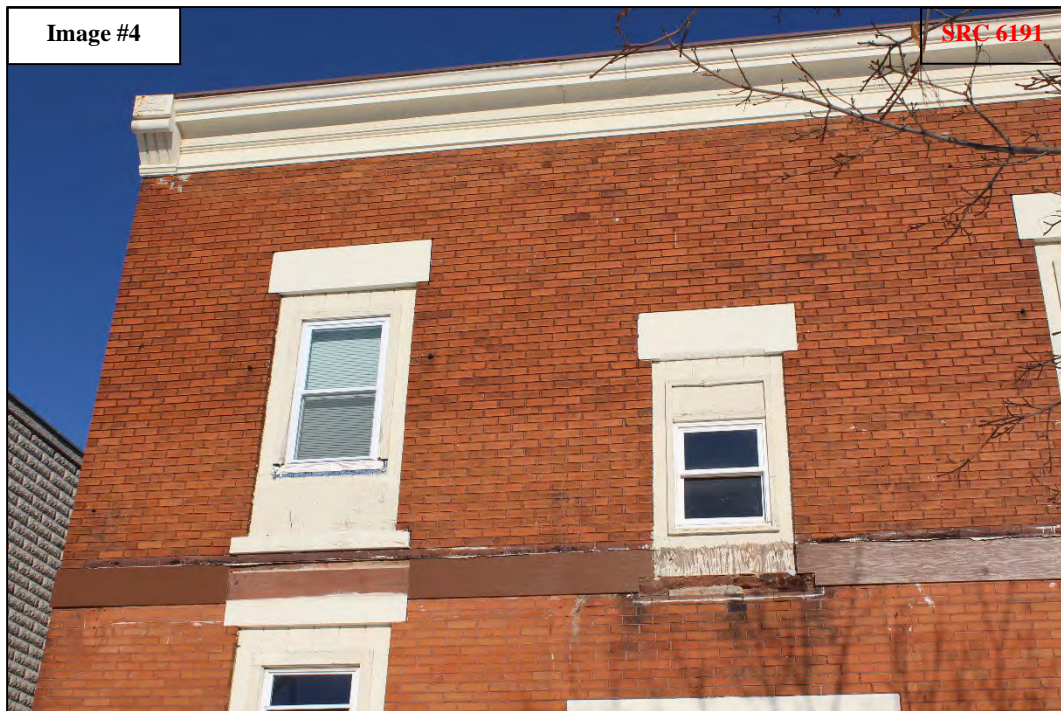
Image #4

23. See **Image #4** for a view of the top of the front left corner of the structure. It appears that some of the brick window openings had wood framing on the interior of the opening to allow for a smaller window. Some of that wood framing appeared to need some repair work and painting. There also appeared to be a horizontal band of wood framing just above the main level window openings where there may have been a previous roof or canopy. There does appear to be a flashing above the wood band which further supports that there was a previous roof or canopy. Some of that horizontal wood band needs some repair work, sealants and paint. Some of the brick work below the upper windows appears to need some sealants and/or patching.

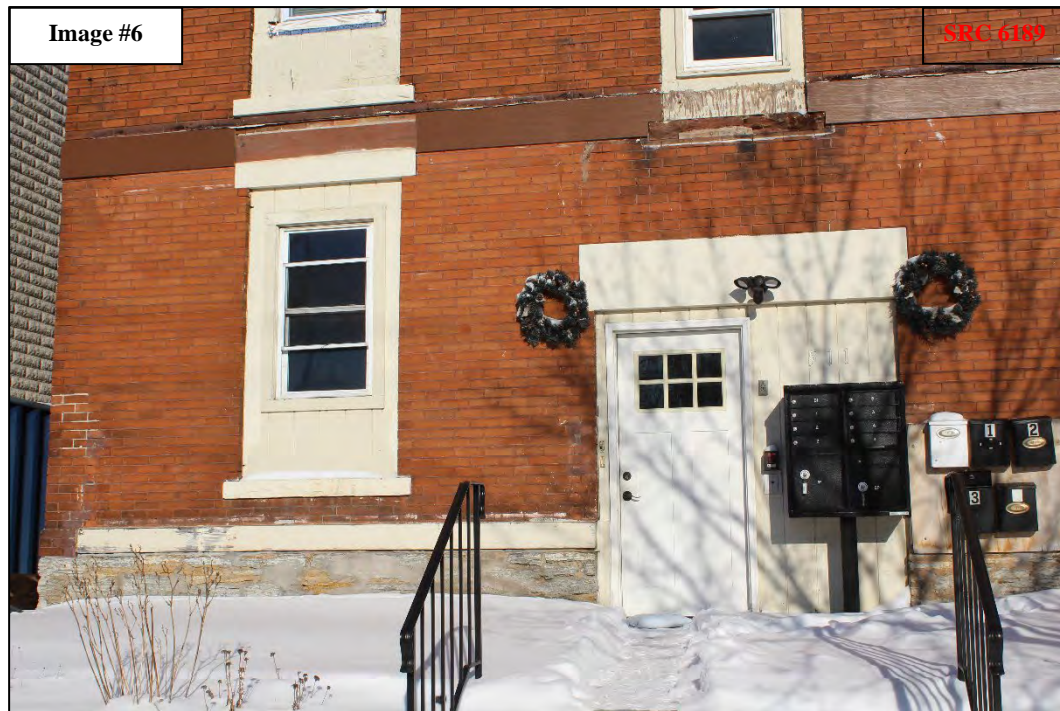
25. See **Image #6** for a view of the bottom of the front left corner of the structure. See the previous images of the front for comments that may apply to this image. There is also a horizontal wood band just above the foundation wall that may have been a previous deck or porch floor.

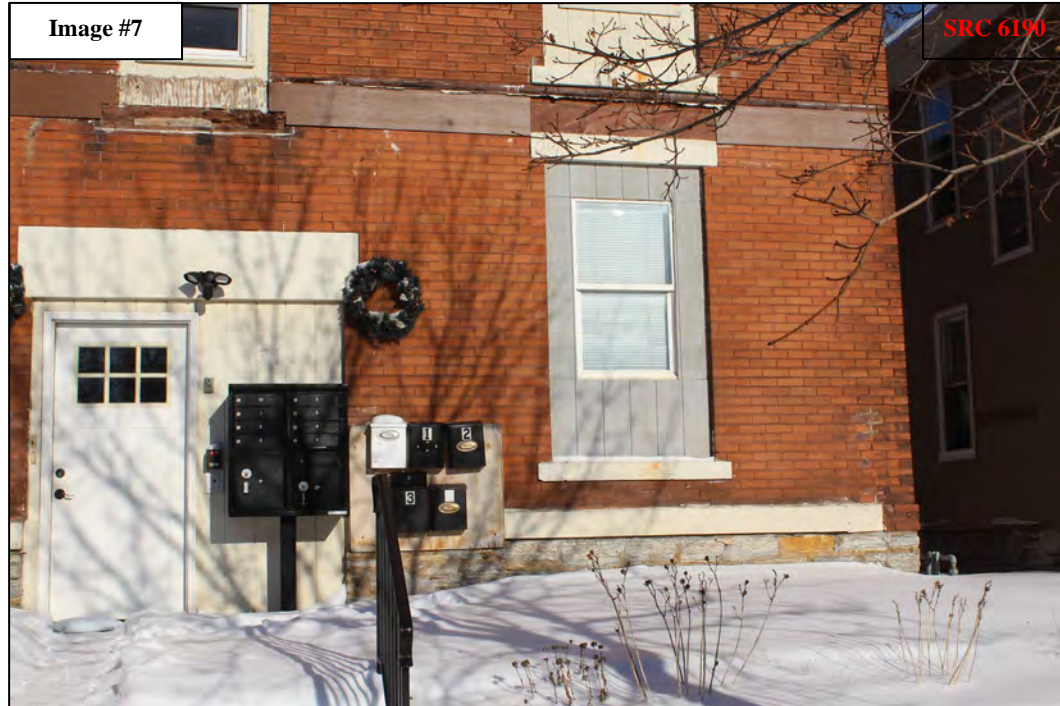
26. See **Image #7** for a view of the bottom of the front right corner of the structure. See the previous images of the front for comments that may apply to this image. There is also a horizontal wood band just above the foundation wall that may have been a previous deck or porch floor.

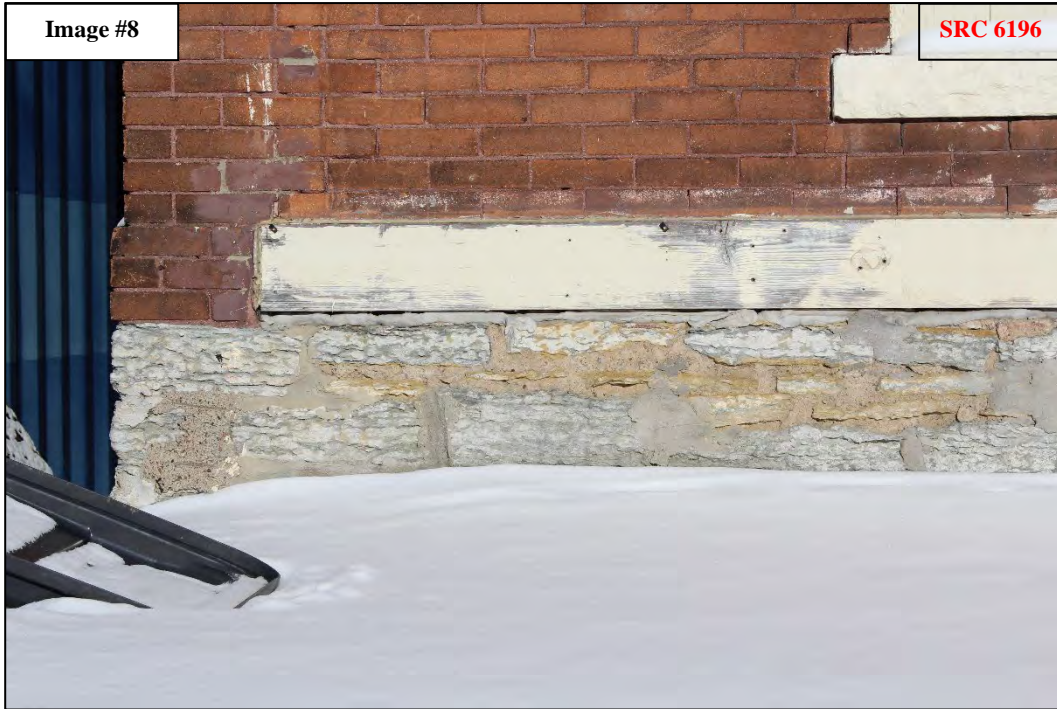
Image #8

27. See **Image #8** for a closer view of the bottom of the front left corner of the structure. This image is adjacent to the next image. There appears to have been considerable patching of the limestone foundation wall.

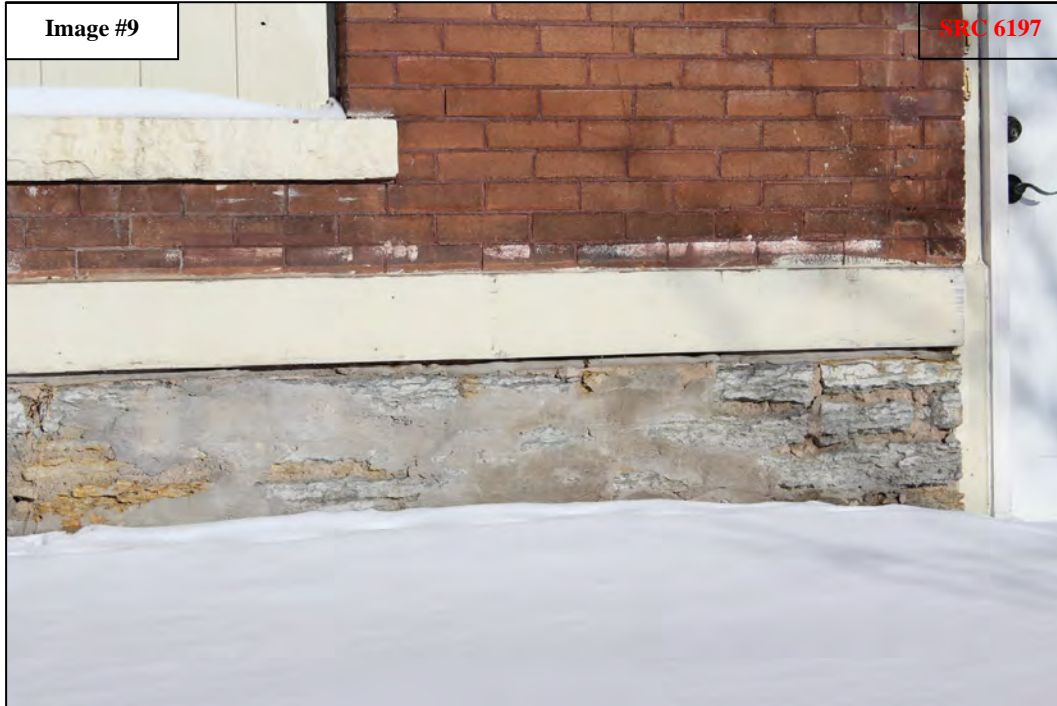
Image #9

28. See **Image #9** for a view of the bottom of the front left of center of the structure adjacent to the front door. This image is adjacent to the previous image. There appears to have been considerable patching of the limestone foundation wall.

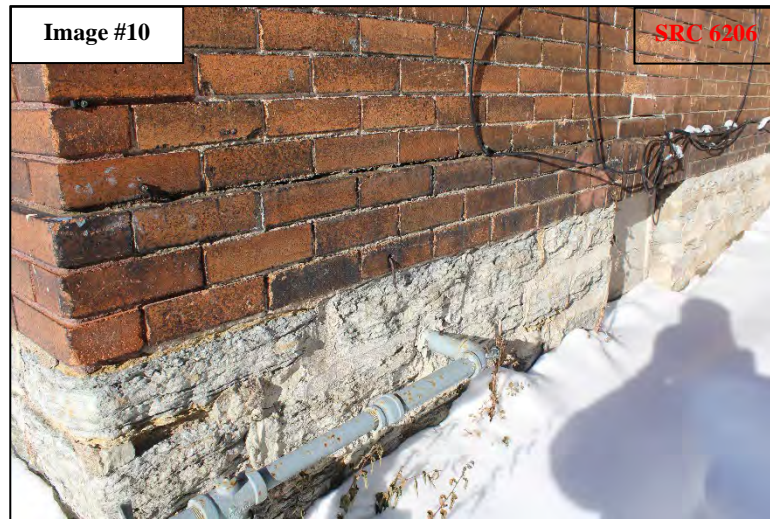
29. See **Image #10** for a view of the front end of the right side wall. This image is adjacent to the next image. There appears to have been considerable patching of the limestone foundation wall. There is also areas of missing mortar in the mortar joints that should be repaired (tuckpointed).

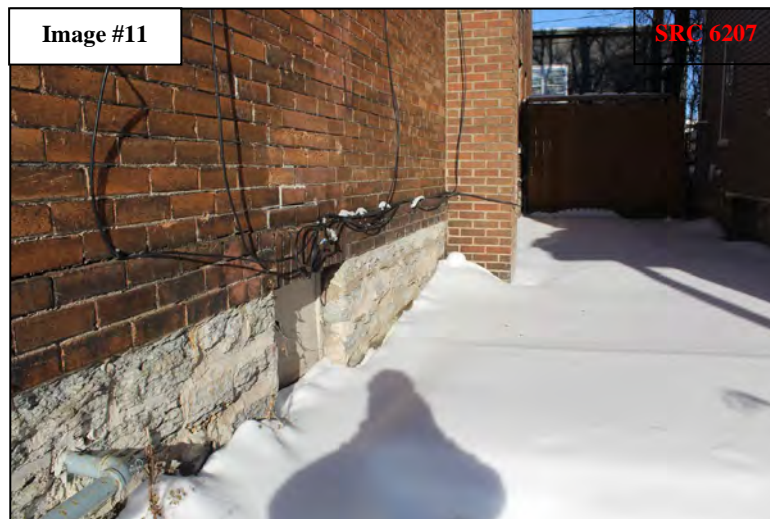
30. See **Image #11** for a view of the right side wall. This image is adjacent to the previous image, just further towards the back of the structure and adjacent to the next image. There appears to have been considerable patching of the limestone foundation wall.

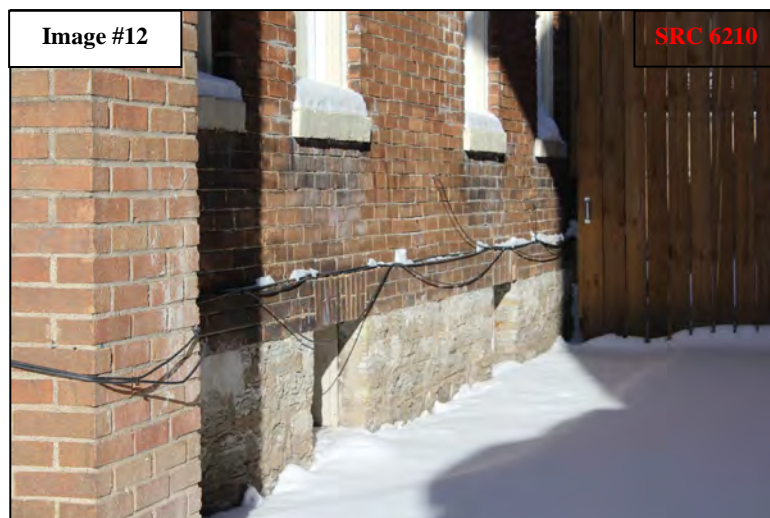
31. See **Image #12** for a view of the right side wall. This image is adjacent to the previous image, just further towards the back of the structure. There appears to have been considerable patching of the limestone foundation wall.

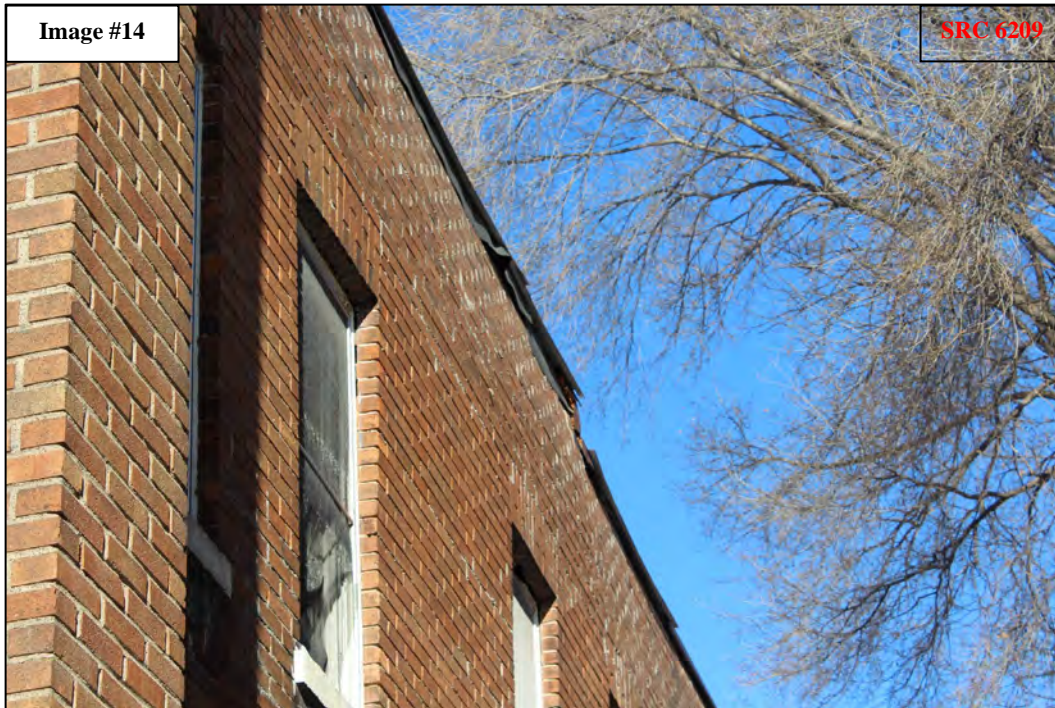
Image #14

32. See **Image #13** for a view of the back end of the right side wall of the structure.
33. See **Image #14** for a closer view of the top of the right side wall. This image shows the cap flashing of the wall is not secured to the top of the wall. The membrane under the cap flashing appears to be loose. The cap flashing should be repaired as soon as possible to reduce the potential of moisture intrusion into and around the wall area and to reduce the potential of roofing damage due to moisture intrusion and wind.

- M. The roof edge cap flashing on the left and right side appears to be loose and should be fastened to the wall to reduce the potential of moisture infiltration into the areas around the wall and to reduce the potential of wind damage to the roofing edge material. This should be done as soon as reasonably practicable.

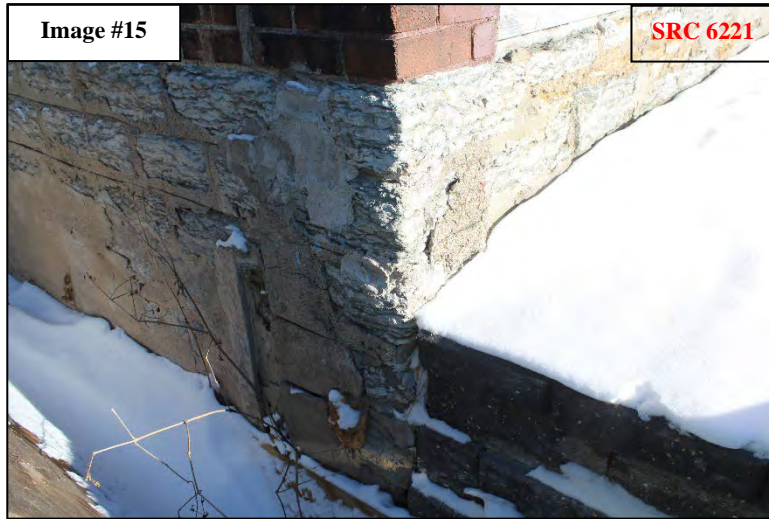
Image #15

34. See **Image #15** for a view of the bottom of the front left corner of the structure showing the front end of the left wall. This image is adjacent to the previous image. There appears to have been considerable patching of the limestone foundation wall.

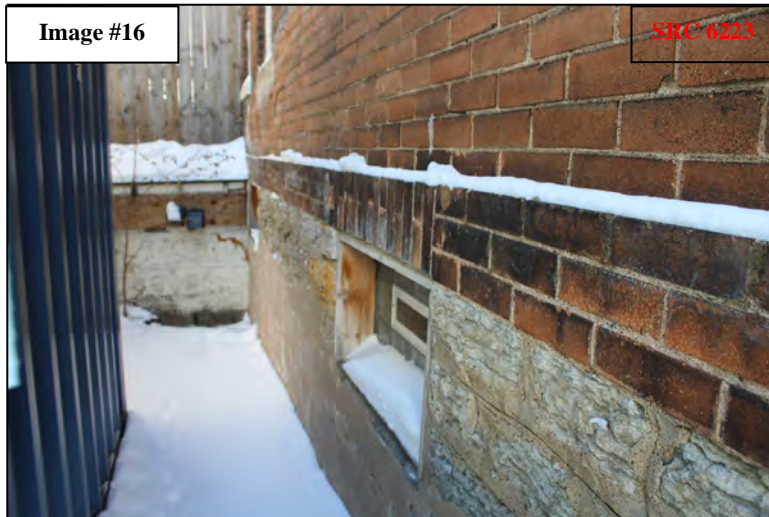
Image #16

35. See **Image #16** for a view of the bottom of the left side wall. This image is taken looking towards the back of the structure and is adjacent to the previous image and is adjacent to the next image. There appears to have been considerable patching of the limestone foundation wall.

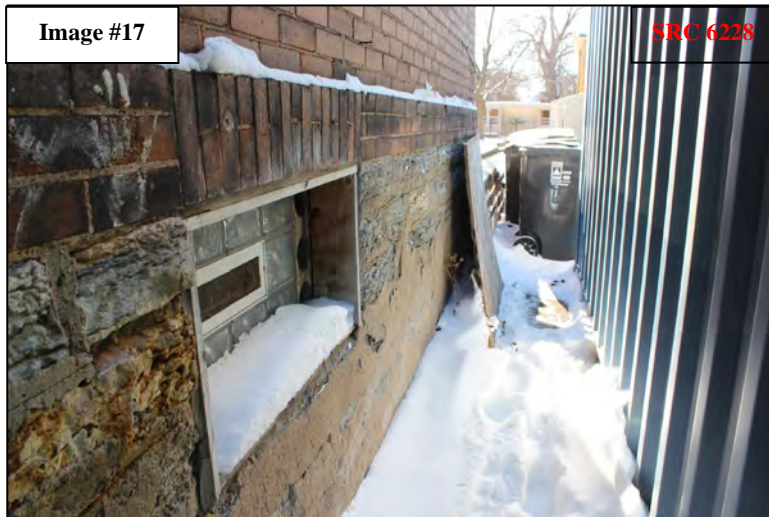
Image #17

36. See **Image #17** for a view of the bottom of the left side wall. This image is taken looking towards the front end of the left wall of the structure and is adjacent to the previous image. There appears to have been considerable patching of the limestone foundation wall.

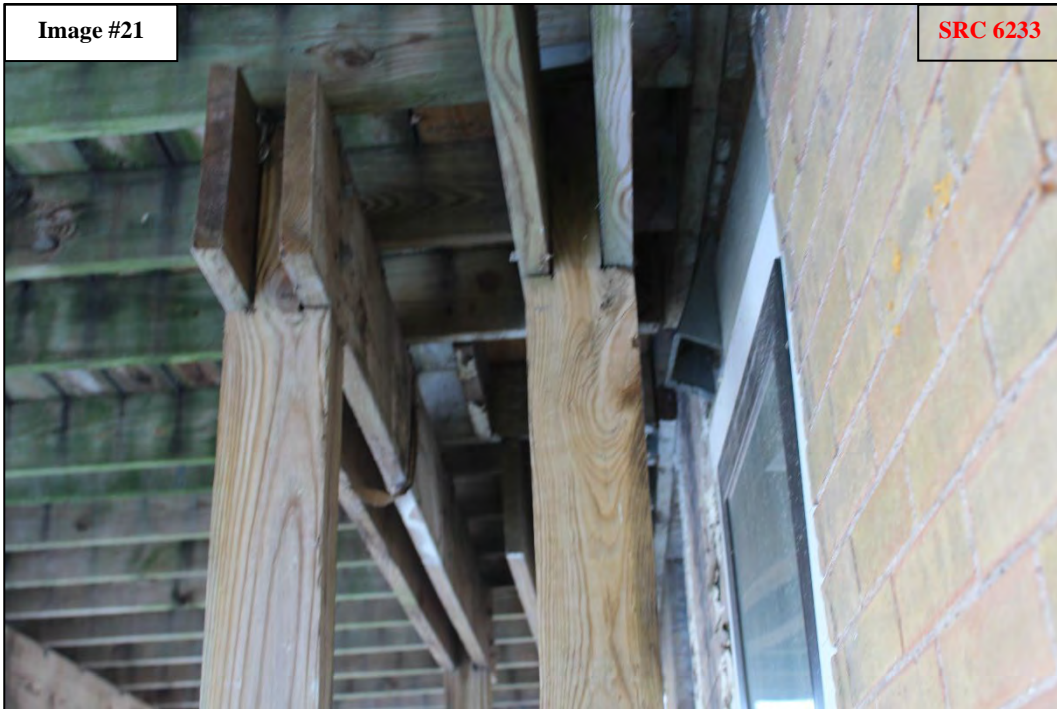
Image #21

40. See **Image #21** for a view of the beams adjacent to the building on double posts. This image shows how the beams bear upon the top of the posts.
41. See **Image #22** for a view of the ledger board and the lag bolts from the ledger board into the main building structure. I do not know the exact spacing, size or length of the bolts or if the bolts go into only the brick or into the building framing behind the brick. See elsewhere in this report for recommendations on lateral bracing of the deck.

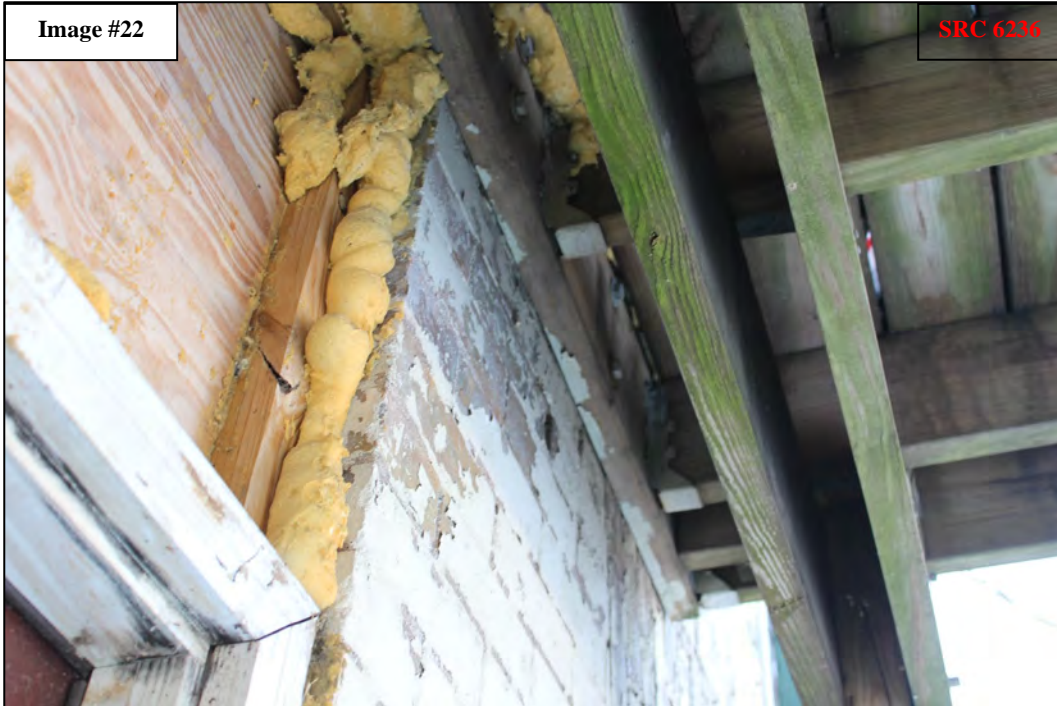
Image #22

- T. I was concerned about the ledger board attachment to the main structure. I could see some of the bolts from the ledger board to the main building, but I did not know what type of fasteners were used, what spacing, the diameter or length of the fasteners, and if the fasteners were just fastened to the brick façade or to the framing behind the brick façade. The main concern was if the fastener was only fastened to the brick, the brick may pull away from the backup framing depending on how the brick was fastened to the backup material and the condition of the connection. I was most concerned about the deck lateral bracing in the front to back direction of the upper deck. See elsewhere in this report for information relating to the lateral bracing of the upper deck.

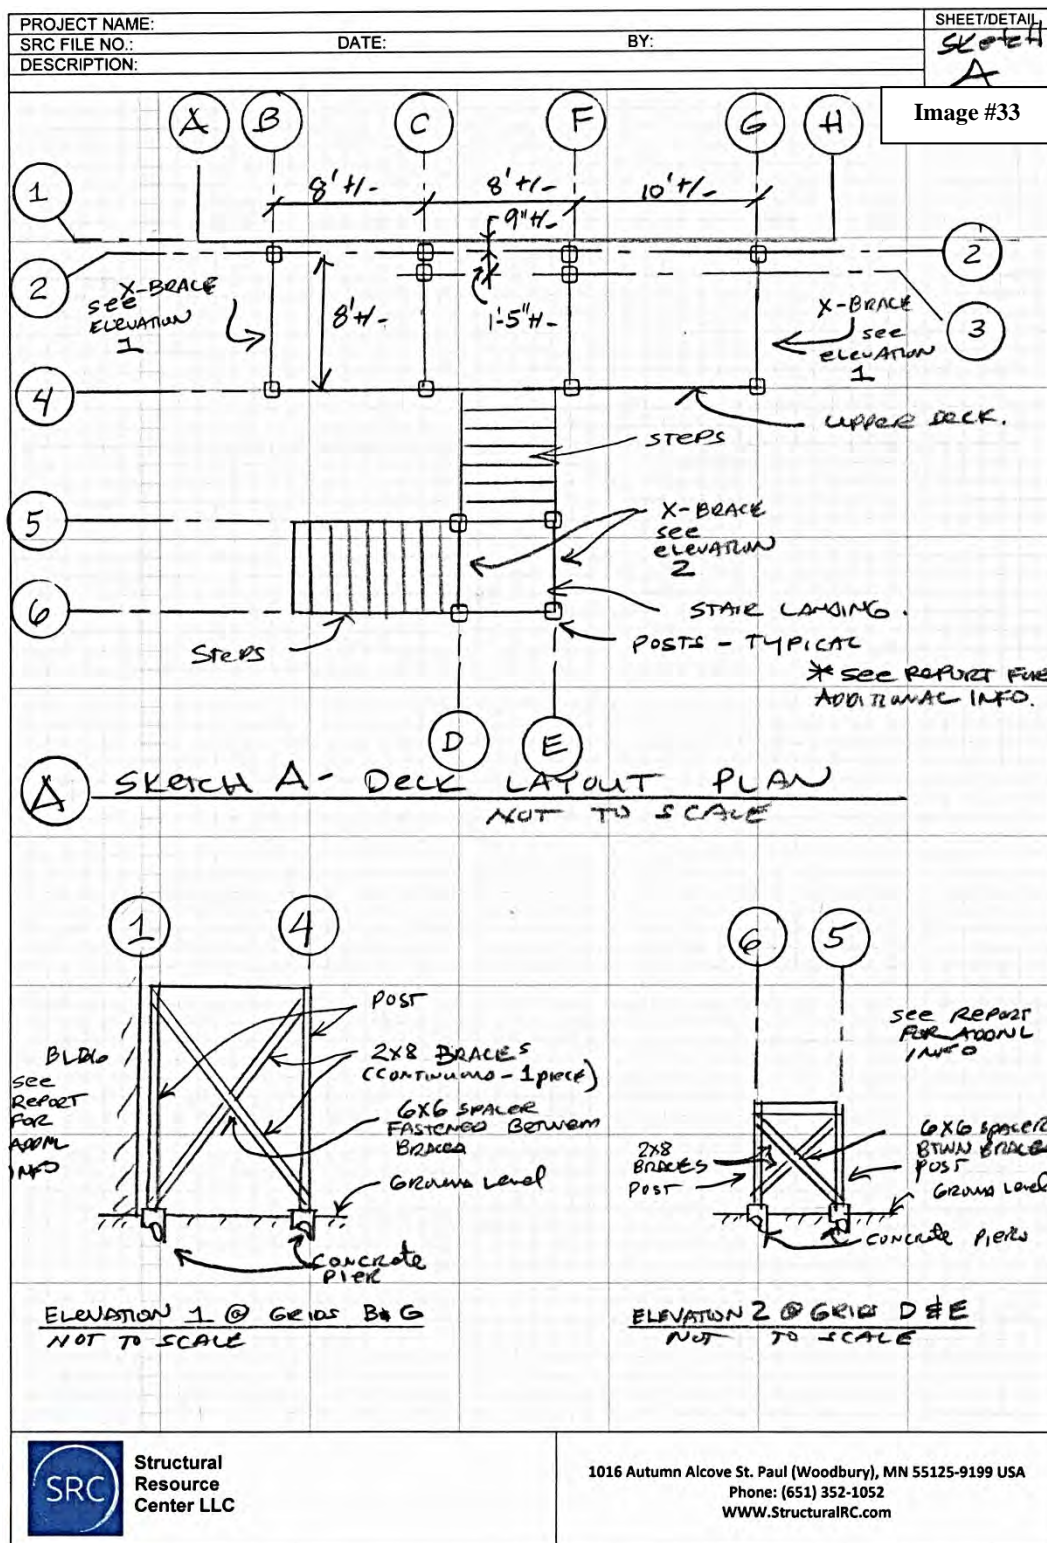
50. See **Image #33** for “Sketch A” of the deck layout and recommended deck bracing.
