PIN: 012823310114

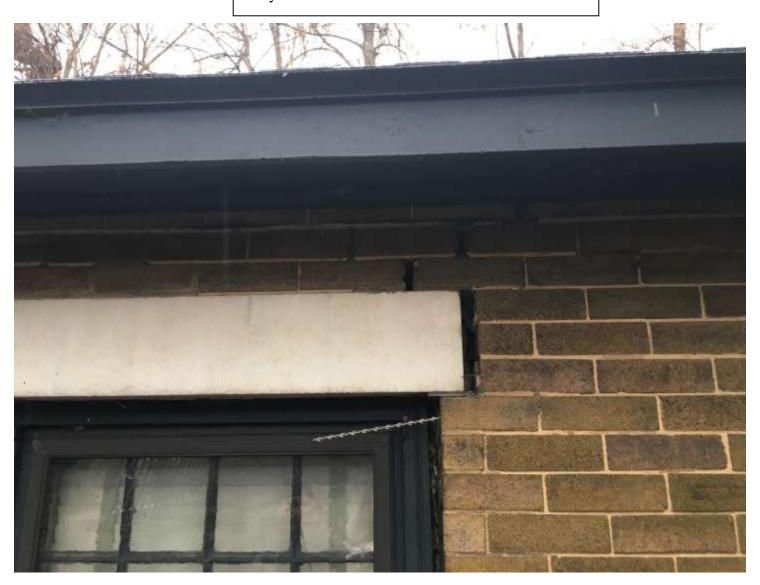
More damage exterior west wall. Window pulling away from the brick

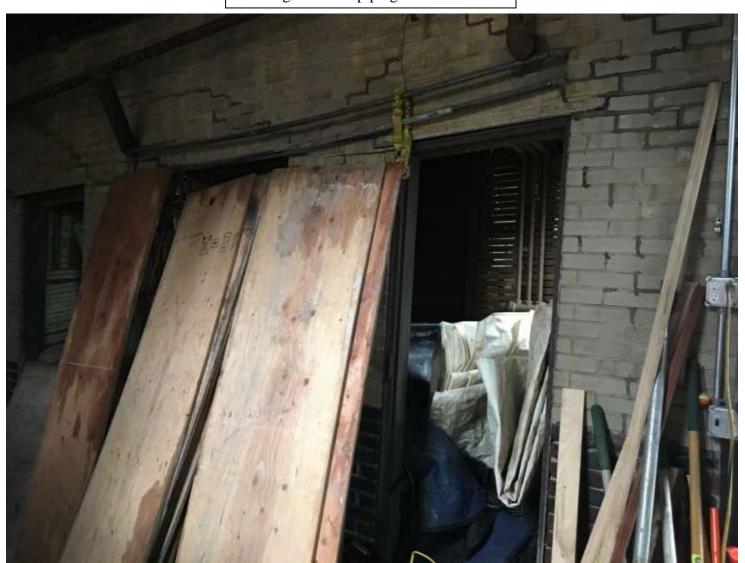
Interior East wall damage with carious cracking. Note the piping.
