Re: Visual Structural Inspection of Detached Garage  
Project Location: 1064 Pacific Street, St. Paul MN 55106  
Criterium File No.: 16-2186

At your request, a visual structural inspection of the detached garage at the above address has been completed. The report that follows has been prepared based on that inspection. This inspection was performed by Paul Schimnowski, PE.

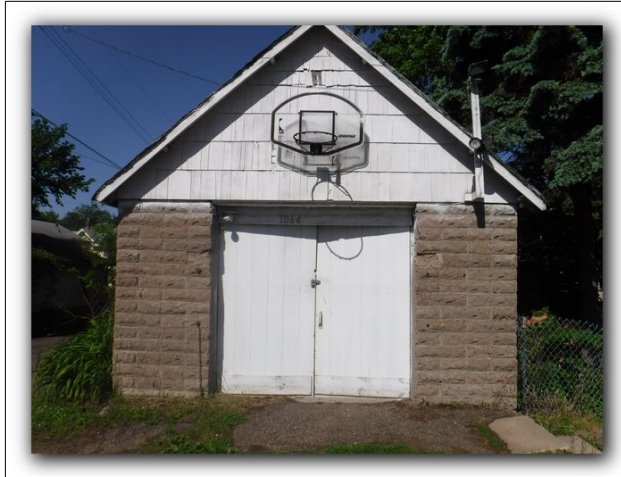
**1** Front/east side of garage.

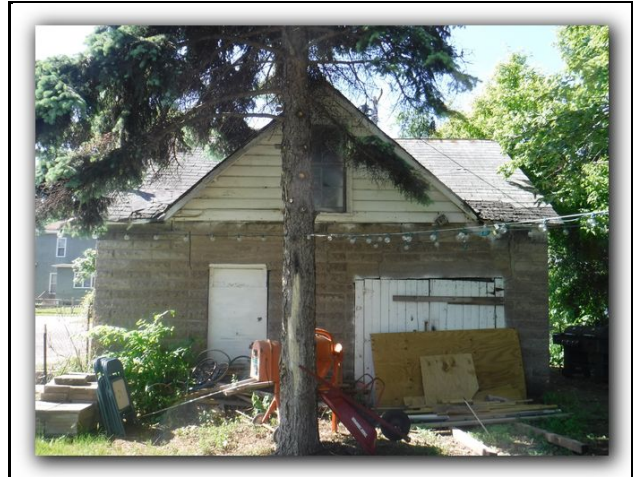
**2** West side of garage.

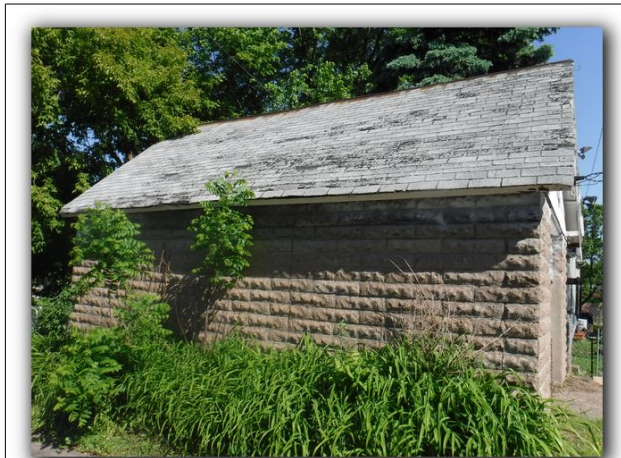
**3** South side of garage. Exterior is CMU block.

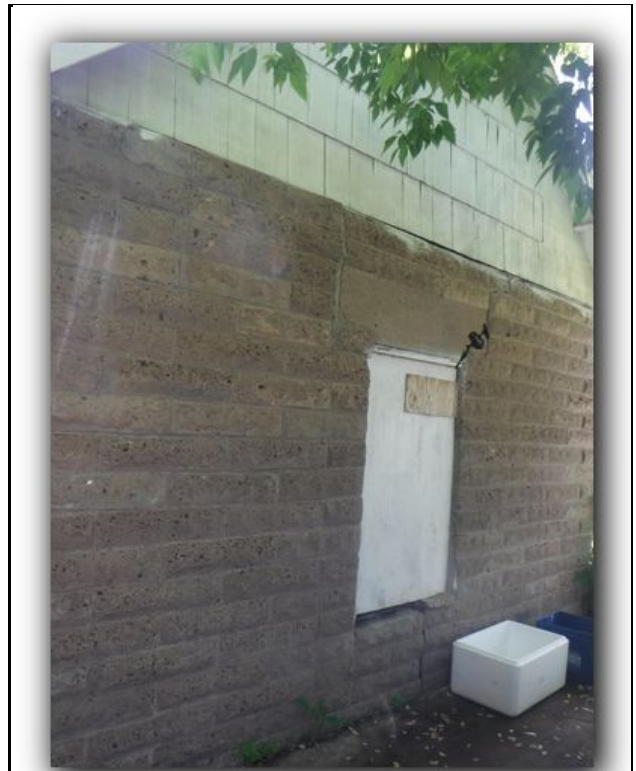
**4** West side of garage.

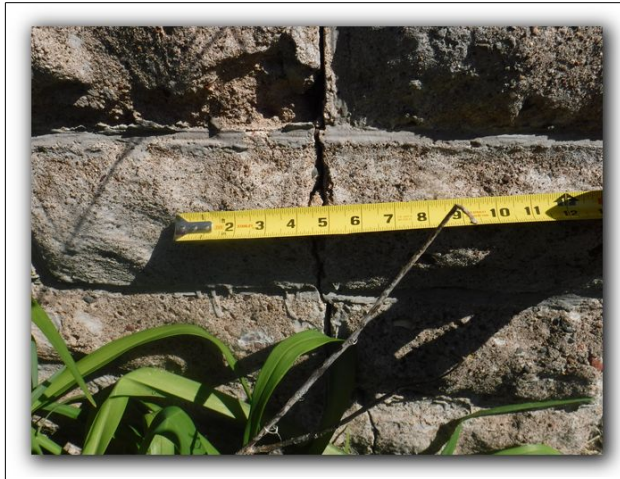
The garage has a concrete masonry unit foundation system. It is accessible and unfinished. The visible areas of the foundation walls are in fair condition with vertical and stepped cracks noted on the north, south and west walls. There is displacement noted at the northwest corner which displaced outward. No recent changes reported by owner. Repairs to the corner should be considered. All other cracks should

**5** Vertical crack in CMU wall. Seal to prevent water intrusion.

- Seal exterior cracks to prevent water intrusion.
  - Consider masonry wall tie-back anchors to limit additional movement at the NW corner.
2. The concrete floor is in fair condition.

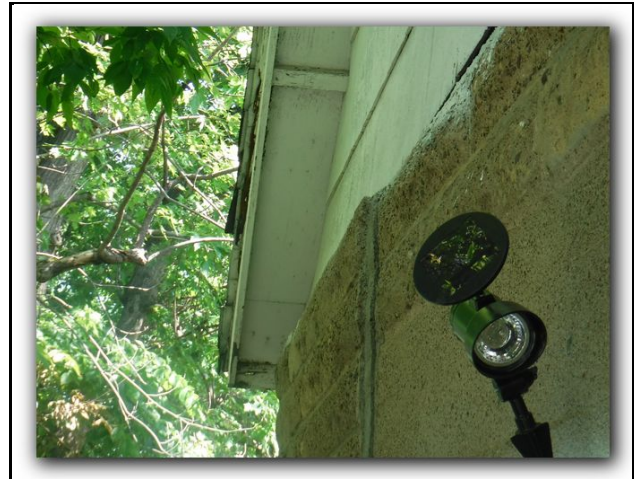
1. The CMU walls are in fair condition. The NW corner is displaced and cracked. No recent changes are reported.
  - At a minimum, the existing cracks in the foundation walls should be monitored for additional movement. A good way to do this would be to take measurements at several spots along each existing crack periodically. A photographic record can also be useful. Please note that cracks will vary throughout the year due to temperature and humidity changes. If this gap increases by more than 1/4", further evaluation is recommended.

**6** NW corner - cracked and displaced CMU wall. Consider tie back repair.

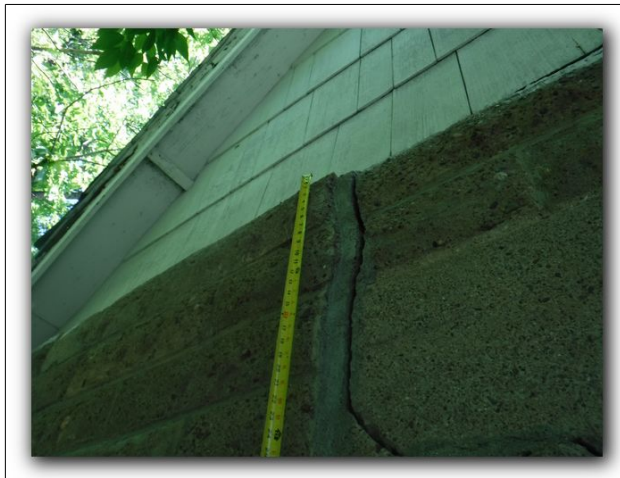
**7** Masonry wall tie back anchors would help limit additional movement.

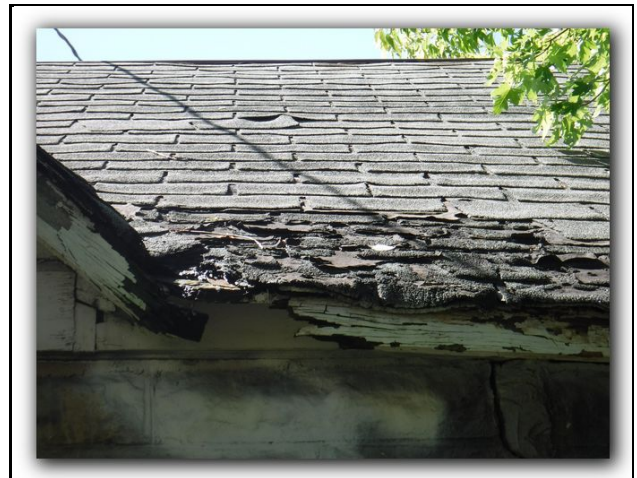
The roof covering of this home is of asphalt/fiberglass and is in poor condition. The flashing is in poor condition. The absence of a gutter/downspout water control system is noted with some correction suggested. The poor condition of the roof and flashing is accelerating the deterioration of the attic/roof framing. The roof covering is at the end of its expected performance. See Specific Items Noted & Recommendations above.

**8** Roof in poor condition. Contributing to water intrusion and rot of roof/attic framing.

- In current condition, limit storage load to 10 lbs per square foot.
4. The roof covering is in poor condition. The flashing is in poor condition.
  - The roof and flashing should be replaced to prevent further water intrusion into the garage. However, replacement of the roof covering without extensive framing repairs or framing replacement is not recommended.

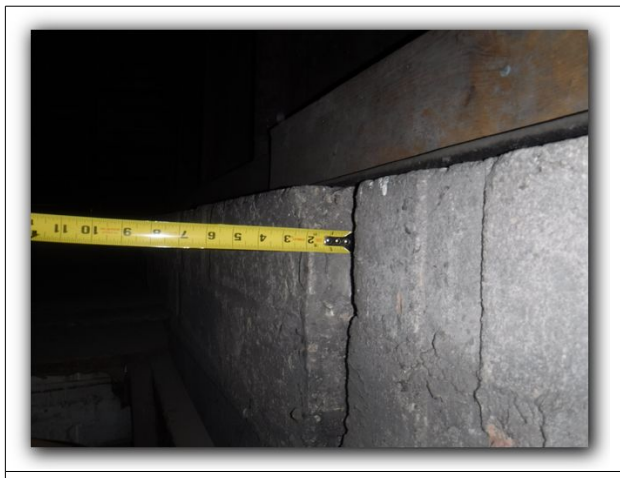
**9** NW corner. Cracked and displaced. Consider repairs.

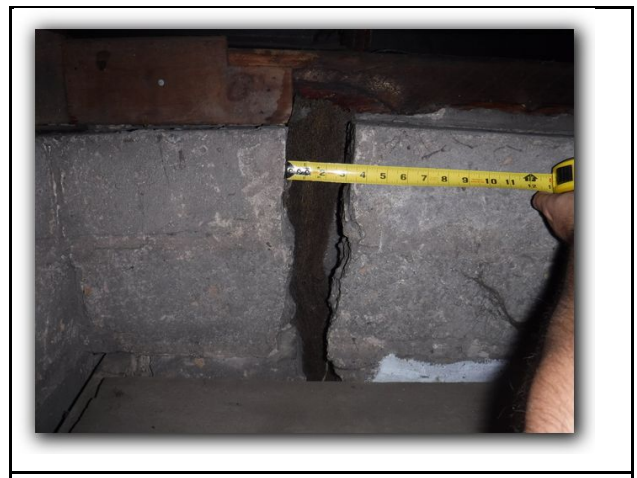
**10** No recent movement reported. Monitor for movement if not proceeding with repairs.

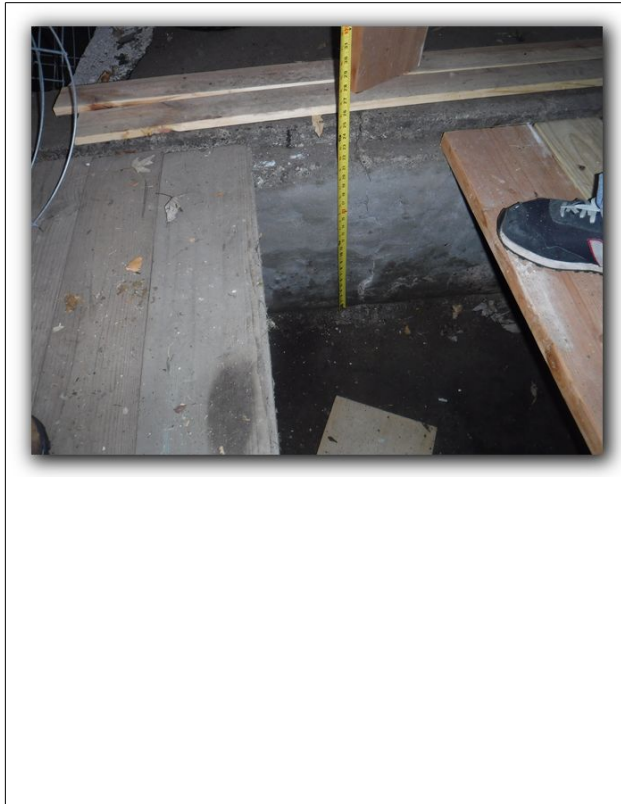
**11** "Work trench" at garage floor. Fill with compacted sand and top with concrete.

- Fill work trenches with compacted fill
  - Top with 5" concrete slab for use as vehicle garage.
3. The attic/roof framing is in fair condition with rot and deterioration of roof joists, collar ties, and ceiling joists.

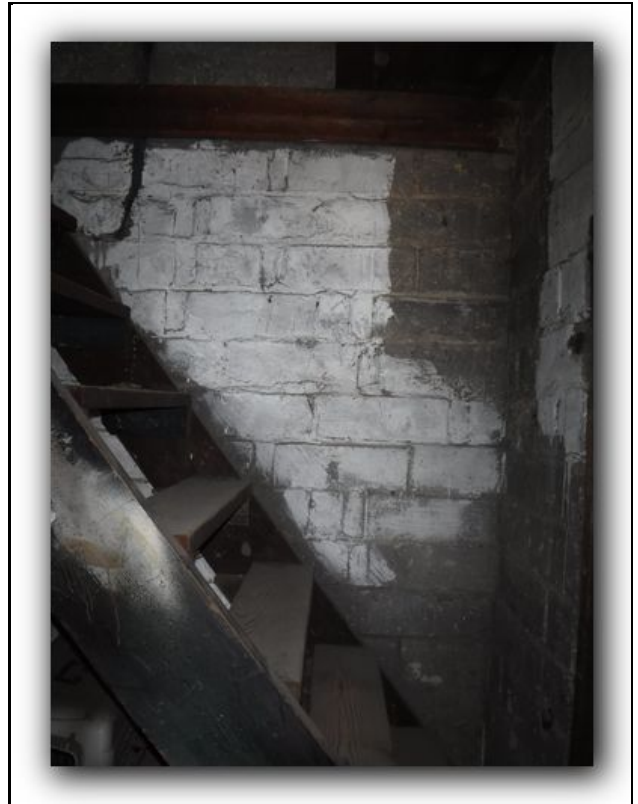
**12** NW corner. Cracked and displaced. Consider repairs.

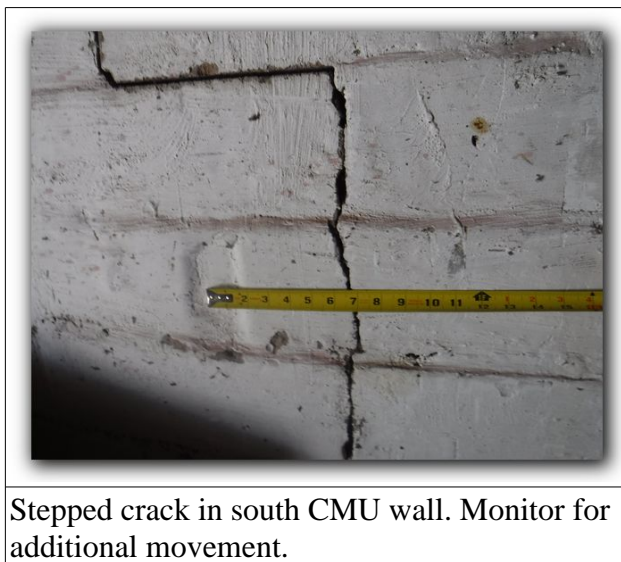
**13** Stepped crack in south CMU wall. Monitor for additional movement.

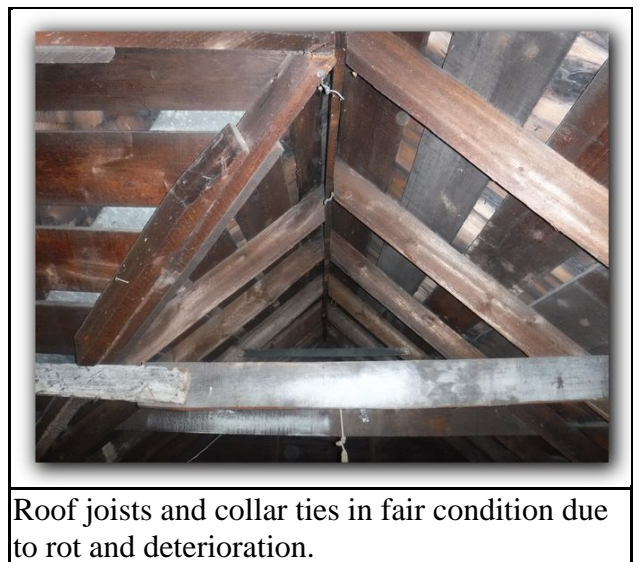
The attic is accessible. Flooring is present. The roof joists, collar ties and ceiling joists are in fair condition due to areas of rot and age-related deterioration. Water intrusion has contributed to damage as well. Extensive repairs will be needed in the next several years. Repair of all affected framing would likely exceed cost of replacement. The storage space can continue to be used with loads limited to 10 pounds per square foot but the attic space is approaching the end of its expected life. See Specific Items Noted & Recommendations above.

**14** Roof joists and collar ties in fair condition due to rot and deterioration.

- Repair or replace damaged joists (see details below) to prolong expected performance.
  - Alternatively, complete replacement of roof/attic framing can be considered.

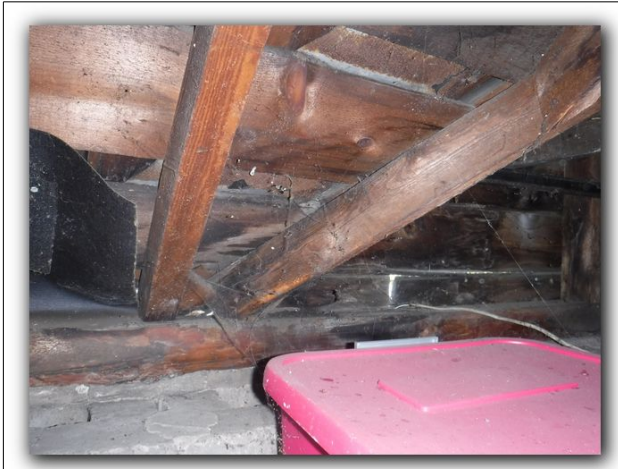
**15** Attic framing - including ceiling joists, roof joists and collar ties in fair condition.

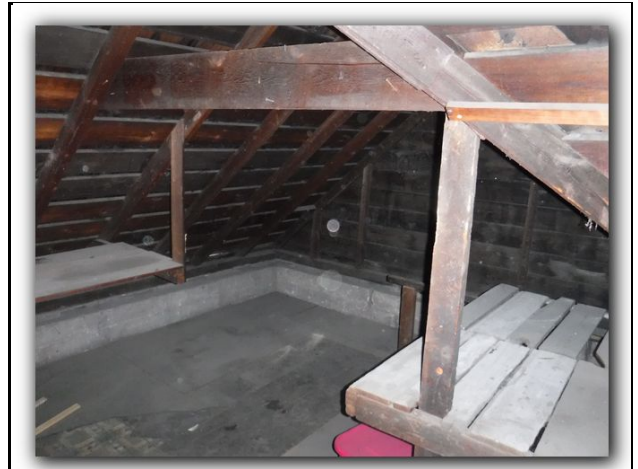
**16** Do not load ceiling/attic floor with more than 10 pounds per square foot.
