**Date:** February 16, 2010  
**File #:** 10 - 108002  
**Folder Name:** 579 LEXINGTON PKWY S  
**PIN:** 102823410033

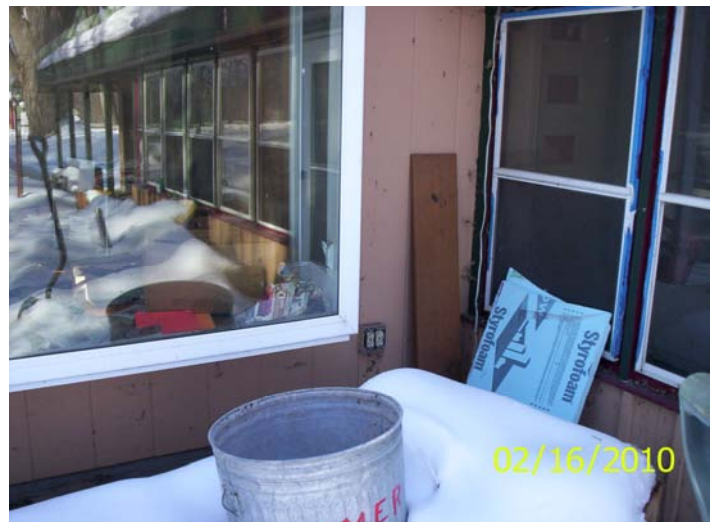
**Open electrical outlet**

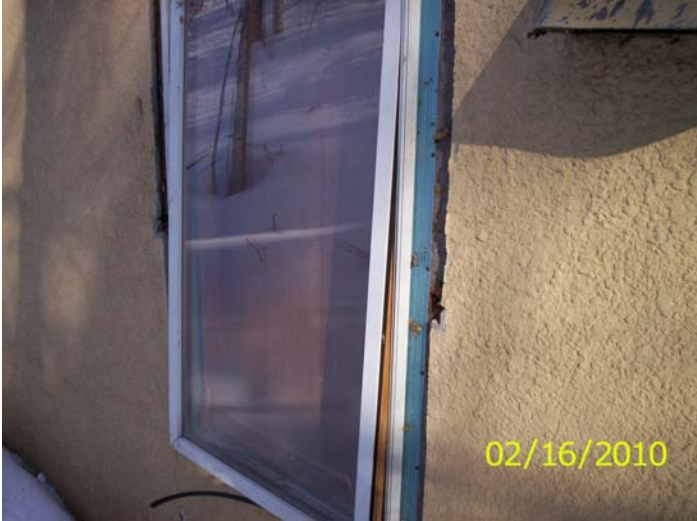
Unfinished window installation, boarded on interior

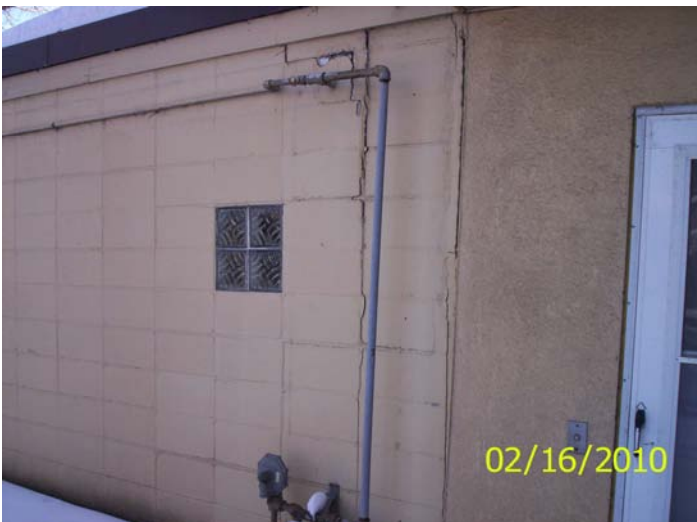
Large separating crack

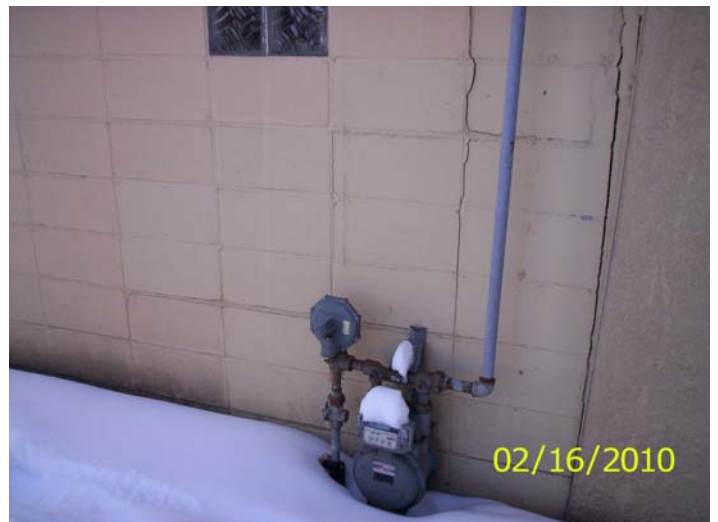
Cracking in masonry

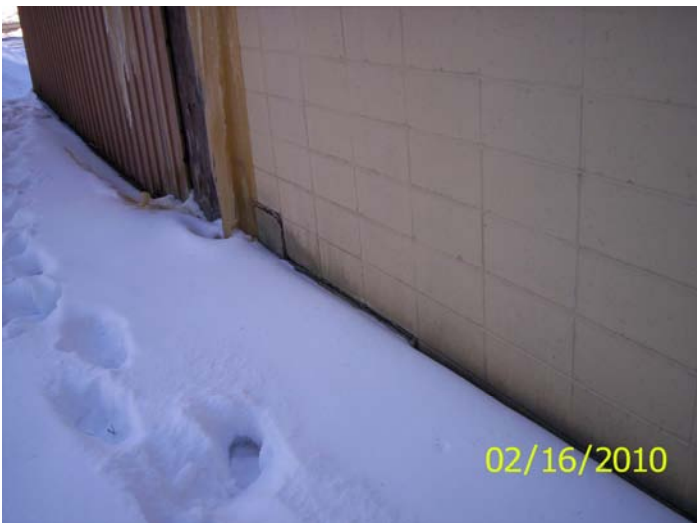
Large separating shifting crack

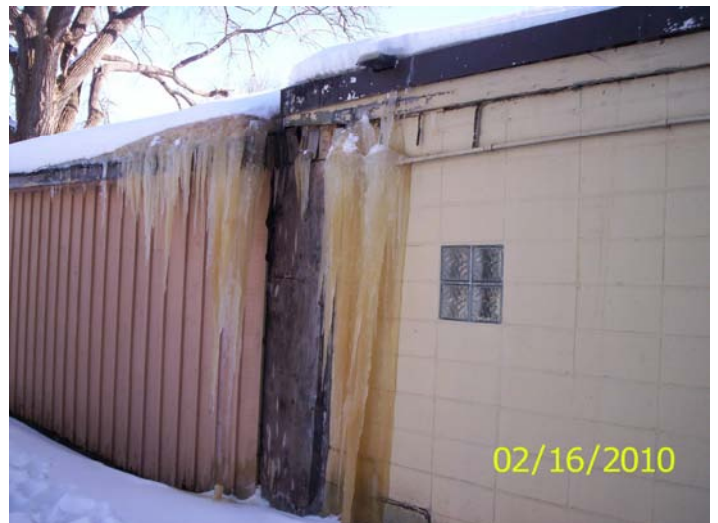
Rotted eaves house and garage, rotted wall

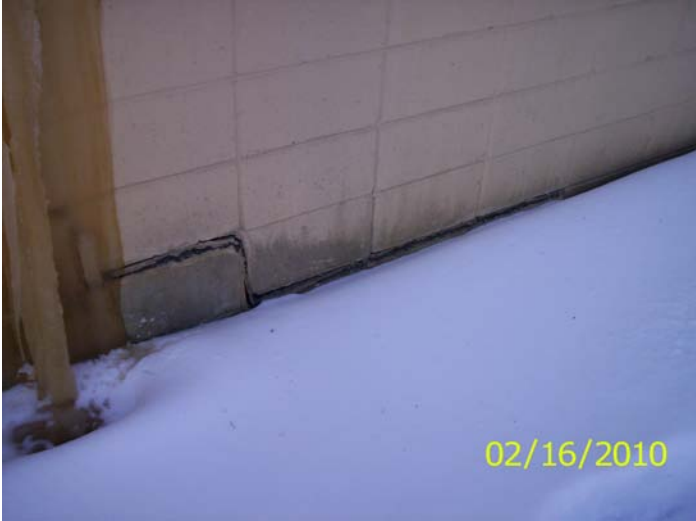
**Large separating shifting crack**
