**Date:** February 05, 2010  
**File #:** 10 - 019633  
**Folder Name:** 591 MACKUBIN ST  
**PIN:** 362923230004

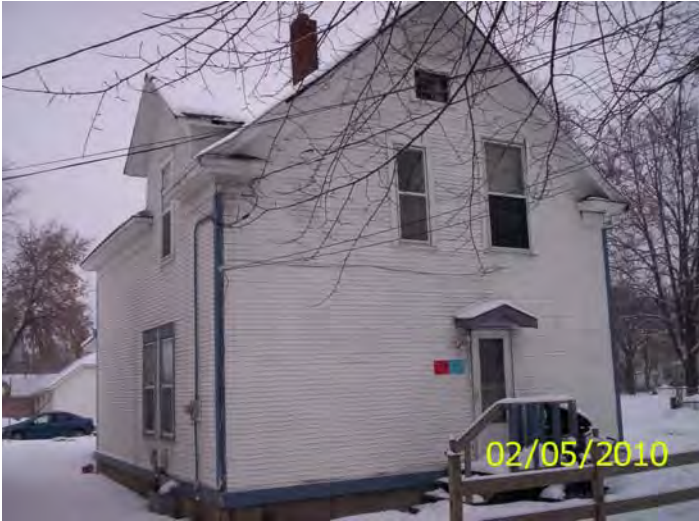
**North and west sides, posting**

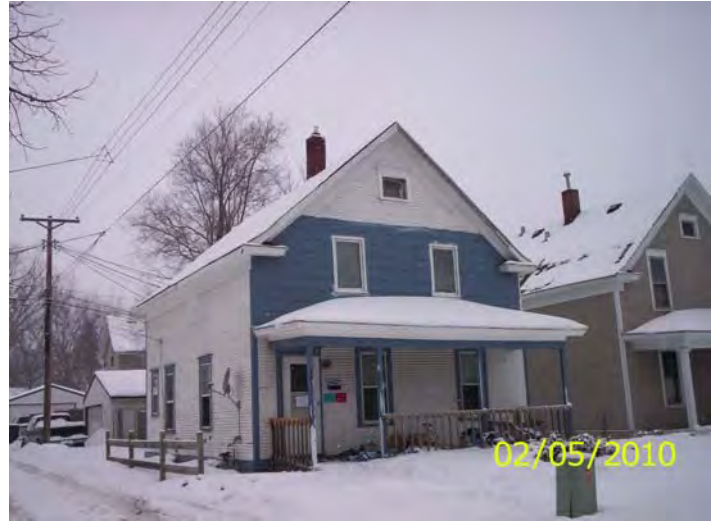
**South and east sides, postings**

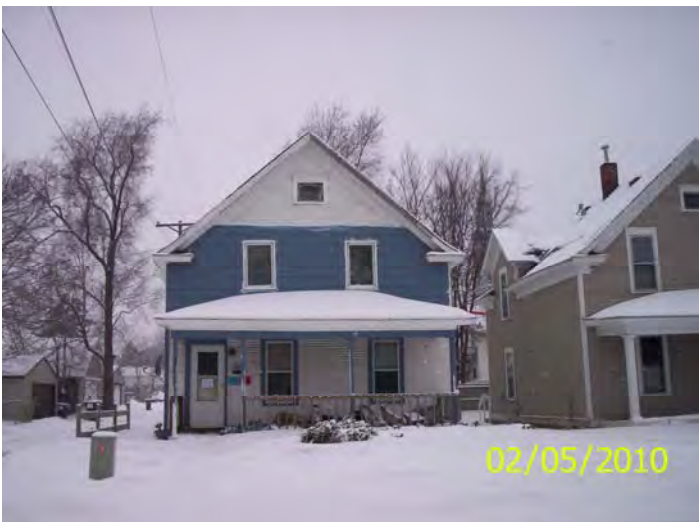
**East side, postings**

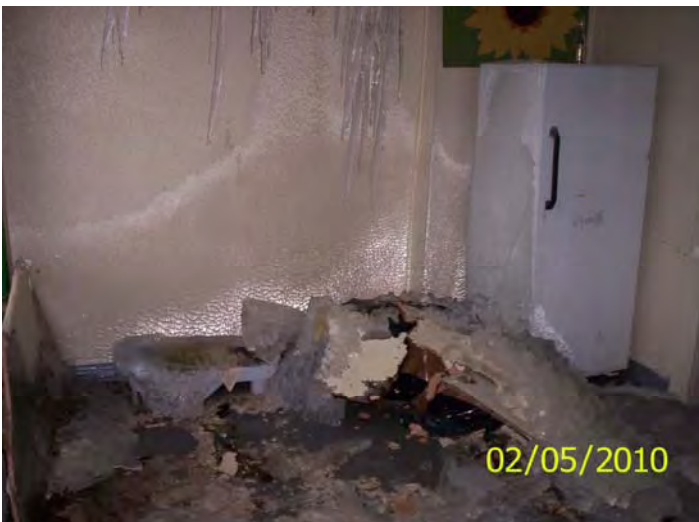
**Kitchen, ice covered appliance, wall, floor**

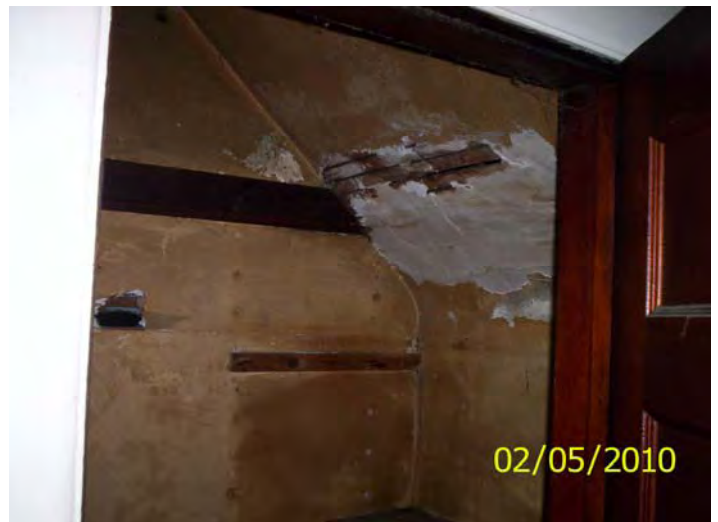
**Damaged ceiling 2<sup>nd</sup> floor bathroom**

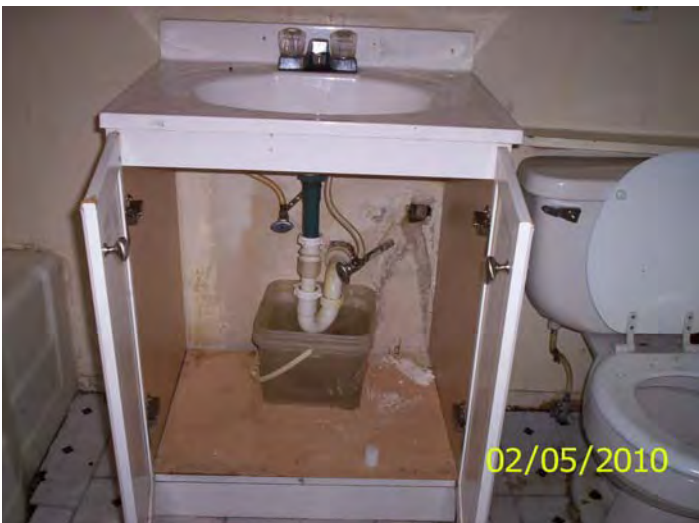
**Improper trap repair, leaking**

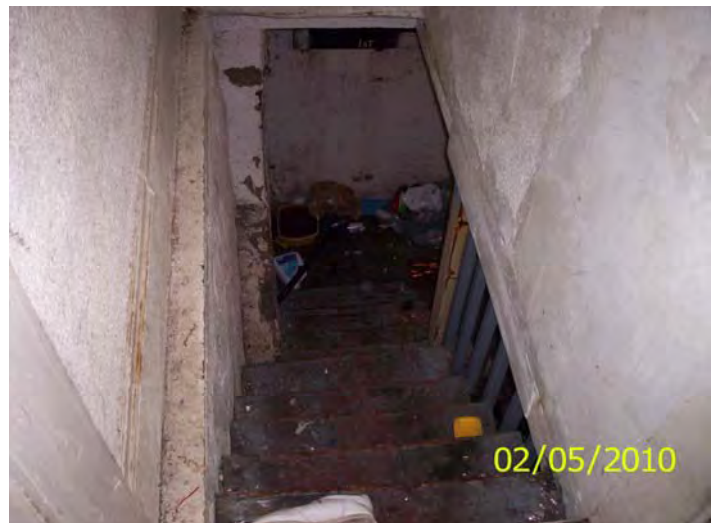
**Stair way to basement, flooding, no hand rail**

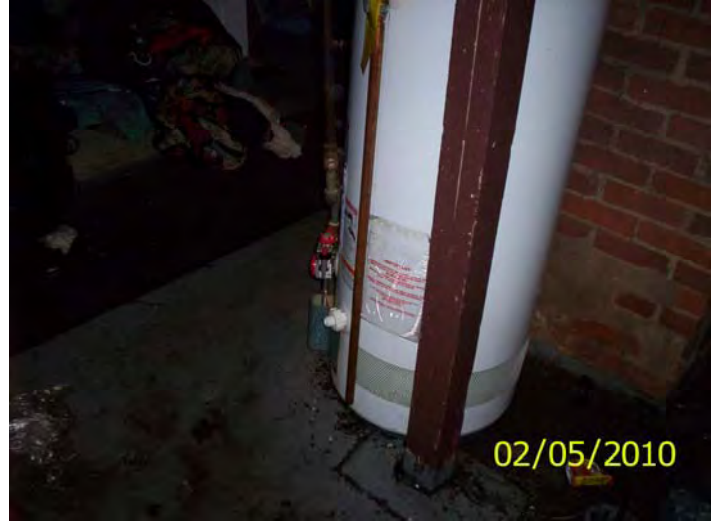
Improper post installation, improper spill tube, no handle on gas shut off

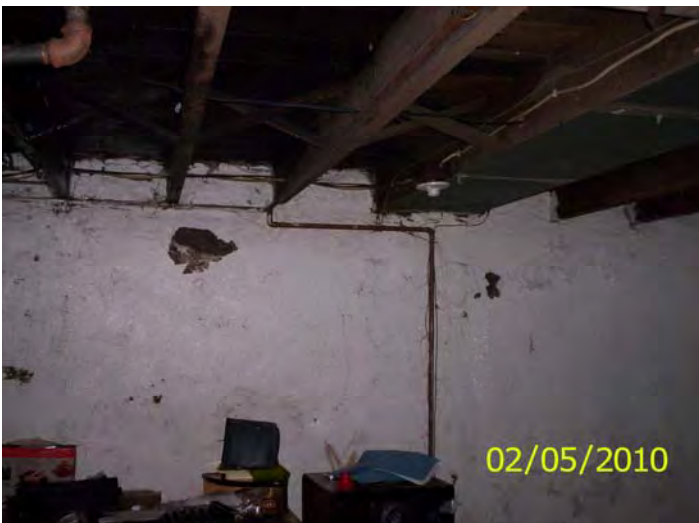
Bubbling, flaking paint
