March 31, 2016

Re: Water Infiltration Investigation  
Ashland Apartments, Saint Paul, Minnesota  
TKDA Project No. 16095

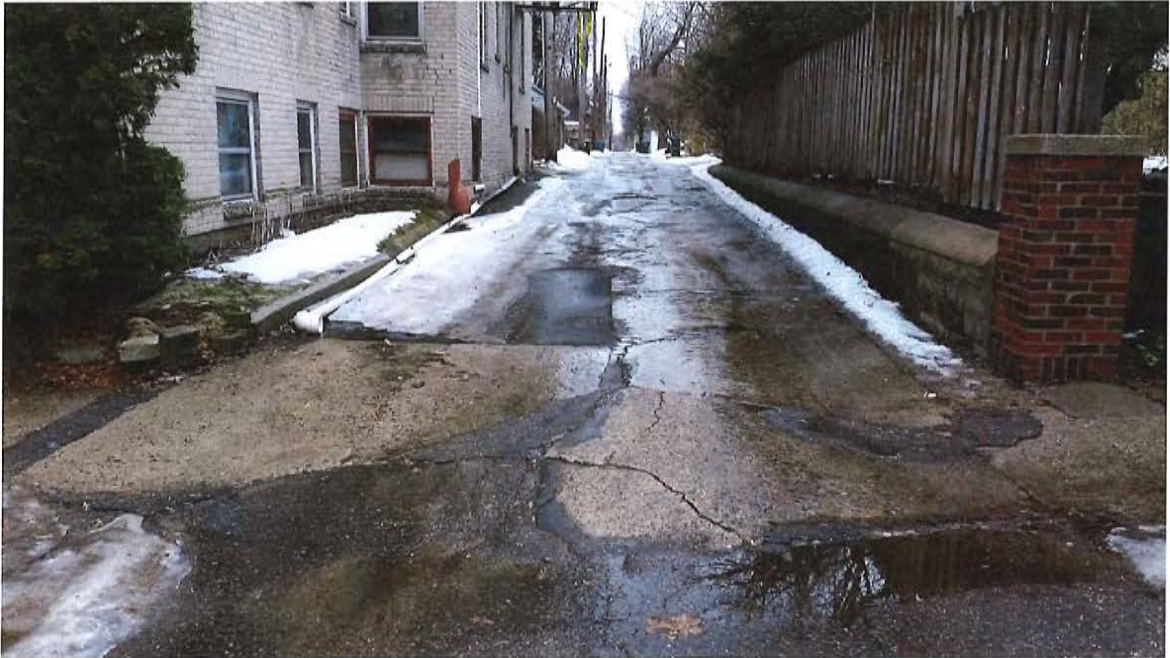
- The pavement in the alley is in very poor condition and severely cracked. It appears that there was an older section of concrete pavement that was patched in the last 10 years with asphalt pavement. There are numerous cracks approximately 1/2 inch in width and sections of pavement that have been displaced vertically over 1 inch.

Alley Condition –photo from the Owner taken February 19, 2016

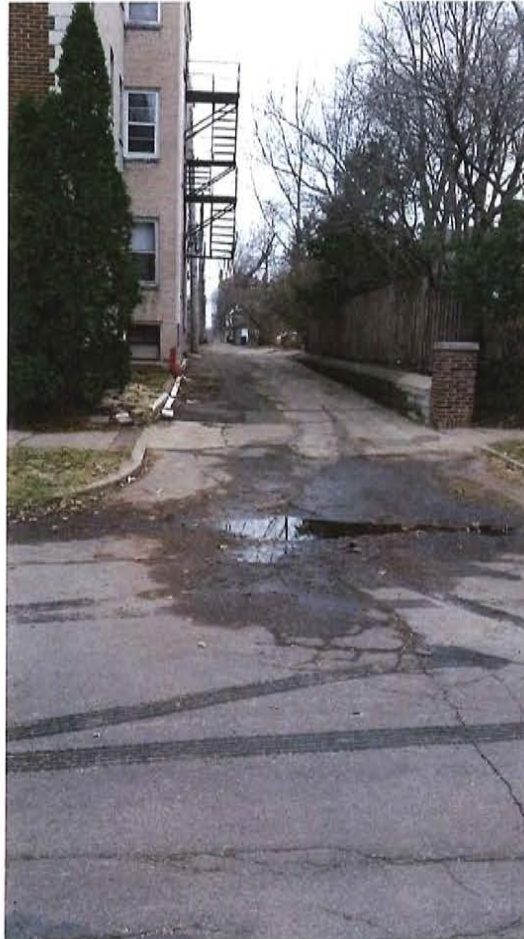
- There is a low spot (depressed approximately 2 inches) in Arundel Street at the intersection with the alley. This low spot was filled with water at the time of the site visit.
- Positive drainage away from the building wall and the absence of ice, snow or standing water adjacent to the building suggest infiltration through the joint of the pavement and the building is not a significant contributing factor.

Low Spot in Arundel Street –photo from the Owner dated March 13, 2016

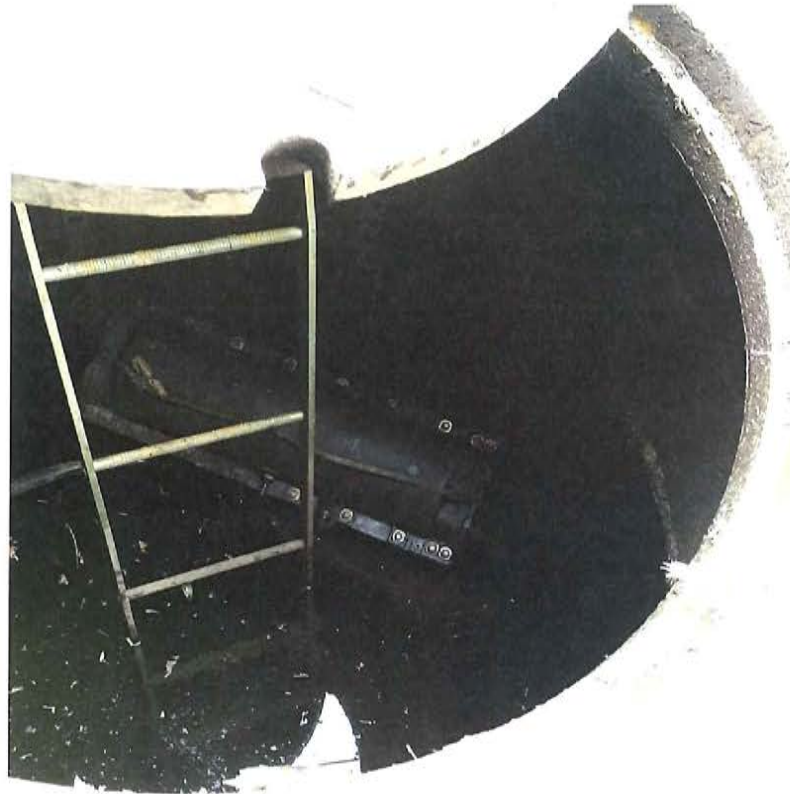
- There is a Bell Telephone utility manhole in the alley near the apartment complex. There is significant cracking and vertical displacement of the alley pavement adjacent to the manhole. Mr. Arnold stated at the time of the site visit that the manhole is abandoned. TKDA was unable to remove the manhole cover at the time of the site visit to confirm the presence of water or whether the utility had been abandoned. TKDA returned to the site on March 29, 2016, and removed the manhole cover and verified that there are several feet of standing water in the manhole. The majority of the interior wall surfaces were saturated, while a few isolated areas were dry.

Standing water in Bell Utility Manhole – March 29, 2016 Photo by TKDA
