MJP Associates, Ltd.  
4362 Oakmede Lane  
White Bear Lake, MN 55110  
PH. 651-426-7037  
FAX 651-426-6643  
www.mjp-associates.com

12/6/2011

Re: Structural Evaluation Column Bases @ West 7<sup>th</sup> Street Pharmacy, St. Paul  
MJP ASSOCIATES, Ltd., Project # 111102, Report #1

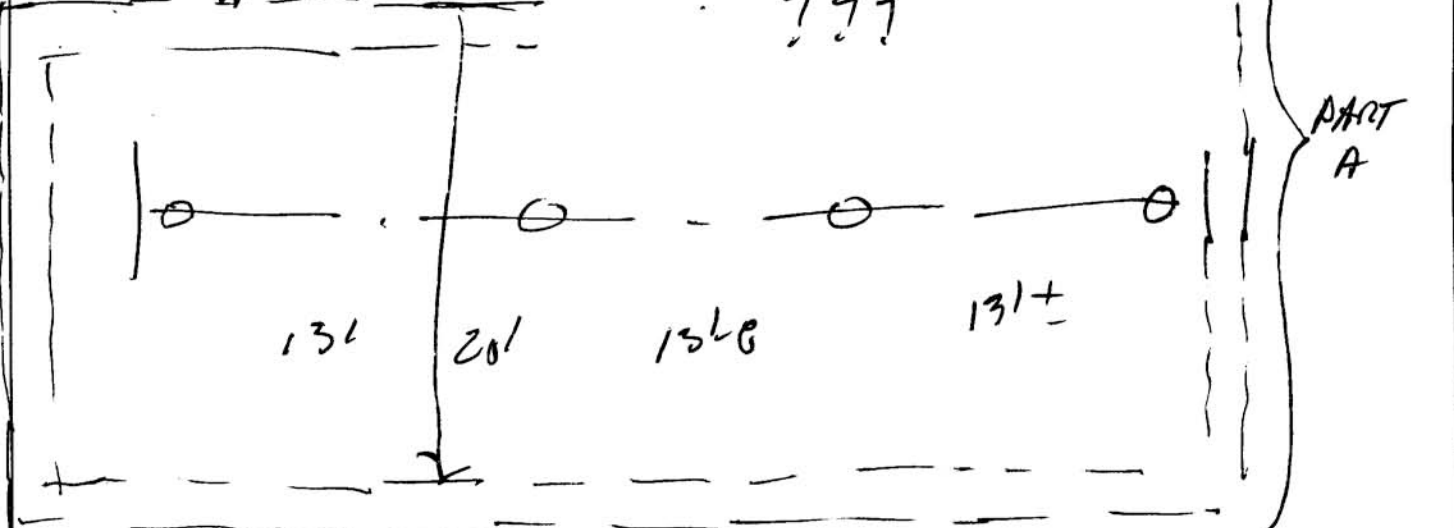
EXISTING CONDITIONS:  
 Col. 3 1/2" SWP 7 @ 6'-6"±

Beam 8 1/4" x 5 1/4" UP  
 0-1 Flange; 1 Web. W8x16  
 0.25 LF 10325 0.161

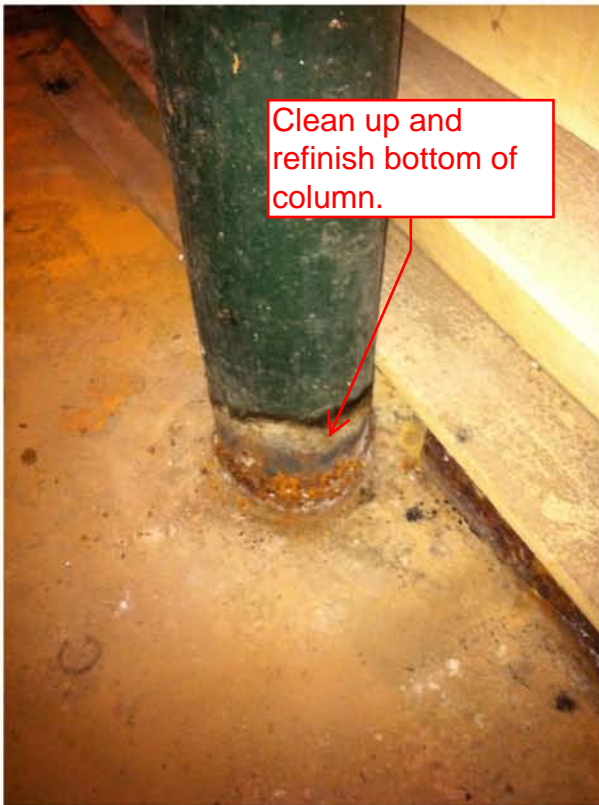
- 5) The columns supporting these beam-line all exhibit rust at the base, some of the rusting is sever.
- 6) With the exception of the wet basement the general condition of the structure looks good.

- 1) Remove the corrosion & refinish the base of the existing cast iron column with a rust inhibiting coating as required. (See Photos IMG\_0722 & IMG\_0724 in Field Report 1)
- 2) Cut off the bottom portion of all steel column ((5) total); provide new base plates; & provide new poured concrete bearing piers. See Detail 1
