# APPLICATION FOR APPEAL

Saint Paul City Council – Legislative Hearings

Number & Street: 1365 ARKNRIGHT City: ST PAUL State: MN Zip: 55130

RE: 1365 Arkwright Street, Unit 203, St. Paul, MN  
Encompass Project #: 18-6763

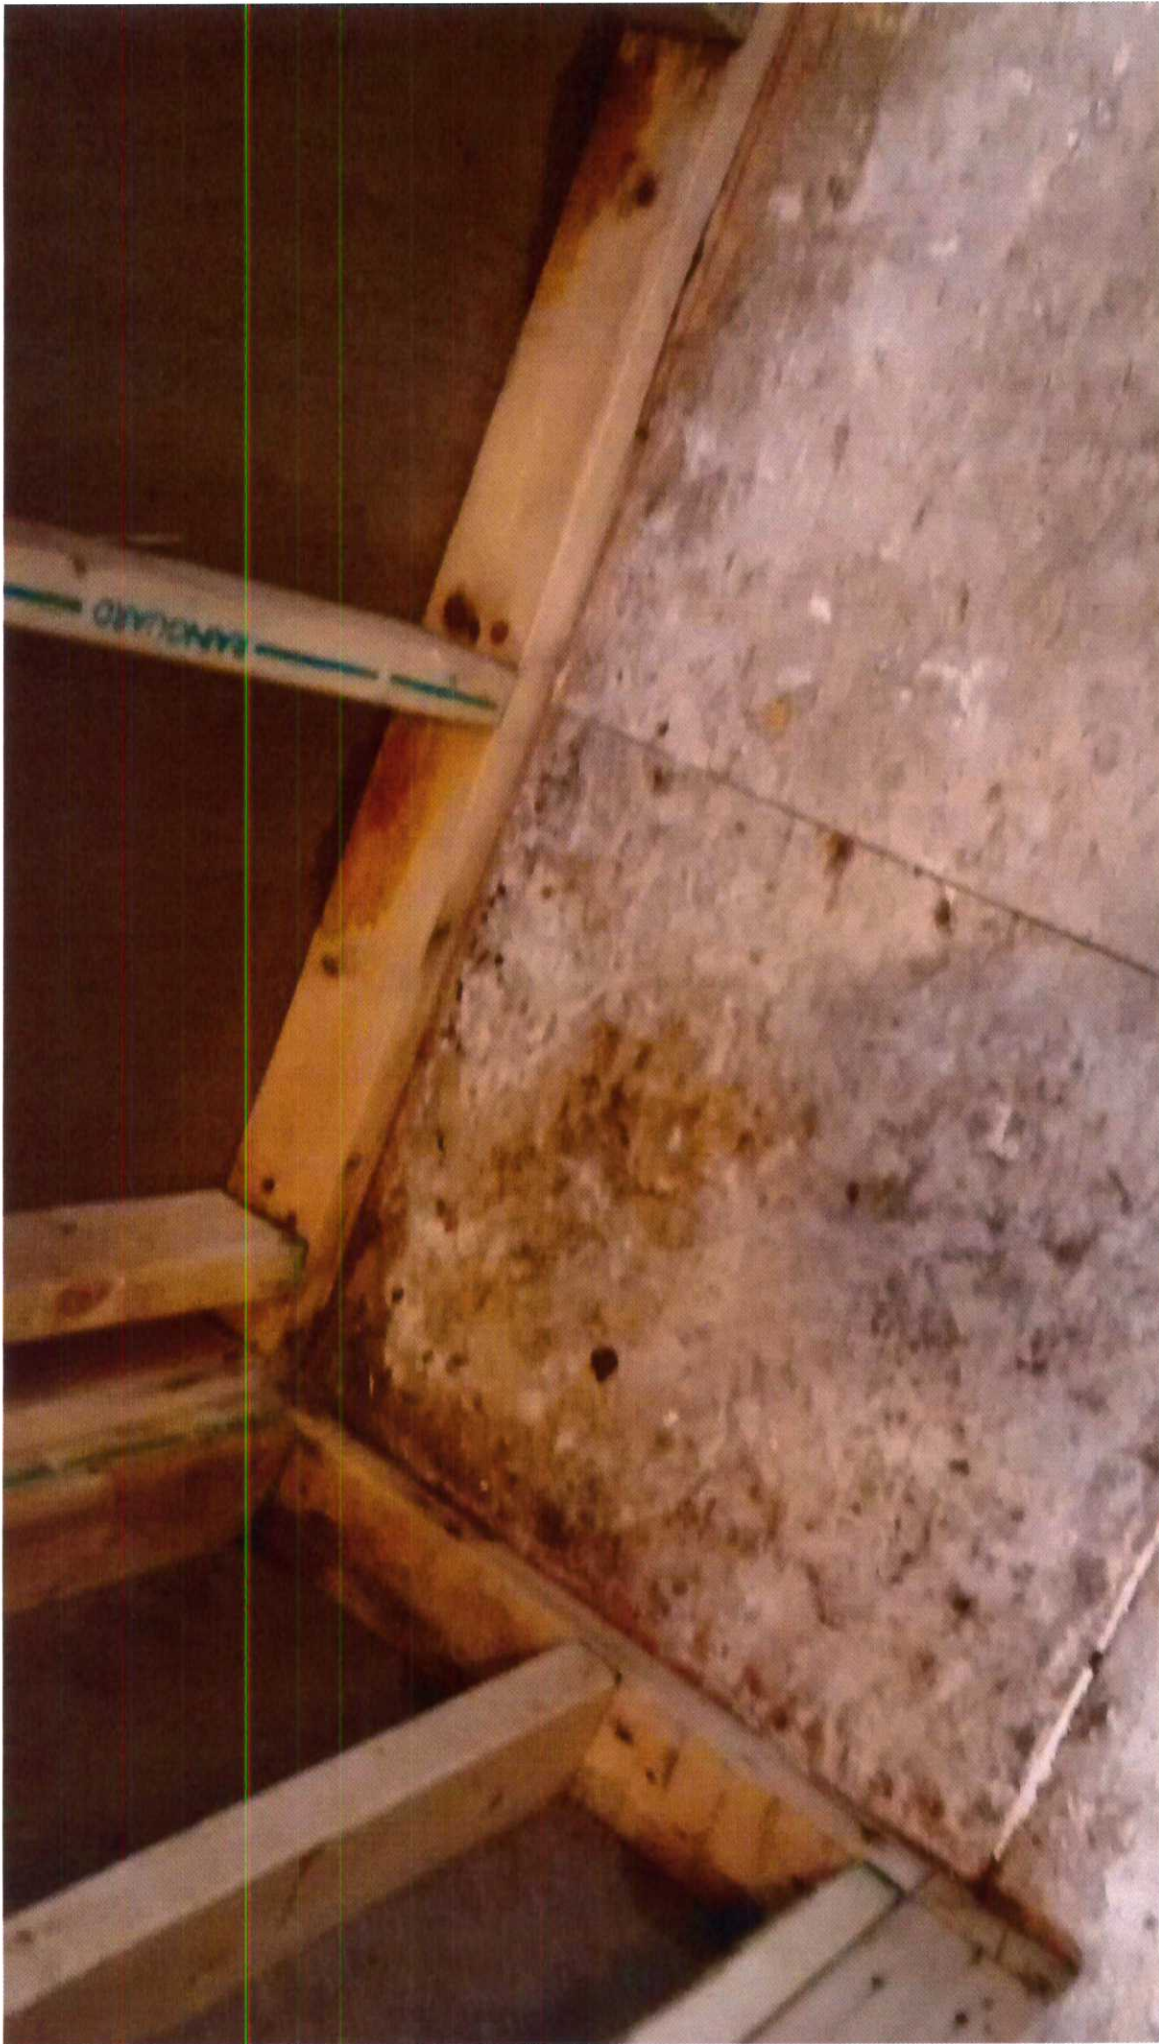
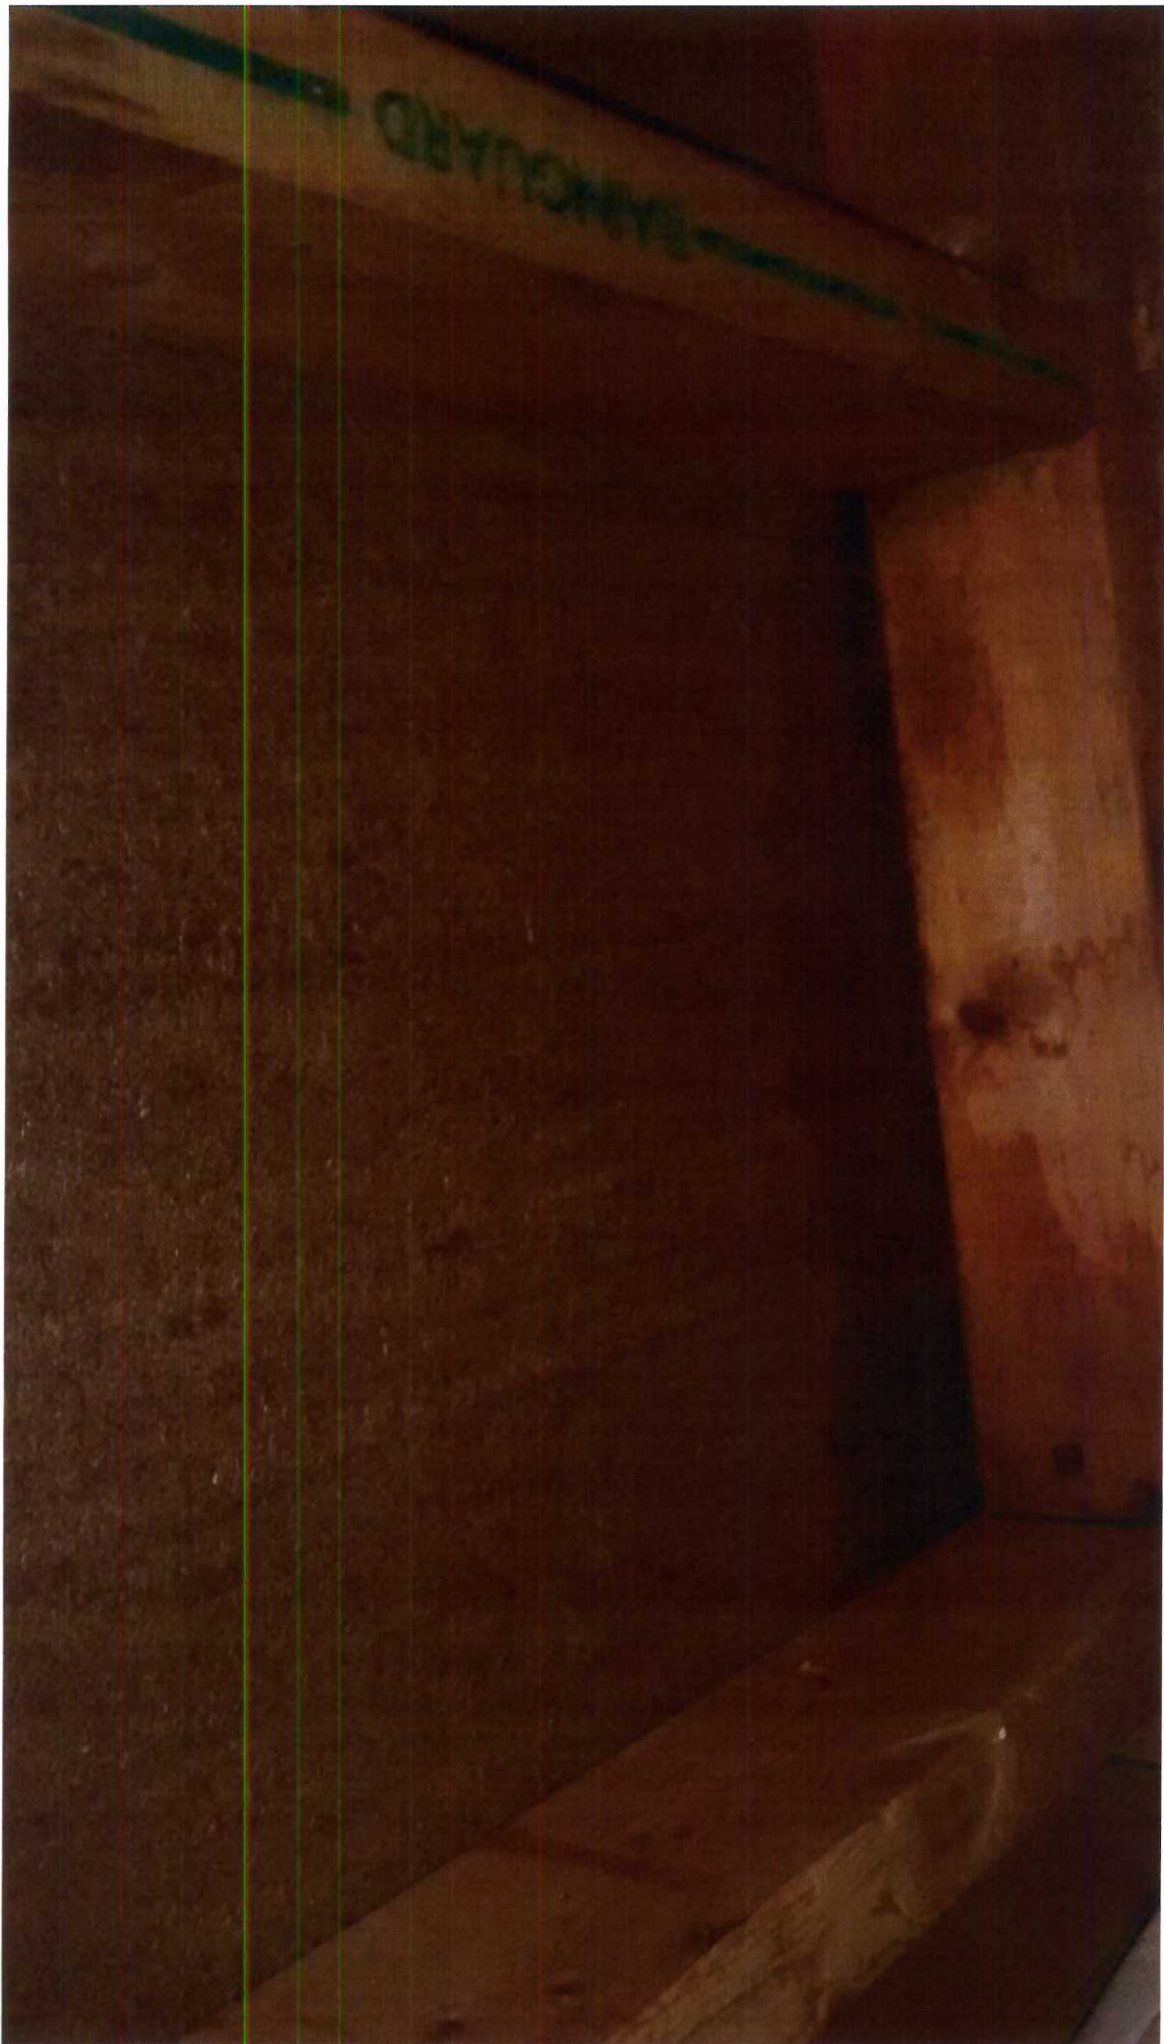
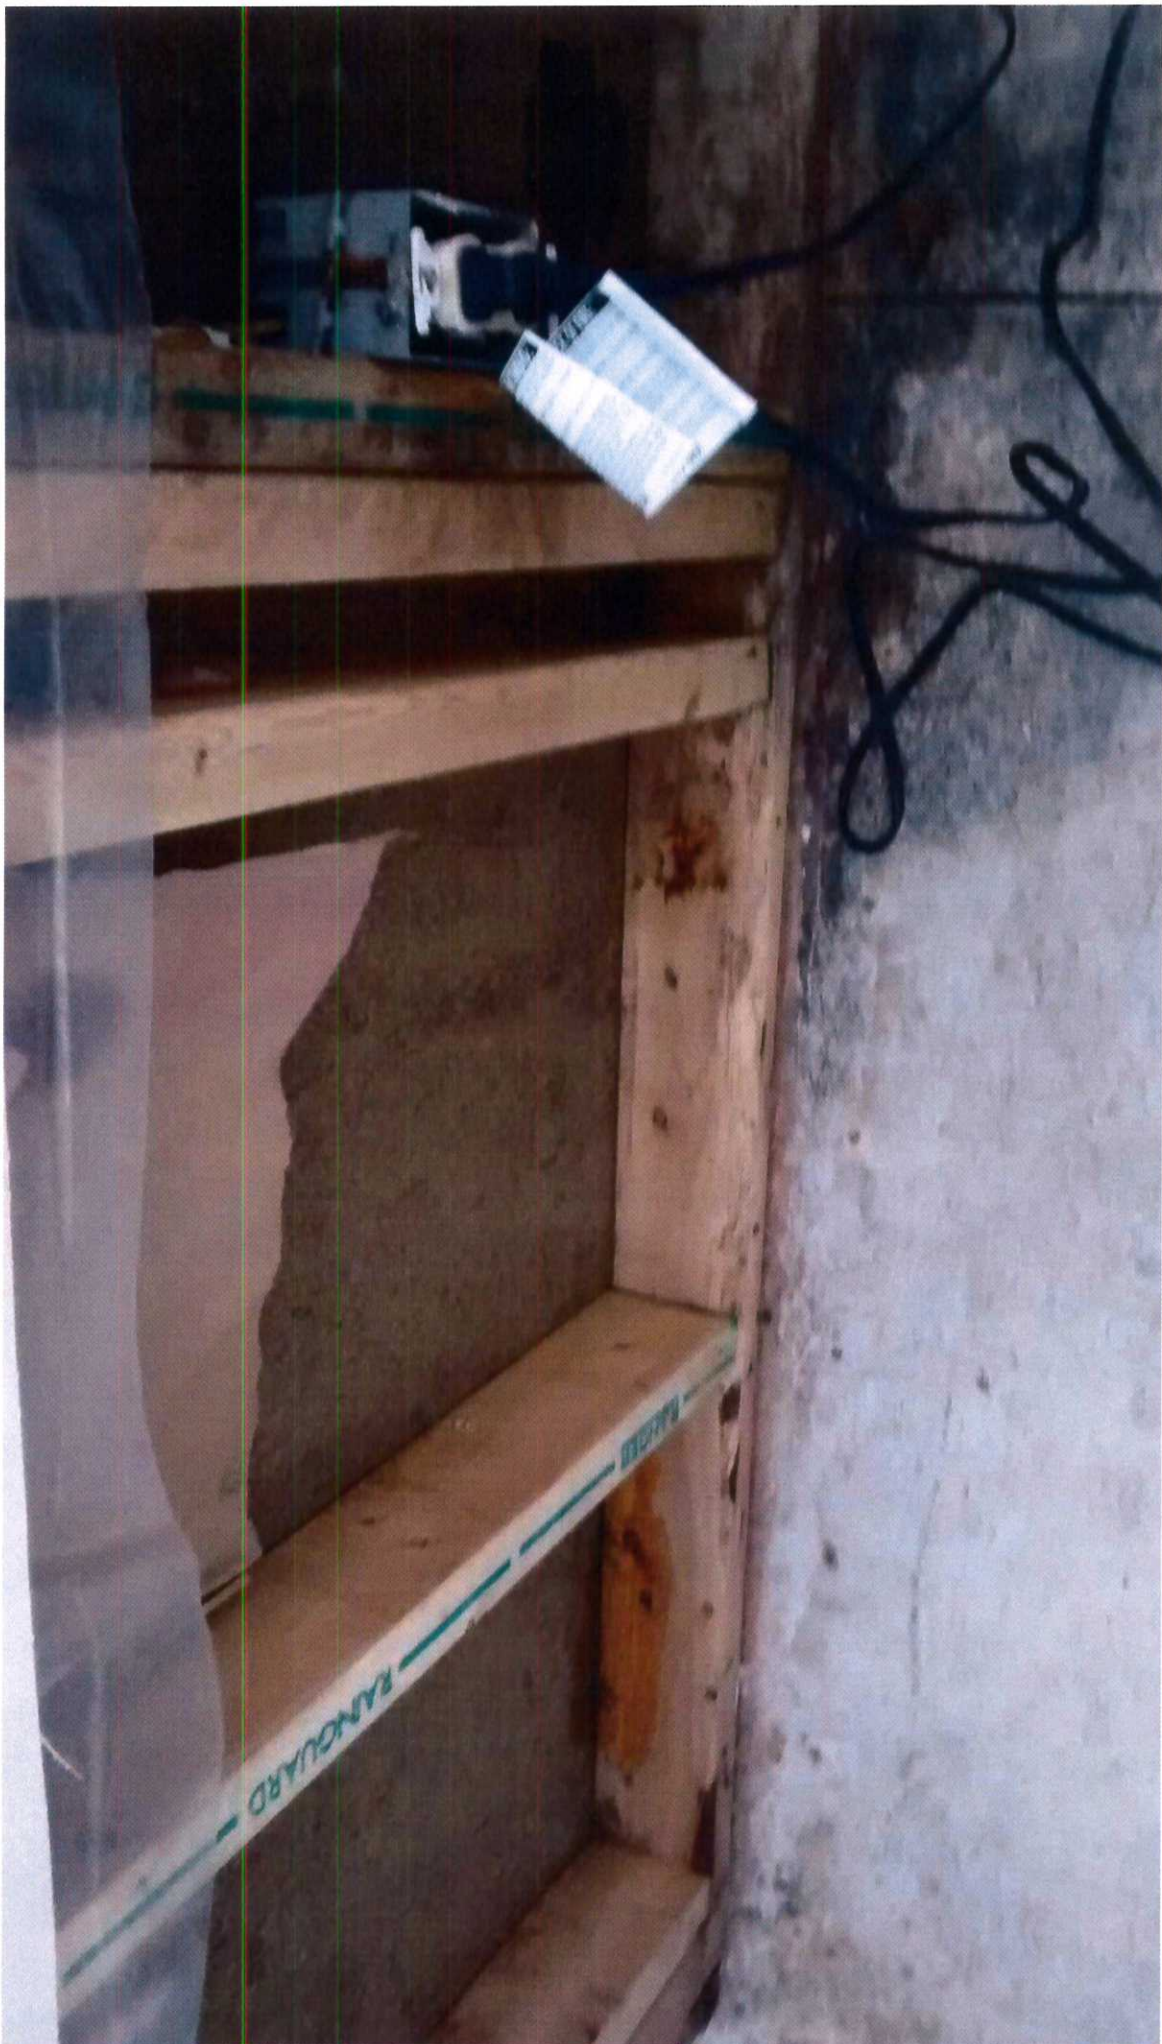
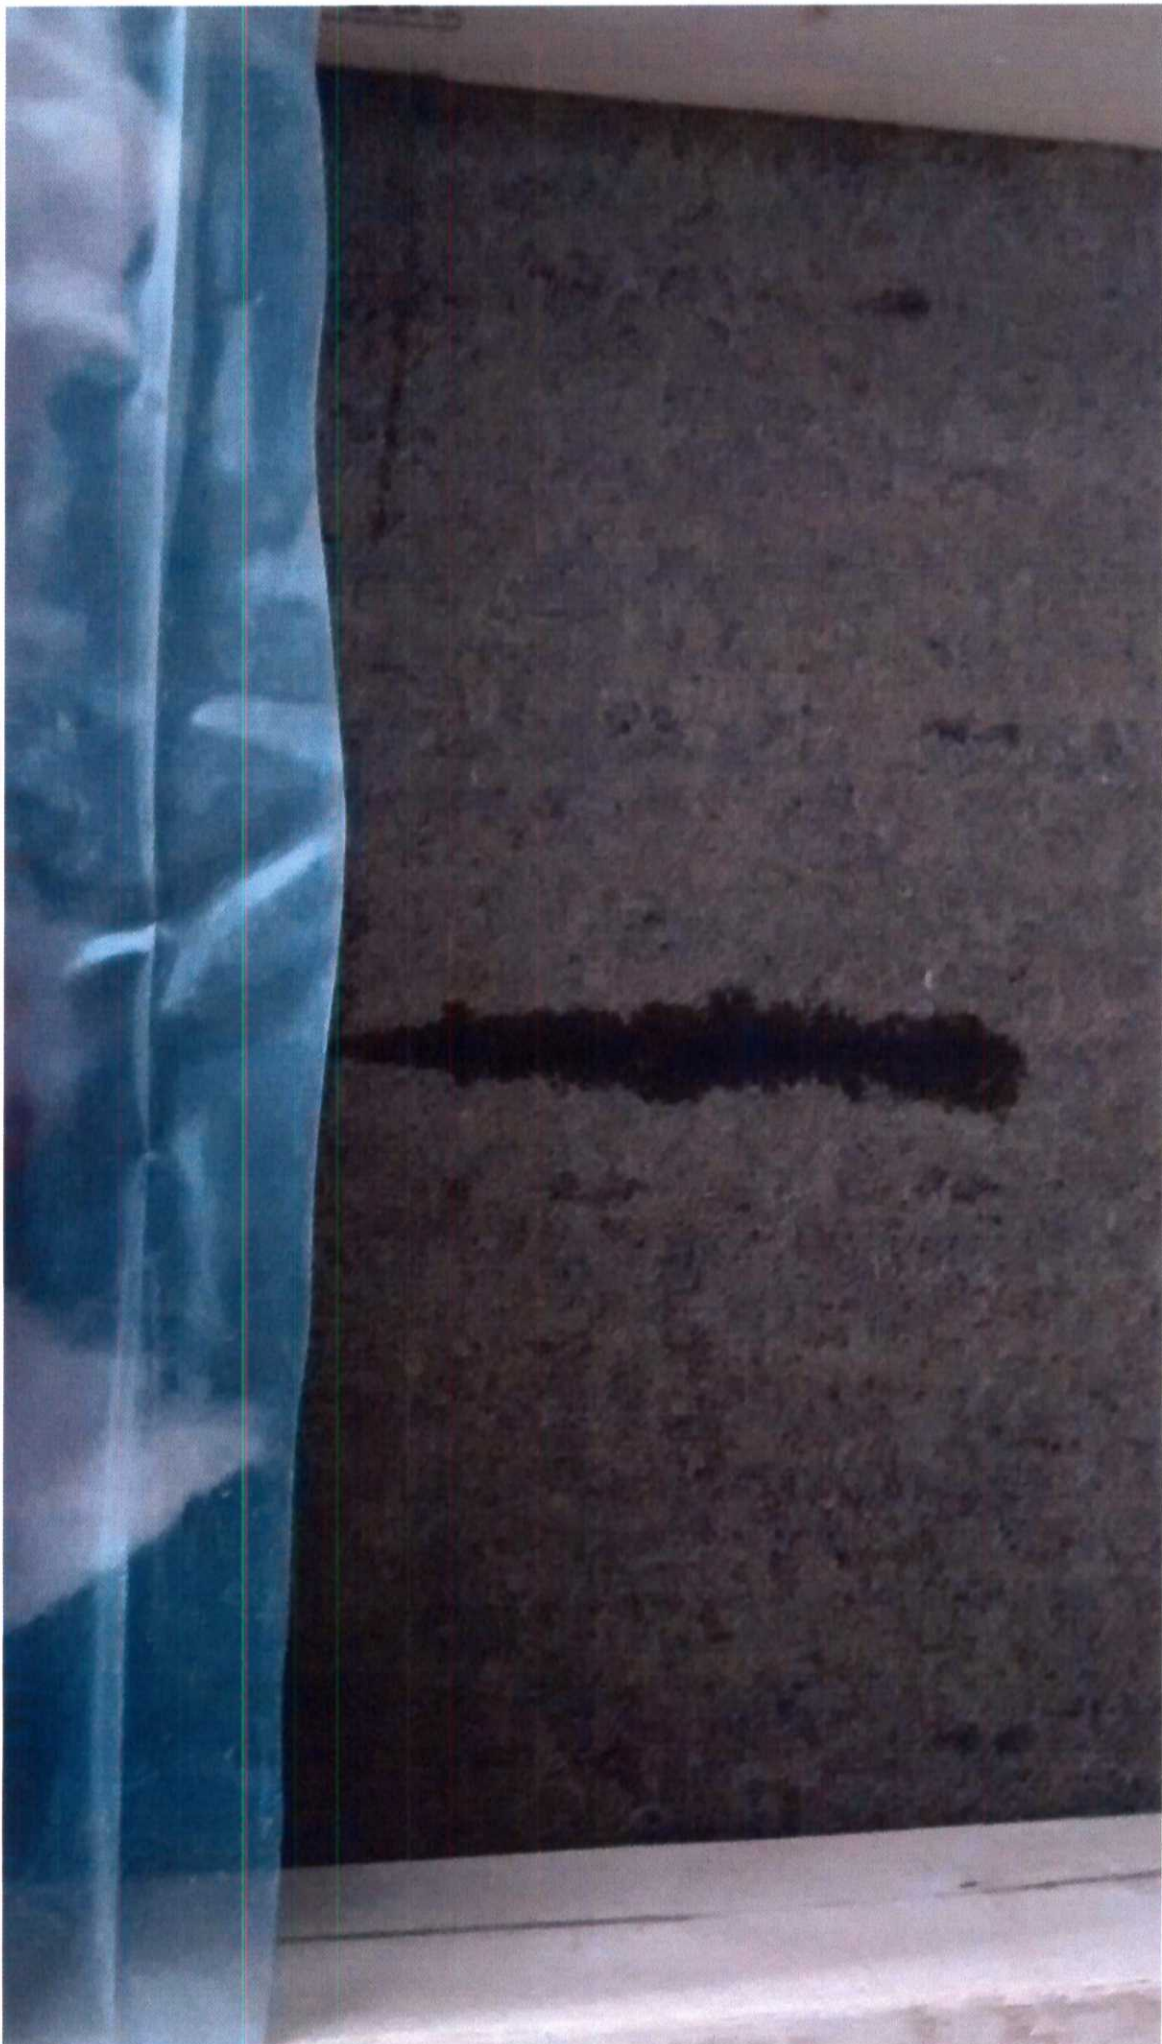
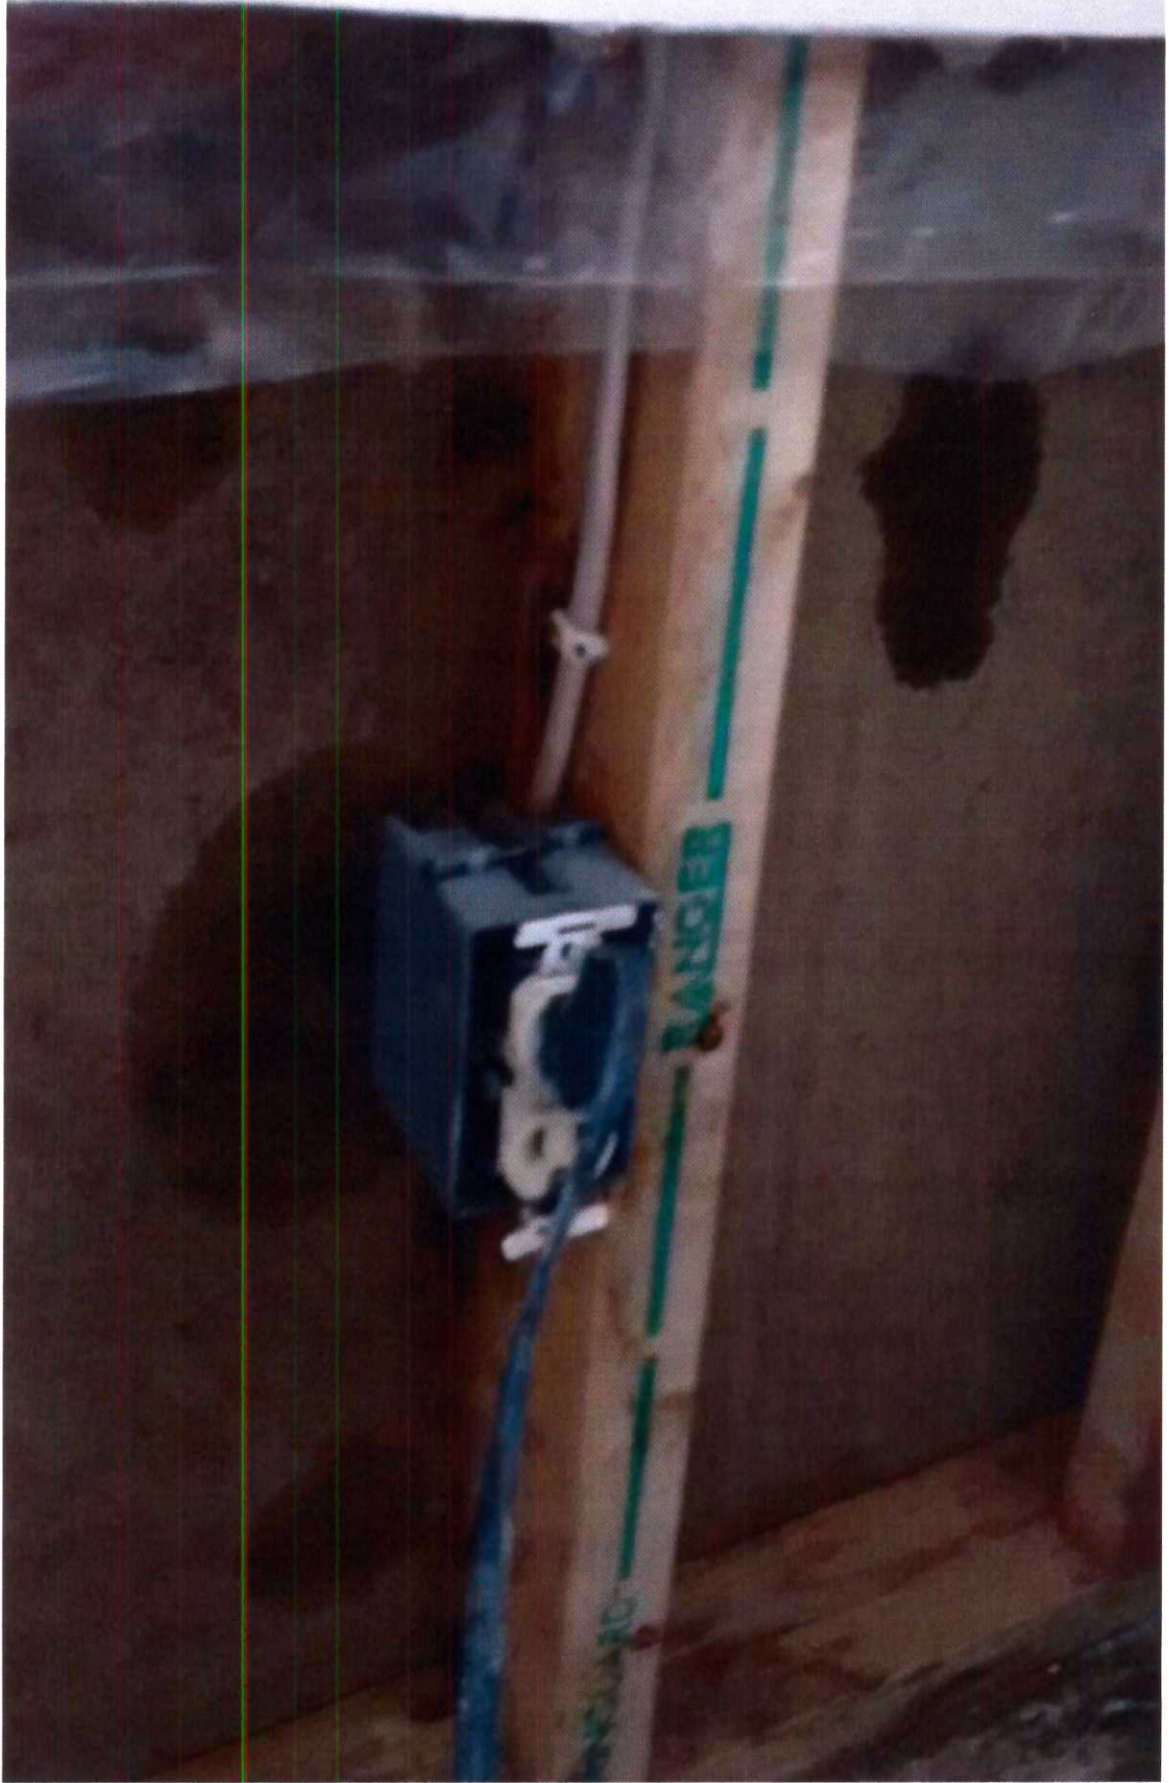
Attachment B1

- On 1/9/2018 I informed Bruce Johnson, president of the Board of HOA via e-mail with attachments of the photos I took on Sunday 1/7/2018 of the wet fiberboard outer wall and floor in the unit. Refer to **Attachment B1** are some of the photos I sent to Bruce.

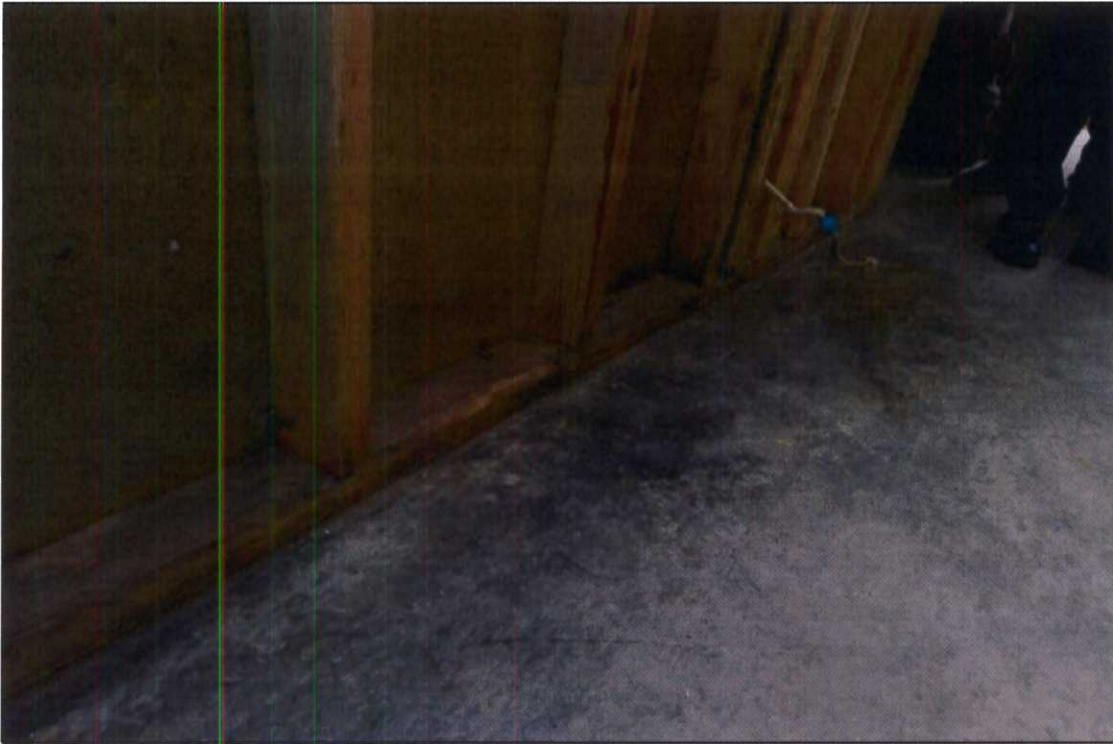
Water staining was present along a majority of the north wall. The most significant staining was present below three windows on the north wall. The staining was located within the wall cavity and on the floor sheathing directly below the window and extending out several feet on each side of the window. Although staining was more extensive below the windows, it was also present along the floor and in the wall cavity away from windows. See Photographs 1 through 14 for examples of observed staining.

**Photograph # 3:** Staining on floor below the window in Photo 1

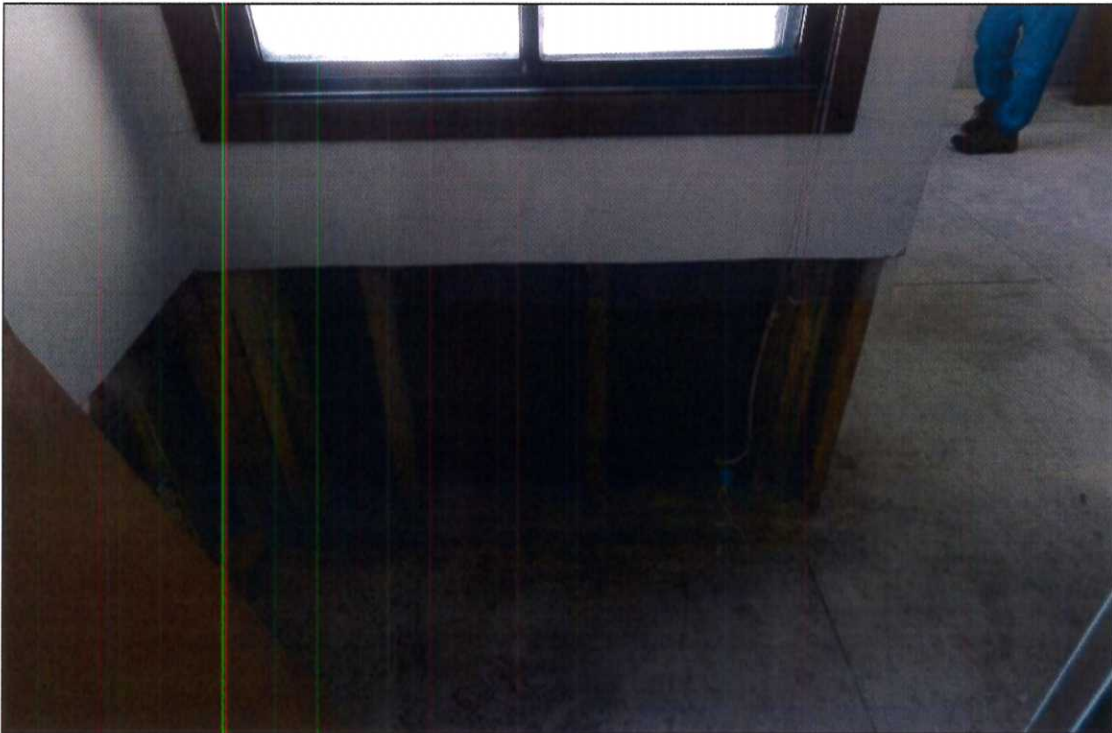
**Photograph # 4:** Water staining on floor below window to the west

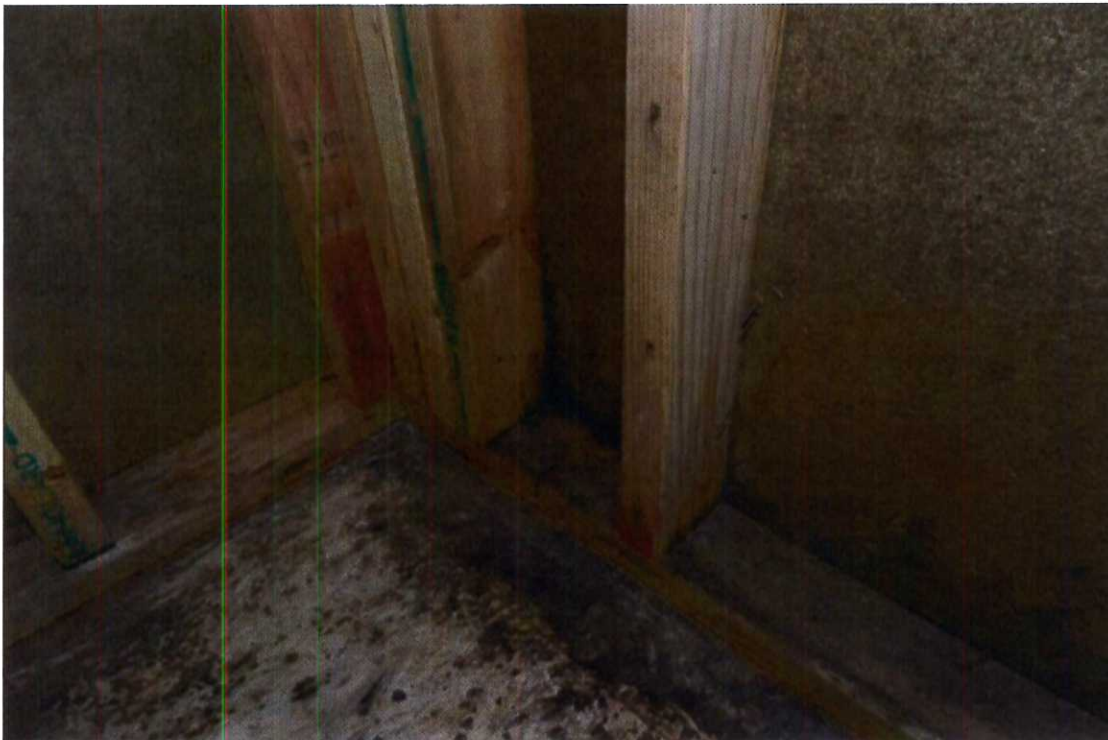
**Photograph # 5:** Close up of water staining below window in Photo 4

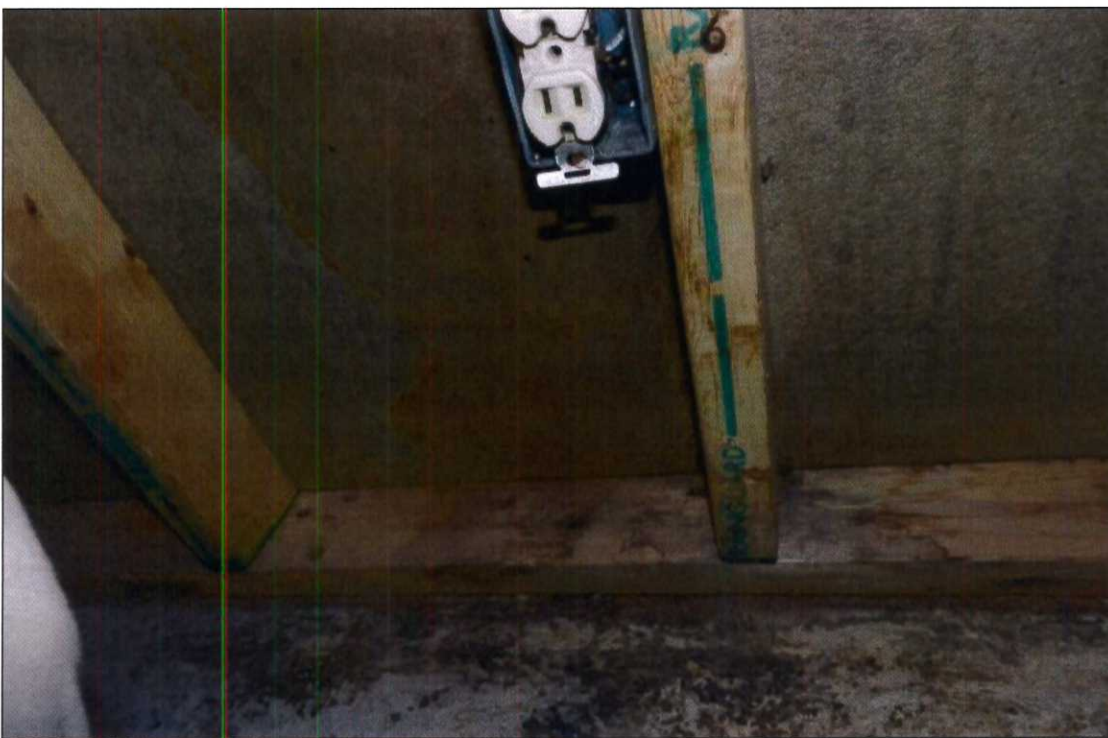
**Photograph # 6:** Water staining in wall to the west of window in Photo 4

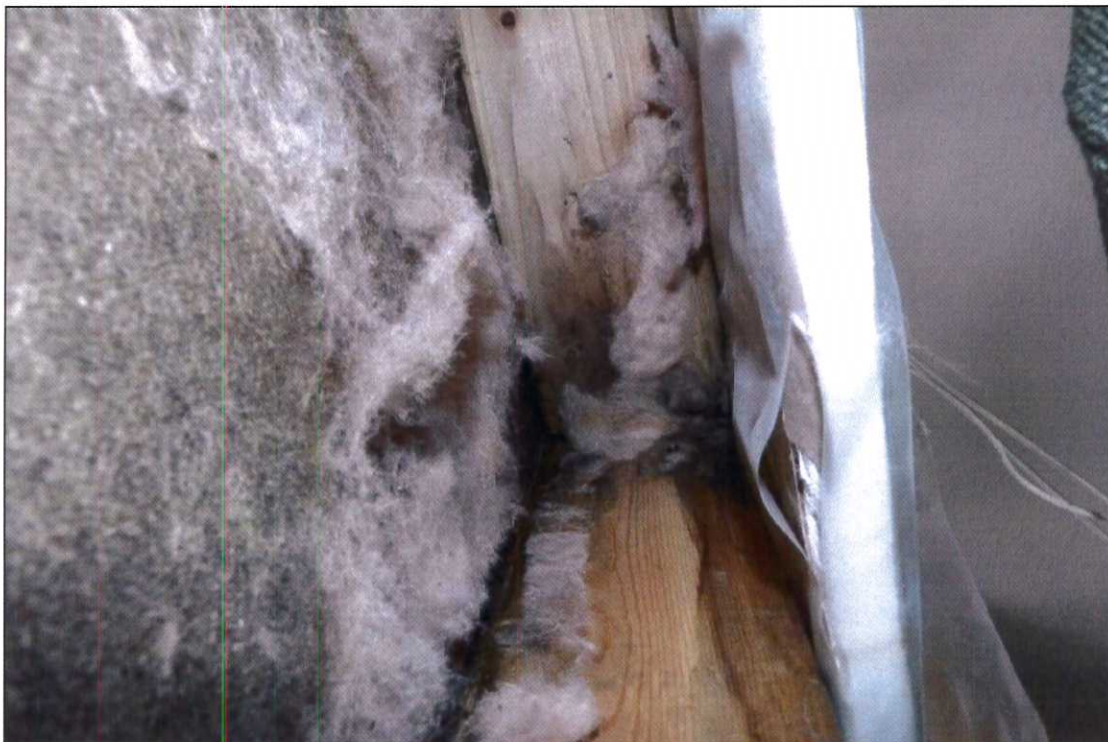
**Photograph # 7:** Water staining in wall cavity below the window in Photo 4

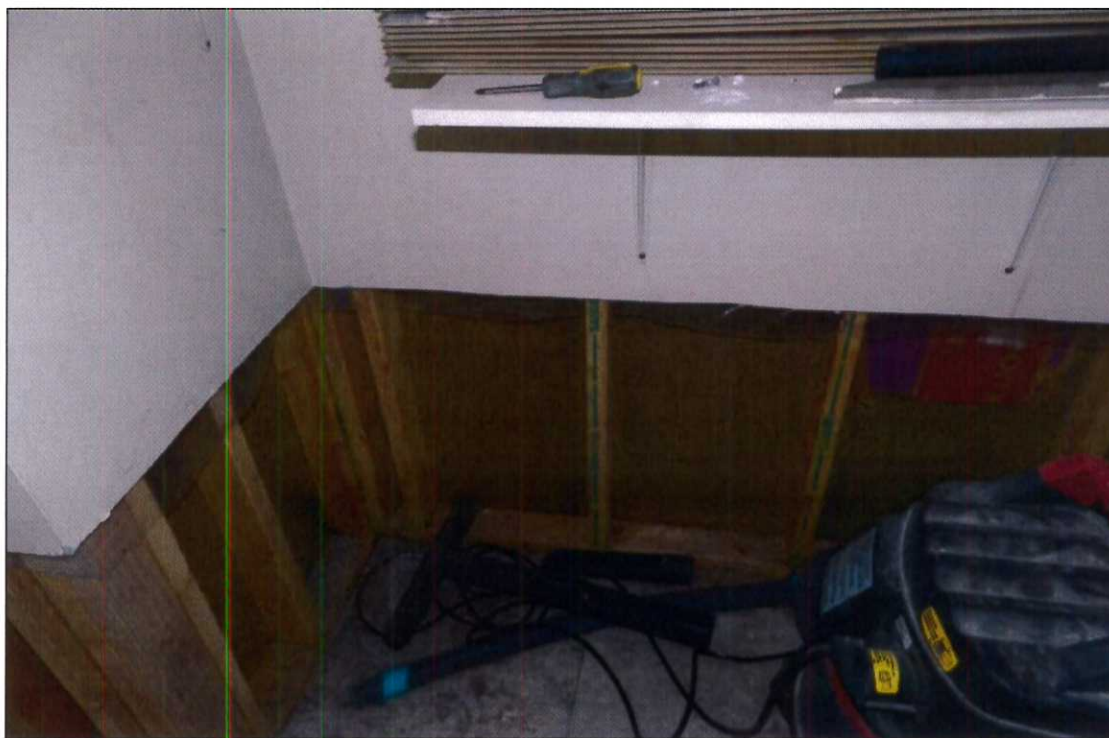
Water staining was present in the bump-out area, located across the hall from the bathroom. Refer to photographs 8 and 9.

**Photograph # 8:** Water staining in bump-out across from bathroom

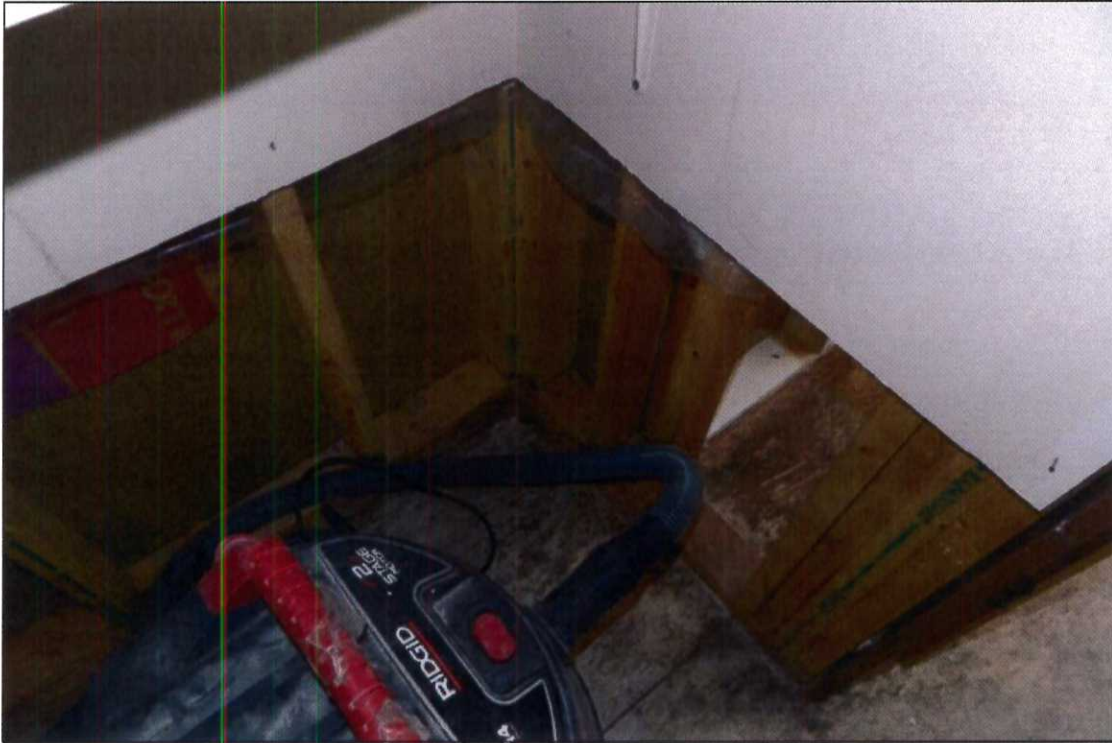
**Photograph # 9:** Water staining on floor in bump-out across from bathroom

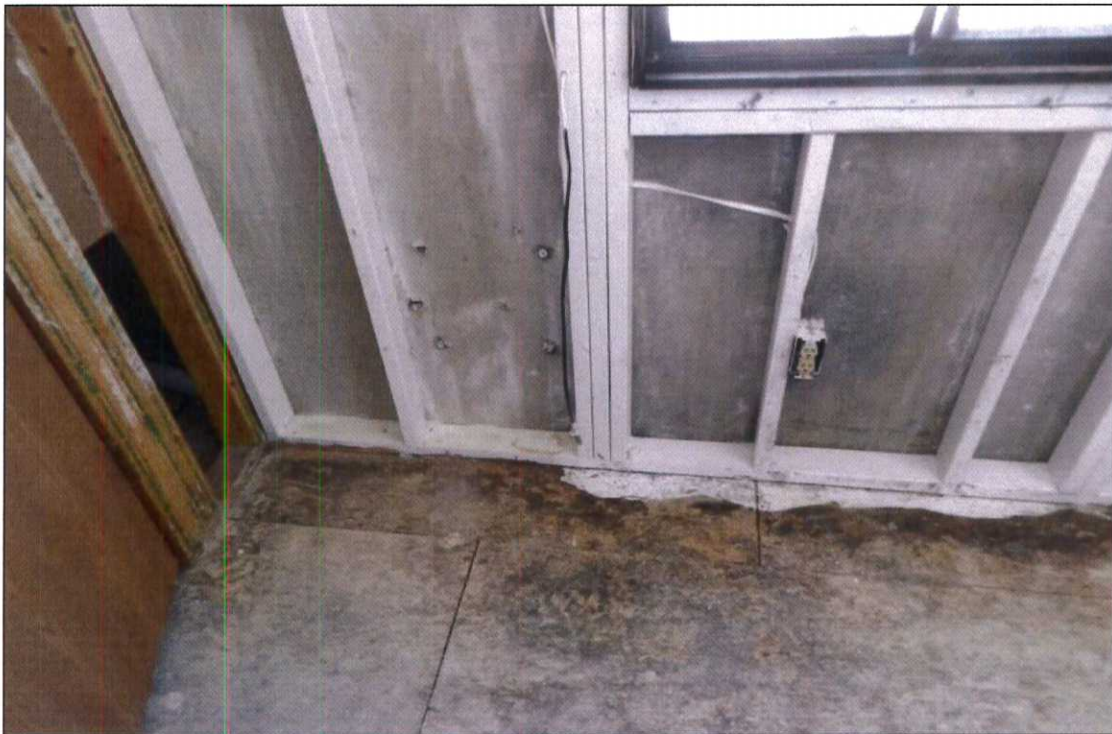
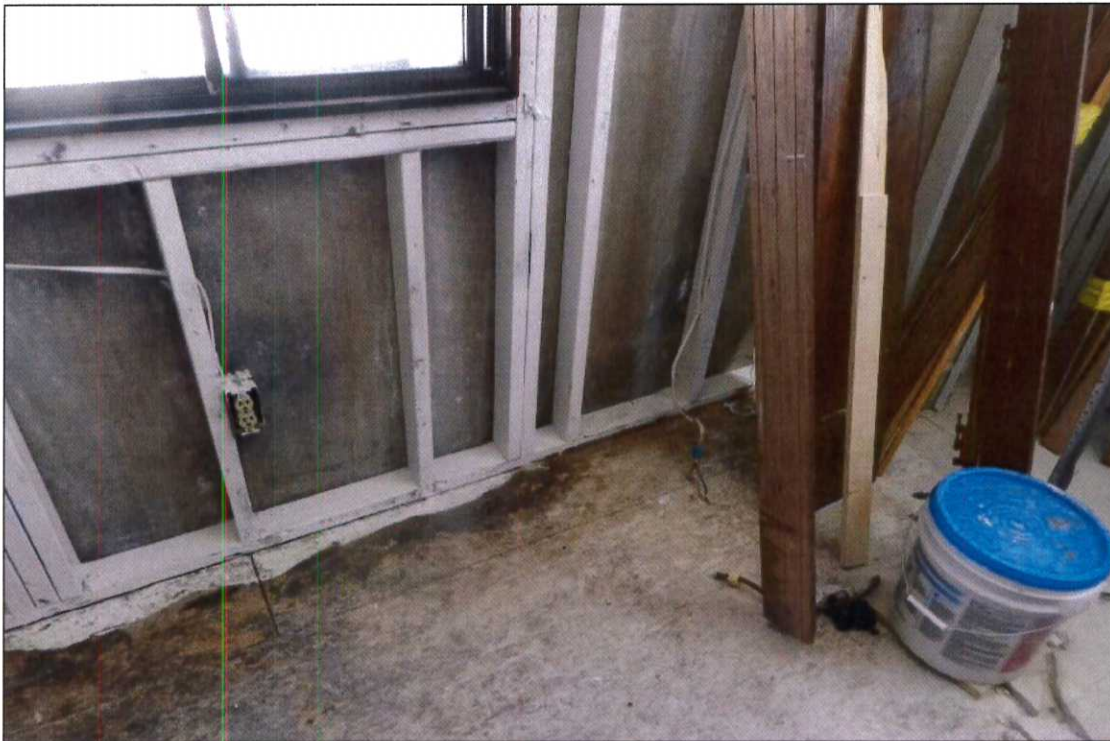
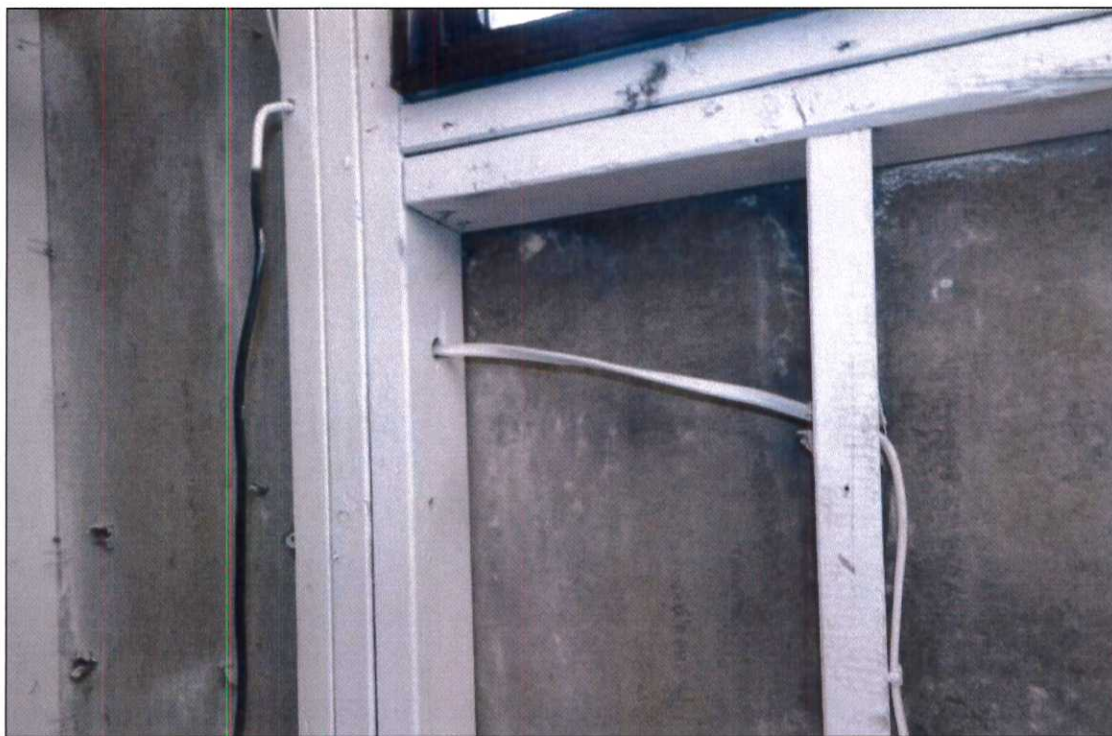
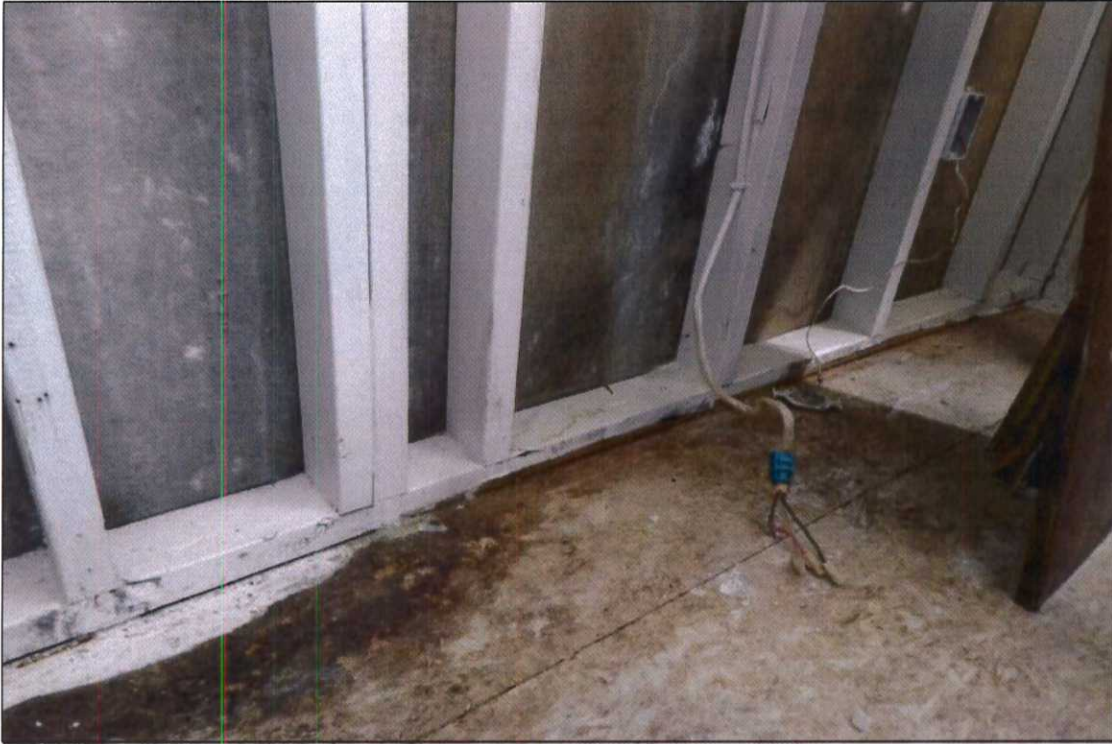
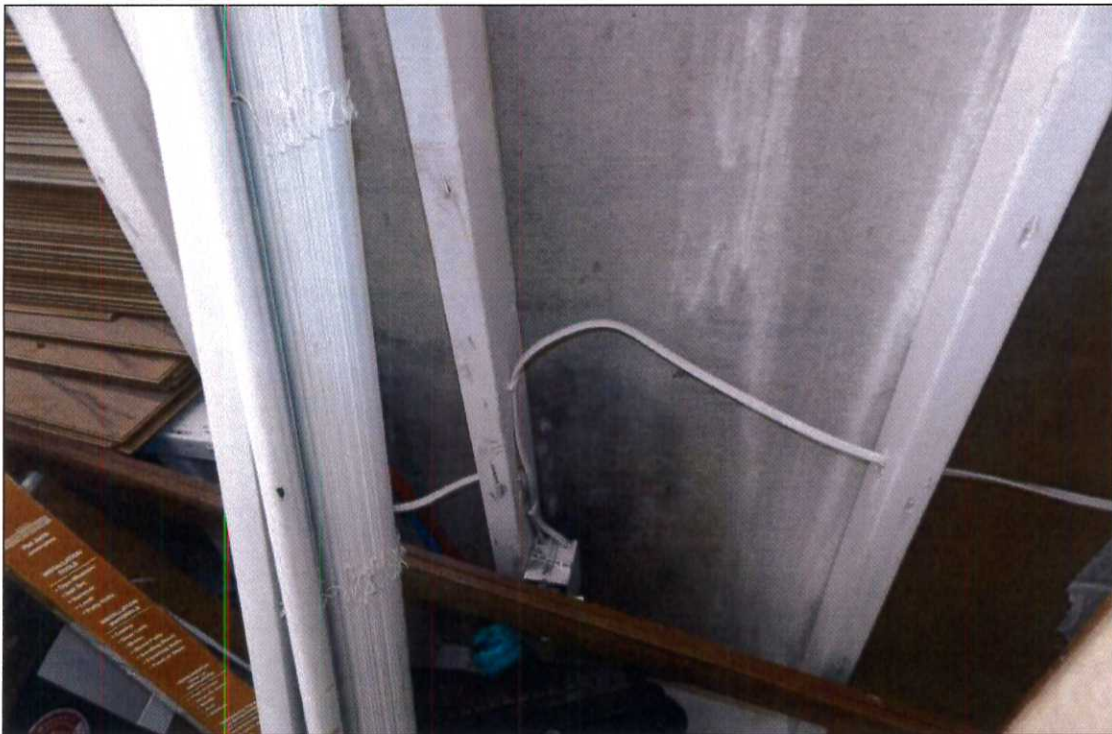
The most significant water issues were observed in the bedroom, where significant staining was present on the floor sheathing and deterioration of the floor sheathing was present. The walls in the bedroom have been painted with a Kilz-type product. The product was applied to the studs, the inside face of the exterior sheathing, and a small area of the floor. Water staining within the wall cavity could still be seen despite the application of the Kilz product. Refer to photographs 10 through 14.

**Photograph # 10:** Bedroom – water staining on floor; Kilz applied to wall
