# APPLICATION FOR APPEAL

Saint Paul City Council – Legislative Hearings

Number & Street: 1365 ARKNRIGHT City: ST PAUL State: MN Zip: 55130

RE: 1365 Arkwright Street, Unit 203, St. Paul, MN  
Encompass Project #: 18-6763

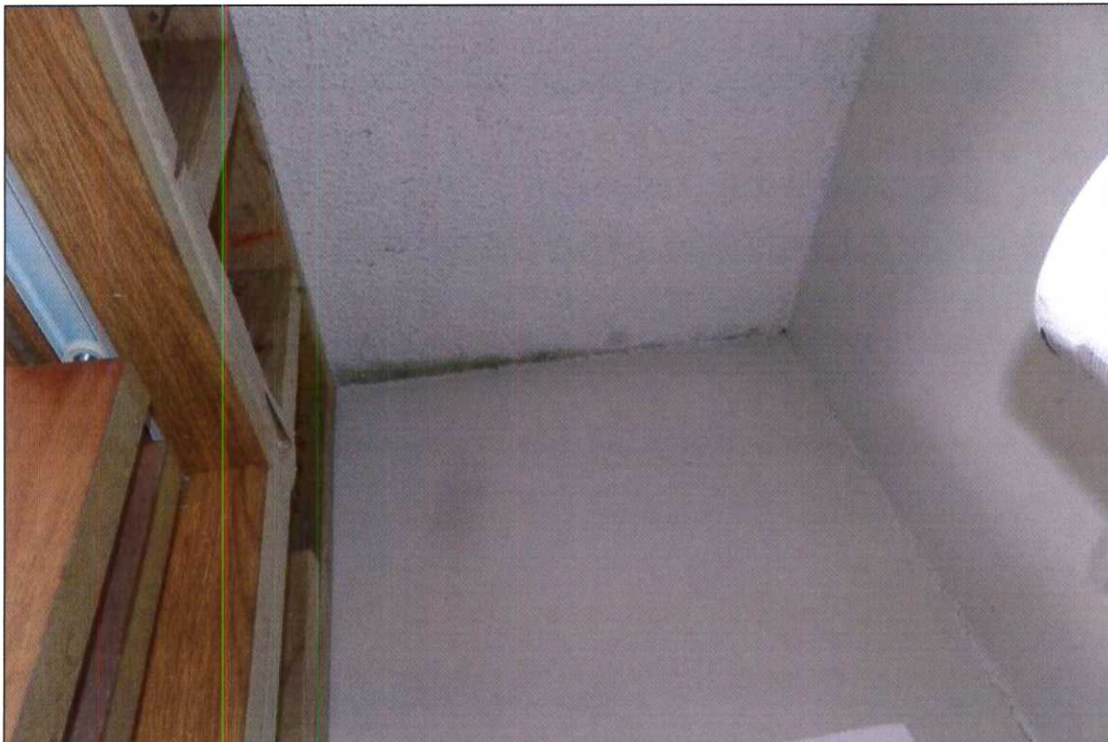
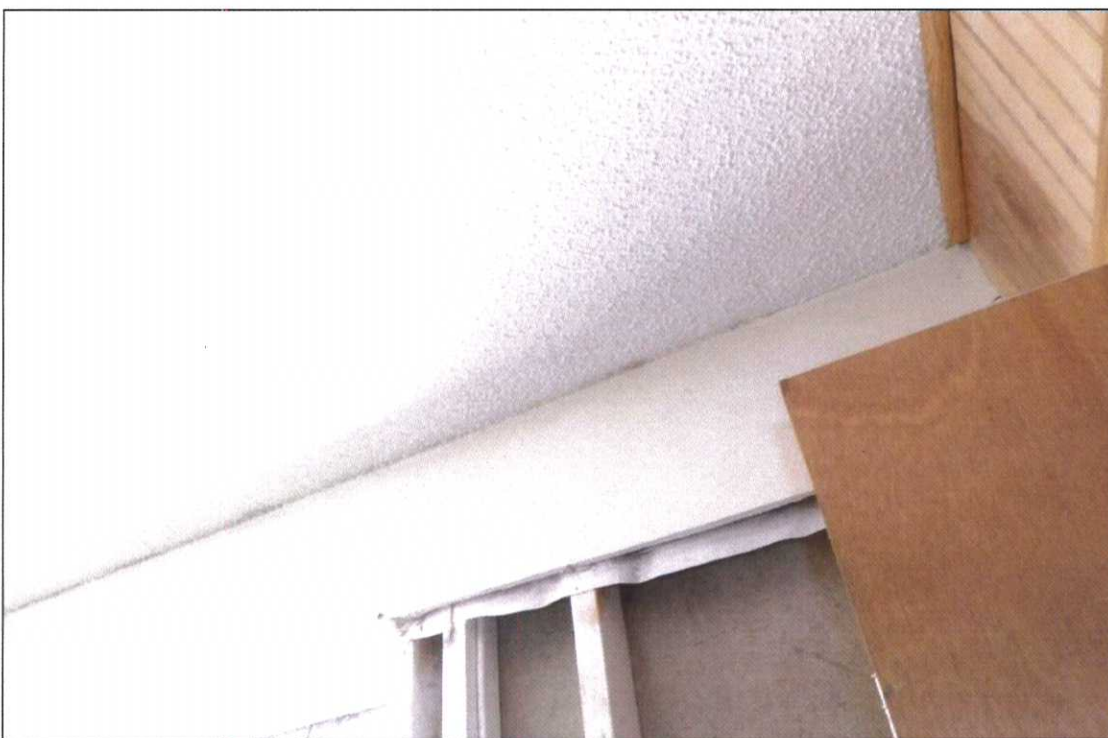
Dark discoloration of the ceiling finish was observed along the north wall. The stains are located in various areas and many are spaced at regular intervals that align with attic truss spacing. Refer to photographs 15 and 16.

**Photograph # 15:** Water stains at wall/ceiling

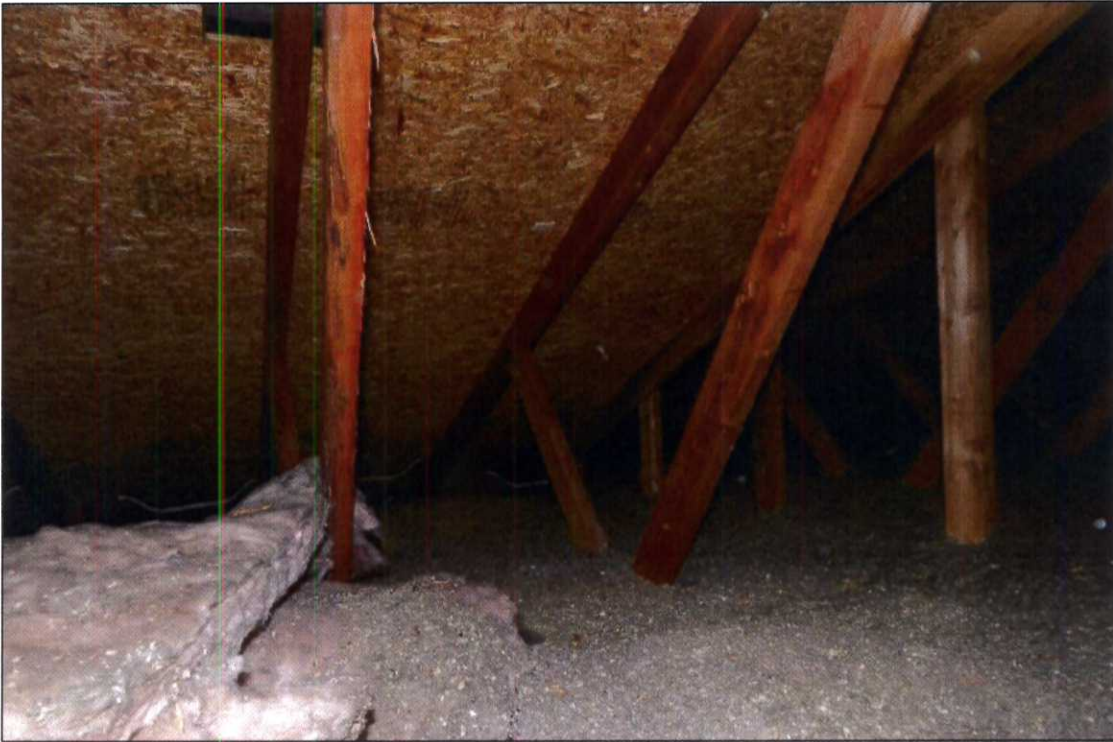
The attic was accessed. Attic insulation consists of loose cellulose. Attic ventilation consists of gable vents, passive vents, and eave vents; baffles are present at the eaves. Dark discoloration of the roof sheathing was present at the area behind the baffles. See Photos 17 through 21 for attic conditions.

**Photograph # 17:** Attic above unit 203

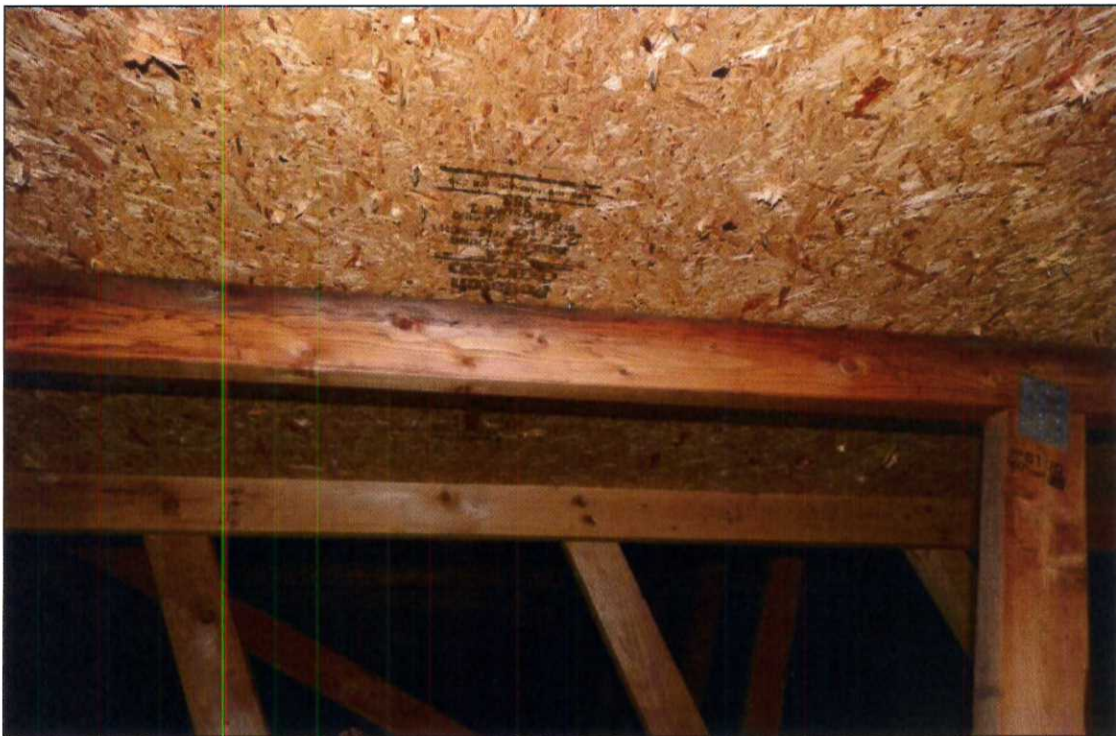
**Photograph # 18:** minor staining on trusses

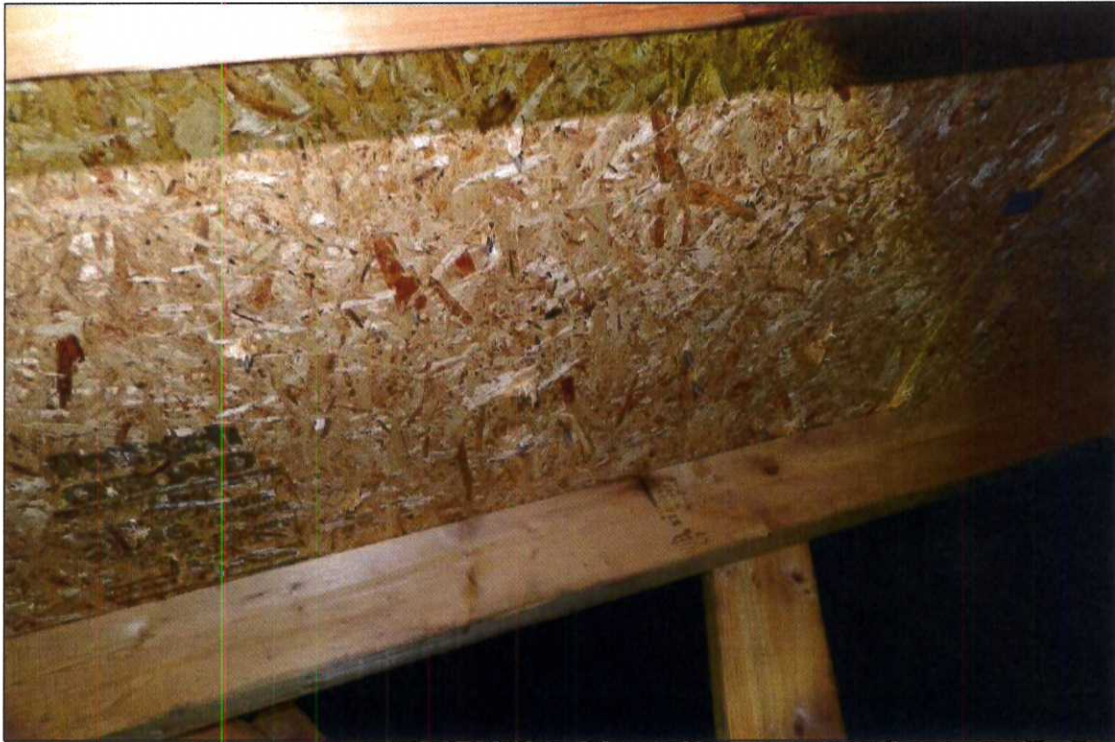
**Photograph # 19:** Sheathing in good condition

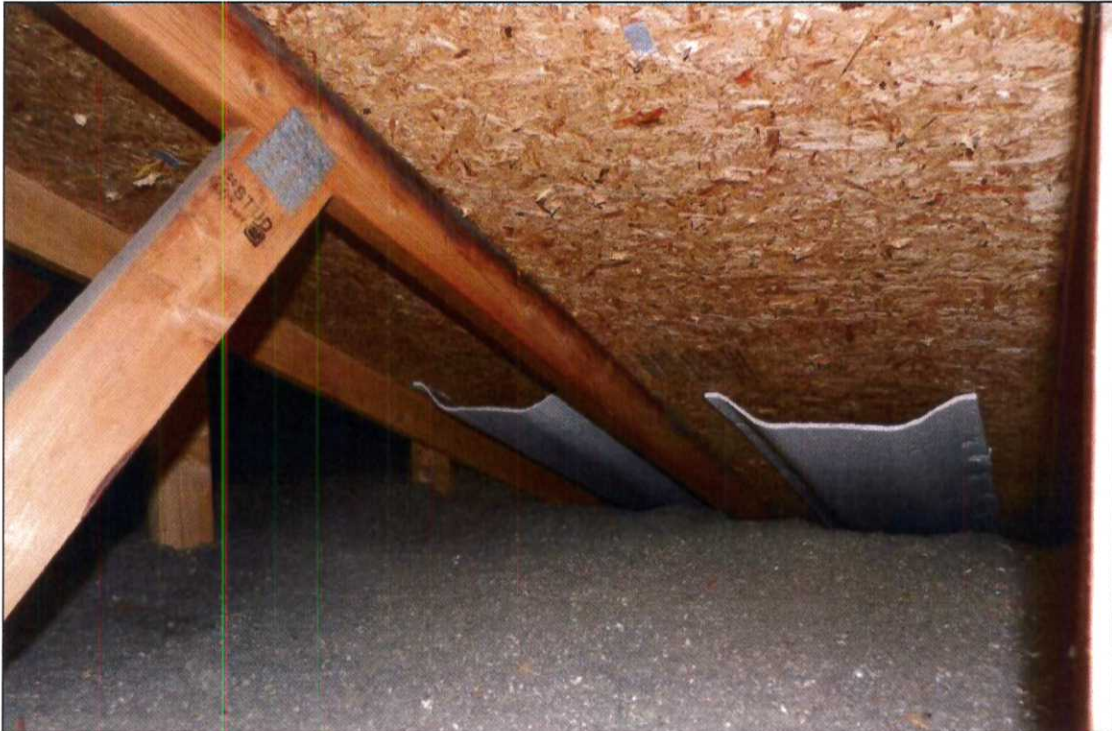
**Photograph # 20:** Baffles present at eaves

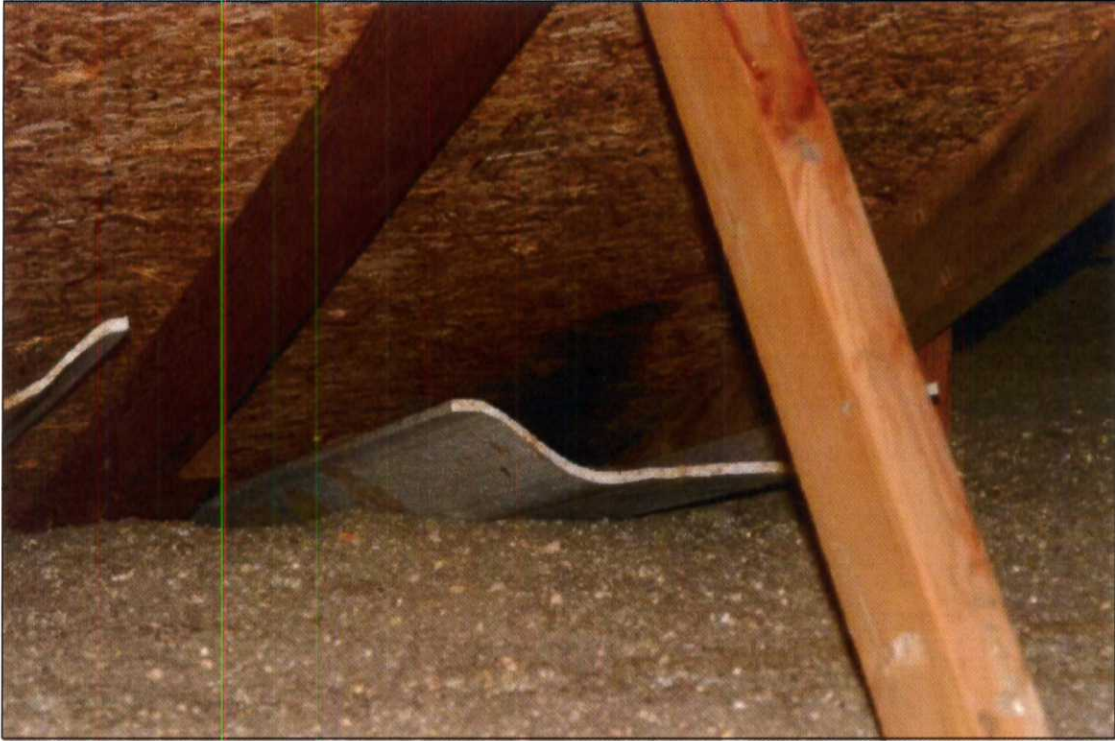
Water staining is present in the wall cavity and on the floor away from windows – though it was notably less than what was observed below windows. This staining is largely due to condensation formation in the wall cavity and in the attic. Warm, moist air that migrates into the wall cavity and into the attic will condense when the weather is cold, and the condensation can drip down the walls, creating the water streaks that were present in some areas. This appears to be the cause of staining in the bump-out area. Attic ventilation at eaves is provided by partial eave soffit vents. The limited eave ventilation reduces the amount of cold, dry air migrating into the attic and, consequently, it allows warm, moist air to accumulate in the attic which can create frost on the cold portions of the interior side of the roof sheathing. Evidence of this was observed by the baffles on the north side (refer to Photo 21). When frost on the roof

sheathing behind the baffles melts, it will drip down the exterior wall sheathing, creating the water streaks observed in the wall cavity. The condensation formation in the attic also likely caused the water stains on the wall/ceiling intersection along the rear wall.

**Photograph # 21:** Water staining on roof sheathing

In order to correct the water intrusion issue at window openings, Encompass recommends that the three windows be removed and replaced, and proper rough opening flashing be installed at that time. The flashing should be installed to protect the rough opening sill and it should extend onto the exterior sheathing. A limited amount of siding removal around the window will be required. Installation of the new windows should include a sealant joint around the perimeter of the windows. On the interior, it should be determined if the staining and discoloration on the studs and sheathing is mold growth, and if it is, a mold abatement contractor should remediate the condition. In order to increase the amount of attic ventilation, soffit panels should be replaced with fully vented panels and an additional passive vent should be installed near the ridge. If condensation on the roof sheathing persists, then it may be necessary to apply a spray foam insulation over a portion of the attic in order to control migration of warm, moist air into the attic from the living space below.

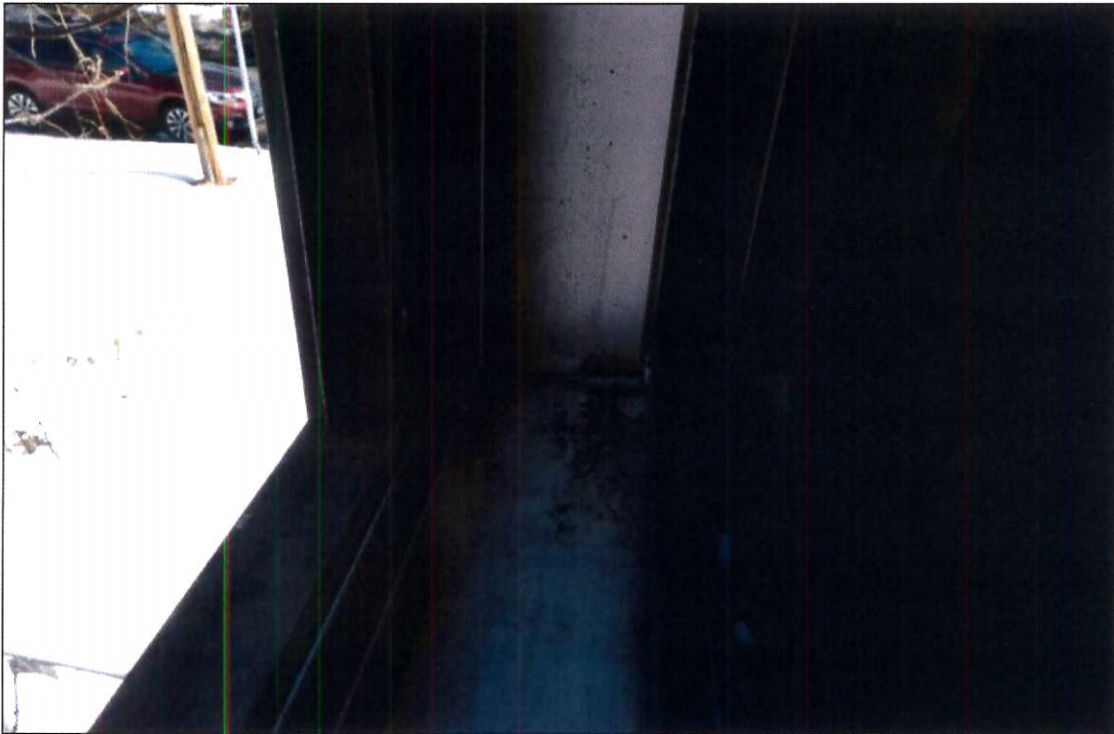
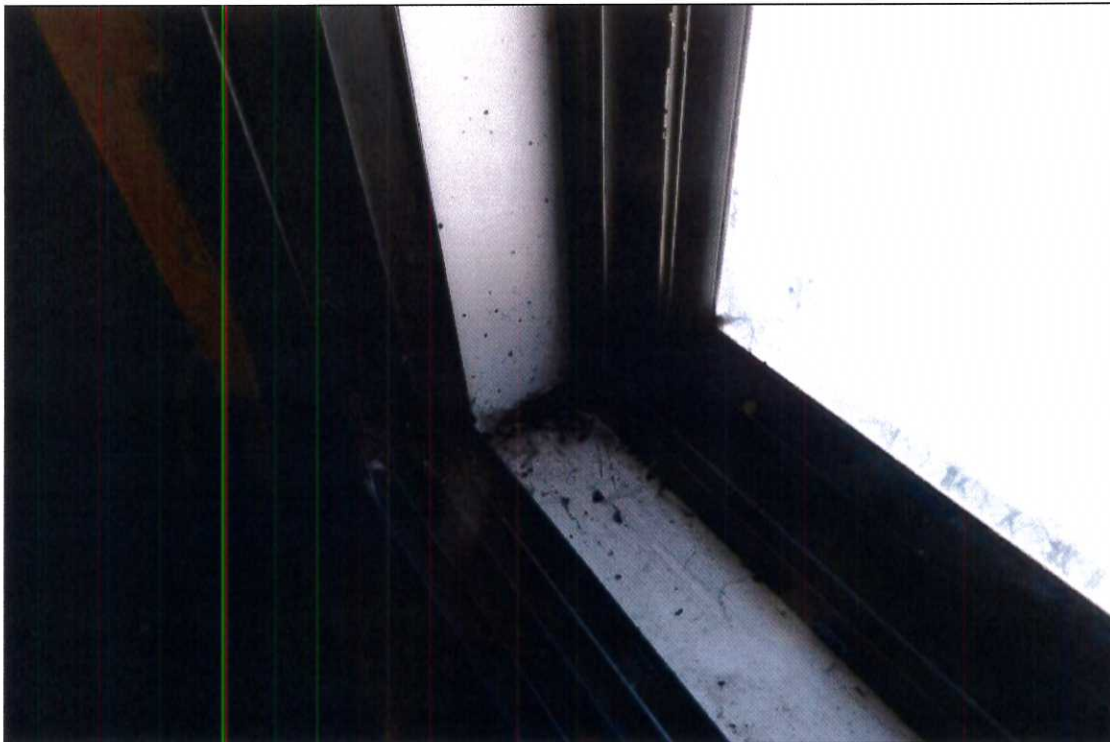
The cause of water staining and possible microbial growth on the floor sheathing and within the wall cavity is consistent with prolonged water exposure resulting from condensation and exterior water intrusion. The condition of the windows and their installation method is poor. The windows have gaps and openings at the jamb/sill intersections that allow water to migrate through the frame and into the rough opening below. No flashing or weather barrier was observed in the rough opening to protect the underlying wood structure below the window; this is a common condition for the age of the building, but it allows water to migrate in to the wall cavity. The chronic water exposure of the windows has caused deterioration of the wood window frame components and this has exacerbated the water entry. Sealant is not present at the joint around the window perimeters. The lack of sealant allows water to migrate into the rough opening and into the wall cavity below. Water staining that observed on the bottom of the rough opening plates and on the wall sheathing and floor sheathing below the windows is a result of migration through windows and around the windows. See Photos 22 through 26 for window conditions.

**Photograph # 22:** Deterioration at window jamb/sill intersection

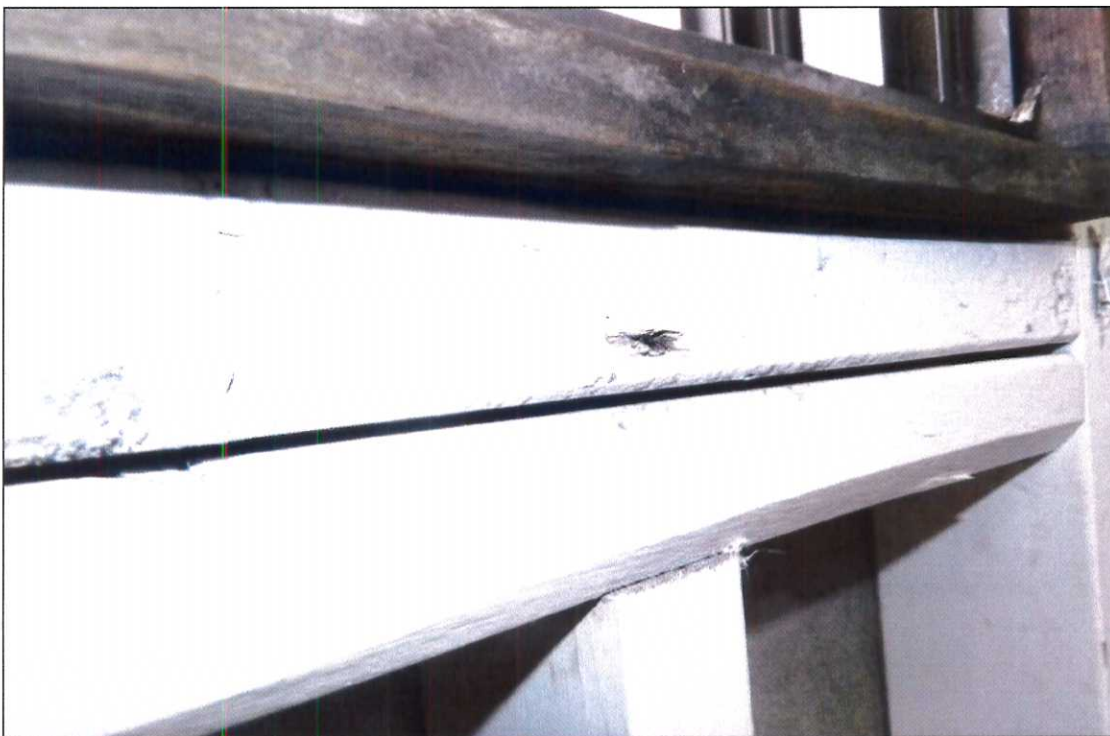
**Photograph # 24:** No flashing below window

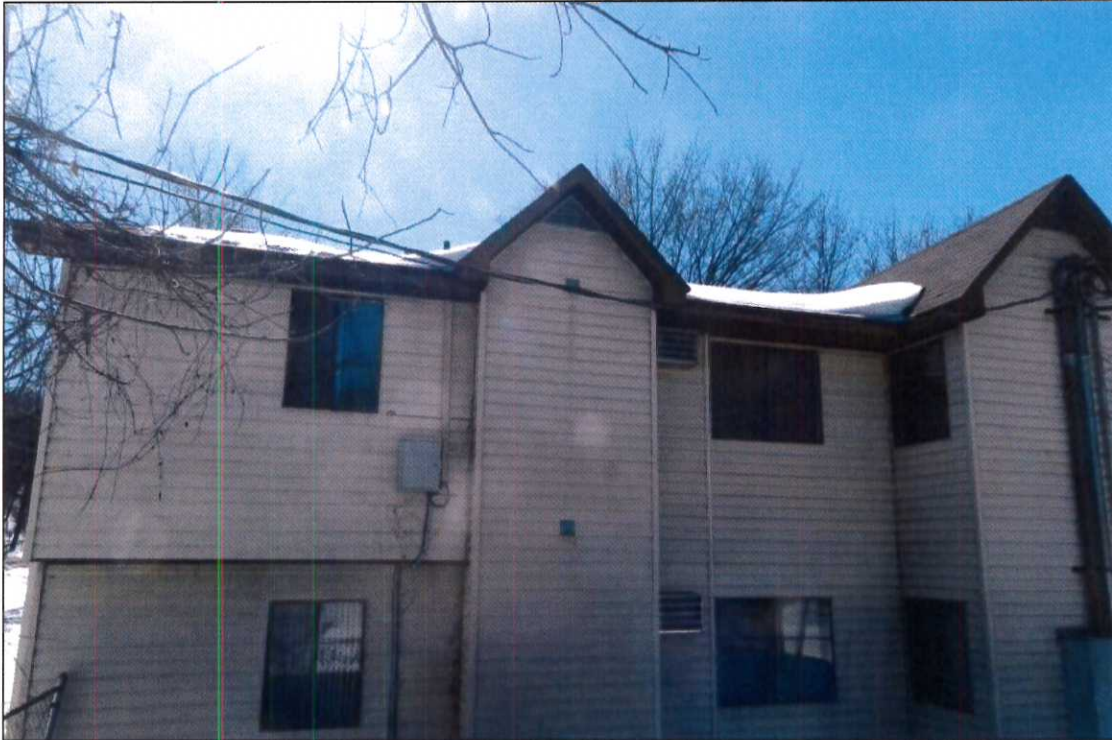
**Photograph # 25:** View of the 3 affected windows

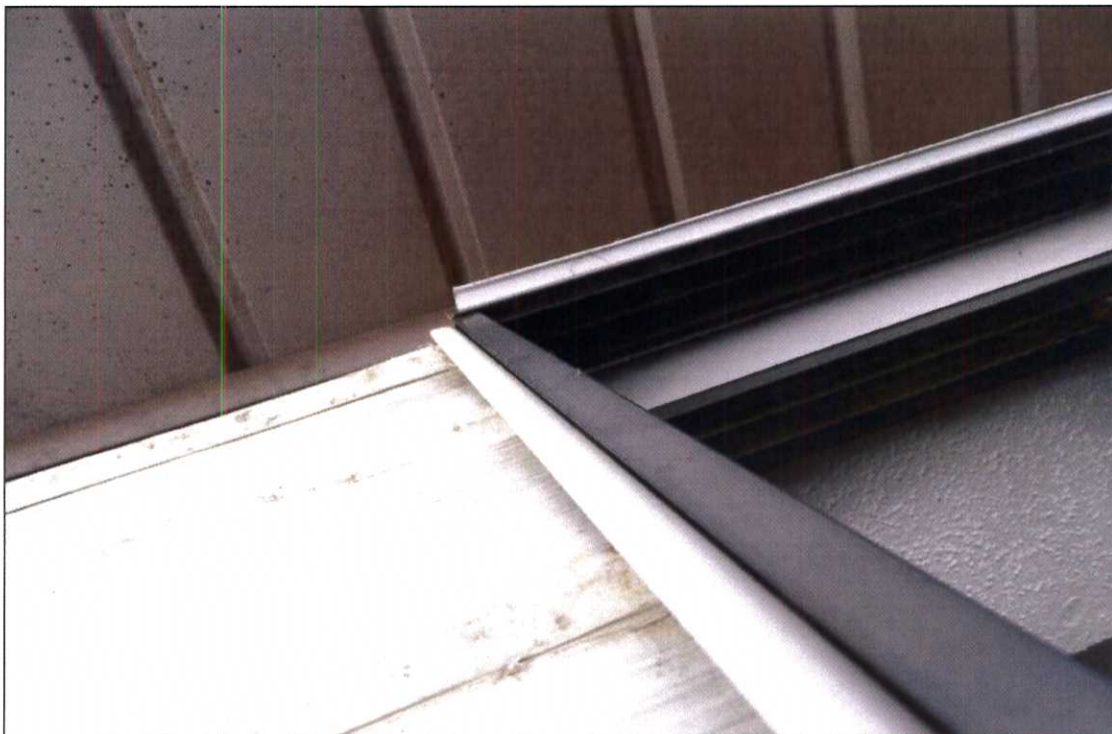
**Photograph # 26:** No sealant between window frame and vinyl siding.
