MEMORANDUM

DATE: Tuesday, November 27, 2012
TO: Amana Construction
ATTN: Mr. Moses Wazwaz
PROJECT: 25 Empire Drive, St. Paul, MN
PROJECT NO.:
WRITTEN BY: Chris Scheevel

Background and Description of Structure

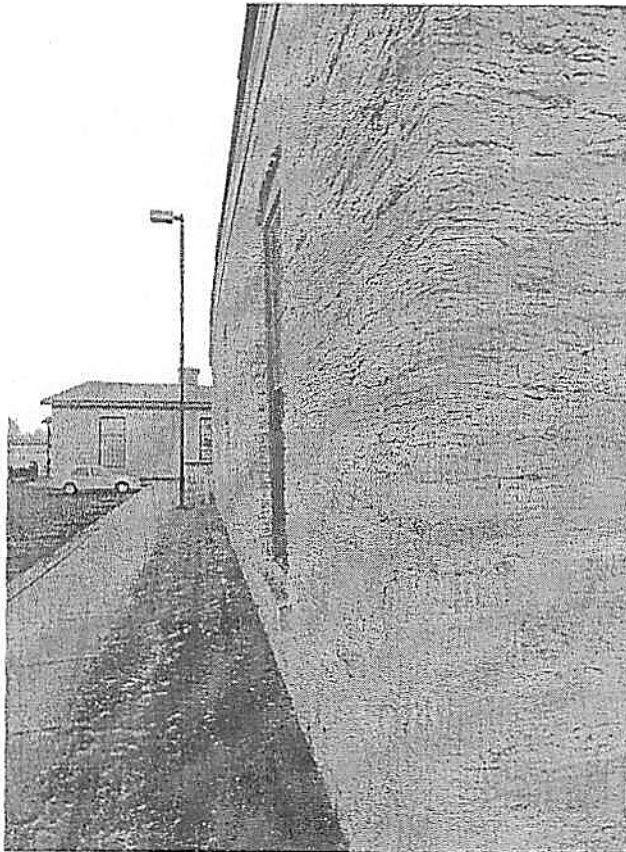
Photo 2: Bowed Exterior Limestone Wall

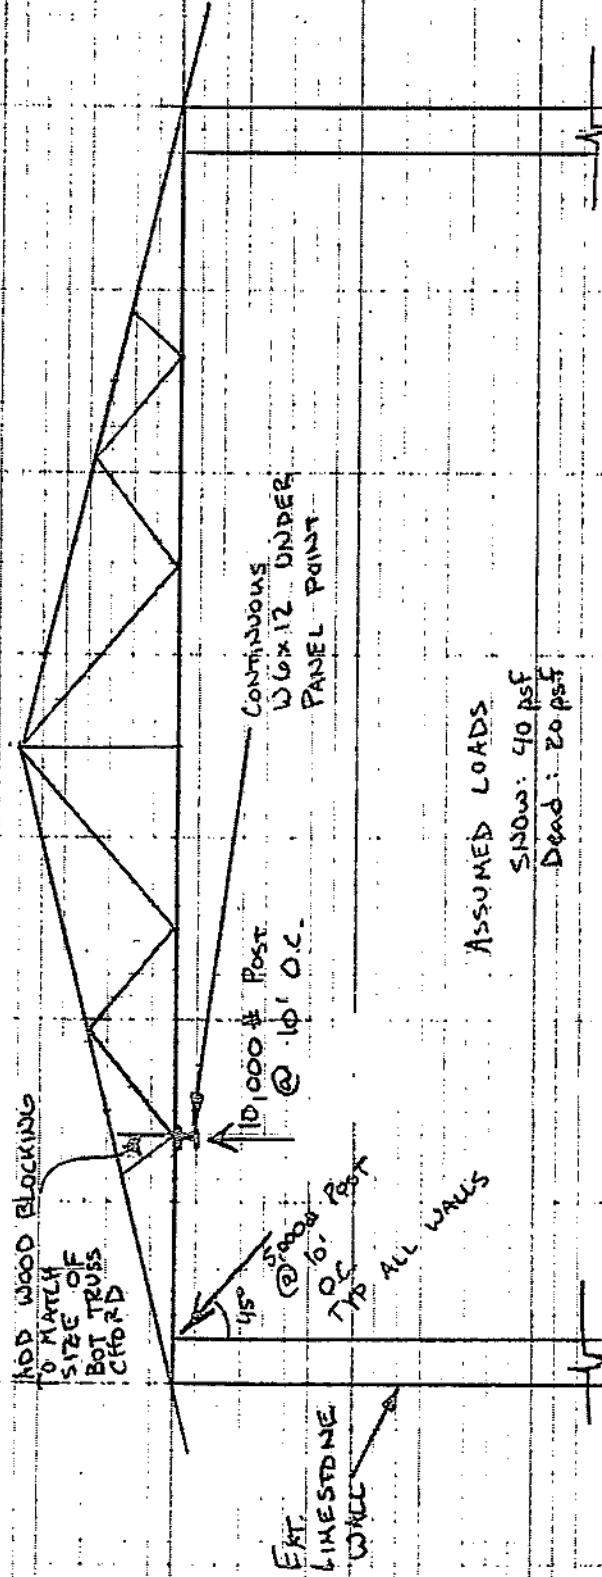
25 EMPIRE DR SHEDDING PLANS

SNOW: 40 psf
Dead: 20 psf
