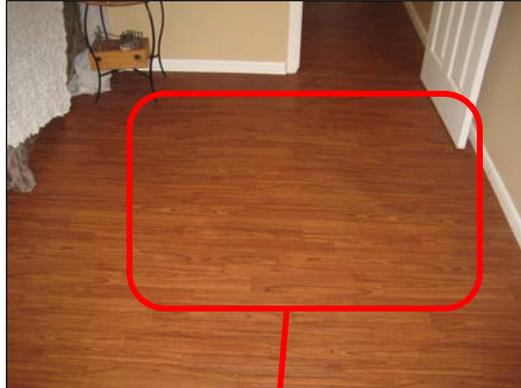
Photo #1:

Loose vinyl floor covering and swollen sub-flooring noted at the floor in the bedroom. Bedroom door no longer closes at this location.

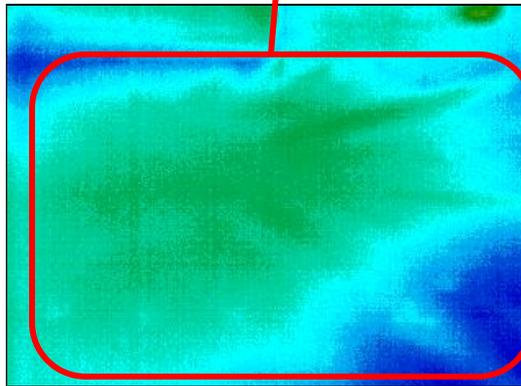
Photo #2:

Thermal anomalies noted at the floor in the bedroom. Sub-flooring has bulged at this location.

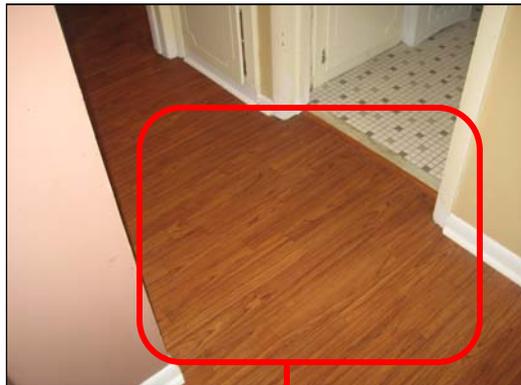
Photo #3:

Loose vinyl floor covering and/or swollen sub-flooring noted at the hallway adjacent to the hallway bathroom.

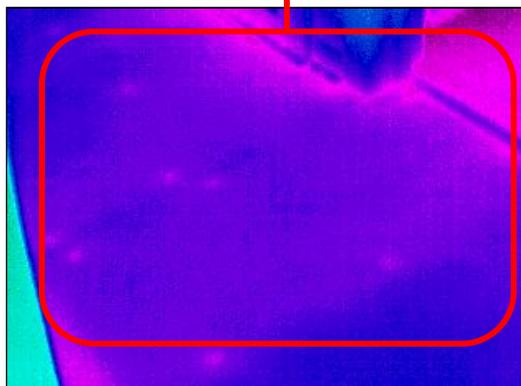
Photo #4:

Thermal anomalies noted at the hallway floor adjacent to the bathroom.

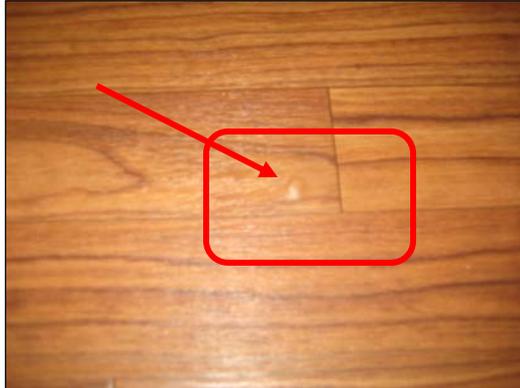
Photo #5:

Protruding fasteners (nail/screw) head noted below the vinyl floor covering.

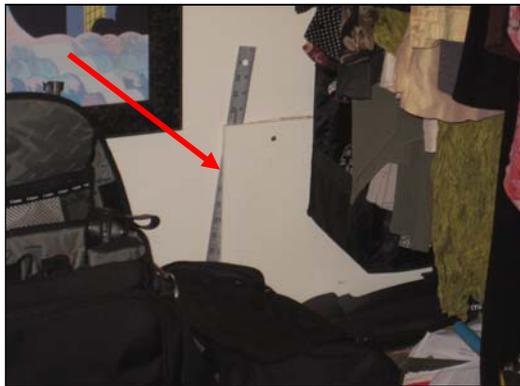
Photo #6:

Potential safety hazard noted at the adjacent units tub/shower access door. This area should be assessed by a fire and safety officer.
