**Date:** January 17, 2019  
**File #:** 16 - 032685  
**Folder Name:** 455 GRAND AVE  
**PIN:** 012823310114

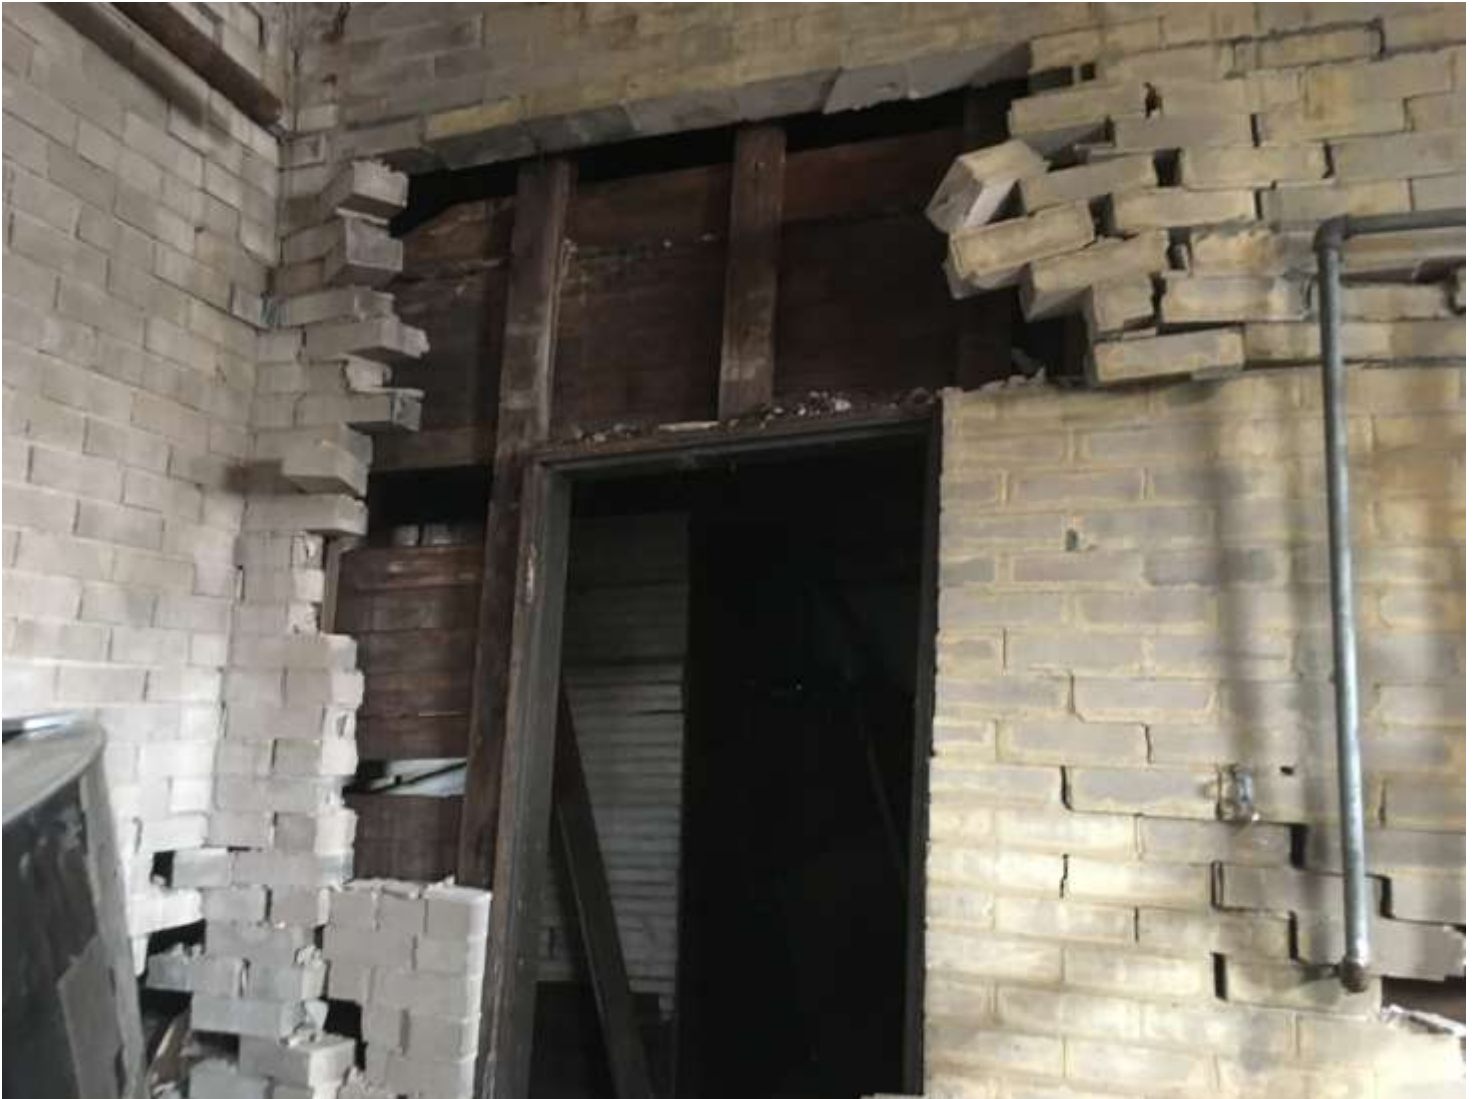
This is the interior, east side wall during  
the second visit.

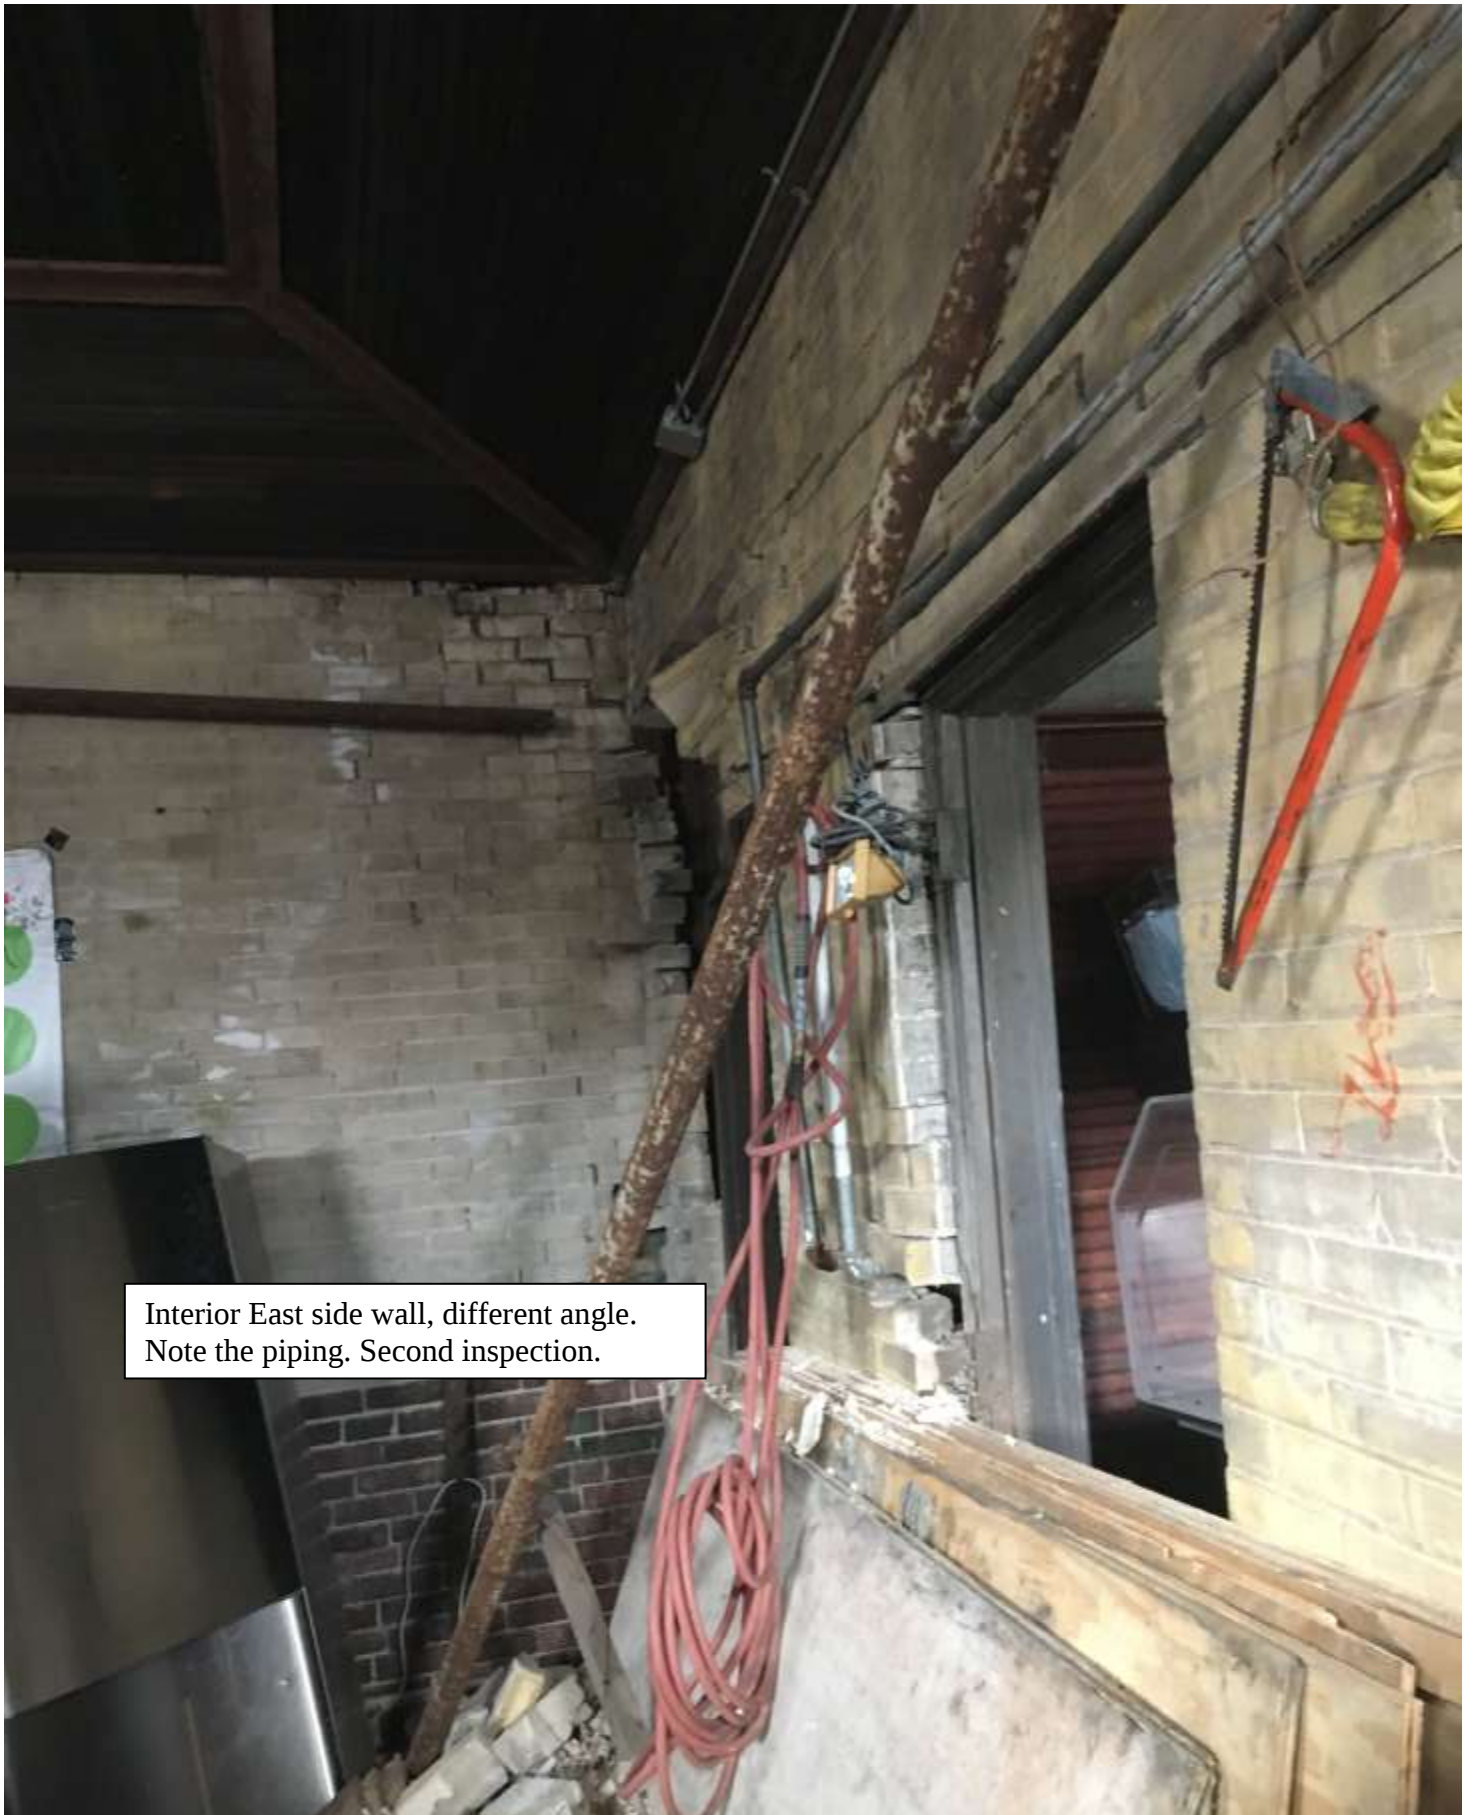
Interior East side wall, different angle.  
Note the piping. Second inspection.

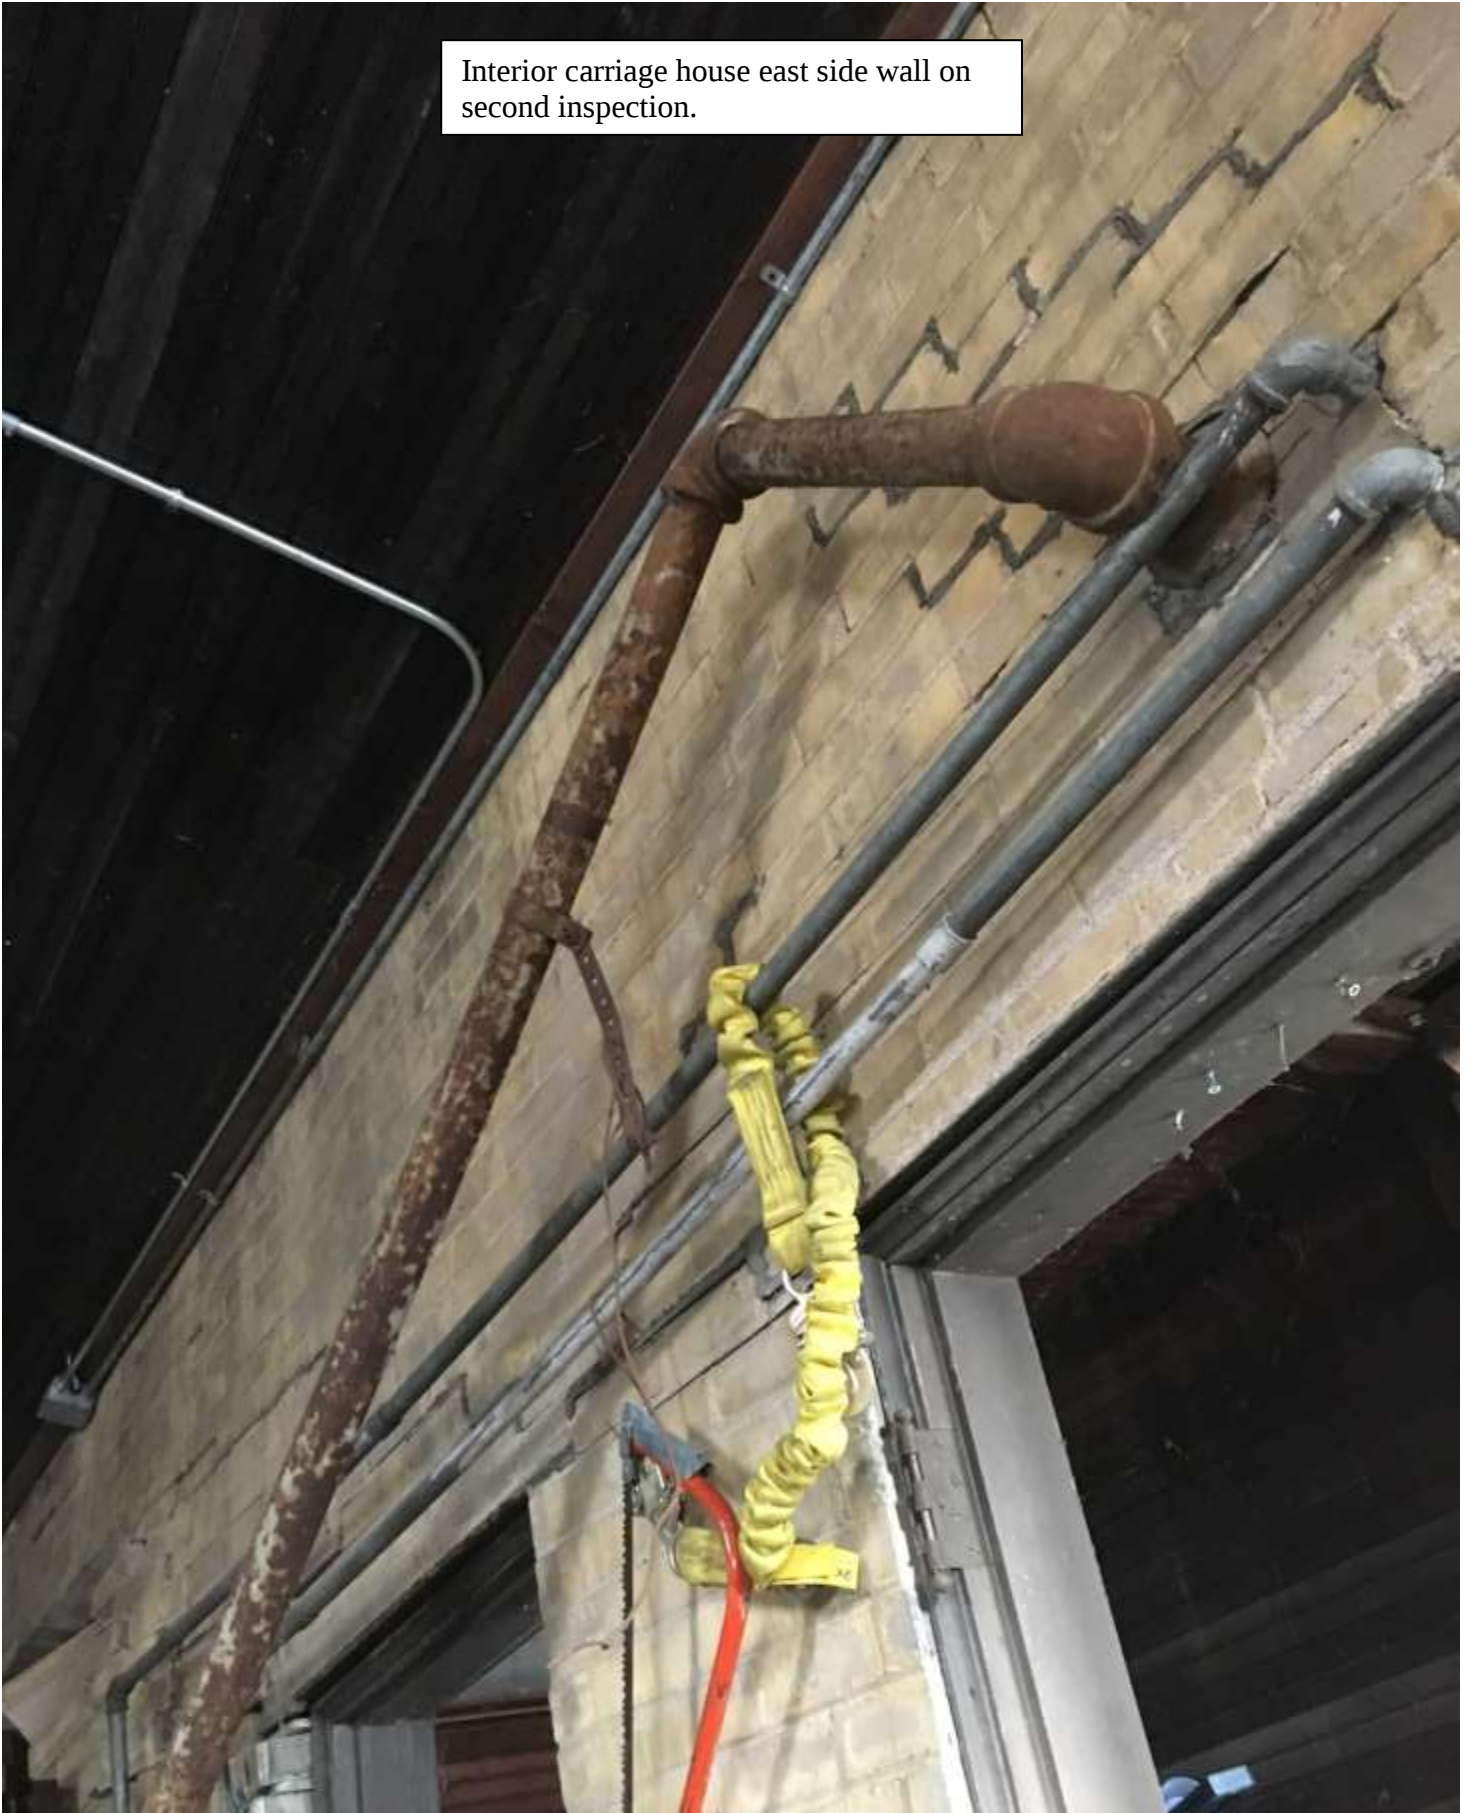
Interior carriage house east side wall on  
second inspection.

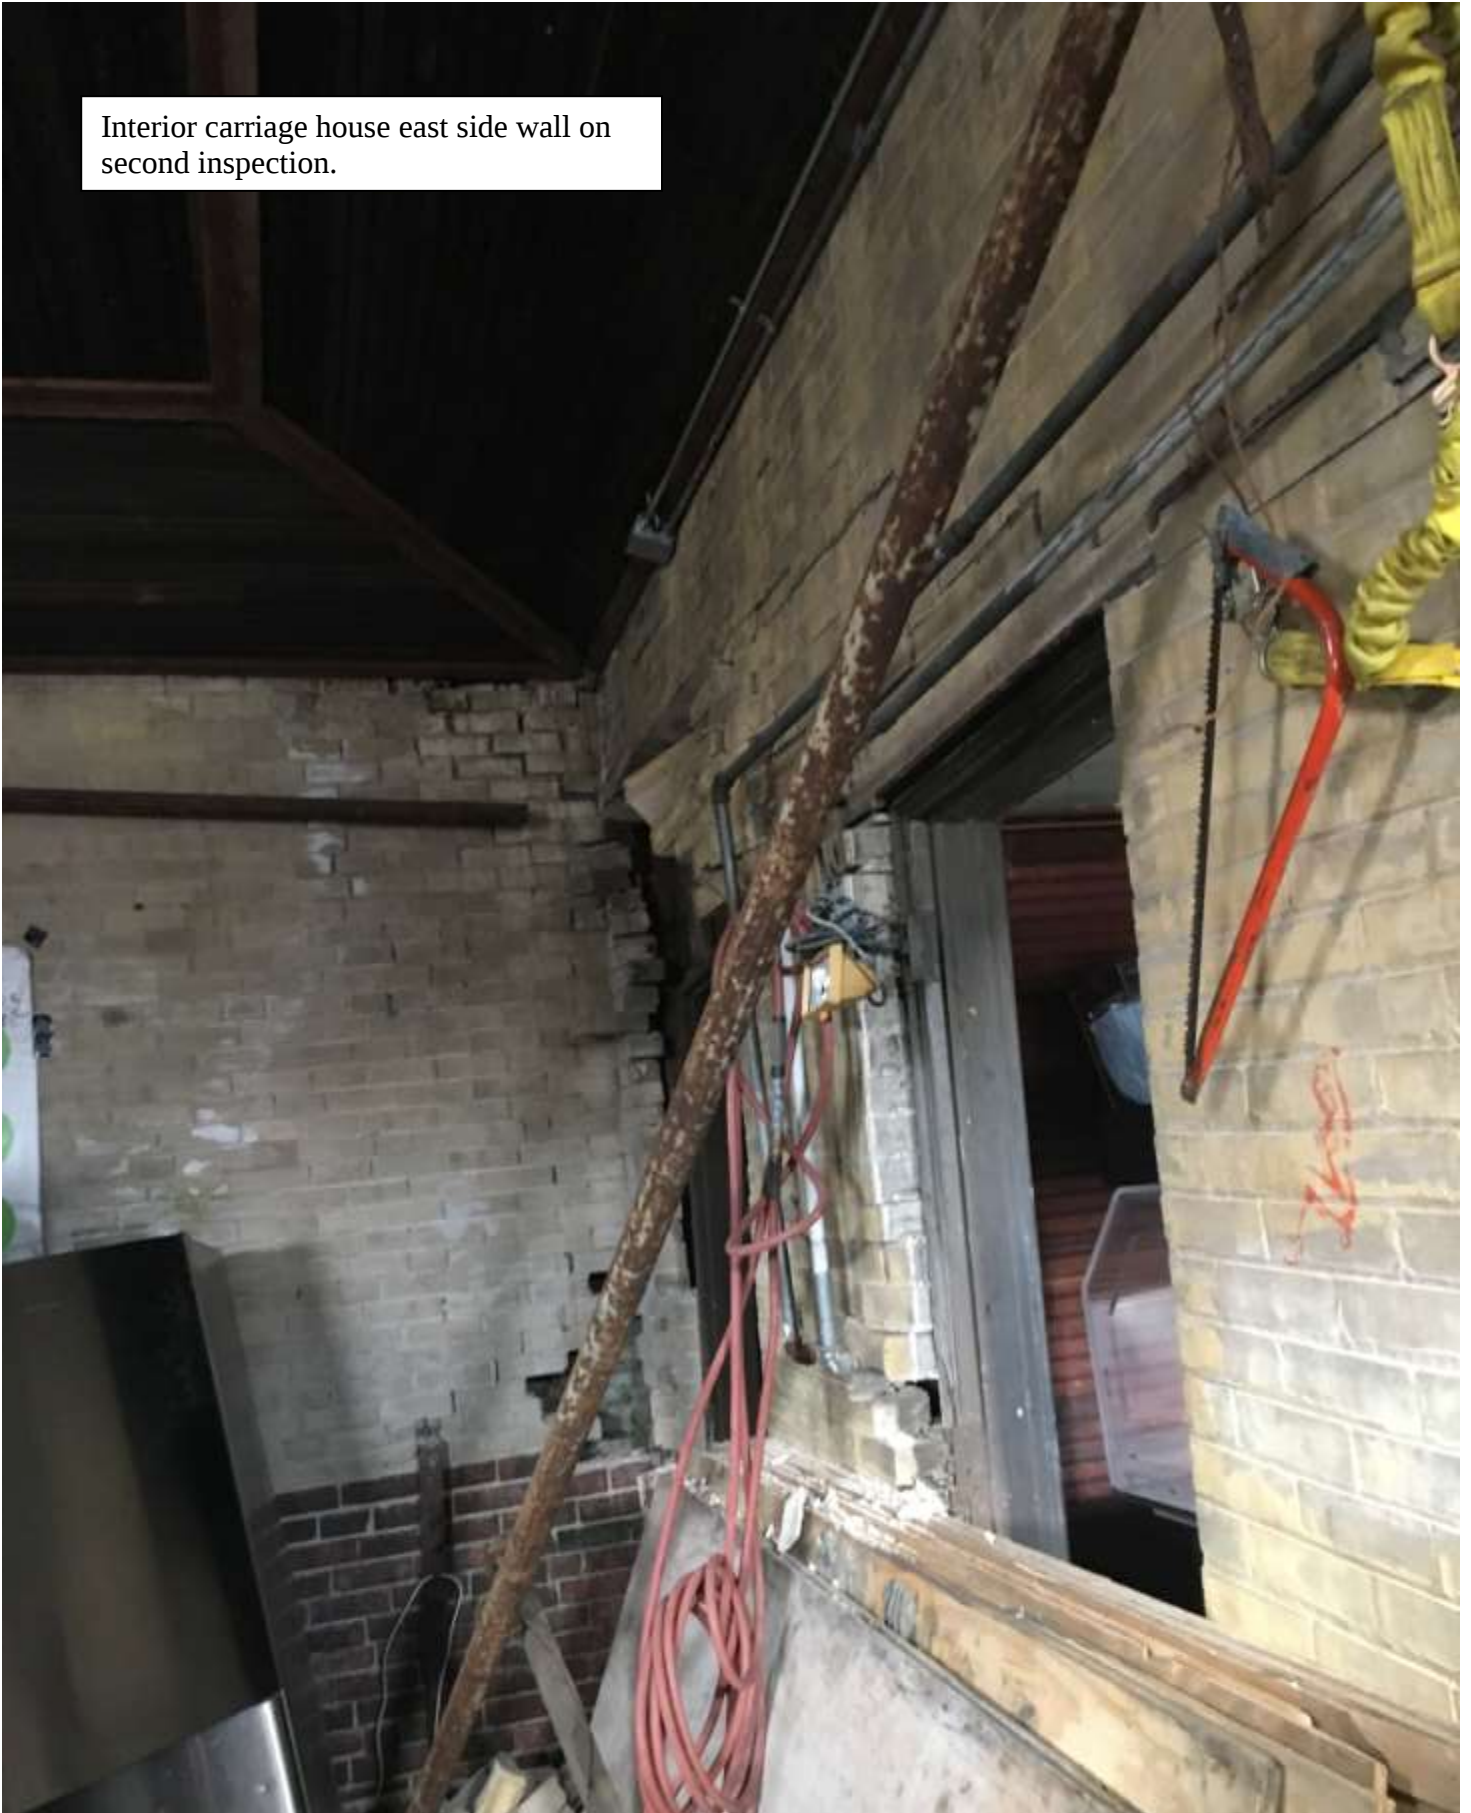
Interior carriage house east side wall on second inspection.

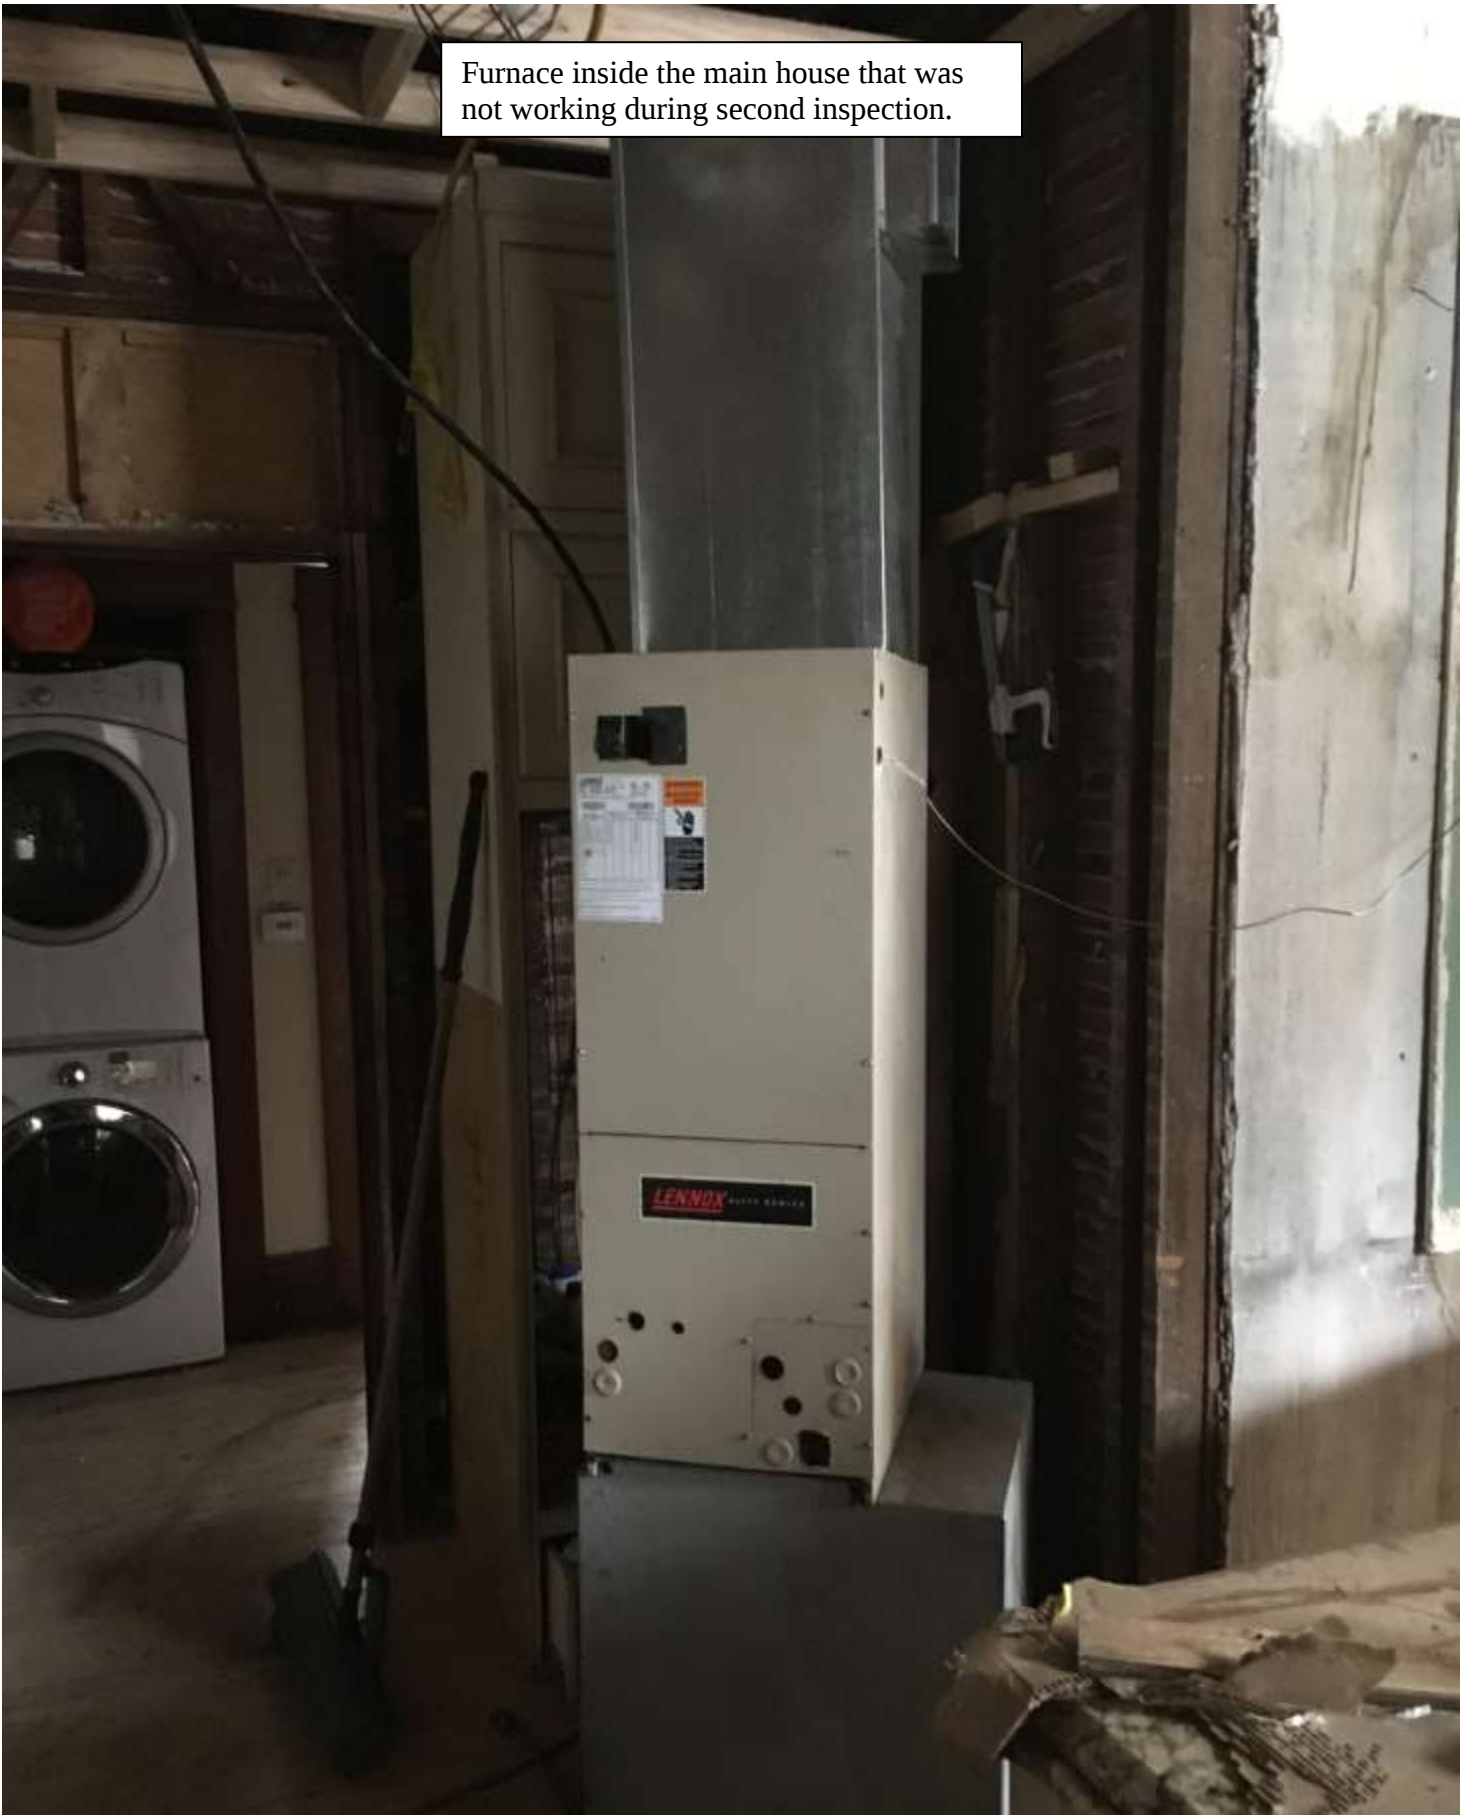
Furnace inside the main house that was not working during second inspection.

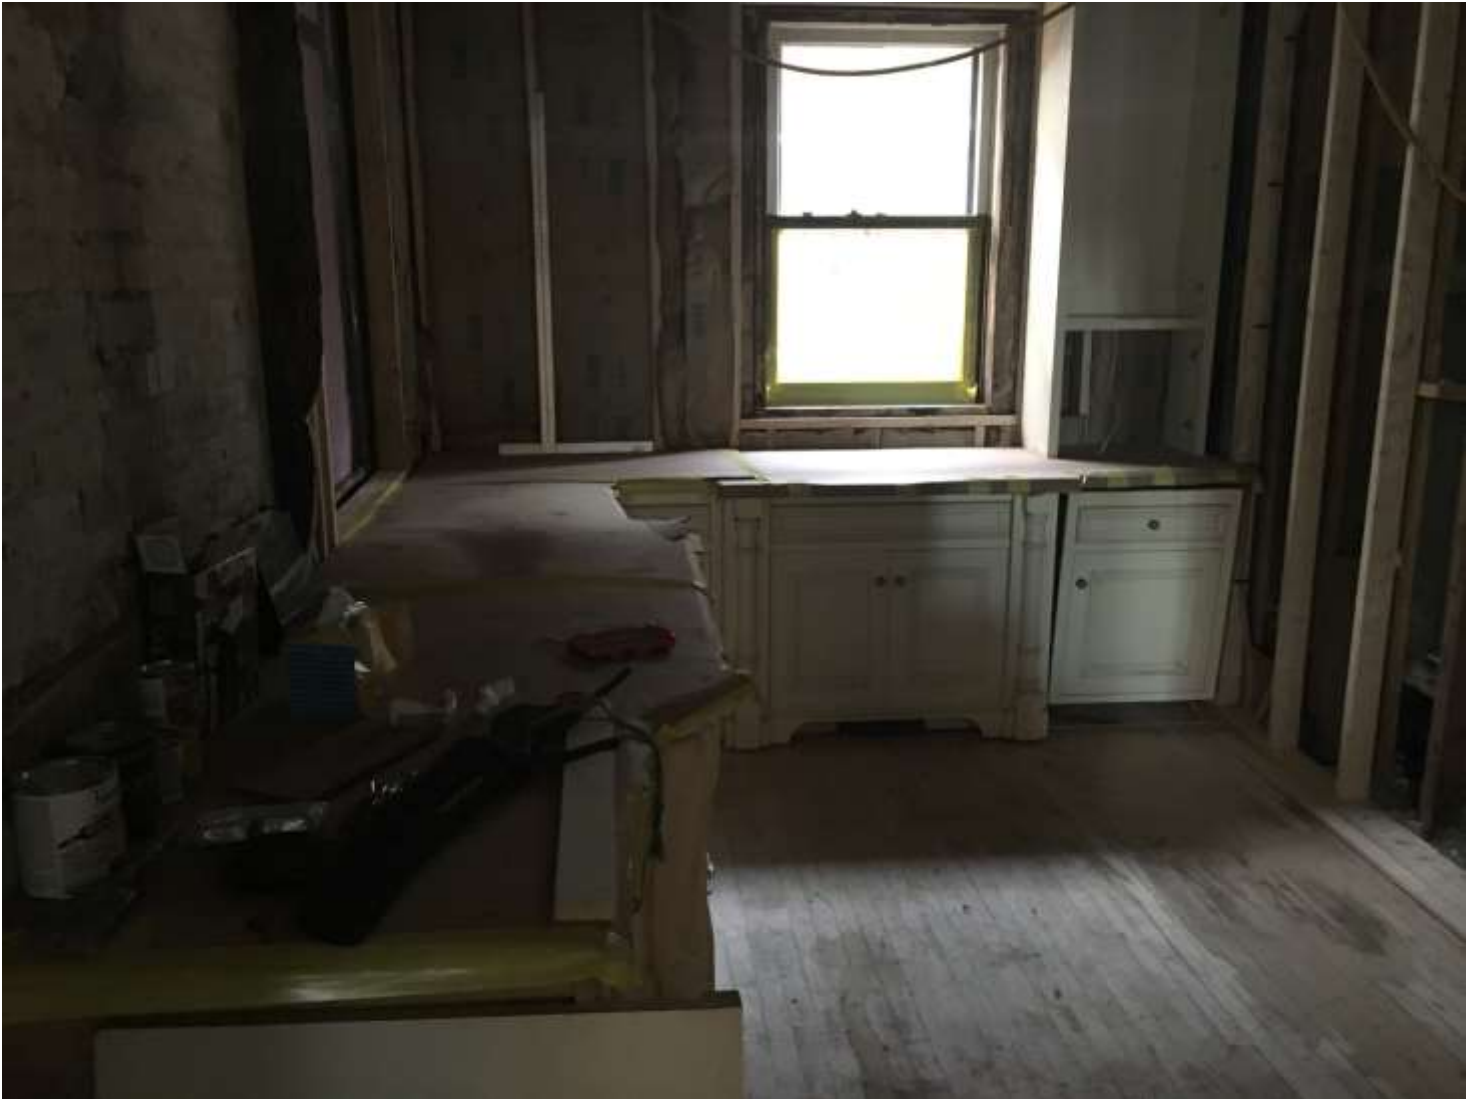
Kitchen remodel in the main house not  
done under permit.

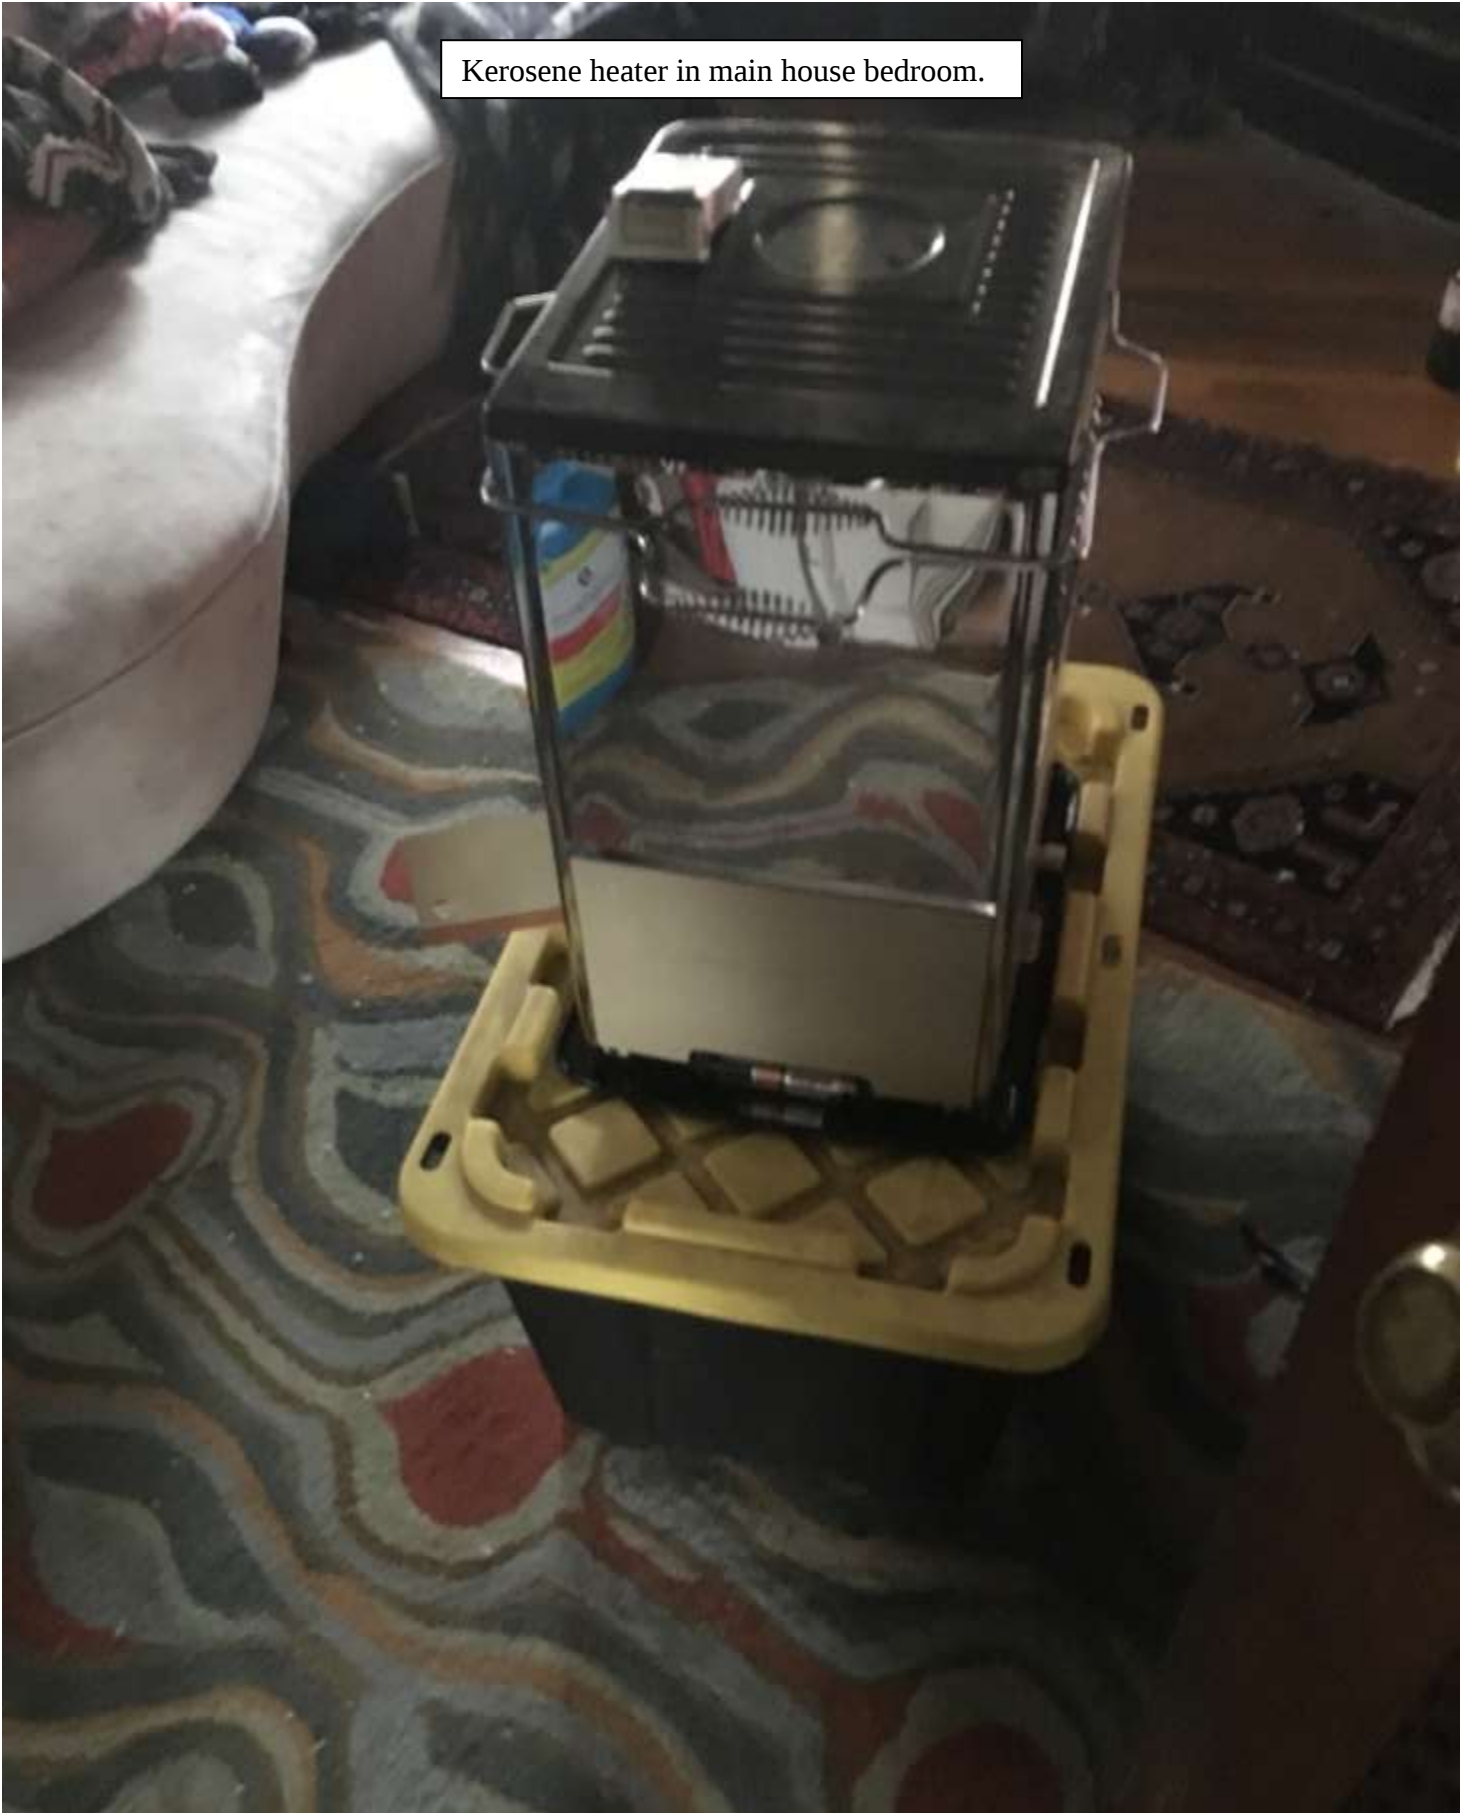
Kerosene heater in main house bedroom.

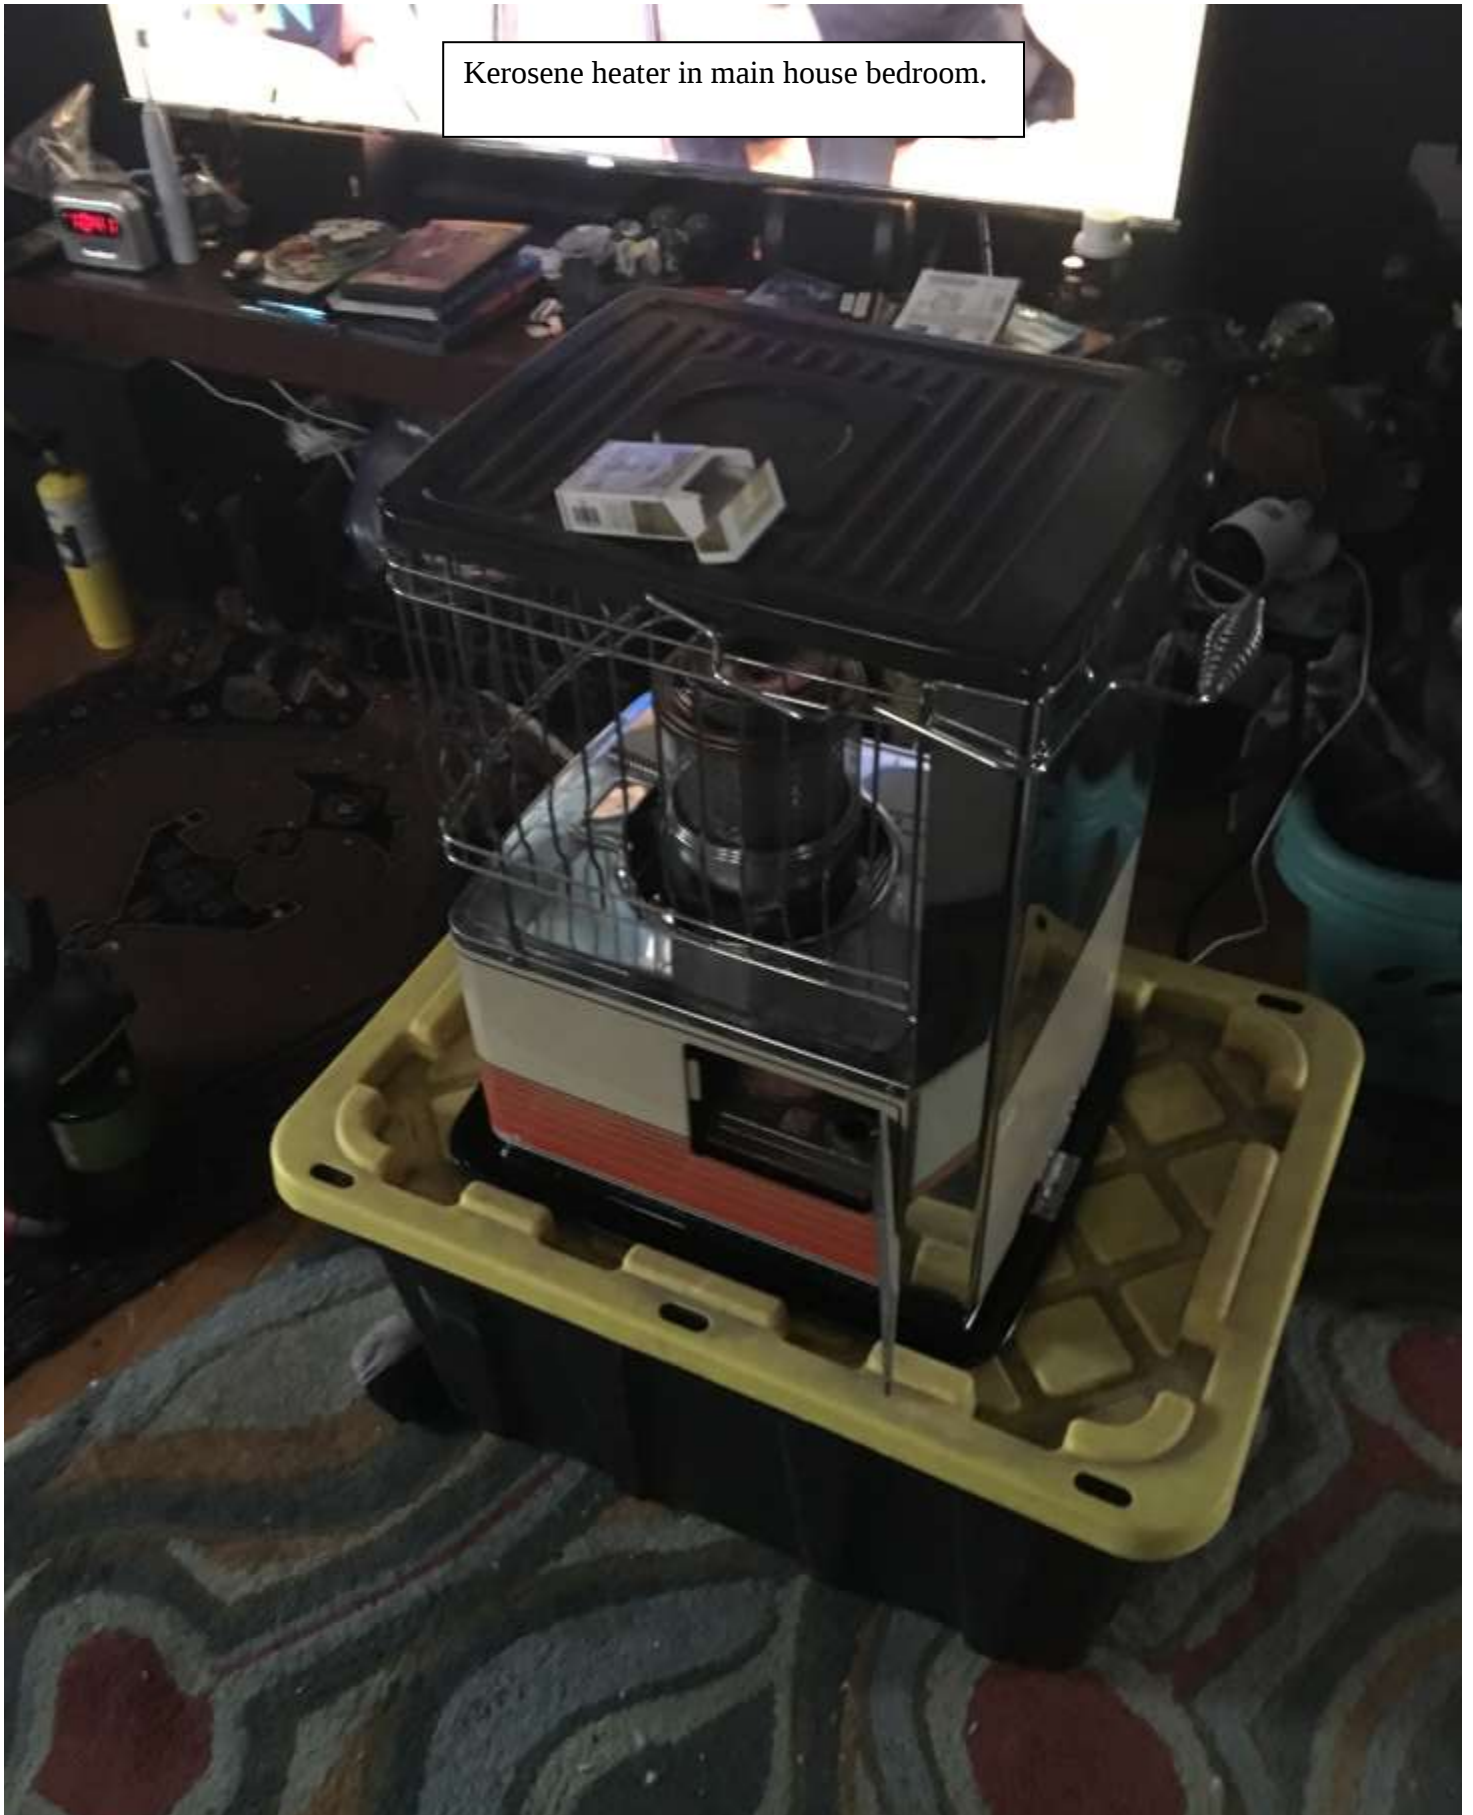
Kerosene heater in main house bedroom.

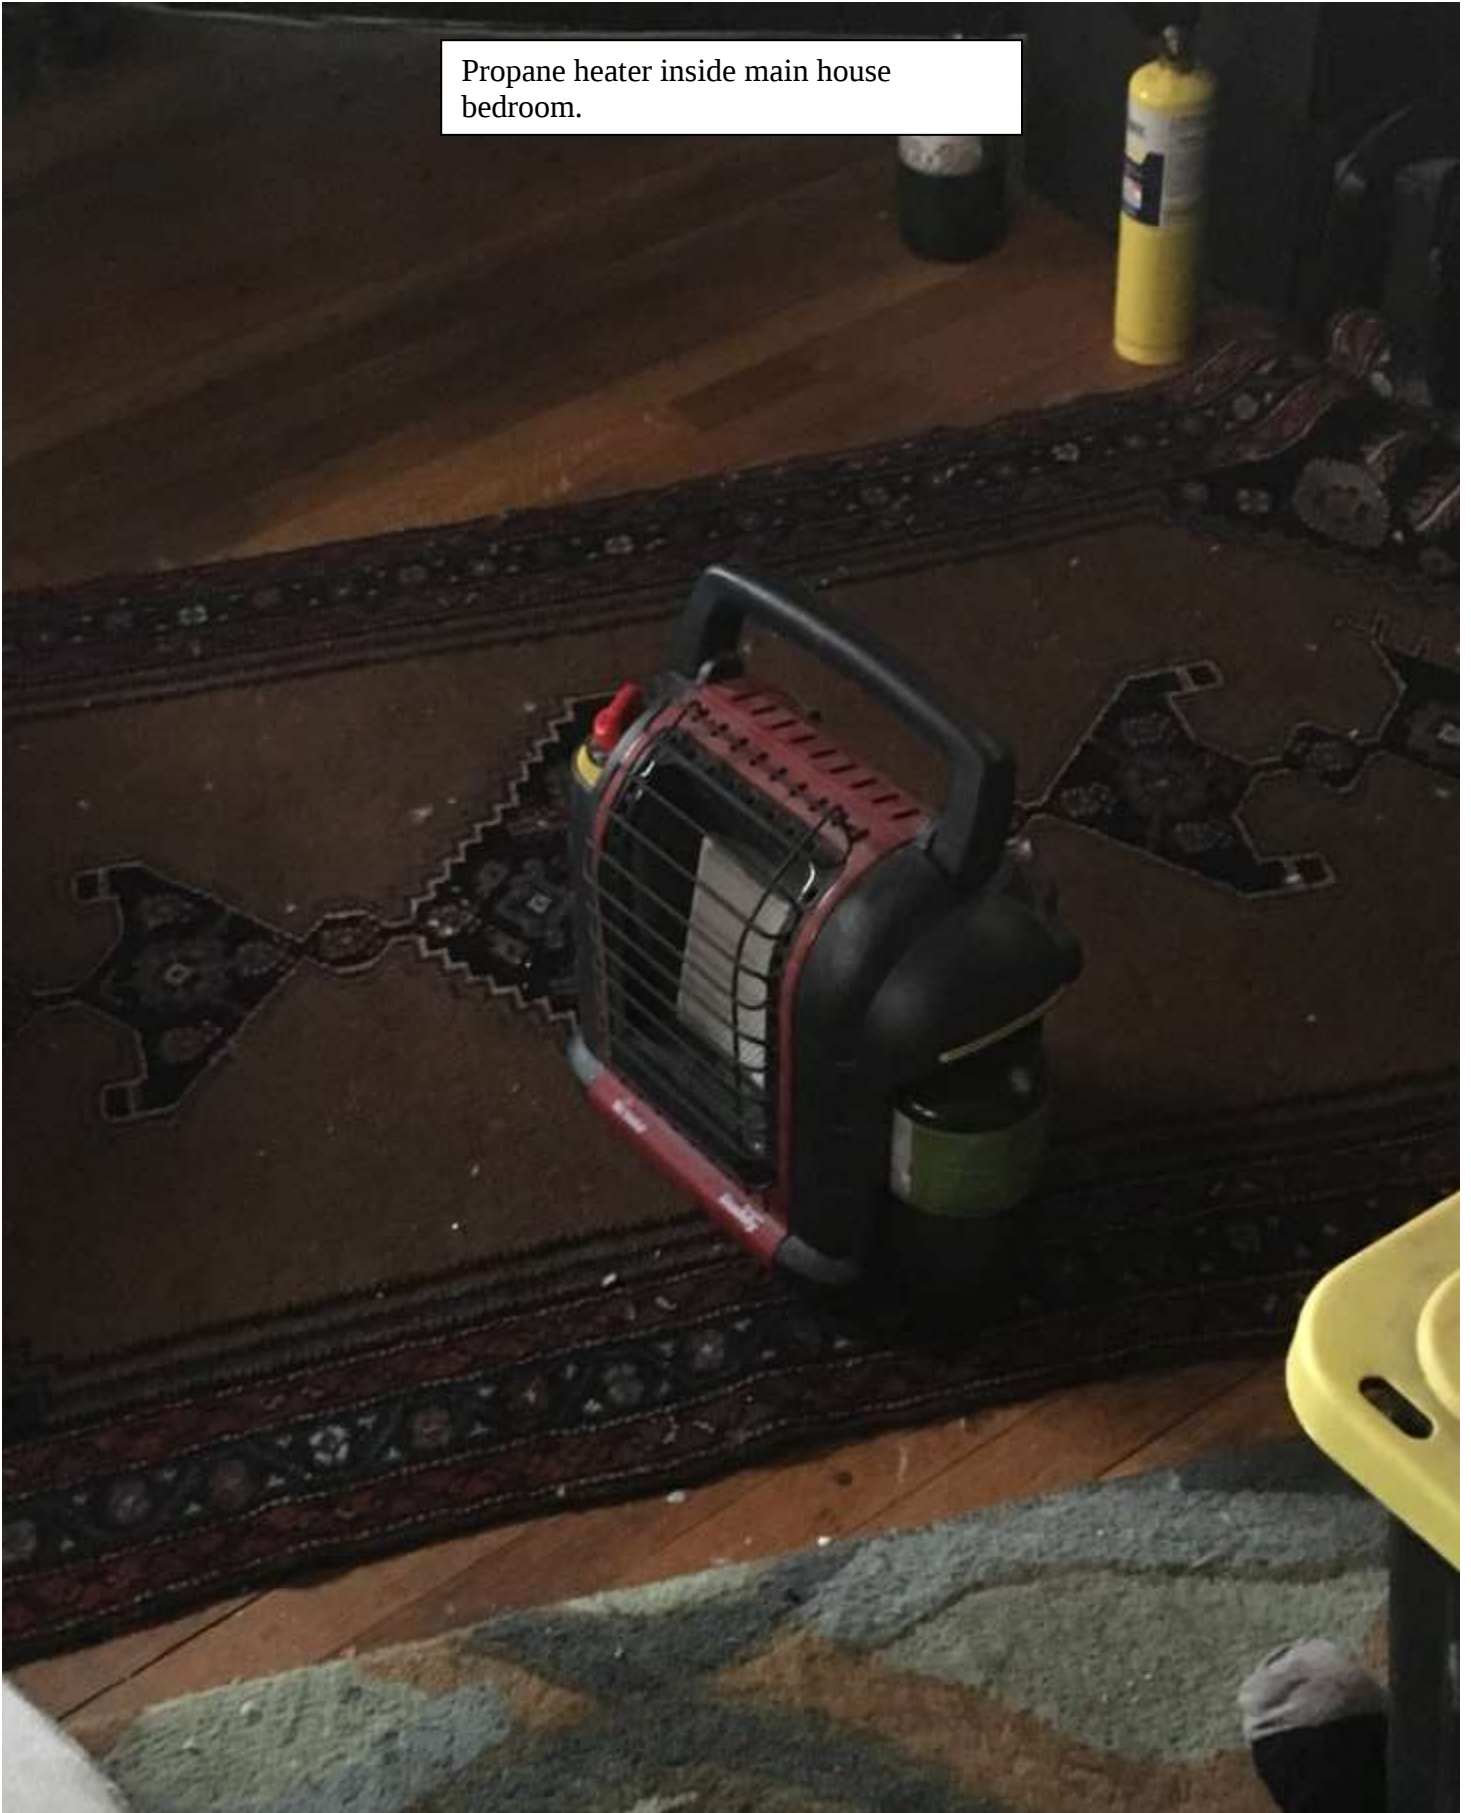
Propane heater inside main house  
bedroom.
