Re: 957 Prosperity Ave, St Paul, MN

On Friday, May 17th, 2019, an engineer from Complete Building Solutions (CBS) inspected your home and discussed the issues that are concerning you. Our assessment and analysis are summarized below.

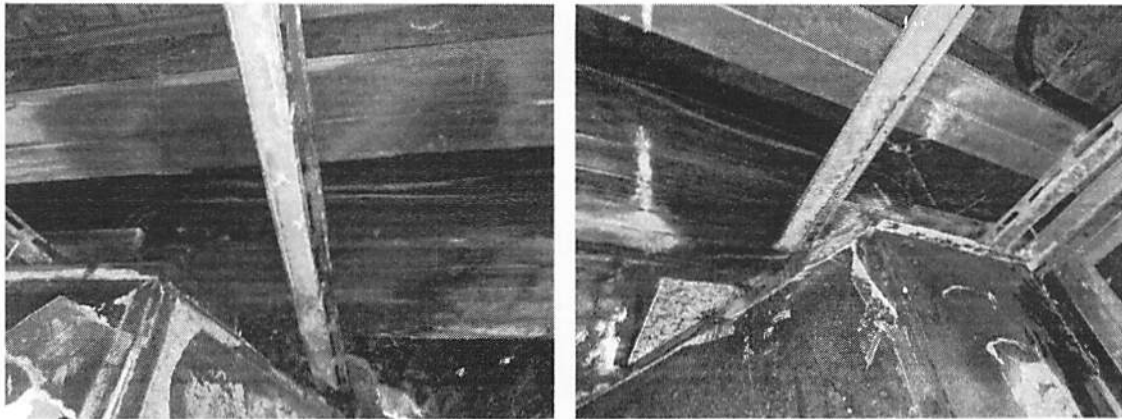
The header at the bay window in the front of the house (Figure 1) is in good condition and does not need to be replaced.

Figure 1: Header - In Good Condition

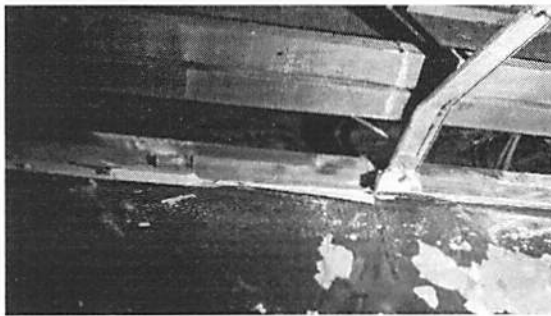
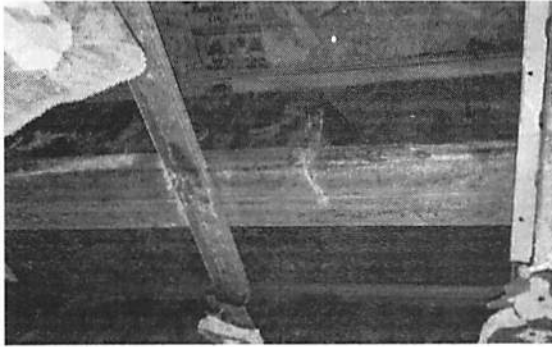
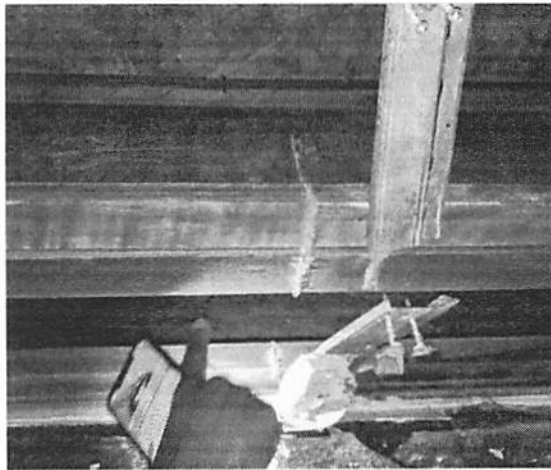
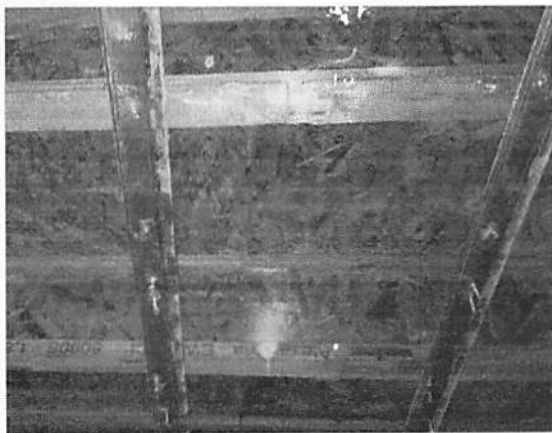
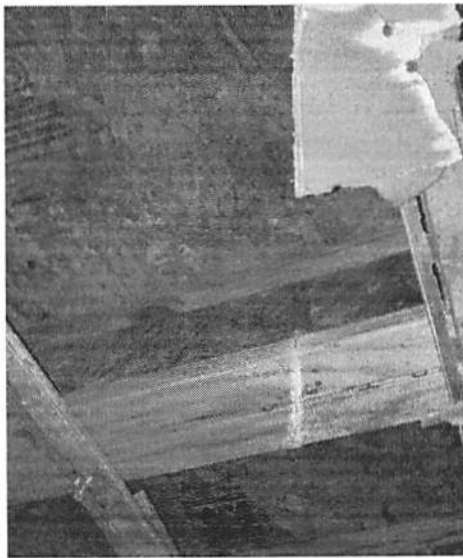
There are multiple existing structural wood I-joist (Figure 2) supporting the 2nd floor that are damaged as a result of the fire and need to be replaced. Any I-Joist that has the bottom chord cut needs to be replaced with a similar member.

Figure 2: Damaged Wood I-Joists - To be Replaced

In my professional opinion: the wood I-joists that have cut bottom chords need to be replaced, and dehumidifiers used to remove the moisture in the home.
