**Larson Engineering, Inc.**  
3524 Labore Road  
White Bear Lake, MN 55110-5126  
651.481.9120 Fax: 651.481.9201  
www.larsonengr.com

November 11, 2019

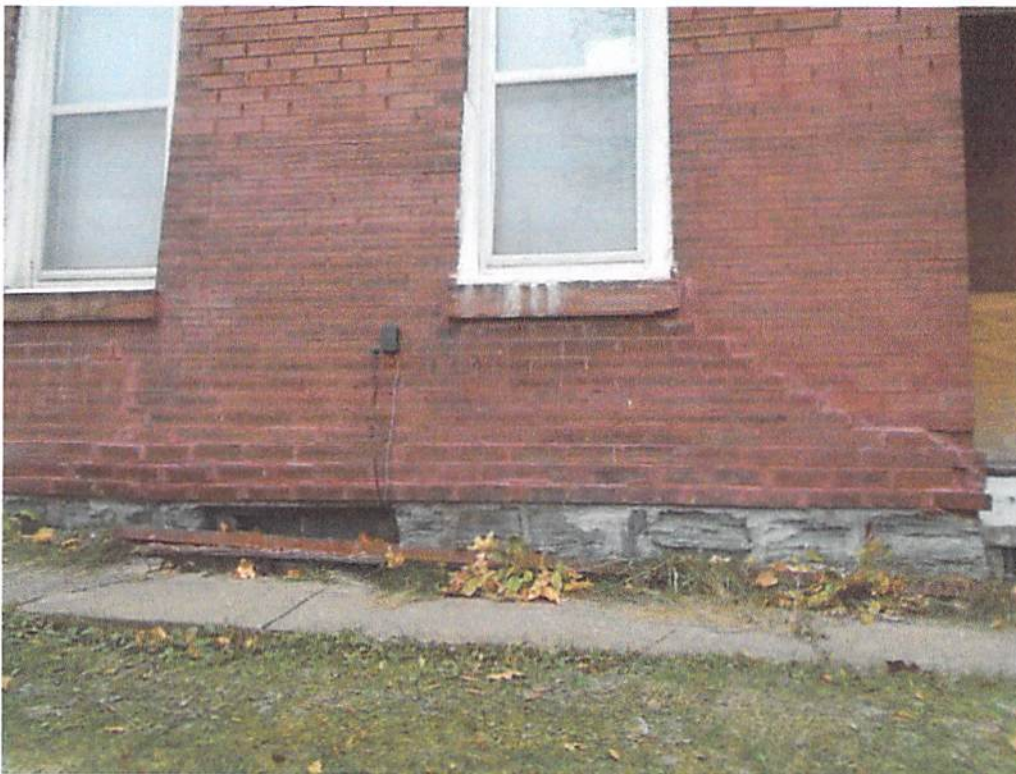
Photo 2: Another photo of the north wall in question, with stair step cracking starting at the sill of from the westernmost window.

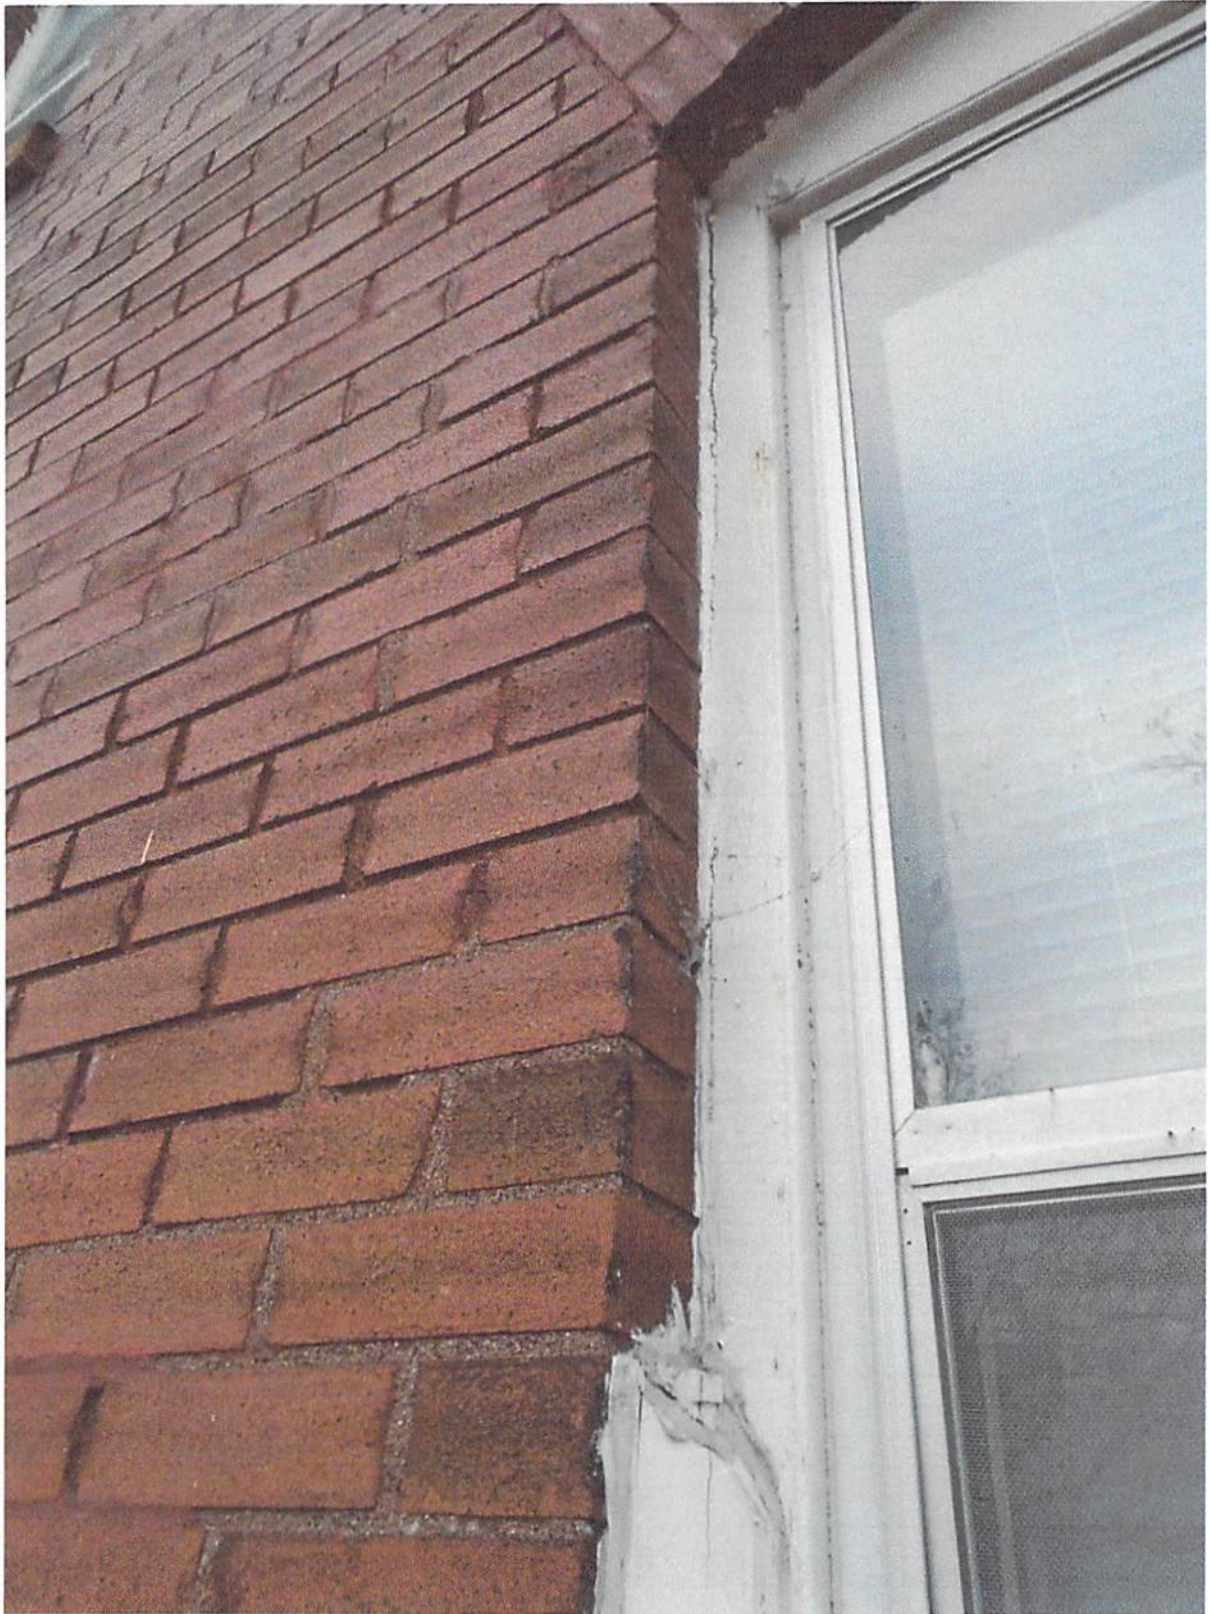
Photo 3: Deteriorated sealant on wood molding around perimeter of window stops show of window head.

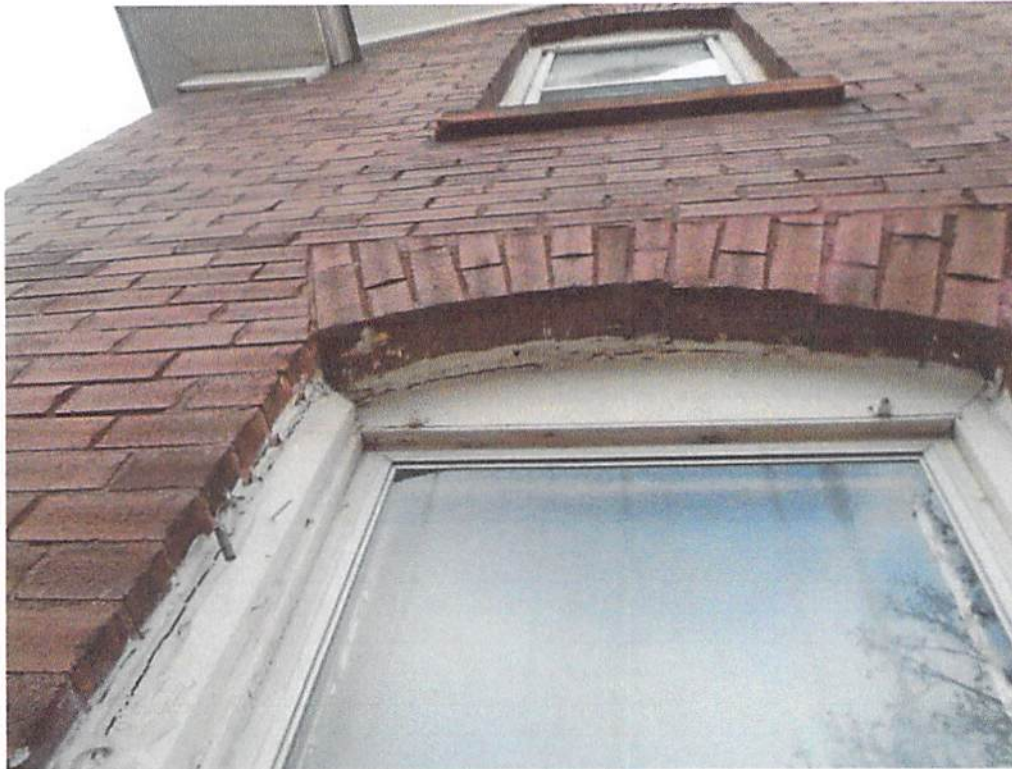
Photo 4: Deteriorated sealant observed around jamb and window head or easternmost window.

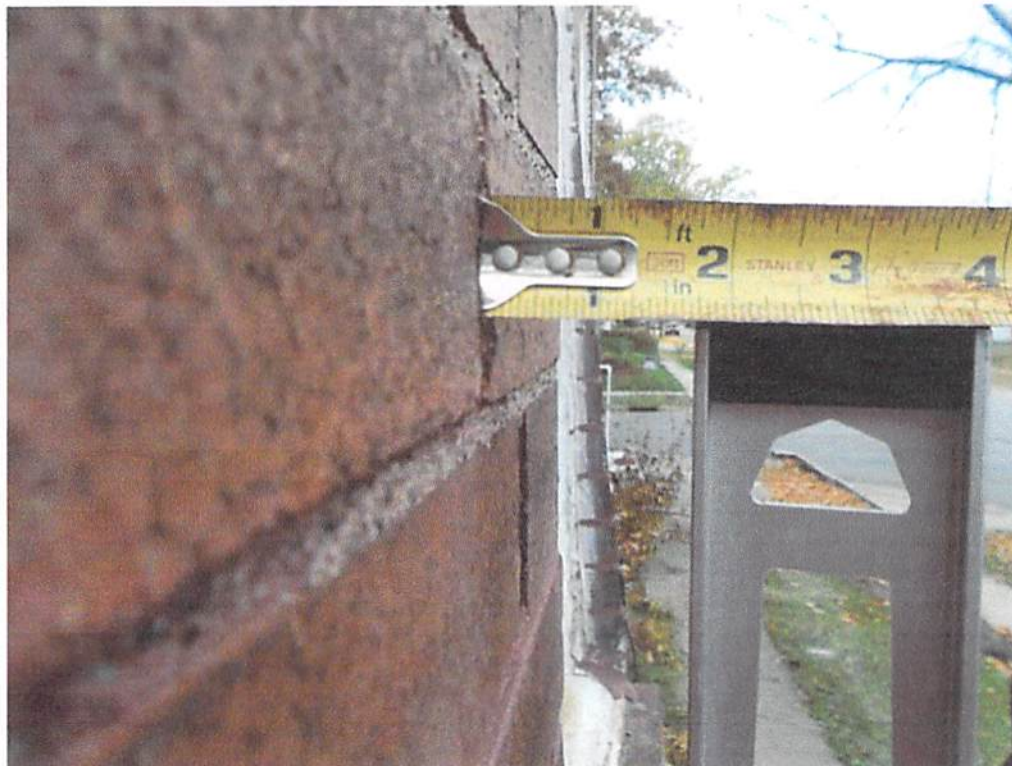
Photo 5: The north wall east of the window opening was approximately 1-3/4" out of plumb in 4ft.

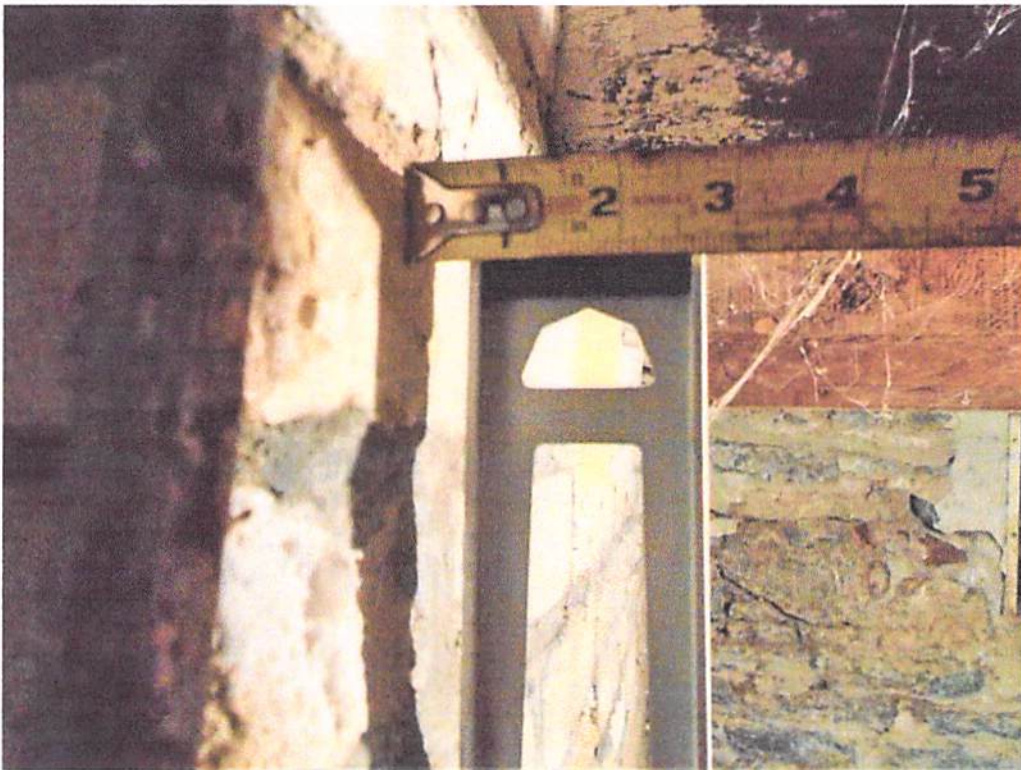
Photo 9: Measurement of the plumbness of the foundation wall east of the basement window on the north side of the residence.

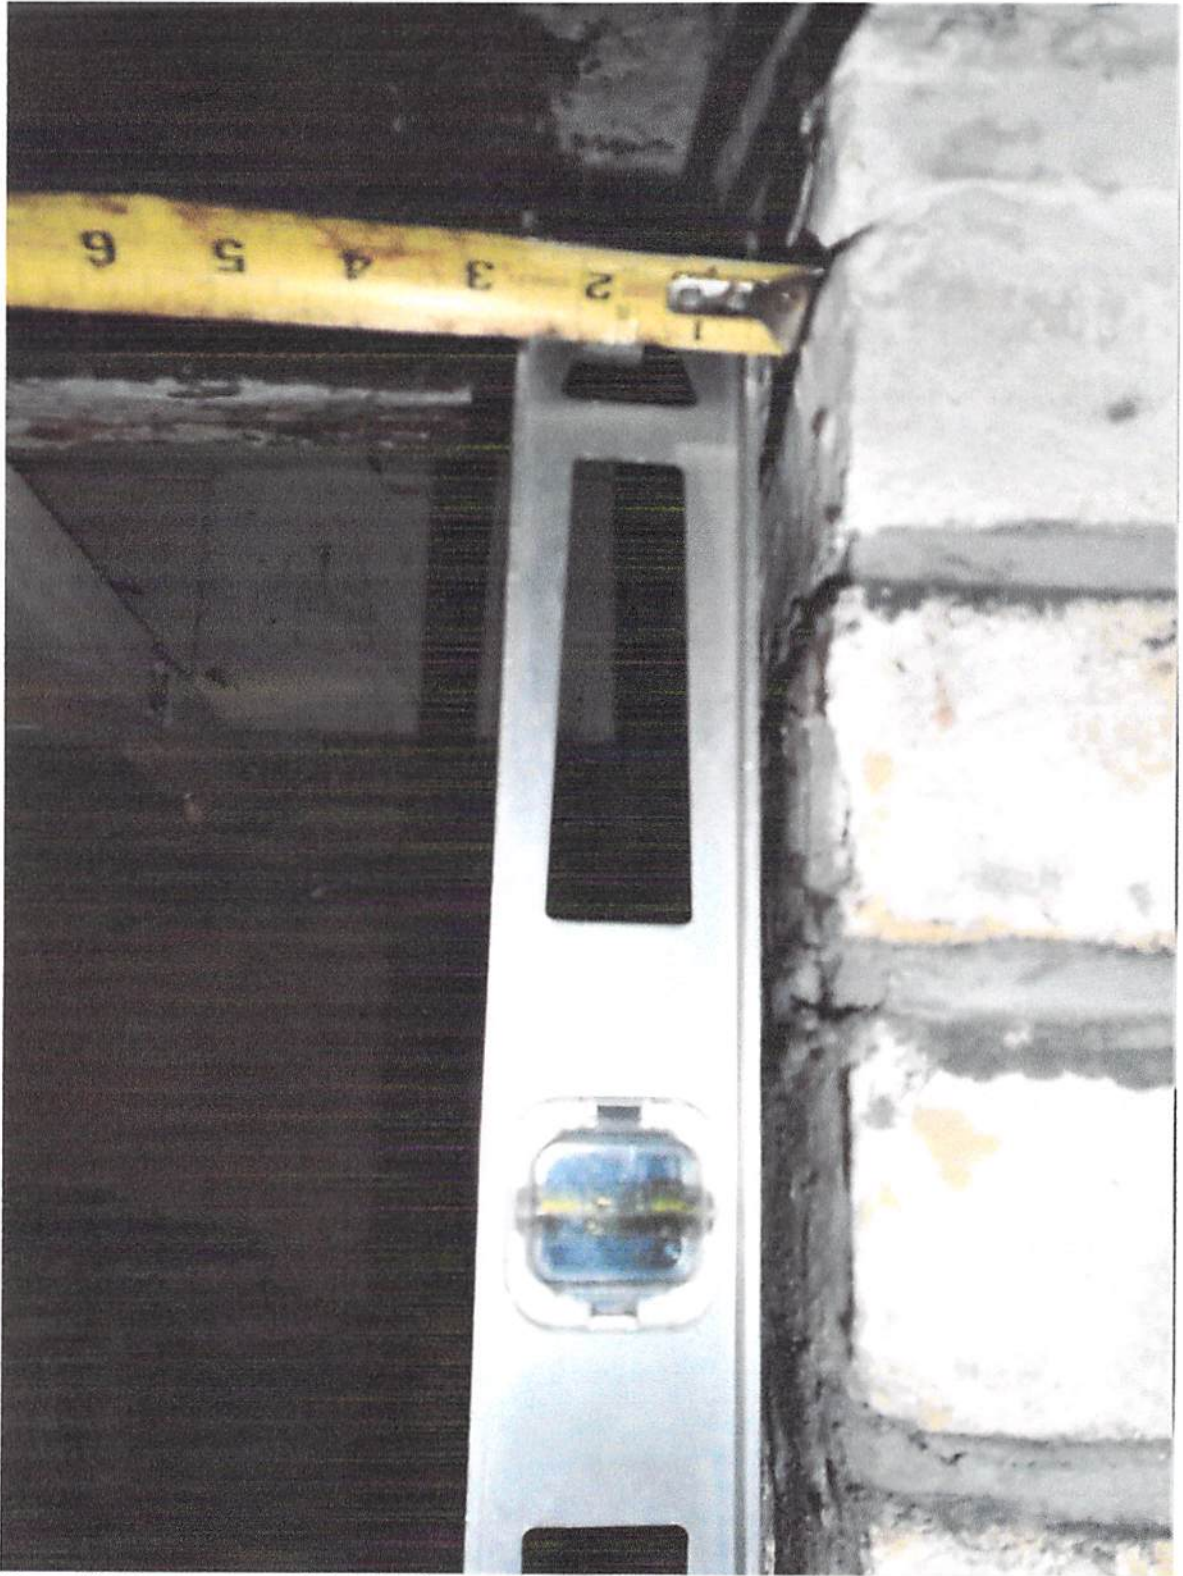
Photo 10: Measurement of the plumbness of the foundation wall west of the basement window on the north side of the residence.

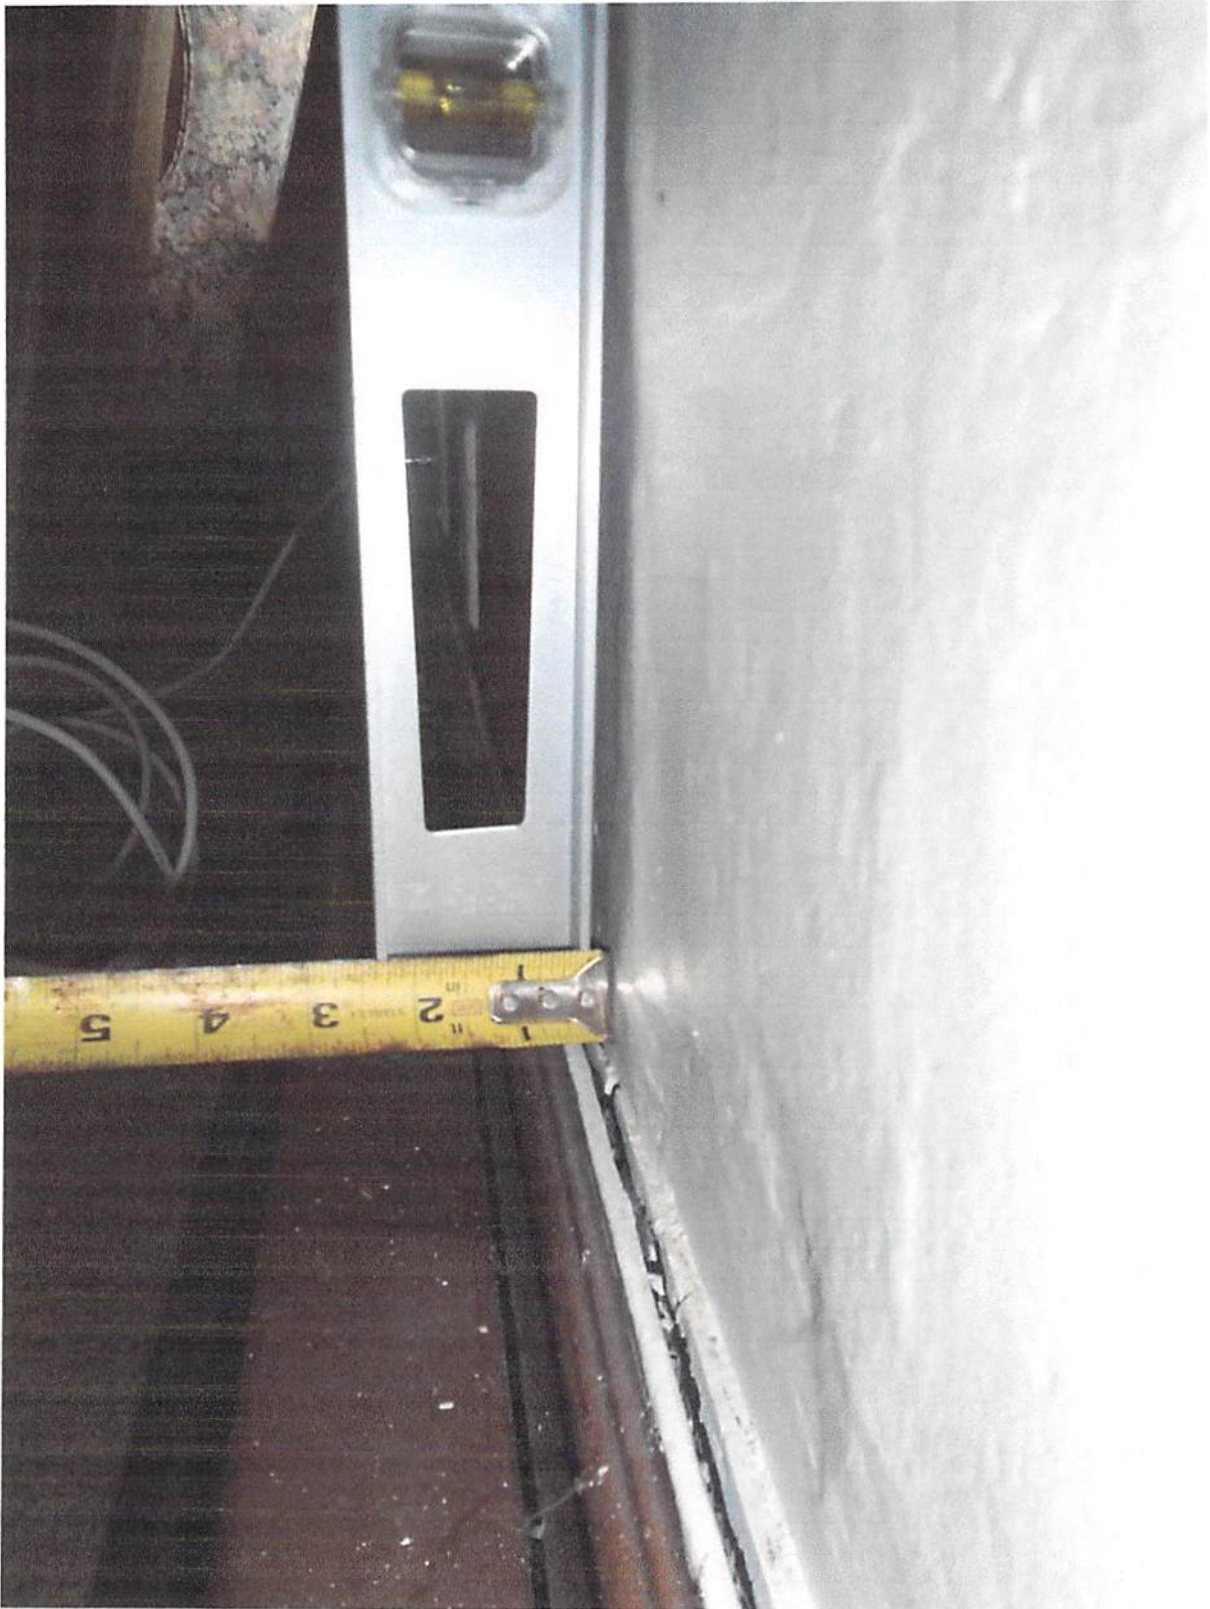
Photo 11: Inside face of interior wall behind the brick façade along the north wall was out of plumb a little less than  $\frac{1}{4}$ " in 4ft.
