Date: September 23, 2014
File #: 14 - 331688
Folder Name: 295 SUMMIT AVE UNIT 3
PIN: 012823130294

HP District: HPL-Hill
Property Name:
Survey Info:

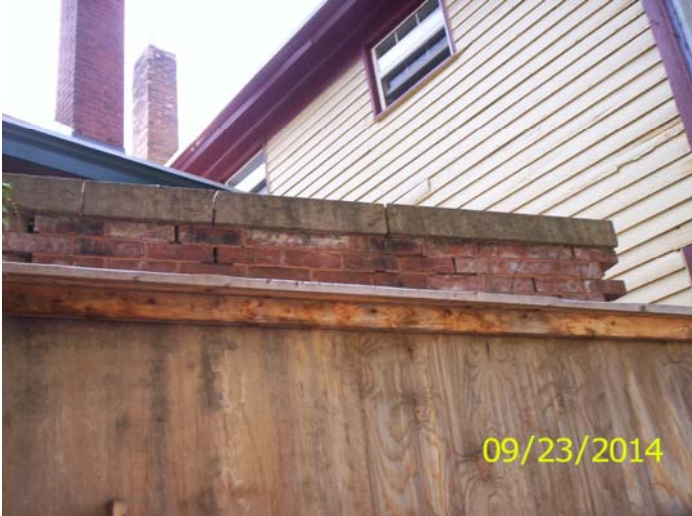
Deteriorated mortar joints

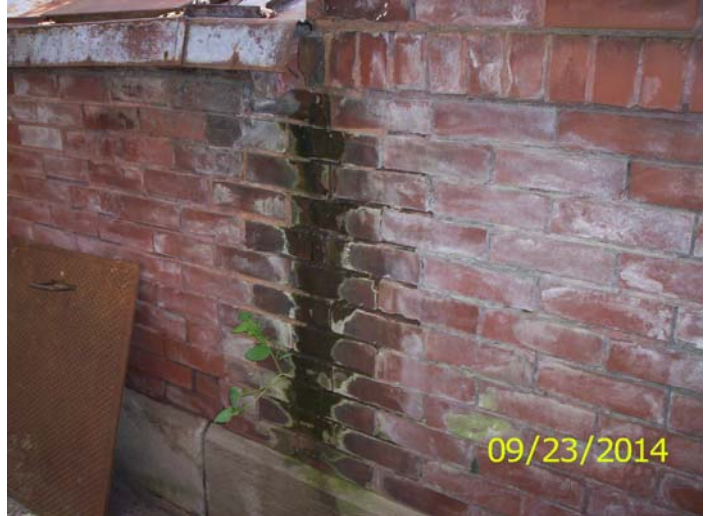
Water damage to masonry

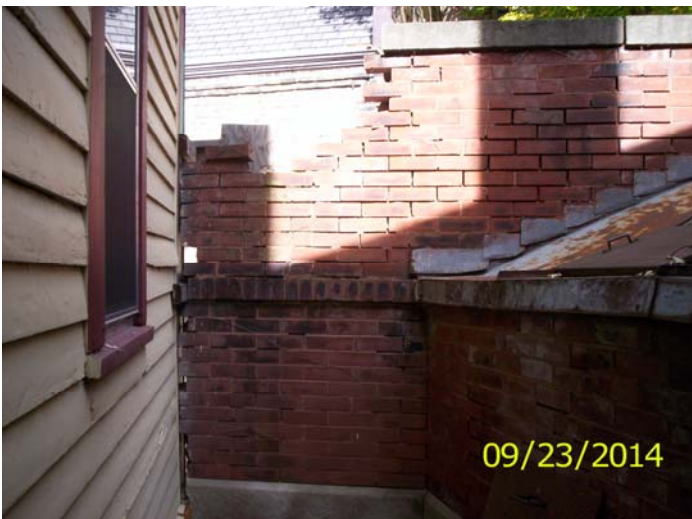
Deteriorated mortar joints

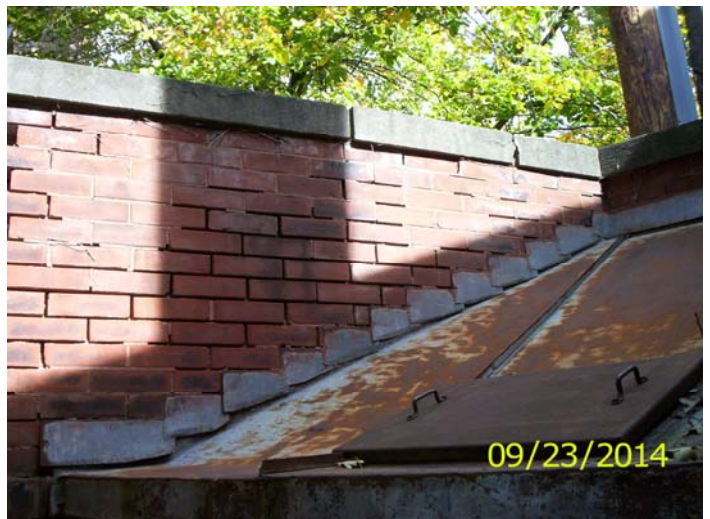
Deteriorated mortar joints

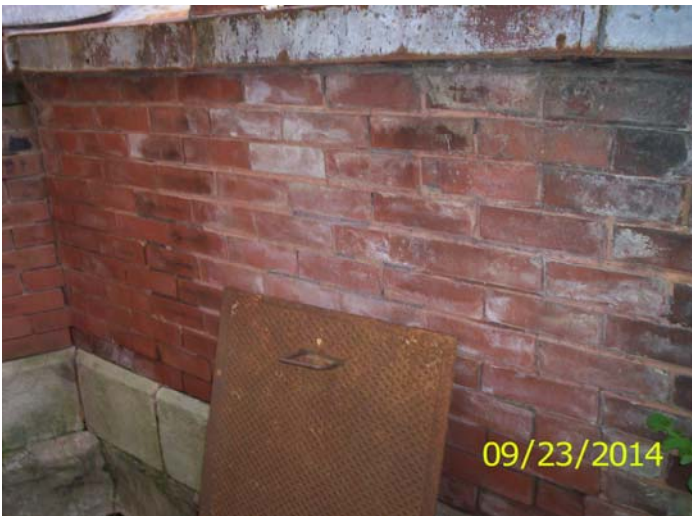
Deteriorated mortar joints

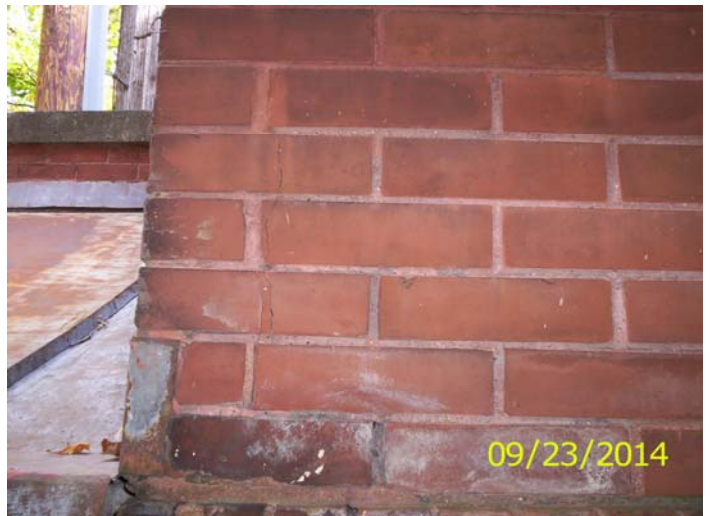
Vertical cracking through brick face

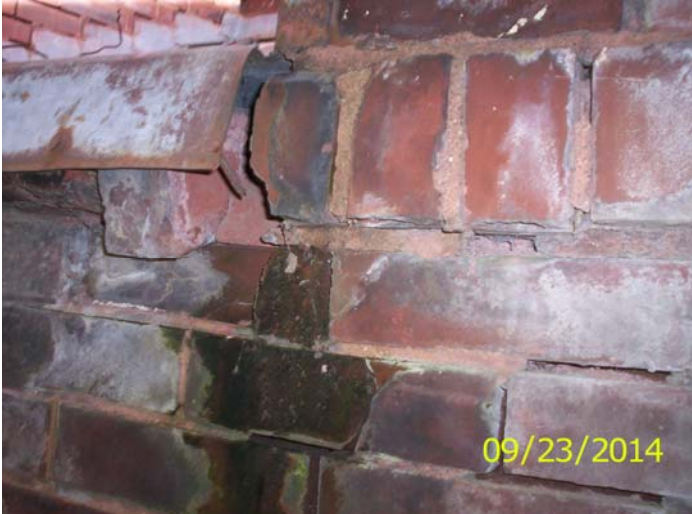
Deteriorated masonry

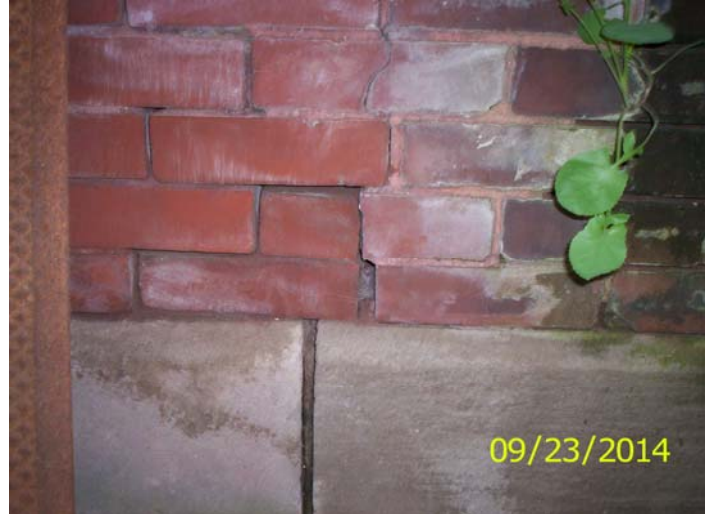
Deteriorated mortar joints, movement in bricks

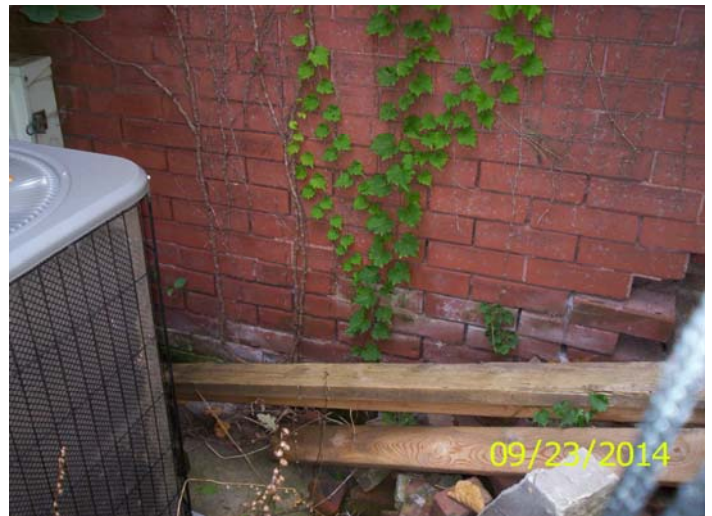
Deteriorated mortar joints

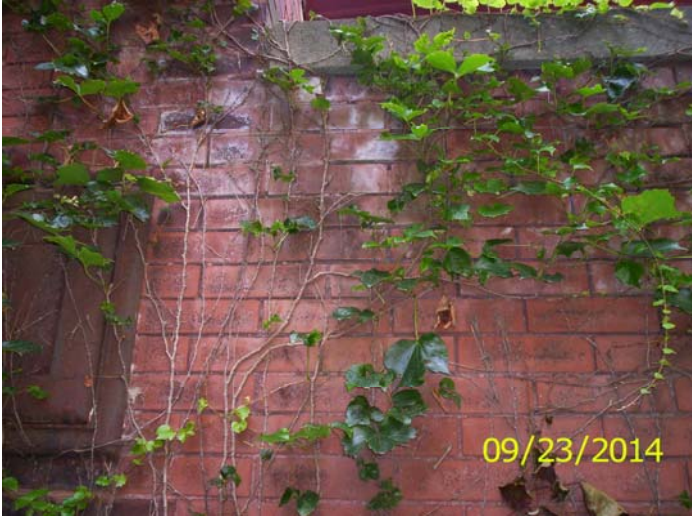
Deteriorated mortar joints
