June 20, 2014

RE: Areaway Condition Survey
MBJ Project No.: 14.508.0

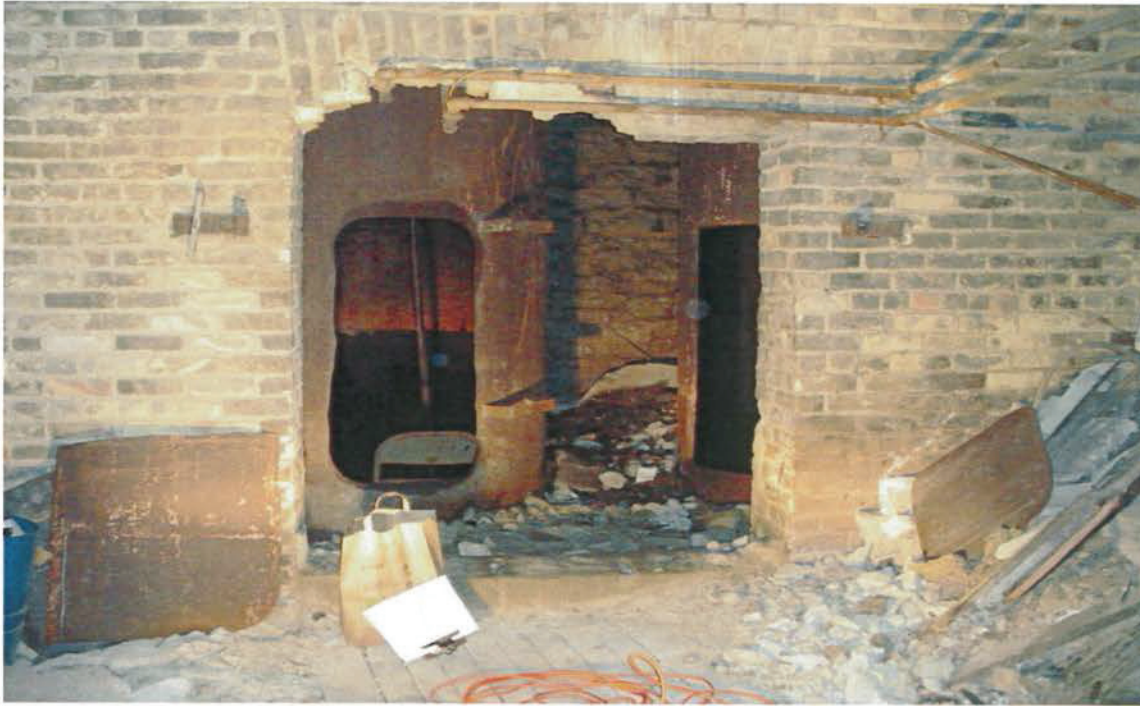
The areaway is located on the west side of the building along St. Peter Street. The age of the areaway is not known but it may date back to 1915 when the original building was constructed. It can only be accessed from the subbasement level. An interior full height partition wall divides the areaway into what we will refer to as the northern and southern sections. The northern section has inside dimensions of approximately 6'-0" x 8'-0". The southern section has inside dimensions of approximately 40'-1" x 8'-0" except at the subbasement level where the width varies at the south end due to an angled segment of wall that extends to approximately 9'-0" above the floor slab (Refer to Image 10). We believe this wall is a common wall with an Xcel utility tunnel. The height of the areaway to the underside of the roof slab is approximately 31'-0". The northern section is completely open to the subbasement on the east side. Access to the southern section is through an approximately 5'-0" x 5'-0" opening in the east wall (Refer to Image 1).

Image 1: (South Section) Opening in east wall.

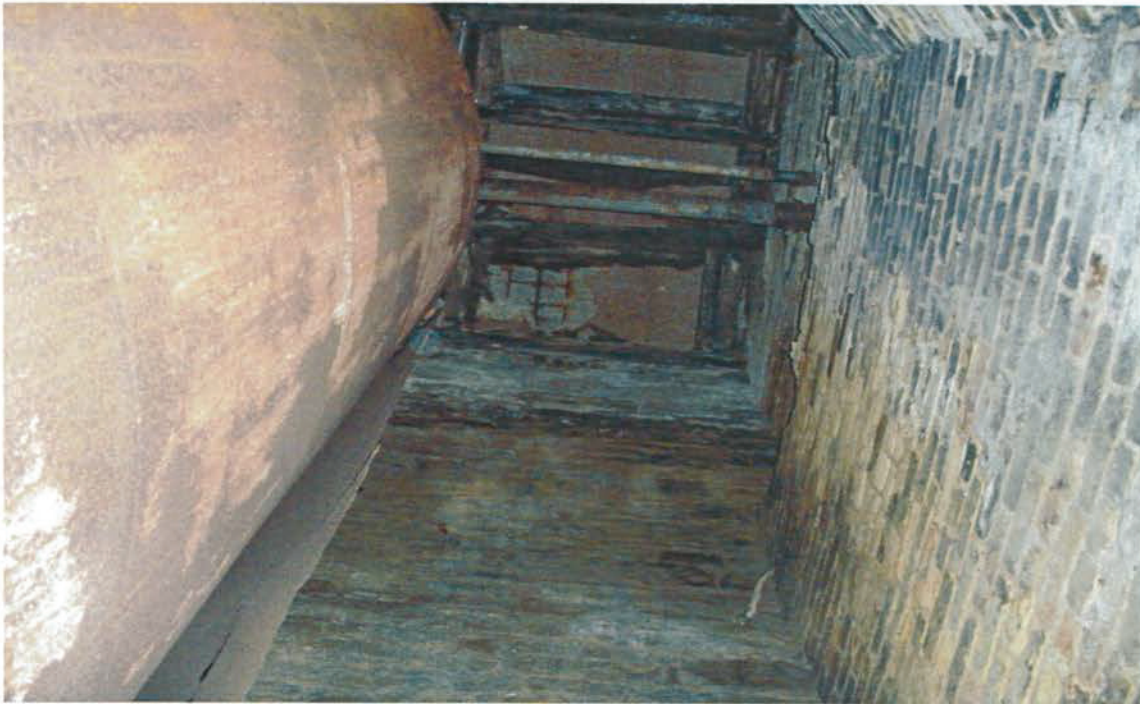
The entire west wall, with the exception of the angled wall segment of the areaway, and the south wall of the southern section are constructed of mortared stone masonry. All of the other walls are constructed of multi-wythe brick masonry. The walls appeared to be in good condition for their age (Refer to Images 9, 12, 14 and 18). We did not observe any cracking or large areas of surface deterioration. The roof structure over the entire areaway consists of a reinforced concrete slab supported on a grid work of steel beams. The primary support beams span between the east and west walls. The roof structure was in extremely poor condition. We observed a significant amount of corrosion and loss of section on all of the steel framing, resulting in failure of some of the supporting members. The concrete slab was also in poor condition. A substantial amount of the slab reinforcing was exposed and appeared to be moderately to severely corroded (Refer to Images 2-6 and 17).

Image 2: (South Section) Roof structure at north end.

Based on the conditions we observed, in our opinion the existing roof structure is not capable of supporting the required design live loads and presents life safety issues in its current condition. We understand that you do not anticipate any future use for this space. For these reasons we recommend the areaway be filled.

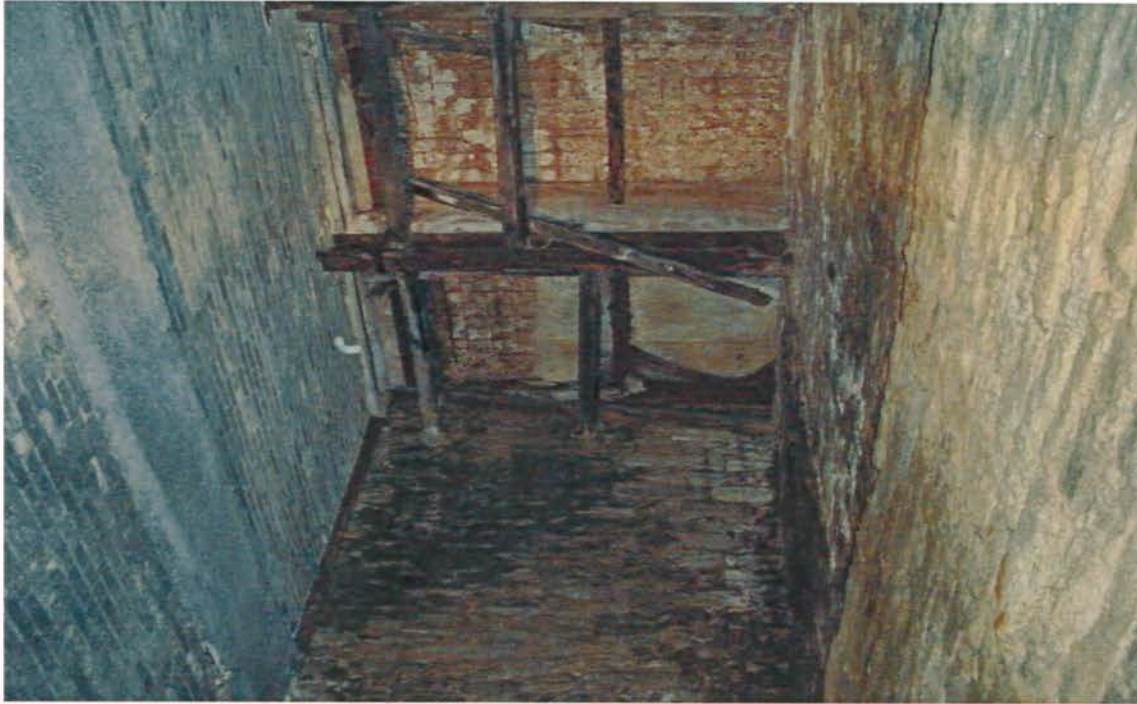
Image 3: (South Section) Roof structure at south end.

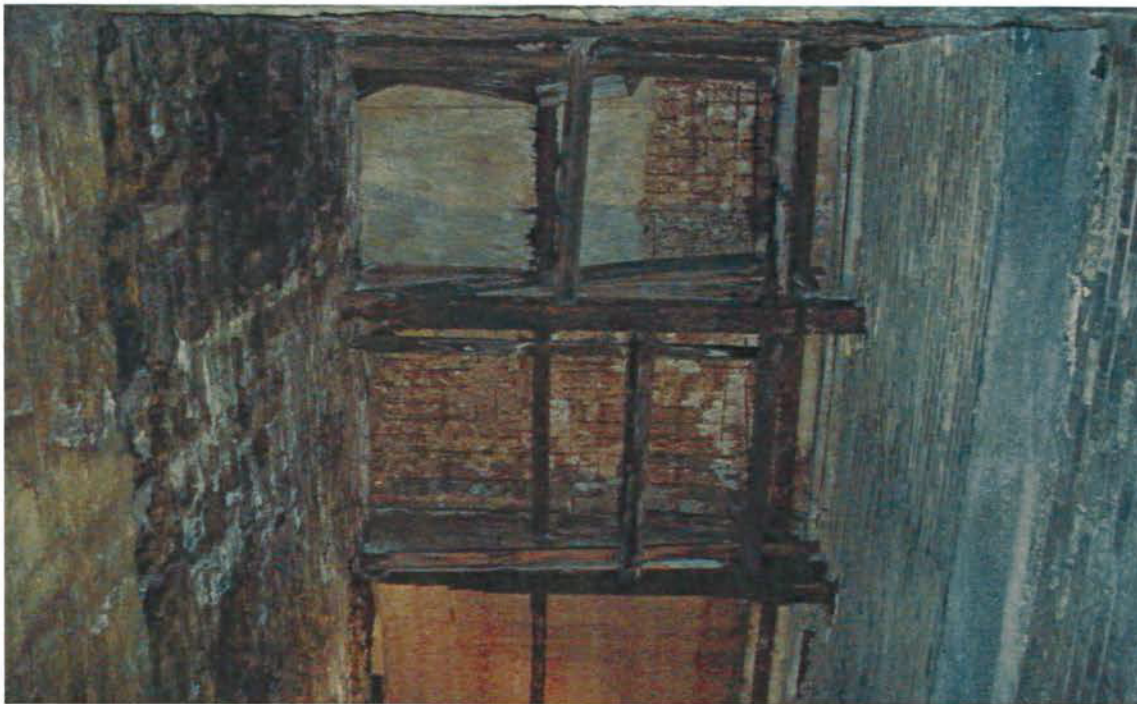
Image 4: (South Section) Roof structure at south end.

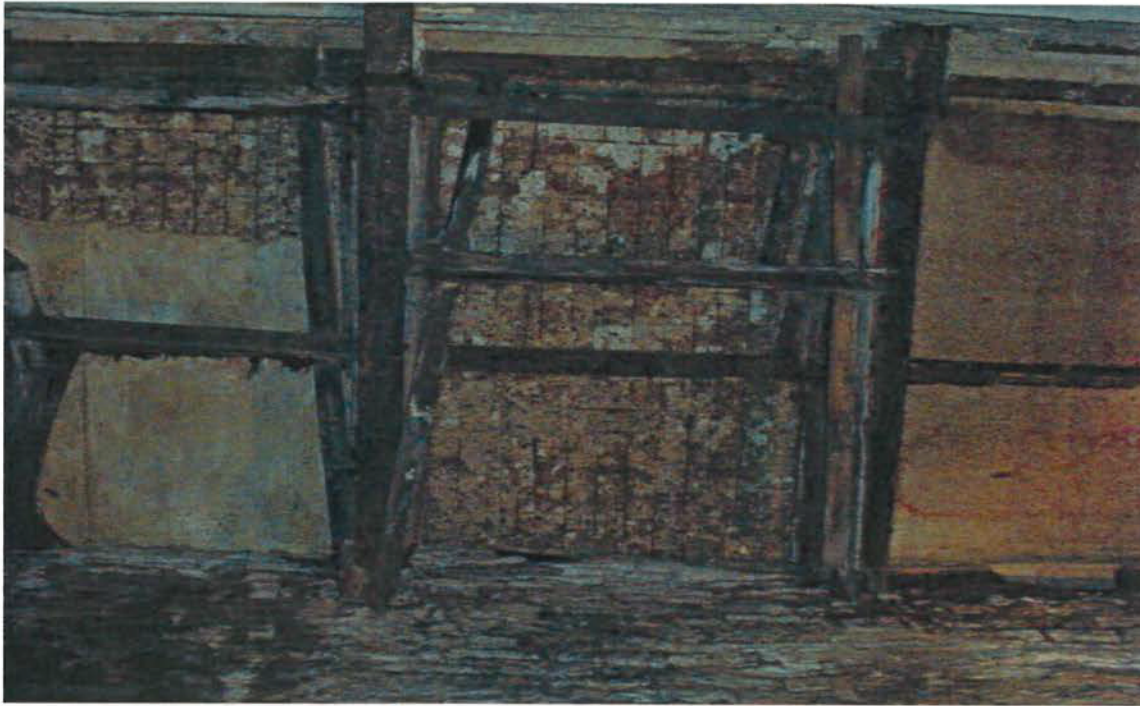
Image 5: (South Section) Close up of roof structure at south end.

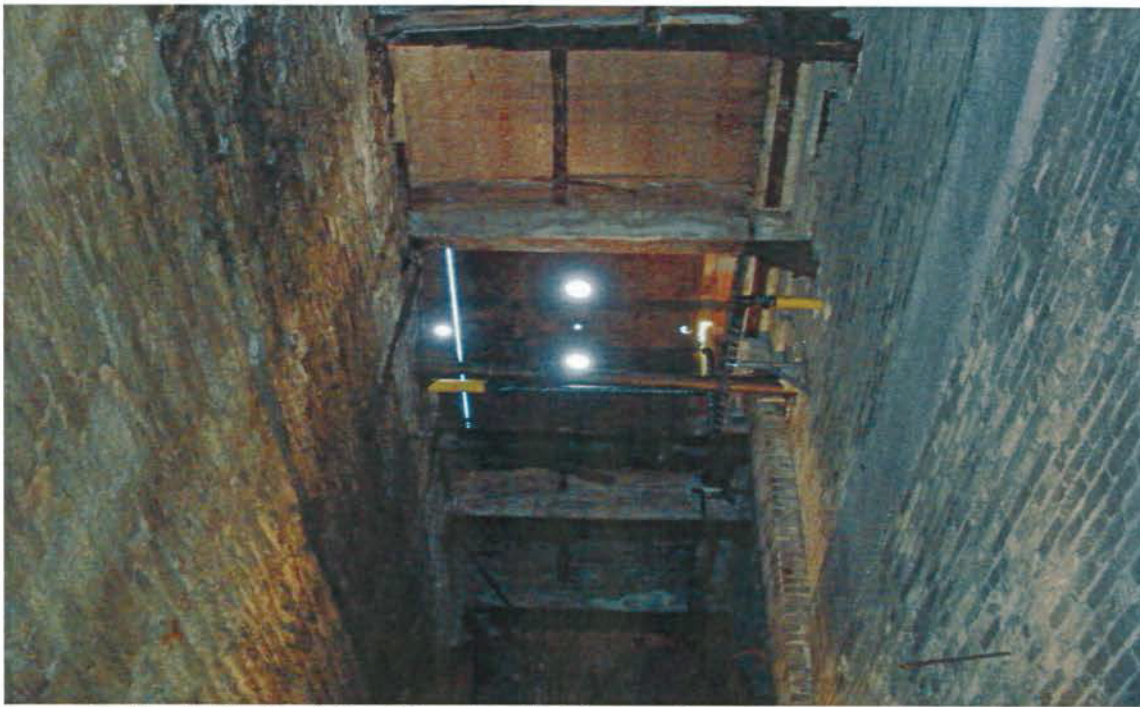
Image 6: (South Section) Roof structure looking north.

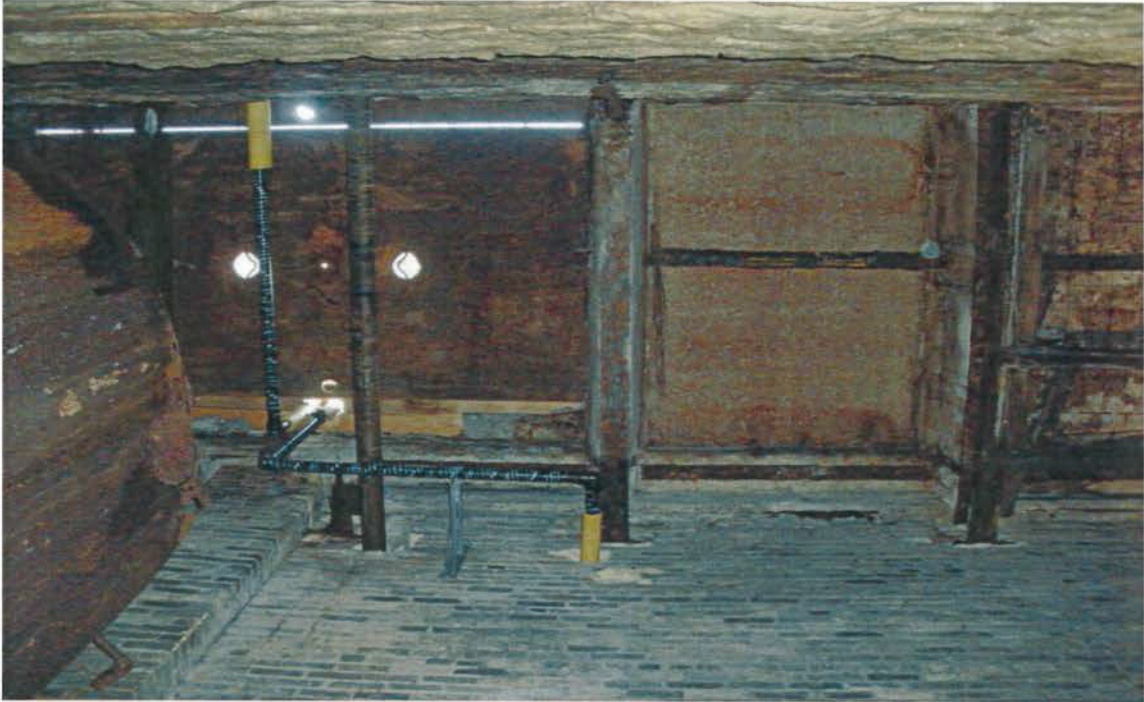
(Refer to Images 7 and 8). The northern section of the areaway contains a small amount of corroded mechanical piping running overhead and also running vertically in the northwest corner (Refer to Images 17 and 19).

Image 7: (South Section) New natural gas service looking east.

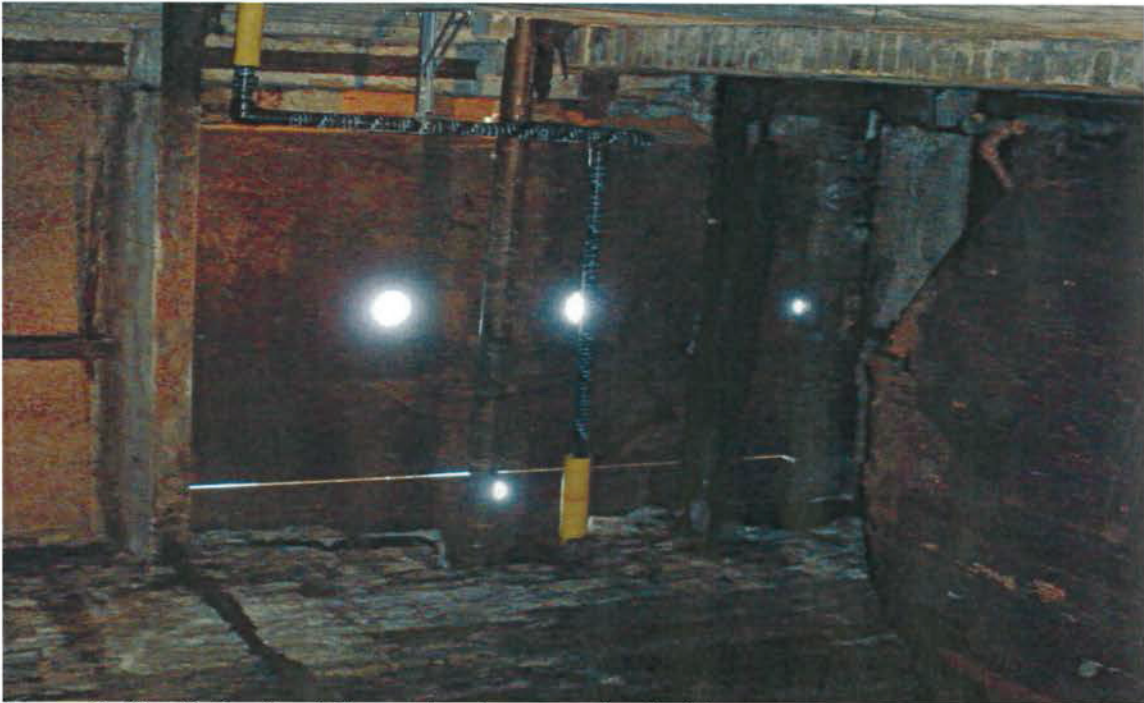
Image 8: (South Section) New natural gas service looking west.

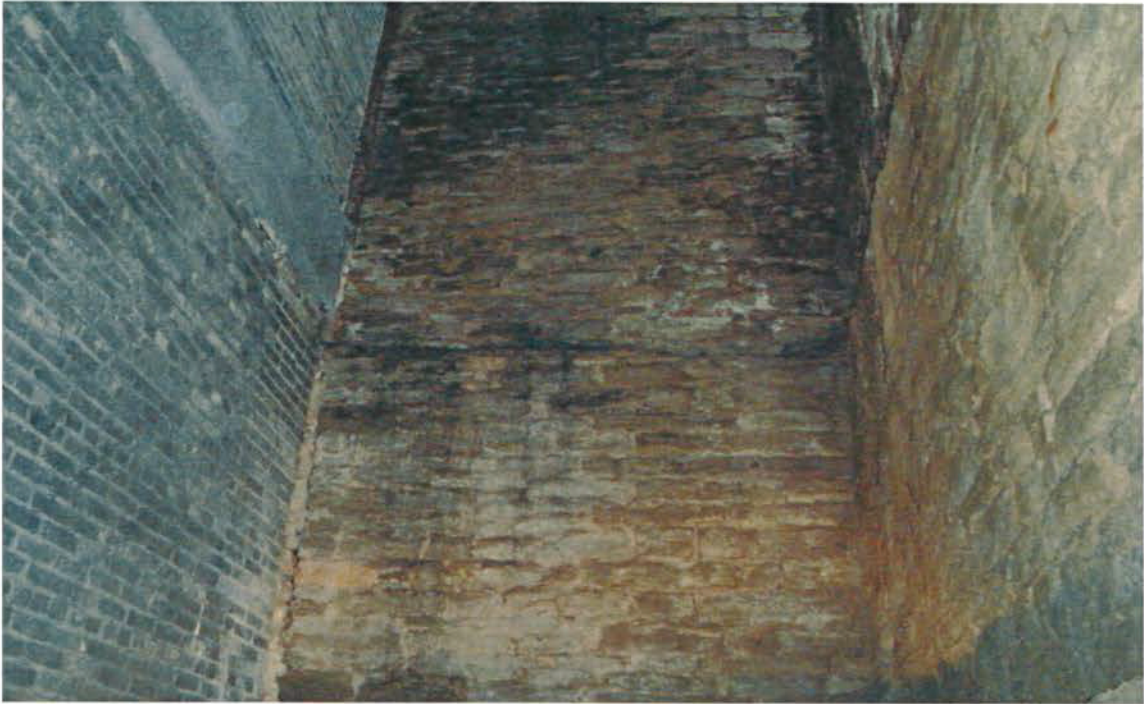
Image 9: (South Section) South wall.

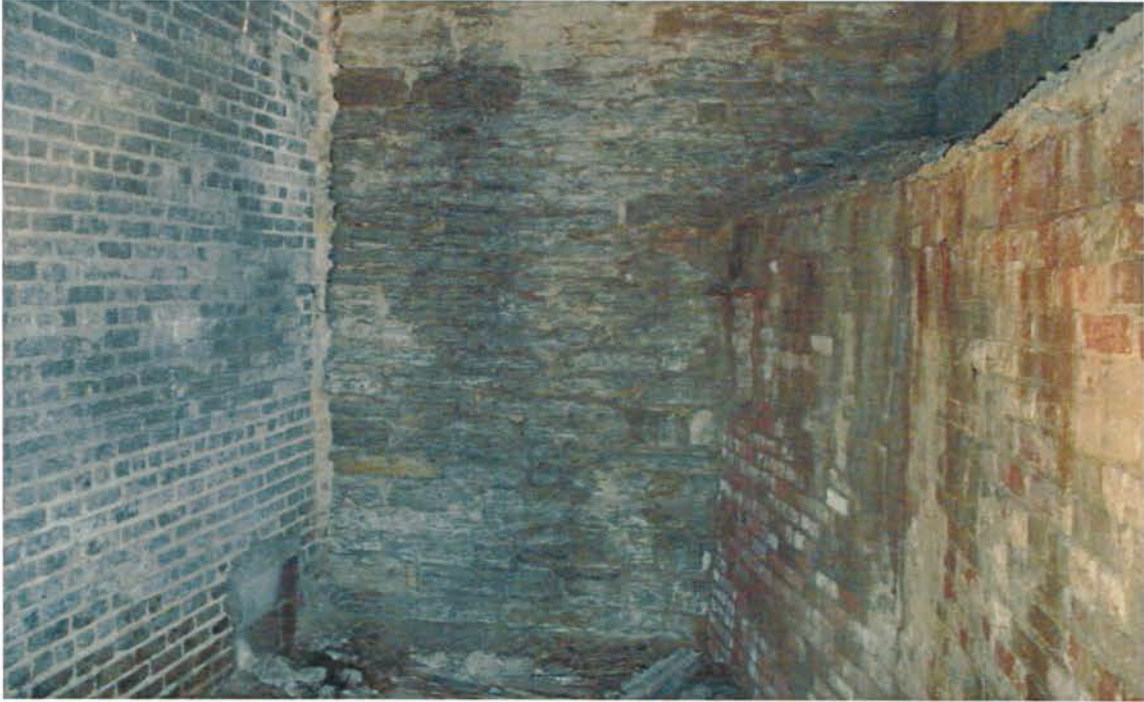
Image 10: (South Section) South wall. Angled wall on right.

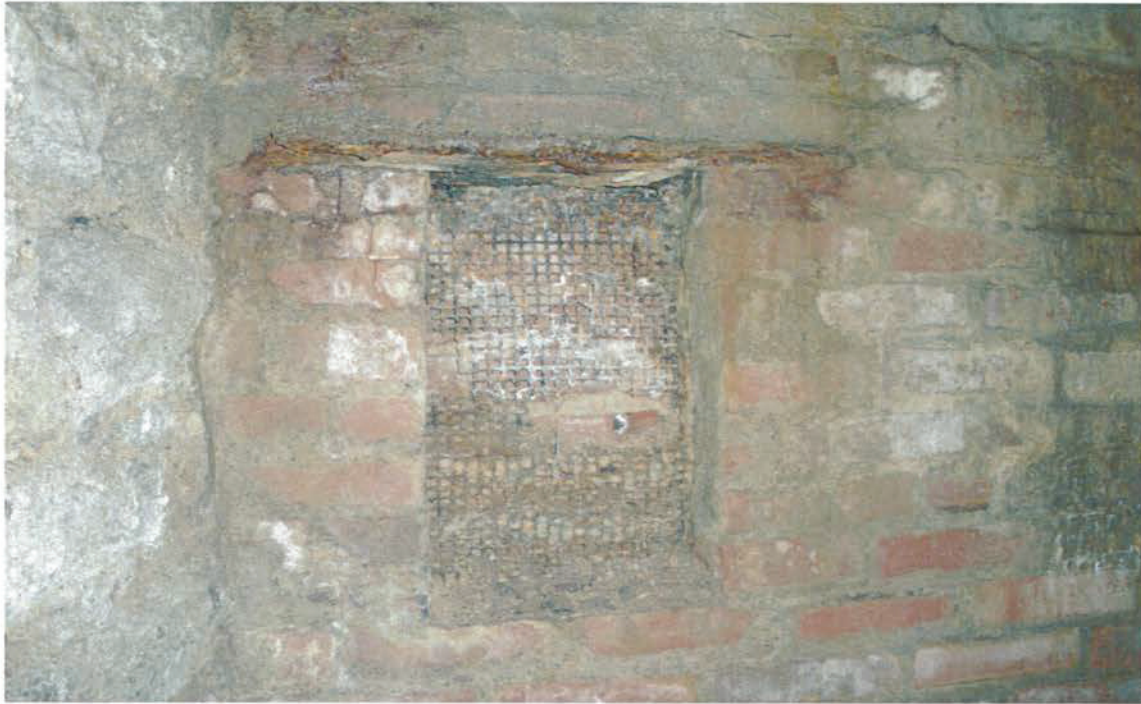
We observed a small wall opening located in the angled portion of the west wall of the southern section (Refer to Image 11). This opening had a heavy wire mesh screen at the face of the wall and was sealed with brick from the outside. We also observed two small openings near the base of the east wall of the southern section that had been infilled with concrete block (Refer to Image 13).

Image 11: (South Section) Opening in angled west wall.

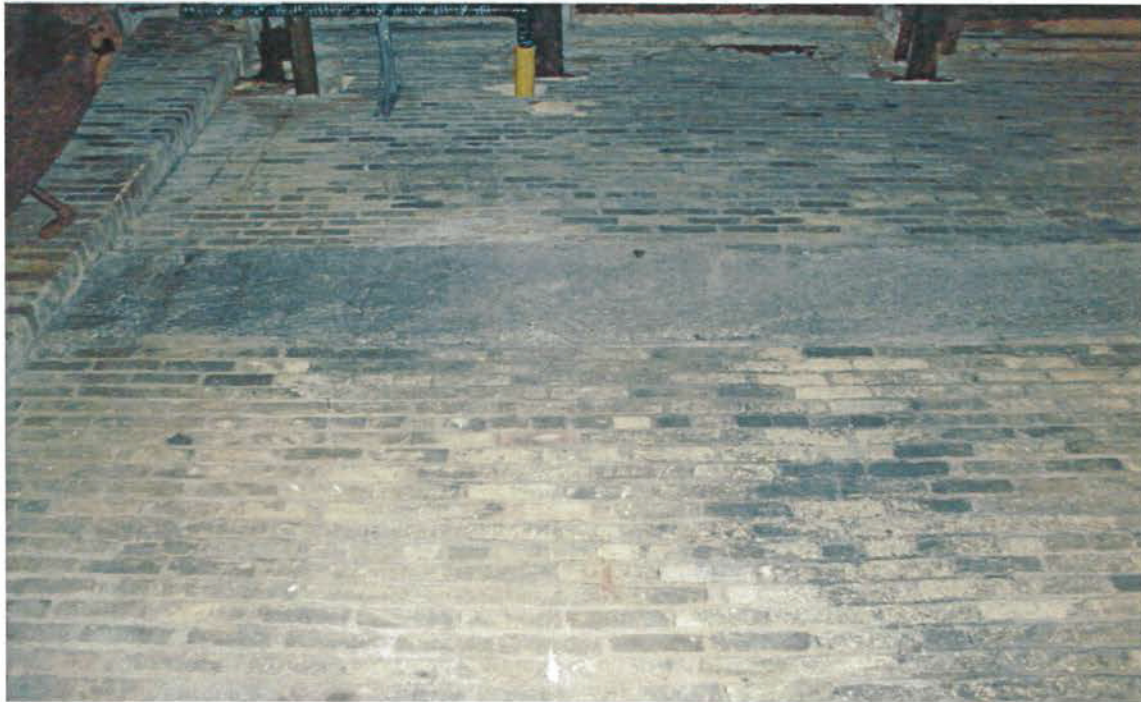
Image 12: (South Section) East wall.

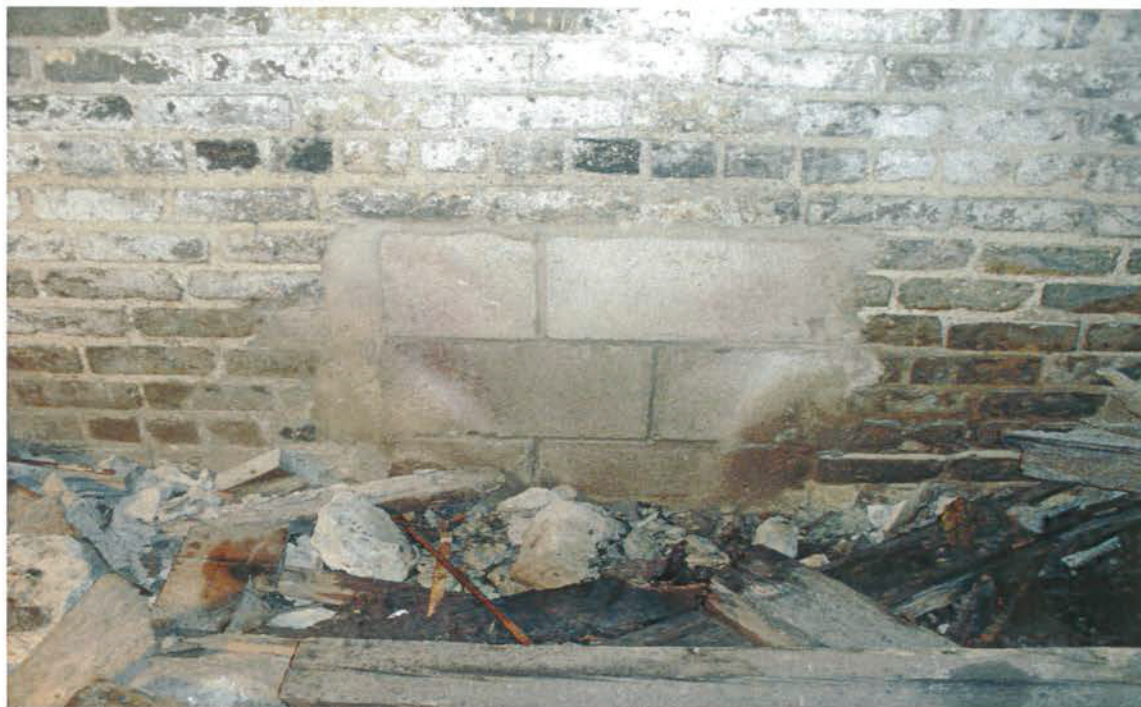
Image 13: (South Section) Block infill at east wall.

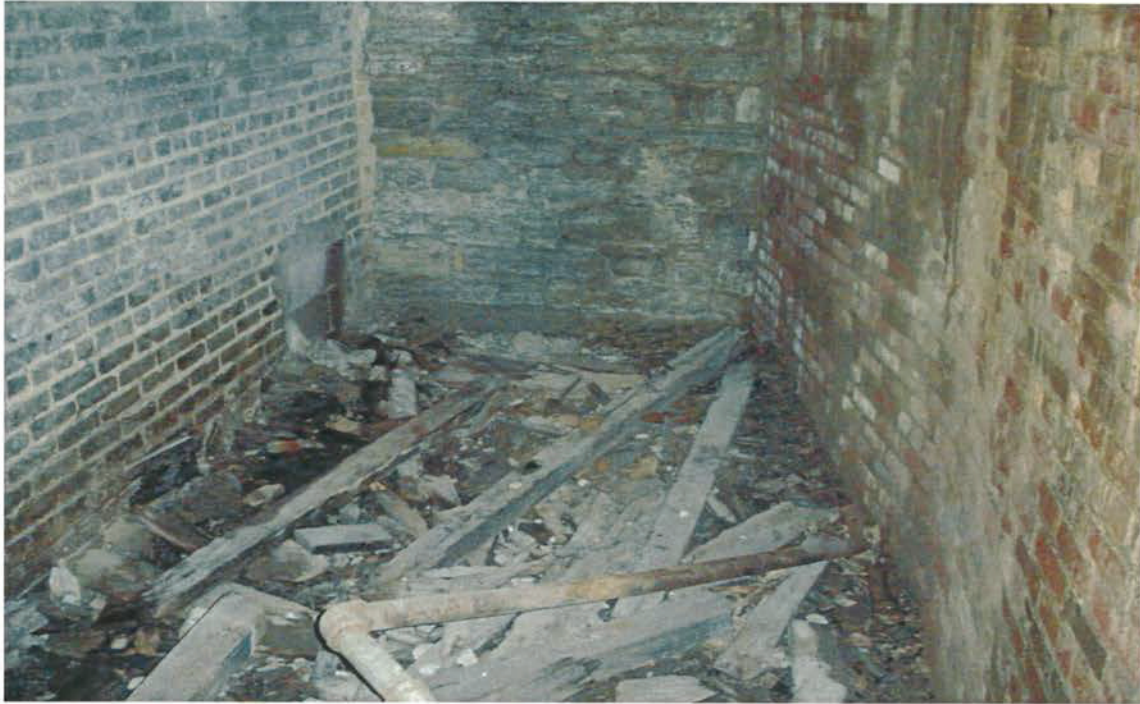
The floor in the entire areaway was covered with a significant amount of rubble and debris, several feet deep in many locations. The debris consisted of a variety of materials including pieces of concrete, wood, structural steel and reinforcing steel (Refer to Image 15).

Image 15: (South Section) Debris on floor.

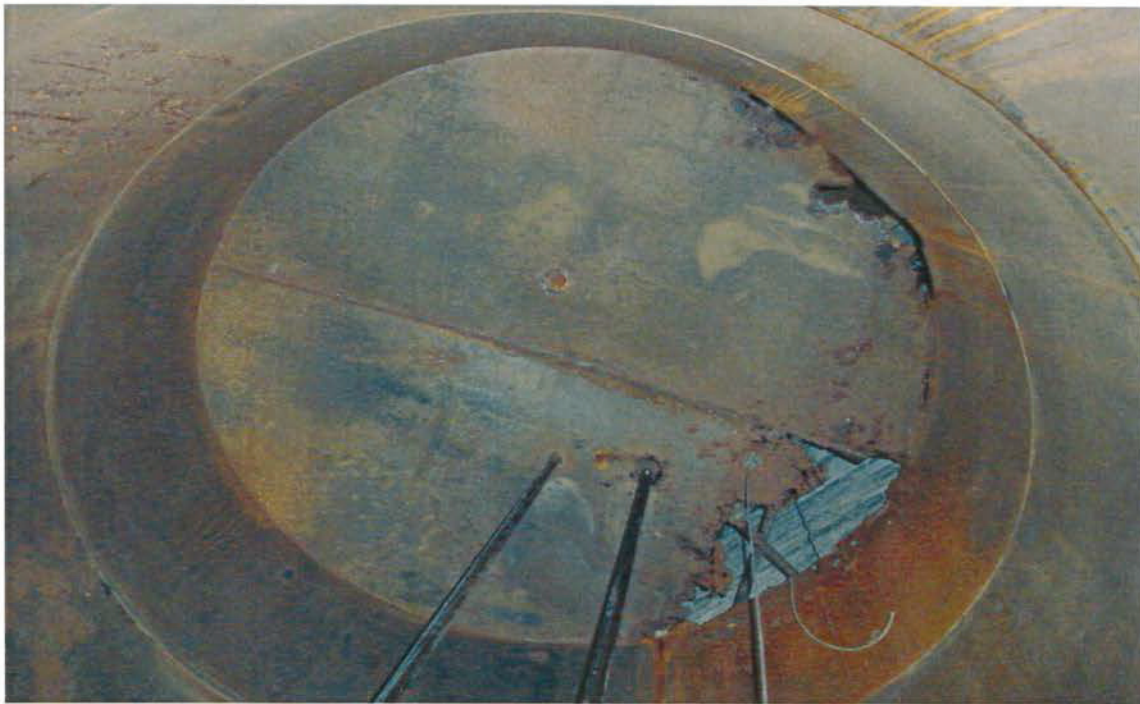
The areaway is empty except for two 7'-0" diameter fuel oil storage tanks that are located in the southern section in front of the opening in the east wall. The tanks are heavily corroded and have recently been decommissioned (Refer to Image 16). Holes have been cut in the tank walls to allow access to the rest of the area. Piping for a new natural gas service to the building is located below the roof slab elevation directly above the tanks. Installation of the new piping required removal of an approximately 12'-0" wide section of the roof structure. This area has not been repaired and is temporarily covered with steel plates

Image 16: (South Section) Roof of steel tank.

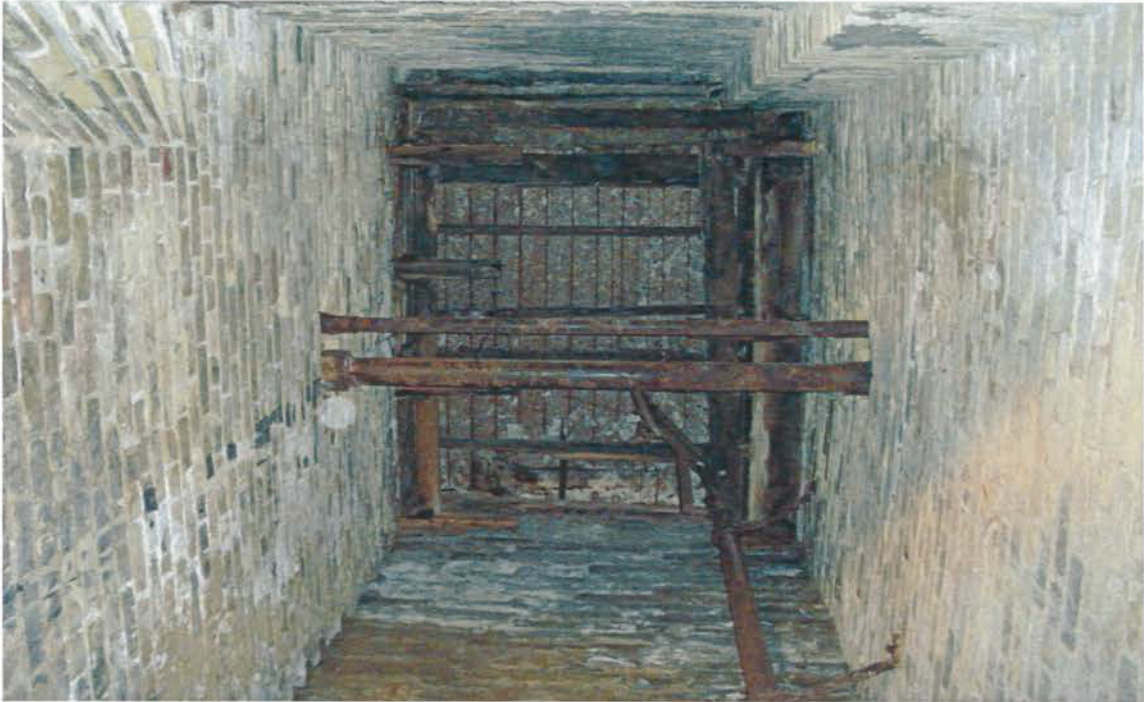
Image 17: (North Section) Roof structure.

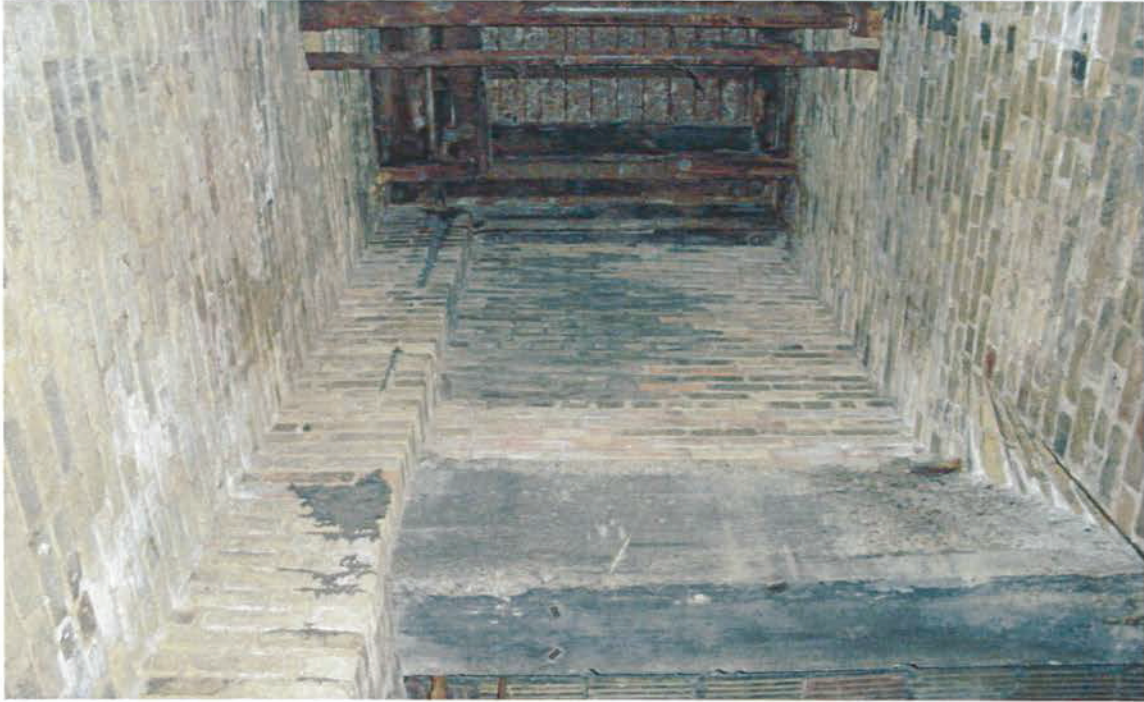
Image 18: (North Section) East wall.

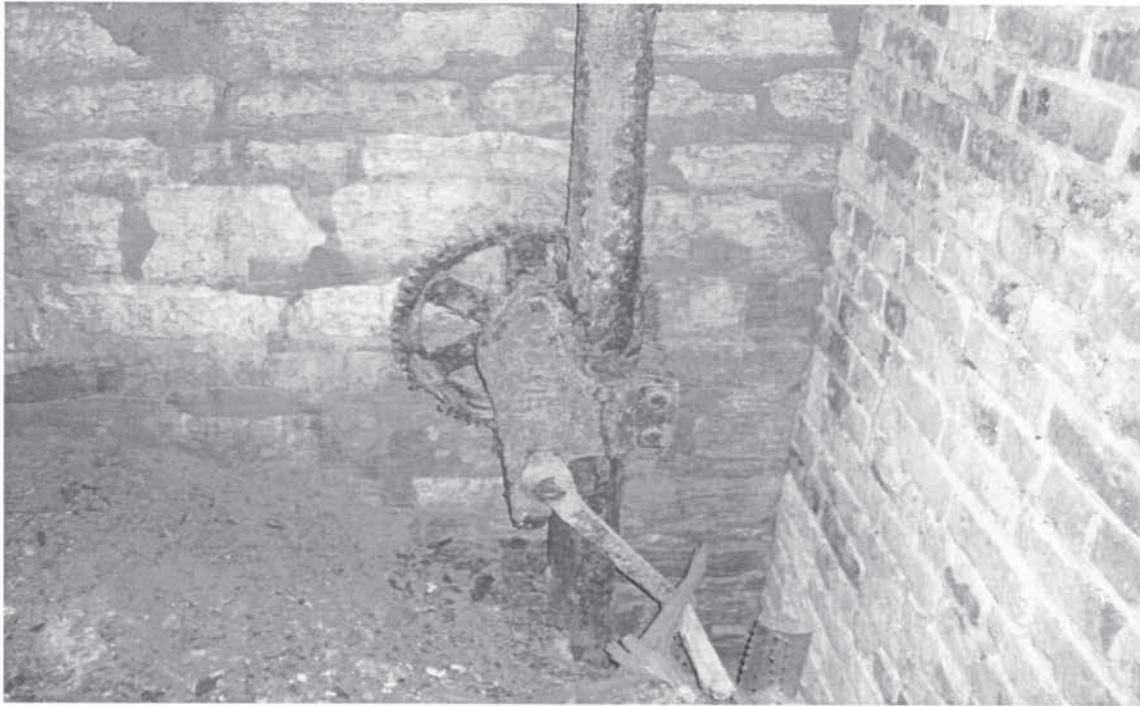
Image 19: (North Section) Existing mechanical in northwest corner.
