Larson Specialty Structures, Inc
5831 Hobe Lane
White Bear Lake, Minnesota 55110
651 429 5143 Fax: 651 207 8146
internetengineering@comcast.net

Re: 69 Douglas St.
St. Paul, MN
Comm. No. 8180

On May 11, 2011 I inspected the above referenced residence. The primary purpose of this inspection was to evaluate settling of two posts in the basement. There has also been some settlement and movement in other parts of the home. These issues are also dealt with below.

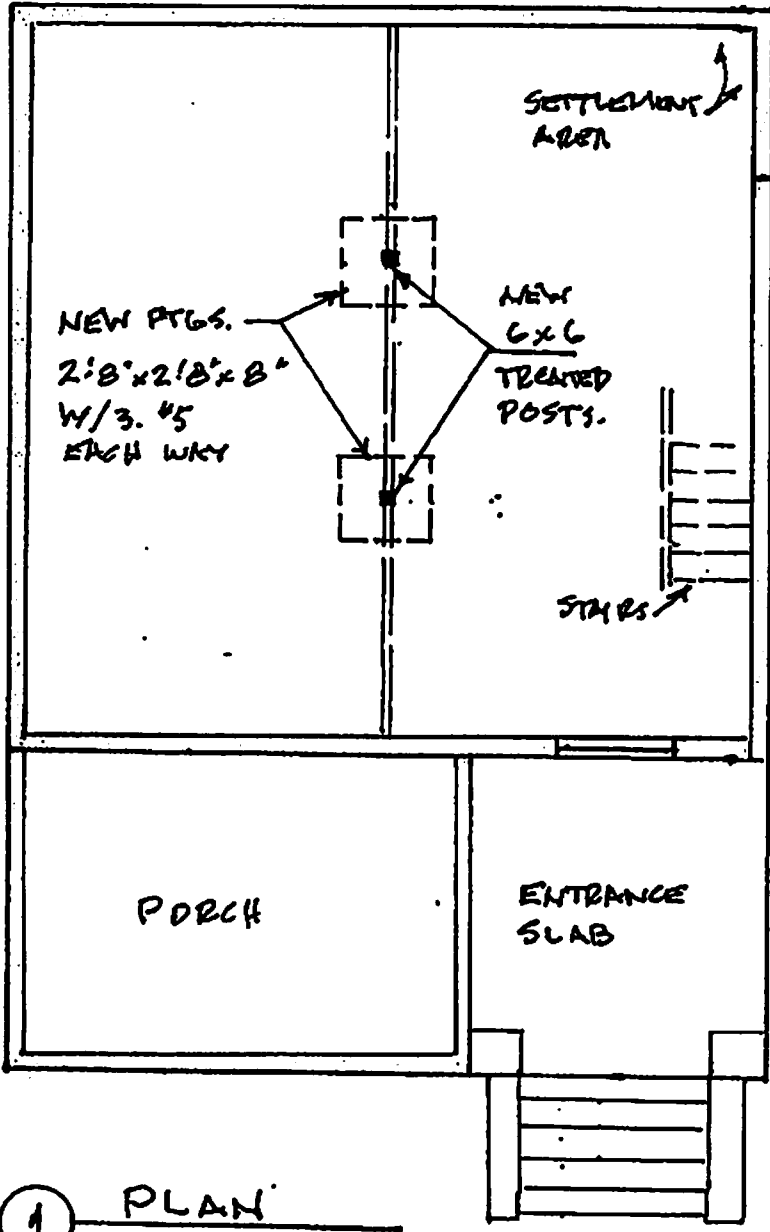
① PLAN

There are two posts in the basement that have settled approximately two inches or more. There has been an attempt to shim the posts up in the past. (See Pictures # 6 & 8) The concrete floor around the posts has also settled. (See Picture # 7)

It is my opinion the settlement of the posts, and also the settlement of the areas described below, are due to the soils becoming saturated. Many clay type soils lose their bearing capacity when their moisture content is too high. The settlement conditions can be greatly improved by improving the exterior drainage conditions.

- Improve Exterior Drainage Conditions.
Install horizontal extensions on downspouts to direct water as far away from the foundation as practical.
- Revise the grade along the north and west sides of the house so water is directed away from the foundation.
- Install two new footings under the posts that have settled as shown on Plan Sheet 1.
- Install two new 6 x6 treated wood posts as shown on Plan Sheet 1.
- It may be possible to raise the beam line somewhat to make the floors above more level.
