Jack Pixley Sweeps

Customer: Vander, Nick - 04/23/2013 Job

Service Address: 2228 Bush Ave E

Internal Inspection

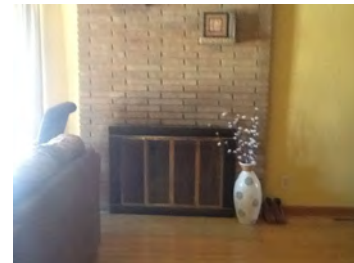
The glass doors on the front of the fireplace should be replaced as one side is stuck shut, there is exposed wood in both the lintel and ash dump areas, also there are gaps around the bricks and bottom flue in the smoke chamber area. Because of the exposed wood and the gaps found this fireplace should not be used.

Our recommendation for these discrepancies would be to remove the exposed wood in the lintel area and parge the smoke chamber and seal off the ash dump completely, also replace the glass doors.

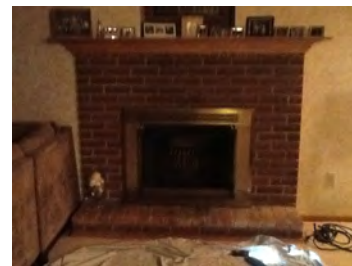
The lower level damper does not work properly, there is exposed wood in the lintel area, and the bottom flue tile is not supported on all sides. Again, because of the exposed wood this fireplace should not be used.

Our recommendations are to remove the exposed wood, parge the smoke chamber, and replace the existing damper with a Top Mount Damper.

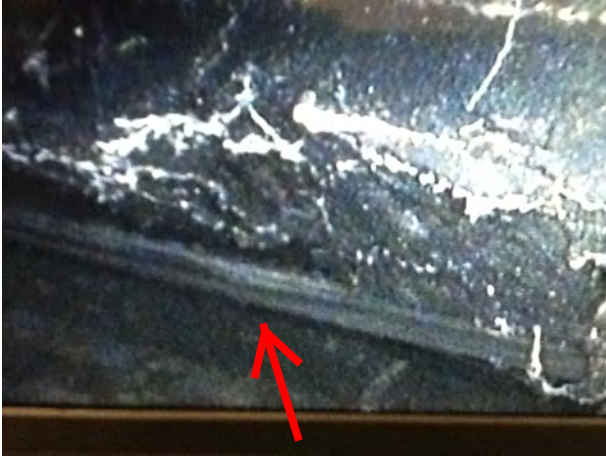
Wood in lintel area main level fireplace

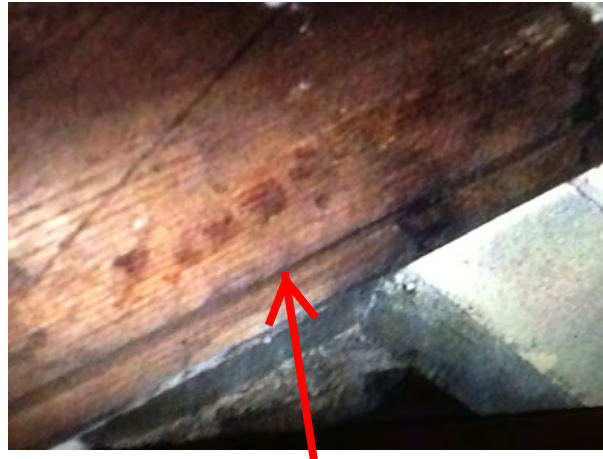
Wood in ash dump of main level fireplace

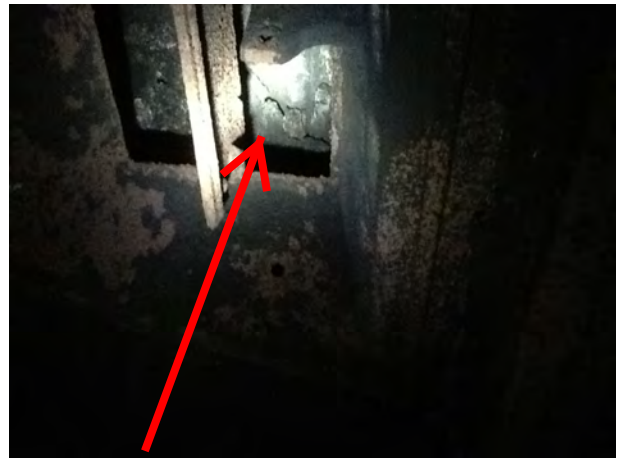
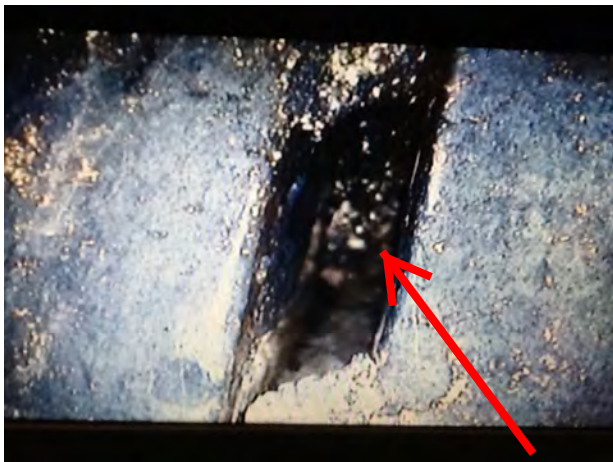
Gaps around the bricks and the bottom flue tile in main level smoke chamber

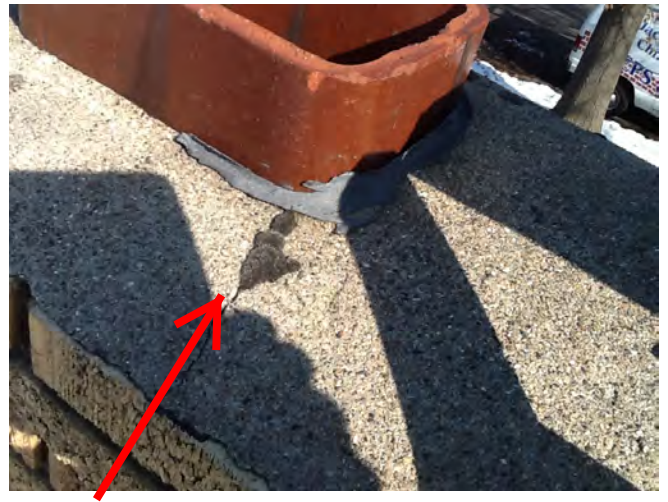
The other area to report is the top of the chimney specifically the wash at the top of the chimney and 6 courses of brick down. The wash has cracks in it allowing water to seep down into the bricks and mortar which is making the bricks spall and the mortar deteriorate.

Cracks in wash at the top of the chimney

Our recommendation for this is to remove the wash and 6 courses of brick and rebuild these areas.

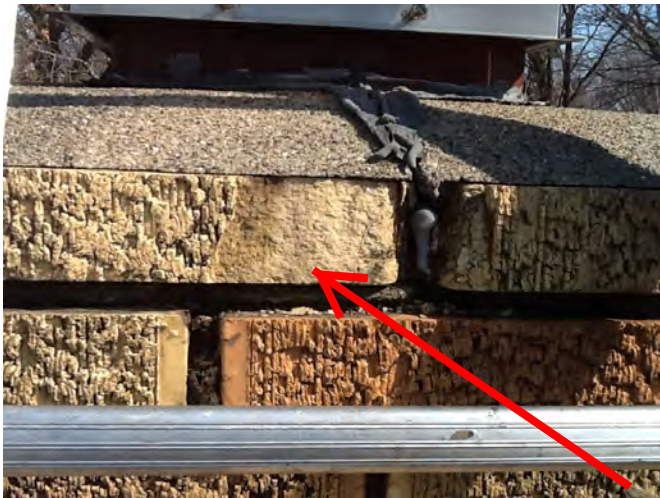
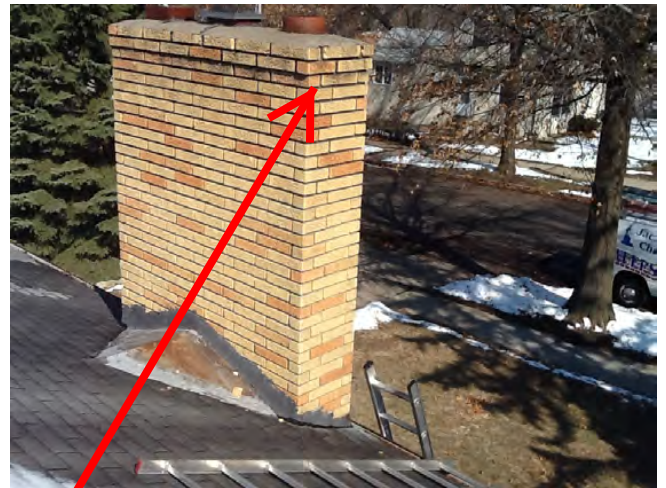
Spalling brick and deteriorating mortar joints
