HERITAGE PRESERVATION COMMISSION DESIGN REVIEW APPLICATION

Street and number: 275 Bates Avenue Zip Code: 55106

RE: 275 Bates Avenue Request for Demolition

Project No.: 15536.00
Re: Structural Condition Review of the building at 275 Bates Ave.

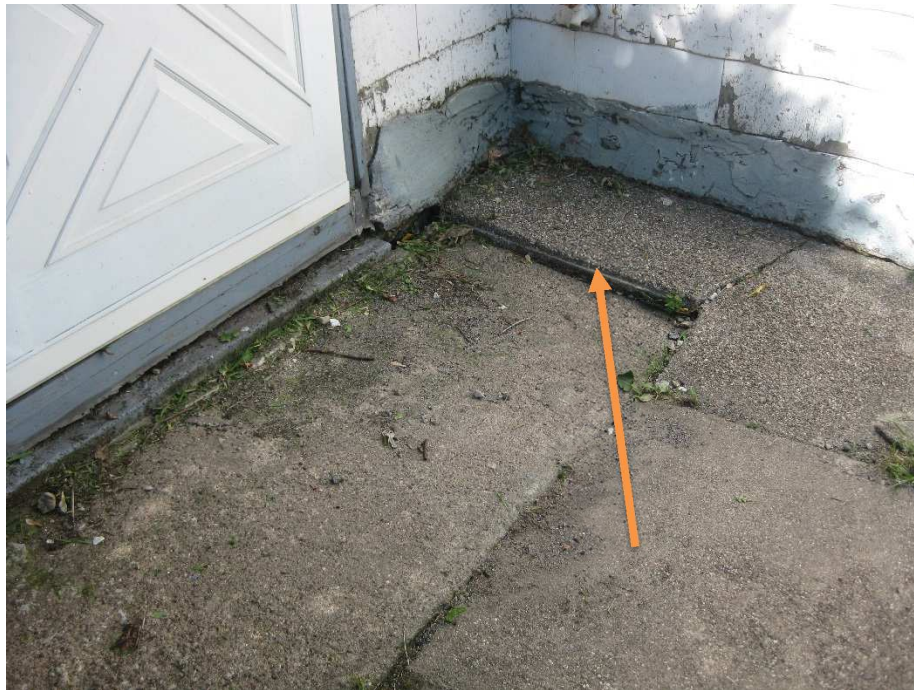
The front porch slab that is assumed to rest directly on grade has settled approximately 1". Picture 1 shows the displacement of a slab joint. The most likely cause of this settlement is water intrusion of the soil below the slab. Picture 2 shows the same slab from a different angle. Runoff along the foundation walls will continue to cause deterioration and may result in freeze thaw damage.

Picture 1 – Front Slab Settlement

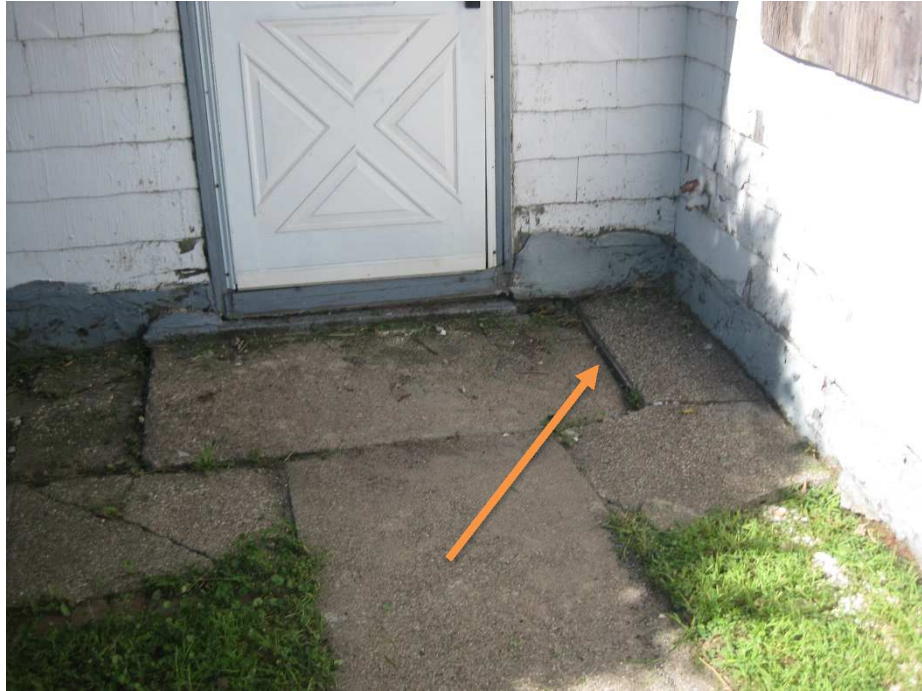
Picture 2 – Front Slab Settlement

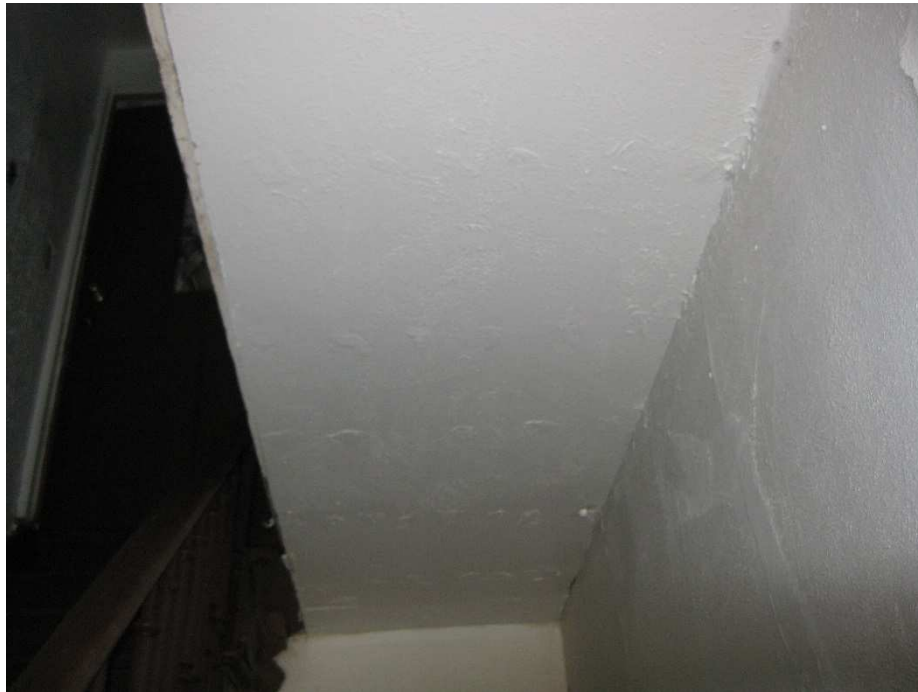
Some of the floors of the building were observed to slope. Picture 3 shows the underside of a floor that has sloped and Picture 4 shows a gap that was created from the movement that caused the floor to slope.

Picture 3 – Underside of Uneven Floor

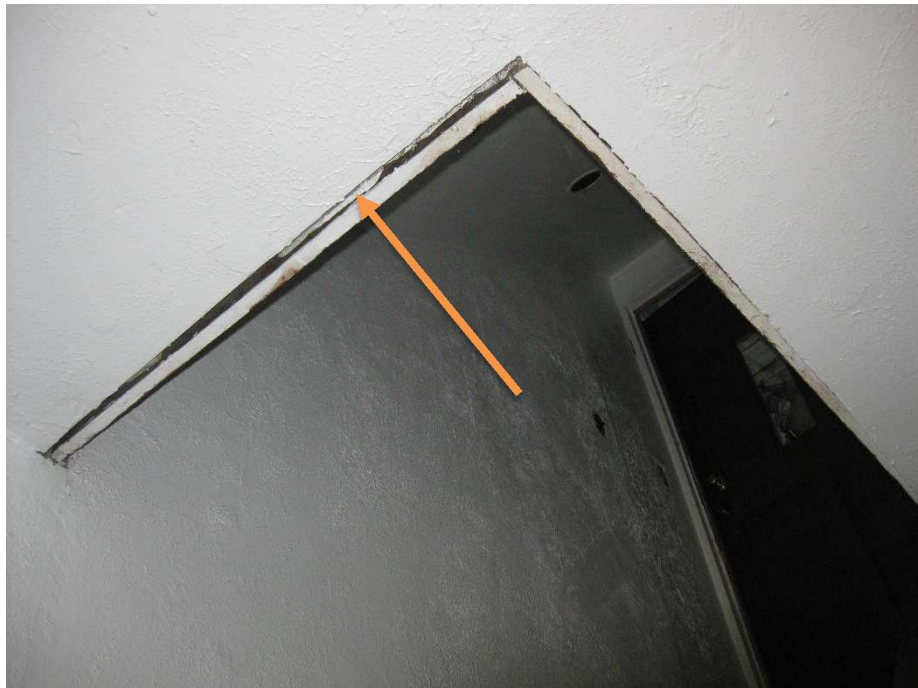
Picture 4 – Gap Due to Sloping

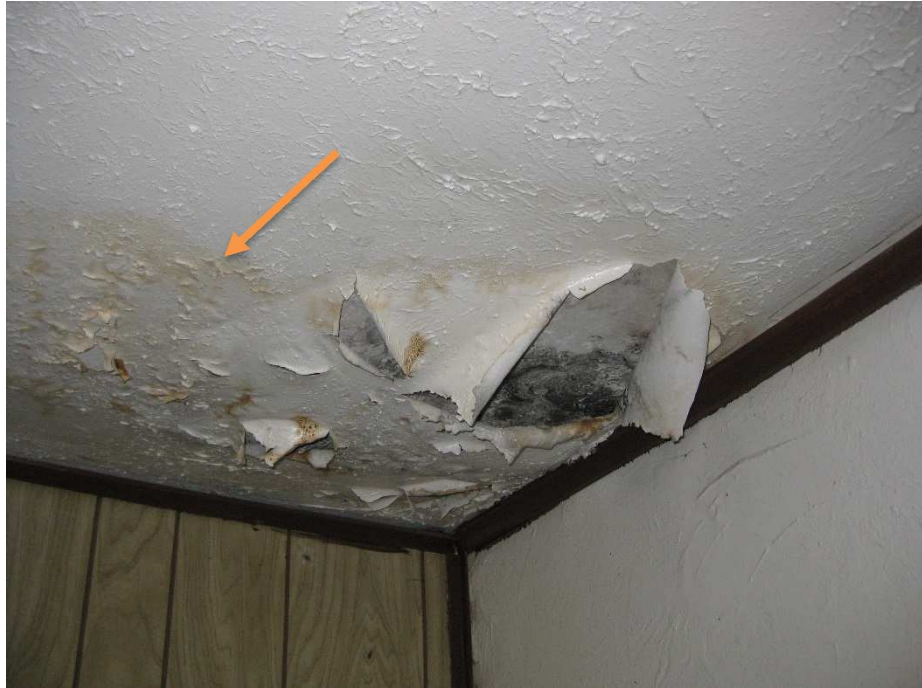
Water damage was observed throughout the building. The ceiling of the second floor was observed to have water stains along with mold and peeling paint. Picture 5 shows the damage of the water to the ceiling of the second floor. Directly above the damaged area is the roof. It is likely that there is damage to the roof which is allowing water to enter the home. We were unable to observe the roof in its entirety. Picture 6 shows the underside of a ceiling system that is rotting. This is likely due to water infiltration and can be assumed to be found throughout the house. Wood rot was also found in the basement. Many of the joists had rot at each of its ends, where it connected to the foundation walls and where it connected to the center beam.

Picture 5 – Water Damage on Second Floor Ceiling

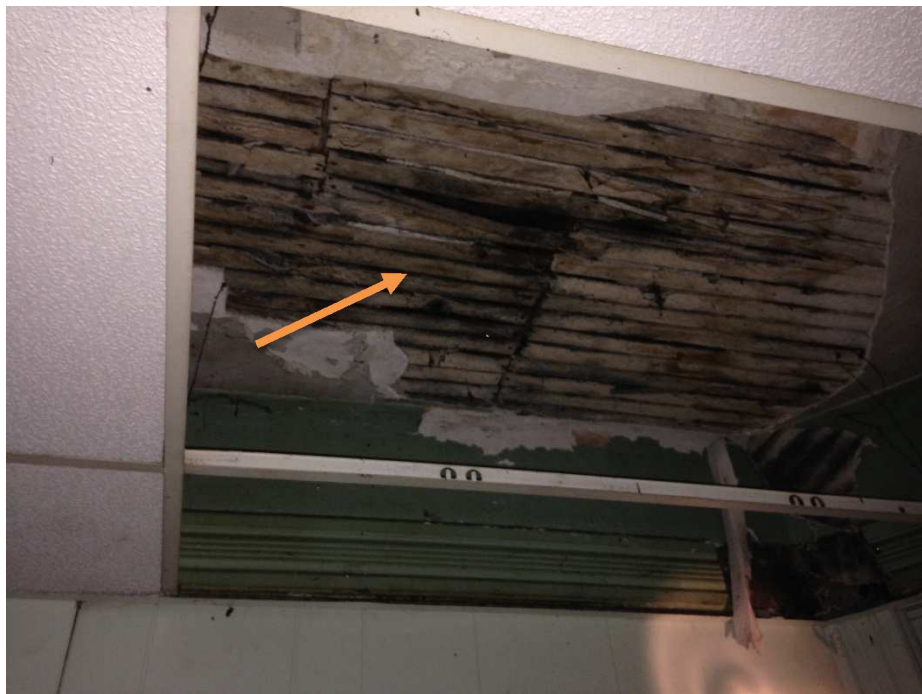
Picture 6 – Deterioration of Ceiling System

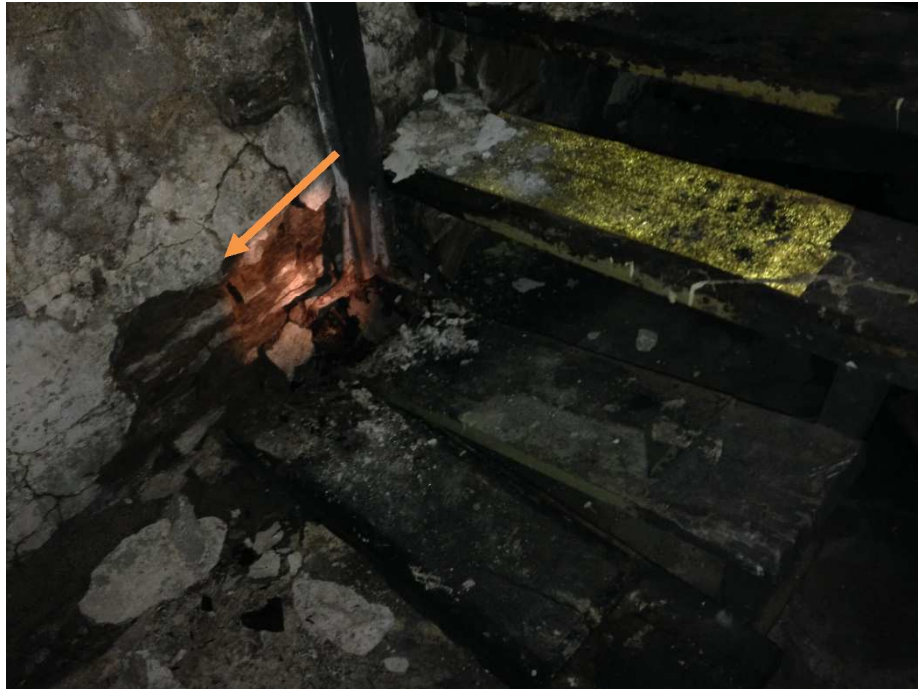
The foundation walls were observed to be crumbling, cracking, and bulging from inside the basement. Pictures 7 and 8 show portions of the walls that are deteriorating. In the basement there are a number of shoring columns that are holding up the beams of the first floor. The shoring columns are rusted and some of them are bent. Picture 9 shows two such shoring columns.

Picture 7 – Crumbling and Cracking of Foundation Walls

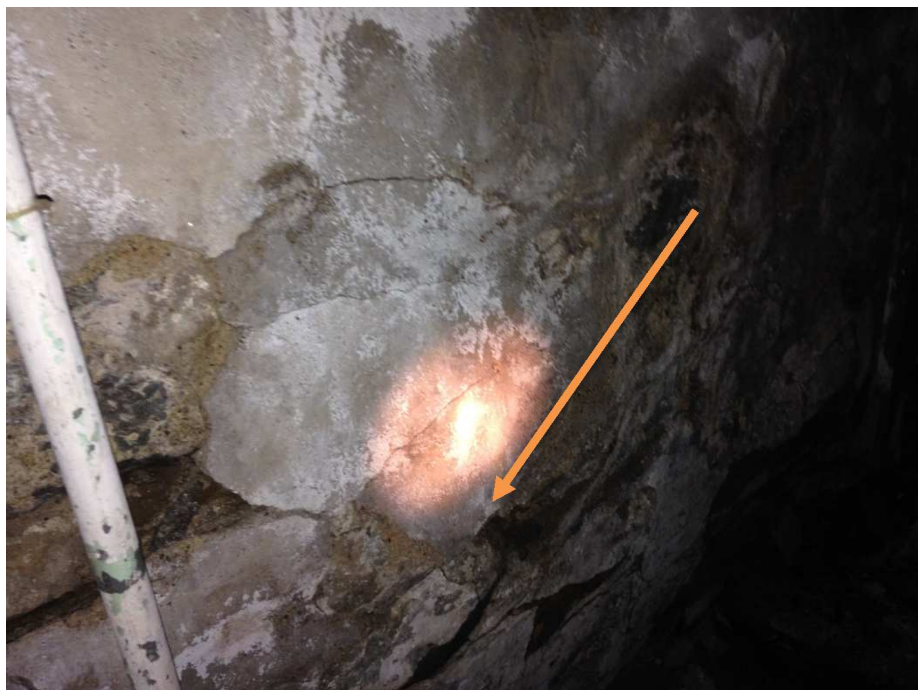
Picture 8 – Crumbling and Cracking of Foundation Walls

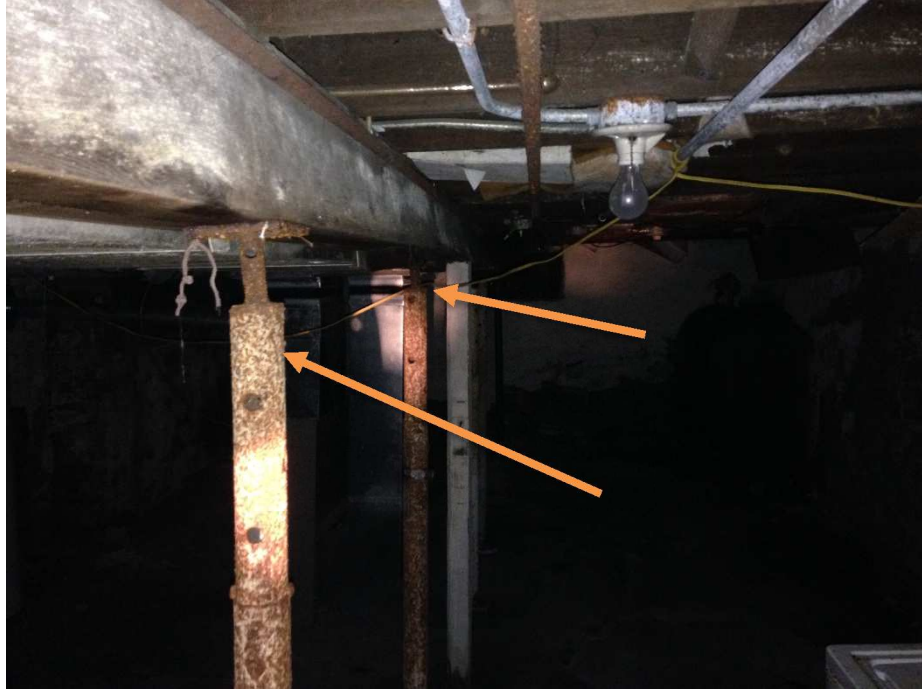
Picture 9 – Shoring Columns Supporting a Beam

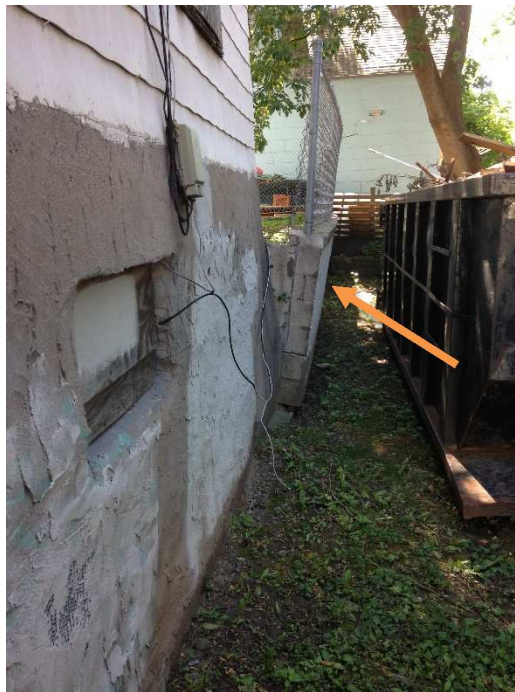
We observed the retaining wall at the exterior of the house to be out of plumb. The wall itself is sturdy, as evidenced by the lack of cracking or breaking, but its foundation has rotated. Pictures 10 and 11 show the wall out of plumb.

Picture 10 – Retaining Wall Out of Plumb

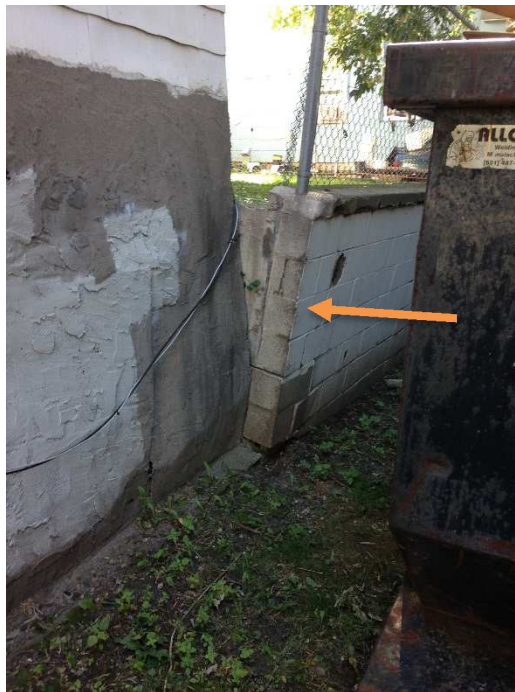
Picture 11 – Retaining Wall Out of Plumb

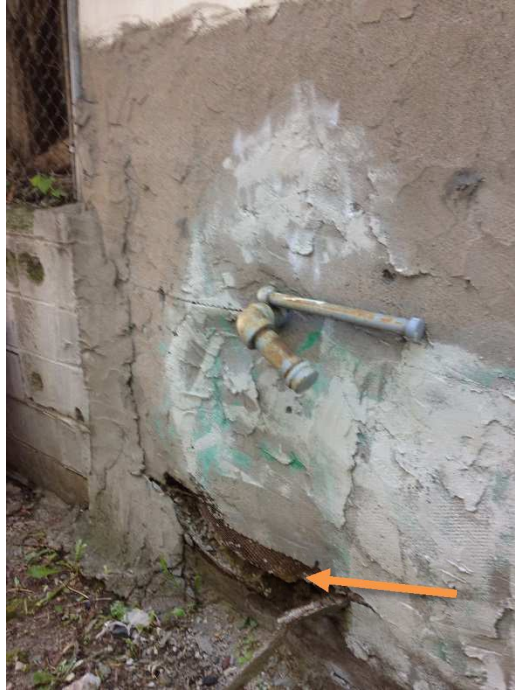
The stucco on the exterior of the house was observed to be deteriorating. Although the stucco is not critical to the structural integrity of the building, the crumbling stucco suggests that water deterioration and/or movement has occurred in the foundation. Picture 12 shows the deterioration of the stucco and Picture 13 shows the stucco bulging, likely due to water. The stucco was observed to be deteriorating in multiple places along the exterior of the house.

Picture 12 – Stucco Deterioration

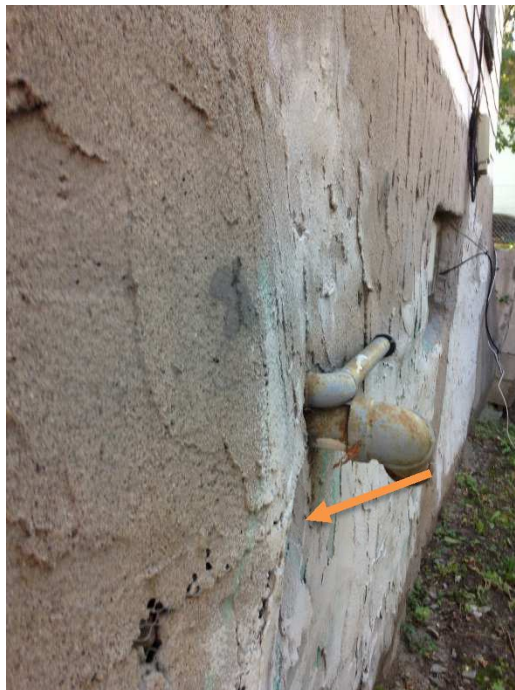
Picture 13 – Stucco Bulging Out

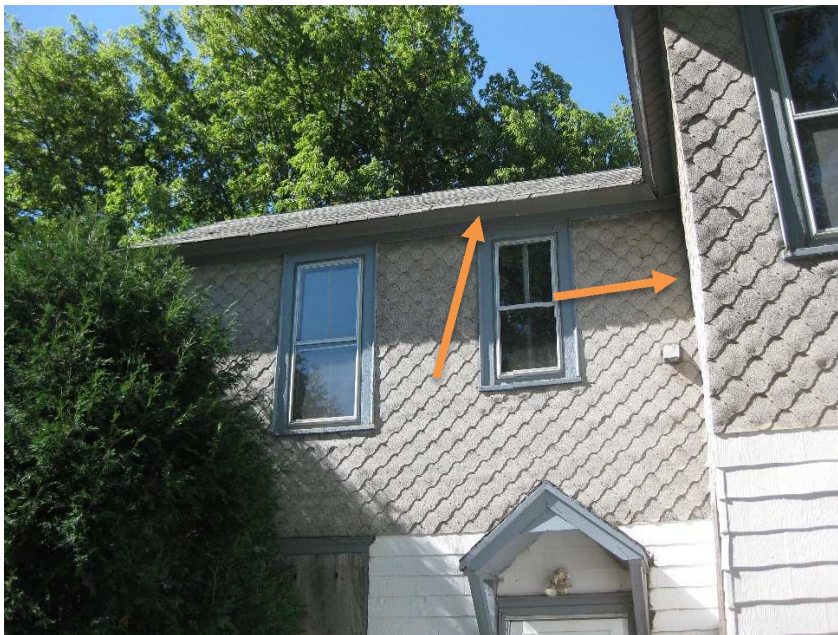
The roof and exterior walls, as observed from the outside, appeared to be in good condition. The roof was flat and there were no obvious problems. The exterior walls appeared to be plumb. Picture 14 shows one such roof and wall.

Picture 14 – House Roof and Exterior Wall
