Former MDS Building

TIF Eligibility Assessment

St Paul Port Authority

October 3, 2014

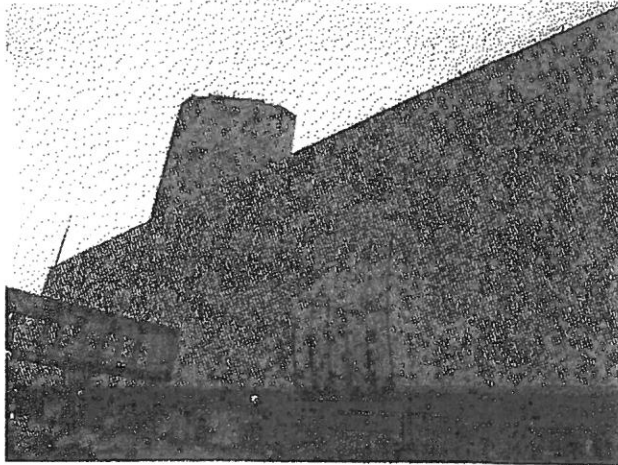
Photo

Defects in exterior building shell: Masonry walls show evidence of settlement cracks. Doors are aged and damaged. Parking on the roof is no longer possible due to structural defects. The building does not have the correct construction type for height and area requirements.

Deficient in facilities for disabled: Lack of maneuvering clearance and accessible features at toilet areas. Counter heights do not meet current code standards. No areas of refuge or adequate size of elevators.

Deficient entry: Occupancy and size require a fire protection system within the ramp area. Upgrade to fire alarm system needed to meet current codes. Stairways lack proper rise/run and handrails.

Chipped and/or damaged wall in numerous locations. Flooring is damaged and inconsistent. Layout exhibits obsolescence.

Defects: Water stained ACT and gypsum; damaged sheathing; aged and damaged interior doors. Potential for asbestos based on age of the structure and 9x9 floor tile. Damaged flooring and potential mold in sub levels.
