**Appeal of the Department Determination for
934, 938, & 942 Ashland Avenue**

Expert Report of John Trostle

Violations of the Covenant of Habitability, Including Conditions that are Hazardous for Tenants' Health and Safety, at 934/938/942 Ashland Avenue

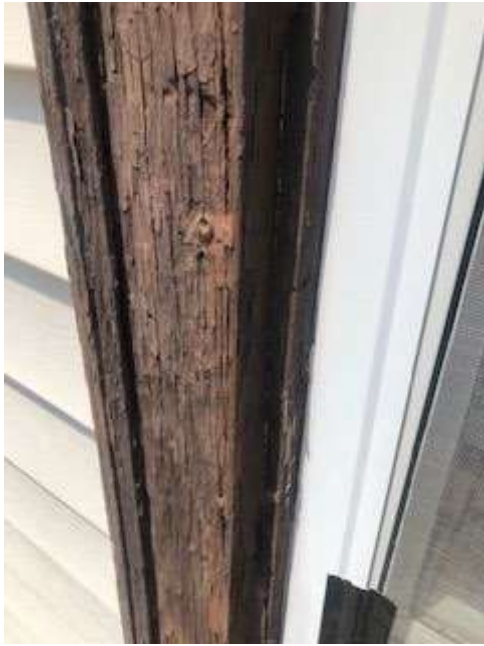
All three building exteriors have areas of wood rot and peeling paint in the siding as well as the wood trim at the doors and windows (see pictures 1-4, below). The gaps at the wood trim and casings cause ongoing water penetration and have contributed to the visible damage in the walls and ceiling cavities (as evidenced by conditions like wall cracks and bulging ceilings—examples of which are documented in pictures 26-28 later in this report). These gaps also present the significant danger of mold developing, or having already developed, in wall and ceiling cavities at common areas and tenant units, which may not yet be visible at the surface. Furthermore, there are gaps present at some upper eaves to the buildings where metal fascia has pulled away from the bottom edge of the roofing.

As for the peeling paint at the stucco, siding, and trim, this represents a danger due to the likelihood that it is lead-based paint. I understand that the three buildings were constructed in 1904, and thus there is a presumption that lead-based paint was used. The peeling flakes of presumed lead-based paint on the exterior of the Ashland Apartments pose a health risk.

1: Rotting/peeling exterior trim

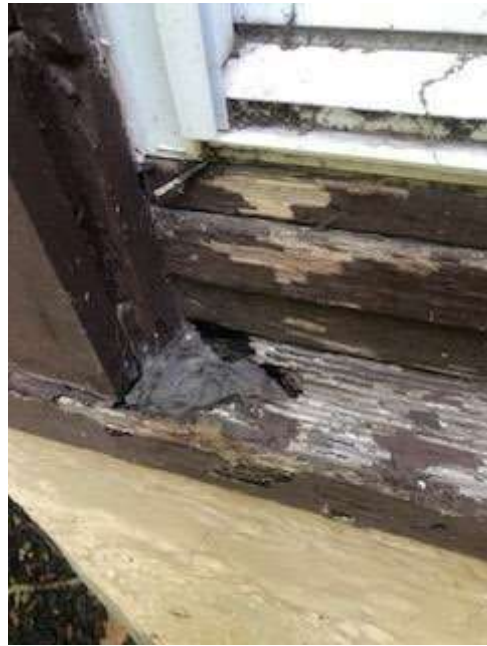
2: Rotting/peeling exterior trim and cavity

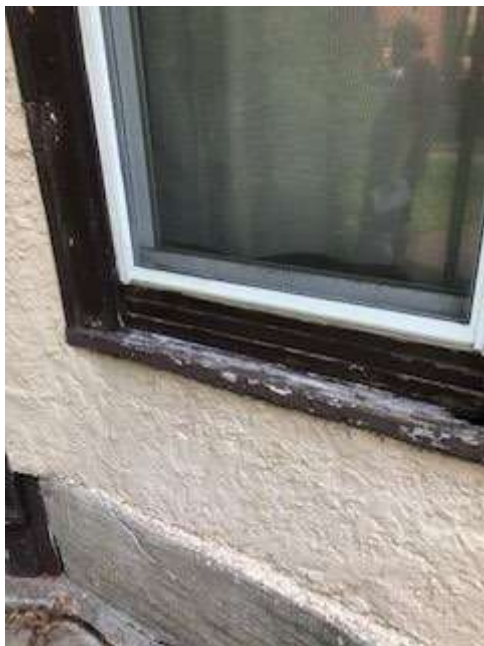
3: Rotting/peeling exterior trim

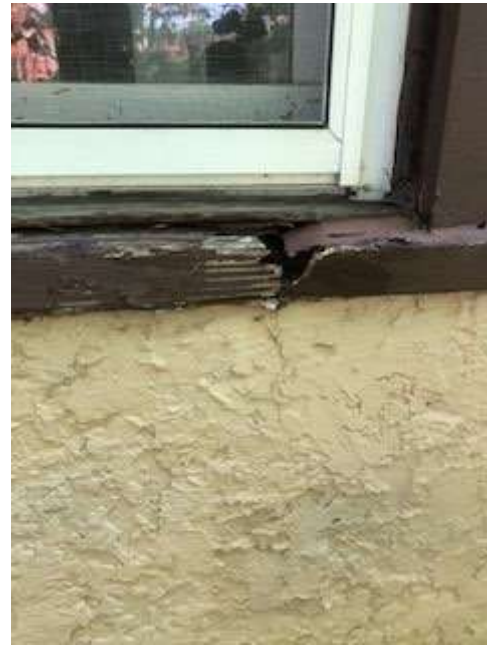
4: Rotting/peeling exterior trim and cavity

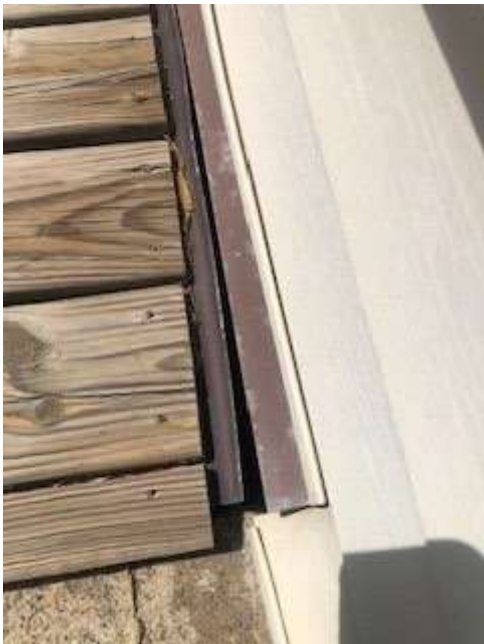
Additionally, Building #938 features a rear stairway that has a broken step, loose handrail, damaged stringer support, and separation at the entrance to the adjoining unit. Building #942 features another rear wooden balcony that is extremely wobbly and separating at the adjoining unit entry. See pictures 5-7 for examples of these conditions. A video of the condition of Building #942 balcony is included with this appeal as “Trostle: shaking upper rear balcony video.”

5: Wooden balcony separating from siding

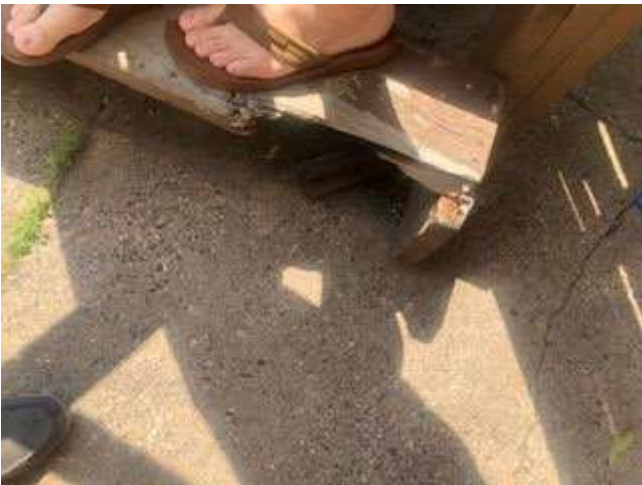
6: Broken step at rear stairs to unit entry

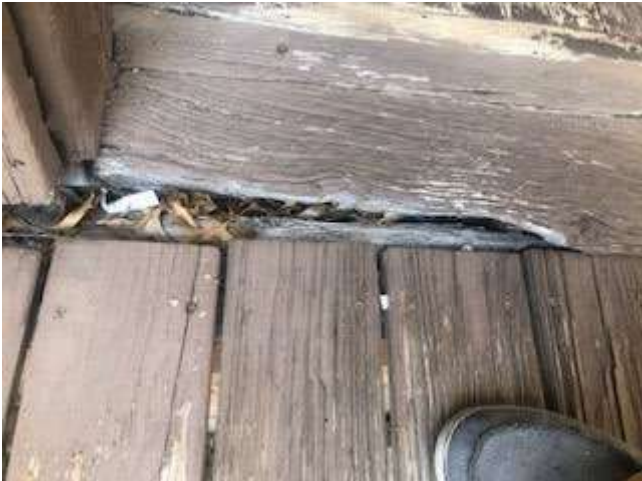
7: Cracked wood at top step for rear stairs to unit entry

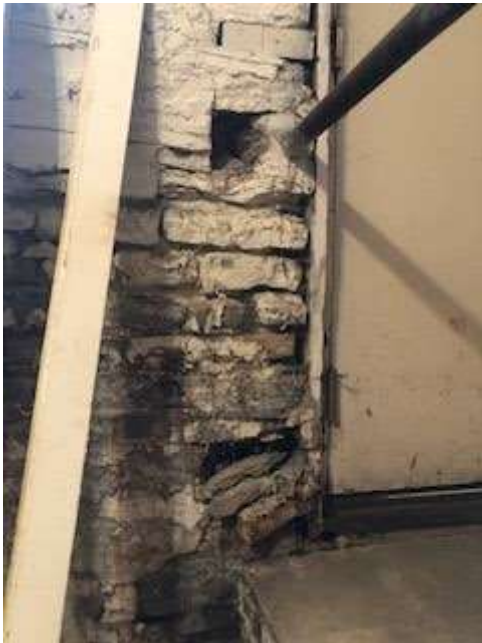
The foundations of each of the three buildings comprising the Ashland Apartments are stone, with some areas of concrete block. My inspection revealed significant wear and large openings at the stone foundations and parge coats (see pictures 8-11). Because the stone contains lime, the mortar joints tend to deteriorate over the many decades after the buildings were constructed, and simply repairing the visible worn mortar areas will likely not completely correct the water infiltration issues. This is due to the visible damage at the concrete step pathways between buildings and mortar wear not presently exposed (see pictures 13-14).

8: Settling and holes in foundation

I strongly recommend that the foundations of all three buildings be evaluated by a contractor specializing in foundation and structural issues. It is clear that the buildings are actively settling and a patchwork approach to the repairs to the foundation and concrete steps between buildings will not correct the water infiltration problems. Importantly, the foundation settling poses a risk to tenants through its perpetuation of existing issues like water seepage causing flooding and mold, cracks in walls and ceilings, and uneven floors. Picture 12, below, demonstrates the flooding that regularly occurs during rainstorms in the basement of Building #934 (in the storage area serving Unit 5) due to the severe foundation issues.

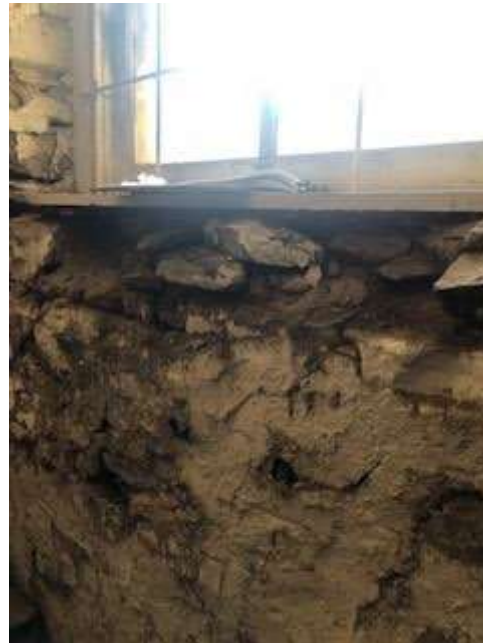
9: Deteriorating foundation at basement window

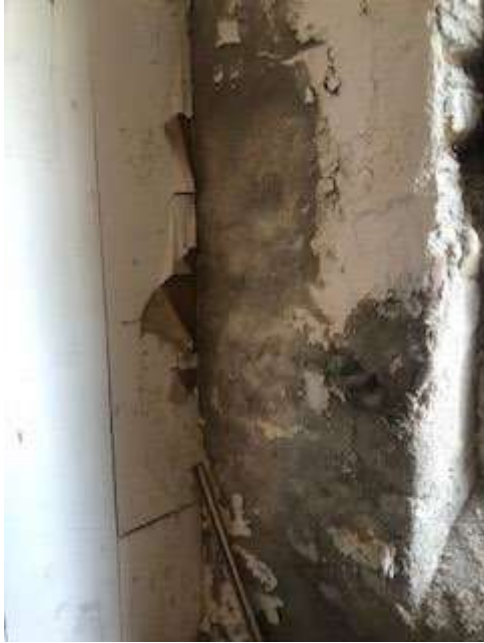
10: Flaking paint and worn foundation

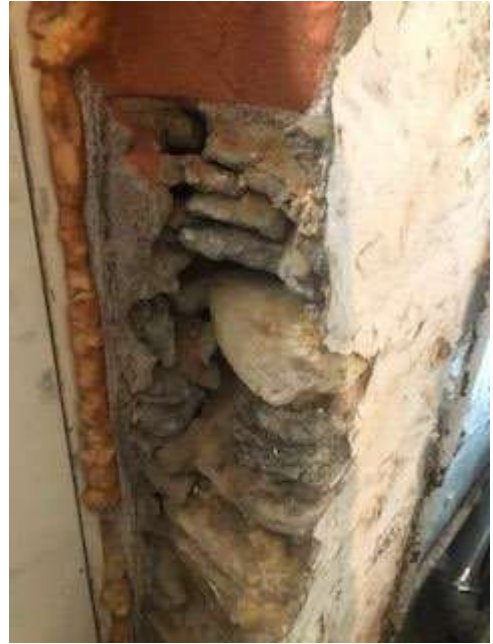
11: Settling foundation with holes

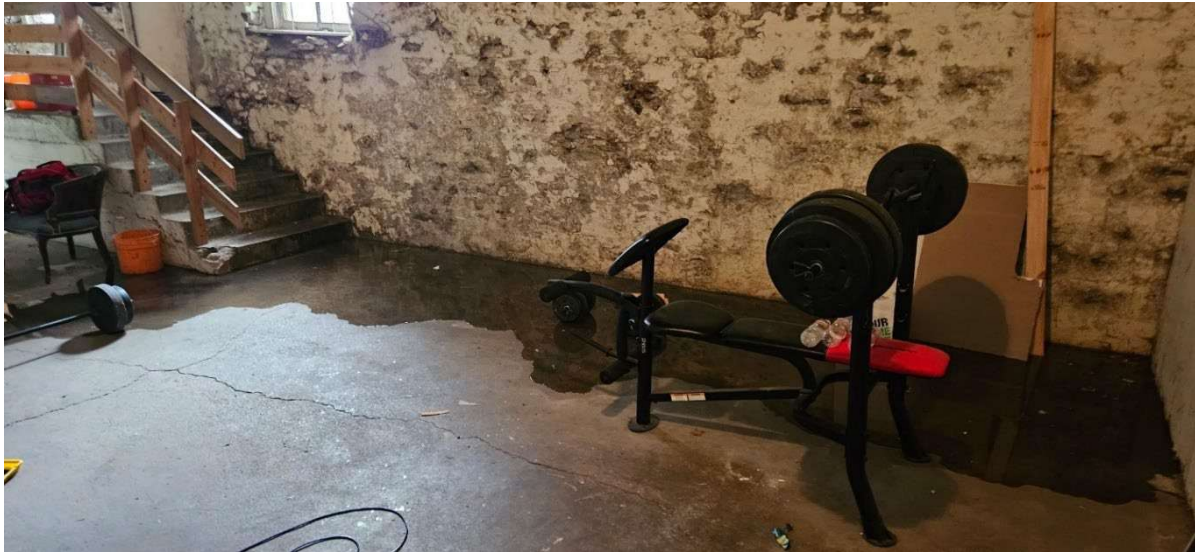
12: Water infiltration and flooding in entry/storage to Unit 5 due to deteriorating foundation (photograph taken by Mr. Cornell on June 16, 2025)

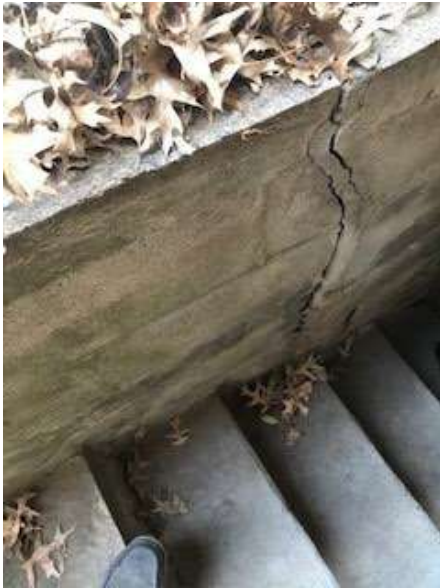
Cracks, damage, and gaps at wall joints to exterior concrete steps are contributing to water infiltration (see pictures 13-15).

13: Cracks at concrete steps to Unit 5

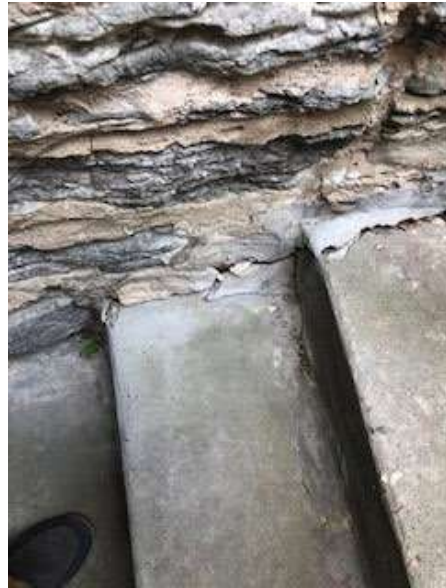
14: Mortar gaps at concrete steps to Unit 5

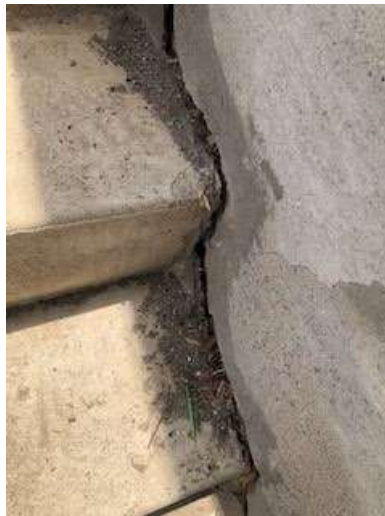
15: Mortar gaps at concrete steps to Unit 5

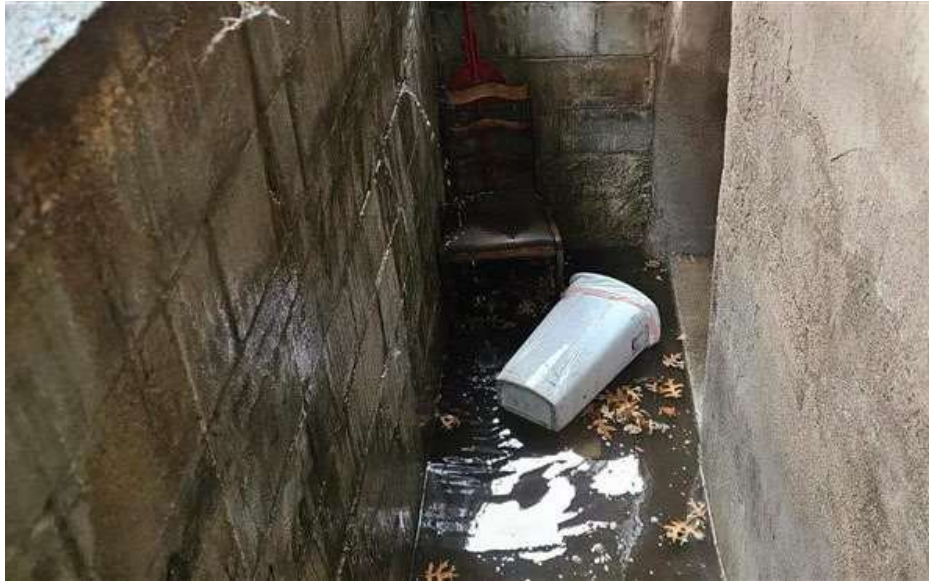
As shown in pictures 16-17, the entryway to Unit 5 in Building #934 (the basement unit) experiences upwards of several inches of flooding during rainstorms due to the infiltration of water through the foundation and cracks in the steps, as well as the lack of drainage at the base of the steps. Picture 16 illustrates the active streams of water coming through gaps in the wall and pooling at the entryway. This flooding—along with the subsequent standing water at the unit entry and the water infiltration into the unit, causing mold and flooring damage—constitutes a danger to tenants and visitors' health and safety, including children who are present in the basement unit.

16: Flooding resulting from gaps and cracks at concrete outside entry to Unit 5
(photograph taken by Mr. Cornell on June 16, 2025)

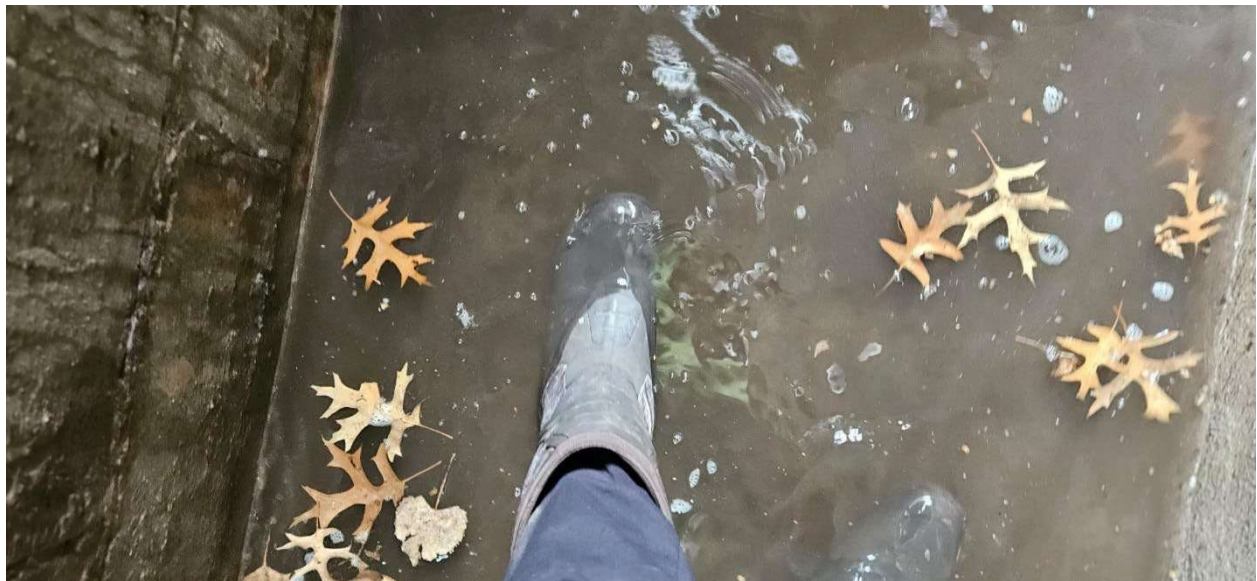
17: Several inches of water from flooding at entry to Unit 5
(photograph taken by Mr. Cornell on June 16, 2025)

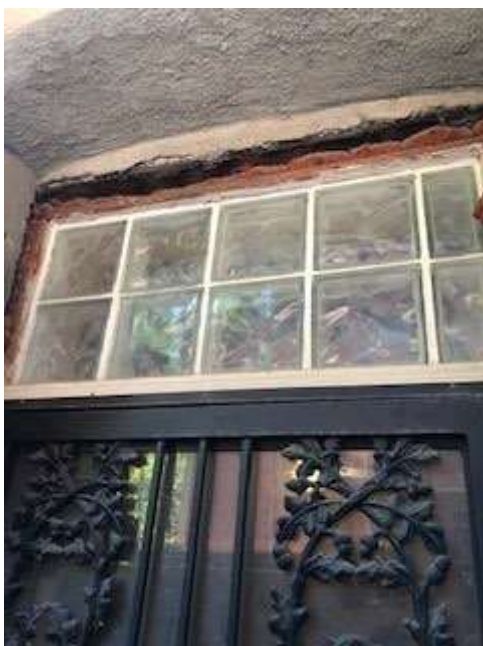
Due to settling, the exterior door to the laundry room and several individual units with primary doors to the exterior have gaps which must be corrected to seal properly (see picture 18).

18: Gaps at glass above exterior door to Unit 5

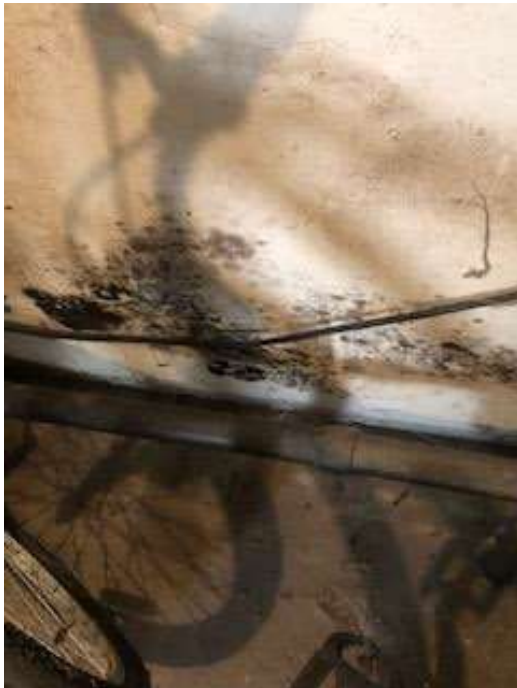
In the laundry room within Building #942, which serves all tenants, there exist highly concerning areas of mold spotting (see pictures 19-20). This appears to be black mold, which poses

a severe threat to tenants' safety when they are using the laundry room and breathing in spores present in the air. In addition to the mold, the walls of the laundry room are otherwise damaged and stained. These are plainly dangerous conditions and some of the most concerning within the buildings.

19: Mold at laundry room walls

With specific regard to the mold issue, it is my professional opinion that the Ashland Apartments will remain in their current dangerous condition without moisture/mold testing in all exterior wall cavities as well as significant abatement efforts for all visible mold in tenant units and common areas like the laundry rooms. I do not believe that this pervasive issue will be resolved without such property-wide efforts by a qualified professional.

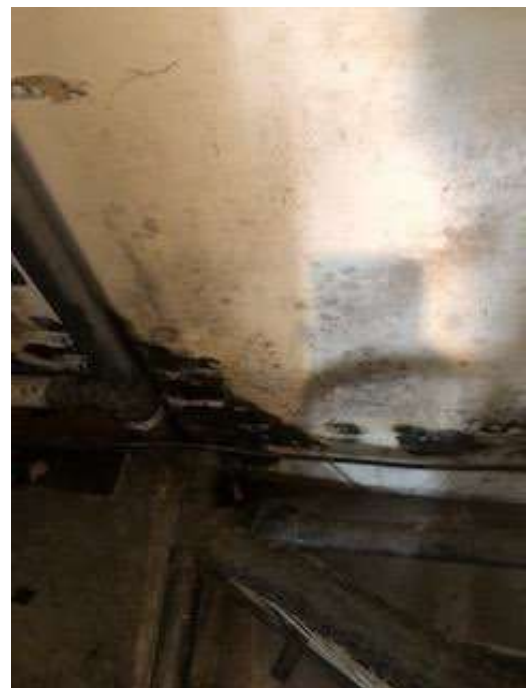
20: Mold at laundry room walls

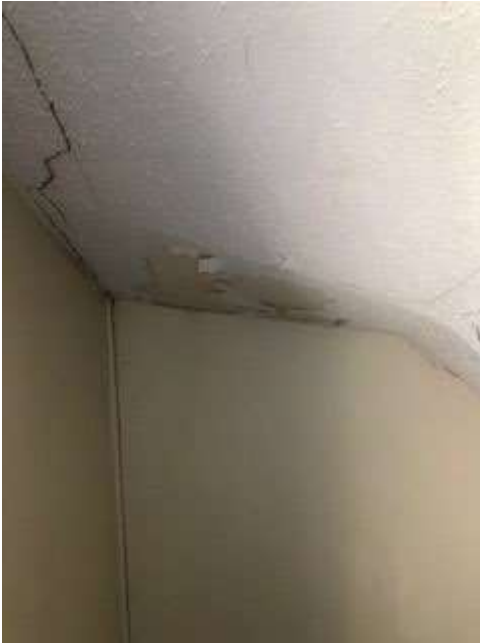
In other common areas, I observed bulging and cracking of various walls and ceilings in the halls and stairways (see picture 21). There is also general damage, staining, and paint wear in these areas that have been left unrepaired (see picture 22). The holes such as that shown in picture 21 may allow rodents and other pests to enter the building.

21: Ceiling flaking and cracking in hallway

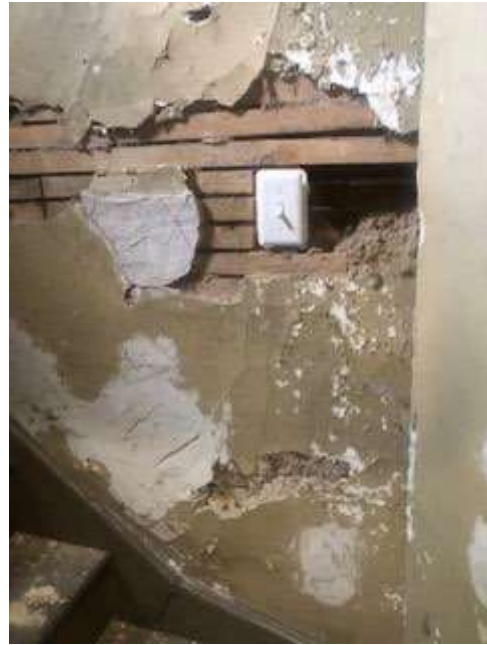
22: Wall deterioration at stairway

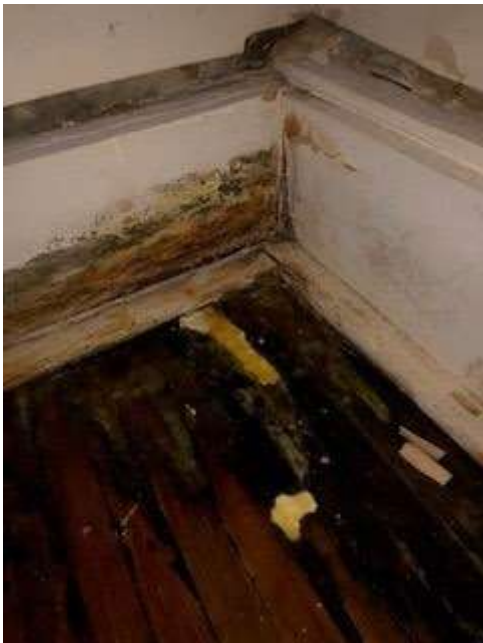
Tenant units accessed in all buildings have various problems related to their walls and ceilings. For one, I observed multiple instances of mold inside units, including on baseboards and in unit showers (see pictures 23-26). There are also many settling cracks and bulging within units, likely due to the buildings' foundation problems (see pictures 27-29). I observed other instances of neglect like peeling paint and staining. I also discovered loose wall panels in tenant units in areas like behind the stove, in bedroom closets, and in shower tubs.

23: Mold/rot at baseboards and flooring

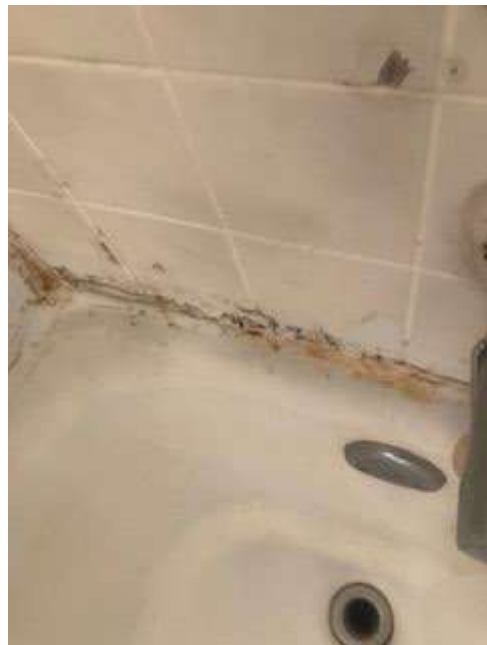
24: Mold and deterioration in unit shower

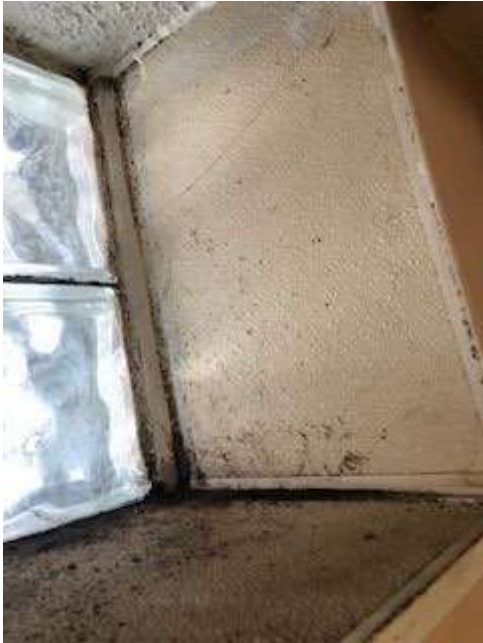
25: Mold at glass block window in unit shower

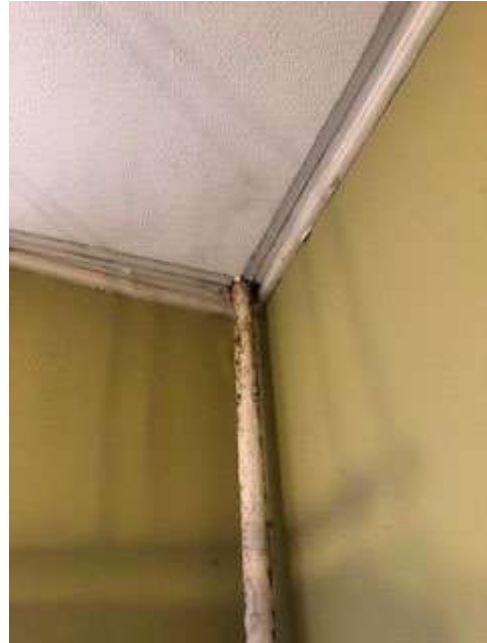
26: Mold/rust on exposed pipe

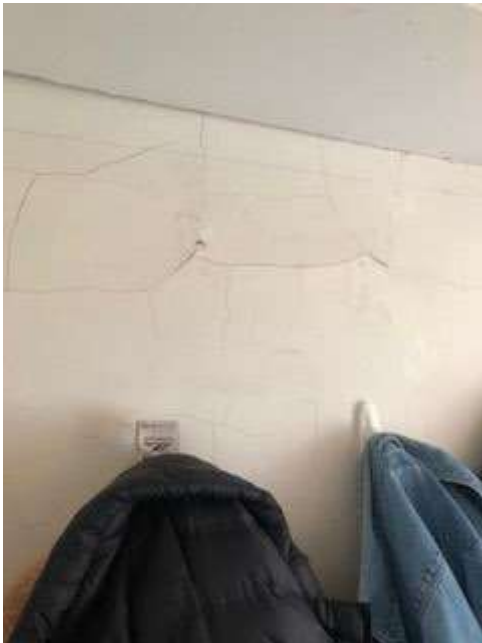
27: Wall cracks in tenant unit

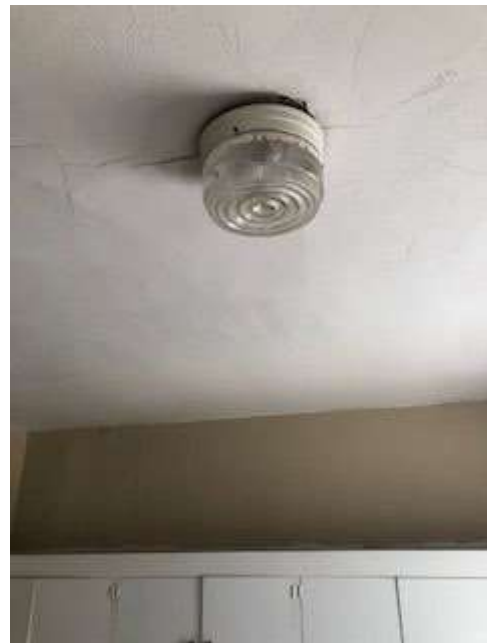
28: Cracking near light fixture in tenant unit

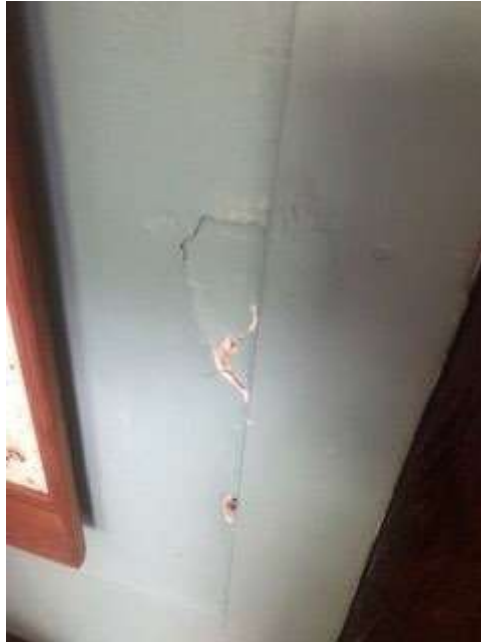
29: Wall cracks in tenant unit

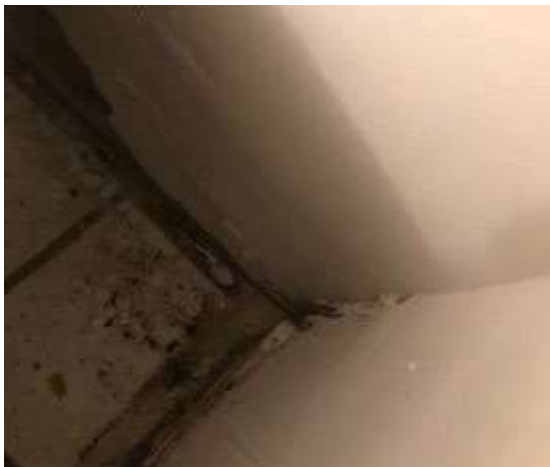
My inspection revealed problems with the flooring in all observable units. Specifically, I found flooring that was significantly damaged, settled, cracked, or completely missing in some corners (see pictures 30-32). There are also instances of shoddy repairs using duct tape (see picture 33), and loose hardwood flooring in all units. Additionally, there are loose and damaged kitchen floor tiles present in Unit 6 within Building #938.

30: Damaged flooring in tenant unit

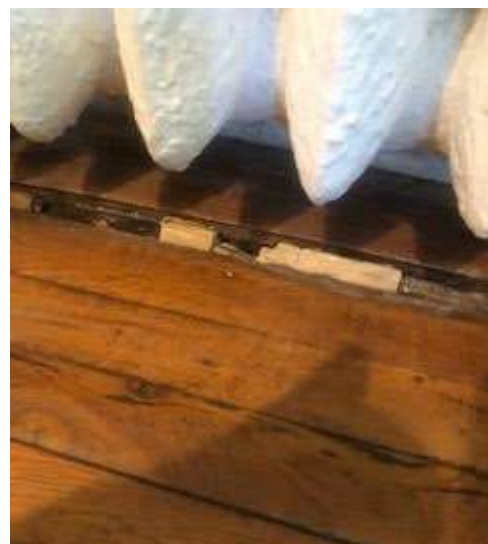
31: Crack in floor under radiator in tenant unit

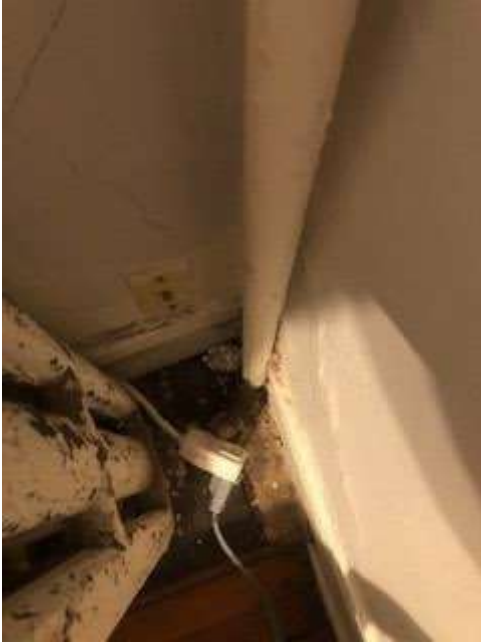
32: Missing flooring in tenant unit

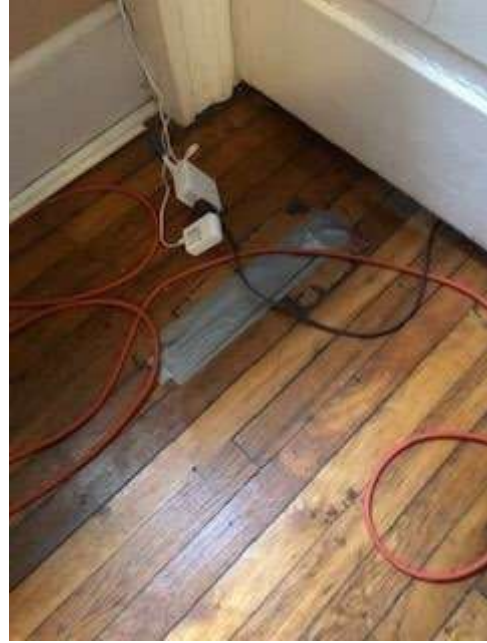
33: Tape to repair flooring in tenant unit

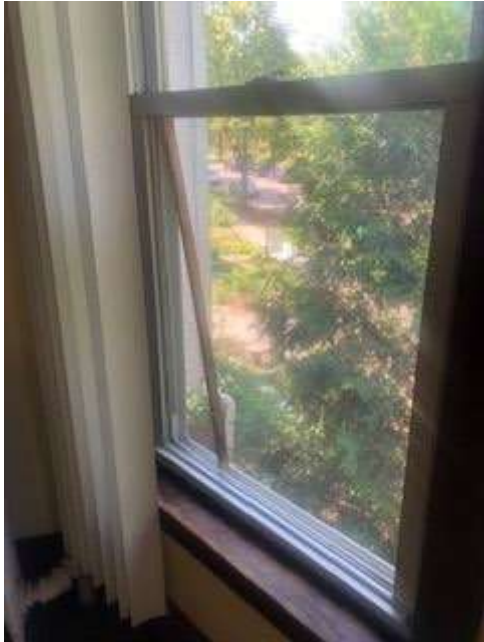
In Unit 11 within Building #942, the upper sash of a living room window is slipping (see picture 34). This means that the upper portion of the window is unable to stay up and closed, and this tenant has had to wedge a wooden post in the window to ensure that it remains closed. I observed other units where tenants have had to use wooden posts to keep their windows closed, such as Unit 9 within Building #942 in which the upper sashes of the bedroom windows are slipping (see picture 35). Additionally, the upper sashes of windows in the living room and kitchen are sagging in Unit 1 in Building #934, though the tenant has not used posts to keep them up.

34: Tenant window held up by wooden post

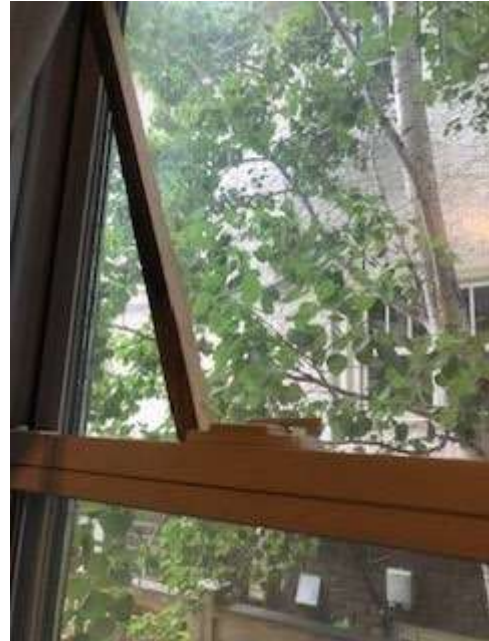
35: Tenant window held up by wooden post

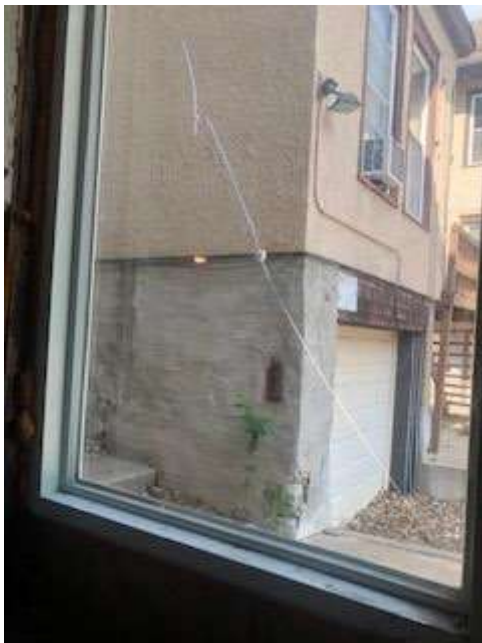
In Unit 6 within Building #938, the living room window glass is cracked and the rear bedroom windows have damaged tilt pins. The laundry room window in Building #942 is also cracked with a small hole that indicates an apparent BB-gun shot or similar incident (see picture 36). In Unit 10 within Building #942, the kitchen includes one window with a large hole in the broken glass (see picture 37), as well as another window with an upper sash that slams down and will not stay closed.

36: Cracked window in laundry room

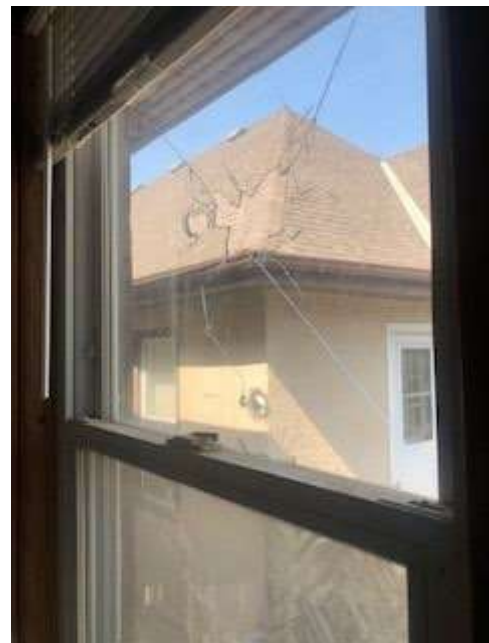
37: Hole in tenant window

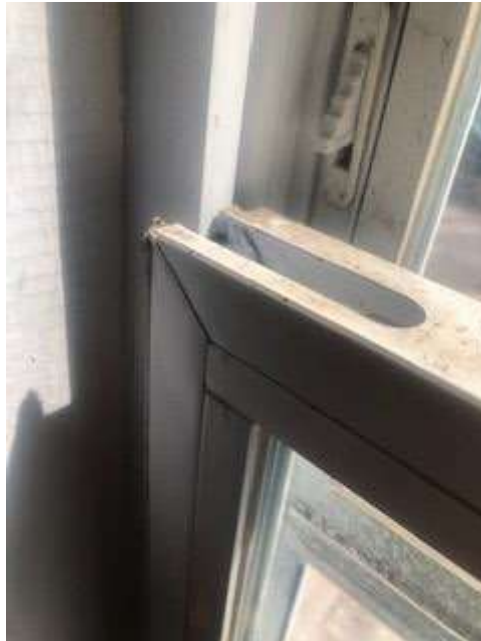
As a general matter, living room and bedroom windows in tenant units across the three buildings include slipping sashes and missing screens. Units also include windows that are off their tracks and do not seal properly (see picture 38).

38: Tenant window off track

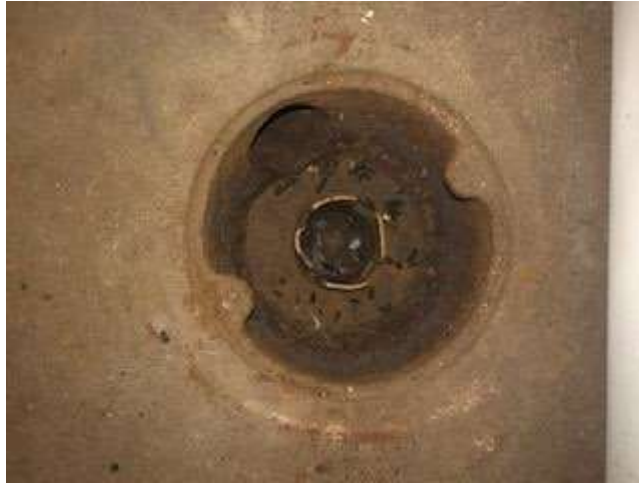
In the laundry room common space, the floor drain is clogged and the clean-out plug is missing (see picture 39). The lack of a clean-out plug means that sewer gas may enter the room, which is dangerous for tenants' using the laundry facilities. It also allows sewer smells to seep into the space. Additionally, the lack of a clean-out plug can allow rodents to enter through the pipes, as evidenced by rodent feces that were present in the floor drain shown in picture 39.

39: Laundry room floor drain missing clean-out plug, with rodent feces present

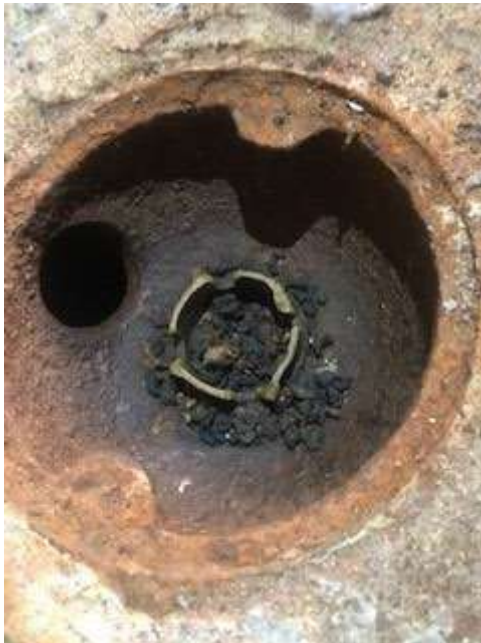
The floor drain in the basement area of Building #934 (which serves as a storage and gym area for Unit 5, seen above with flooding in picture 12) has another clogged floor drain with missing clean-out plug (see picture 40). Again, the lack of a clean-out plug allows sewer gas and smells to enter the space, posing a risk to the health of the Unit 5 tenant who regularly uses this area and has children. I also observed an uncapped plumbing vent pipe sealed with a rag in this room.

40: Unit 5 storage area floor drain missing clean-out plug

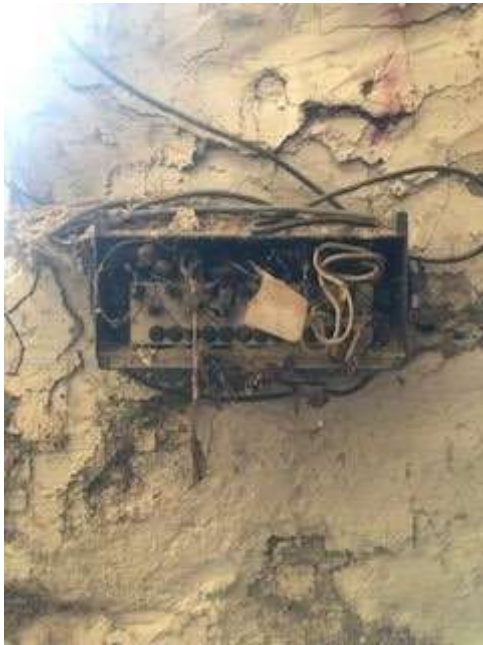
In the laundry room and other basement spaces open to tenants, I observed missing covers at electrical boxes, resulting in exposed wires (see pictures 41-42). In Unit 11 within Building #942, there are open ground 3-prongs at the electrical receptacles in the living room, front bedroom and dining room, which can pose a risk of electrical shock to tenants and damage to electrical appliances (see picture 43). Unit 11 also requires smoke and carbon monoxide detectors in the hallway. In Unit 9 within Building #942, the living room fan light severely wobbles when the fan is running, and is missing a globe cover (see picture 44). Many lights within tenant units have missing covers and globes (pictures 44-45).

41: Electrical box missing cover

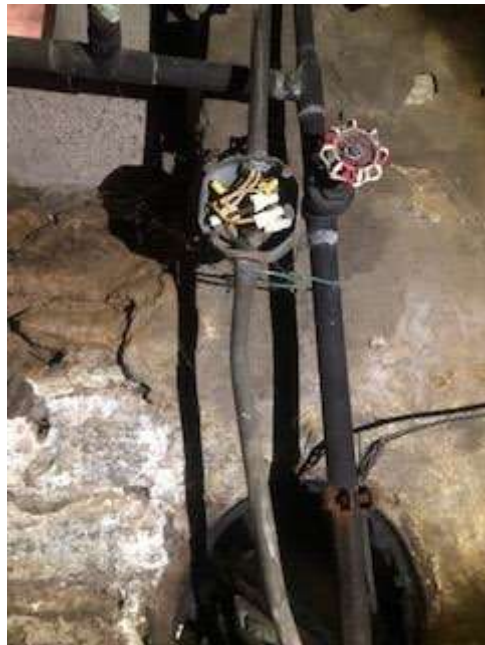
42: Electrical box missing cover

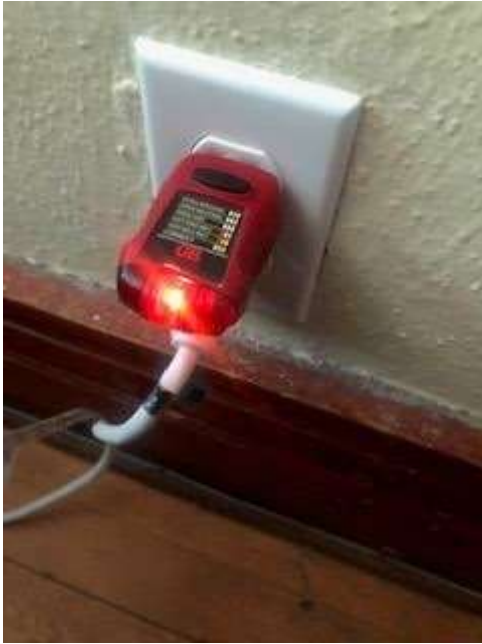
43: Testing unit showing open ground outlet

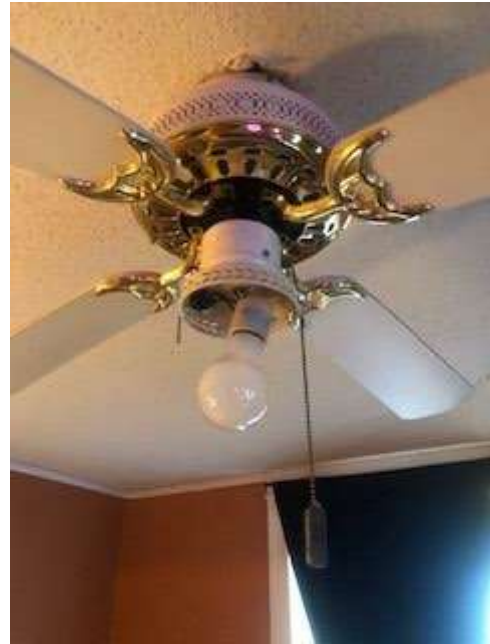
44: Wobbly fan in tenant unit w/o cover

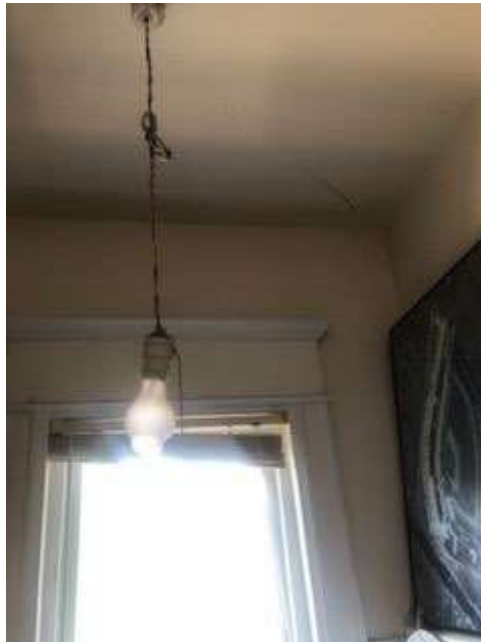
45: Light in tenant unit w/o cover

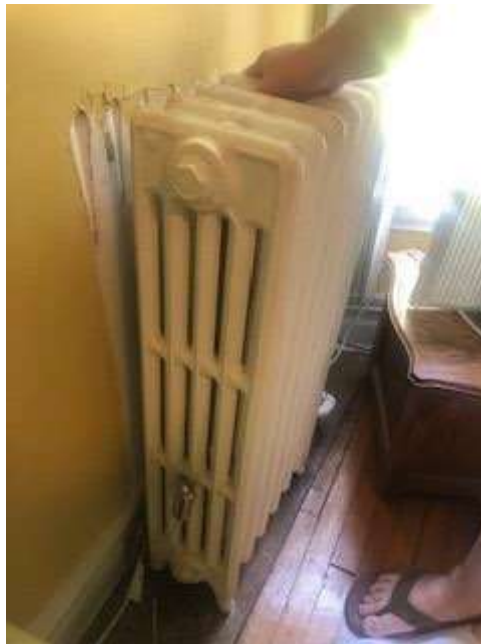
The final area in which I found noncompliance with general habitability standards is the heating of the three buildings comprising the Ashland Apartments. The boiler units show no indication of regular servicing. I also observed numerous loose radiators, including one shown below in the living room of Unit 6 within Building #938 (see picture 46).

46: Loose radiator in tenant unit
