Inspection Report for: 188 Acker St. E Saint Paul, MN

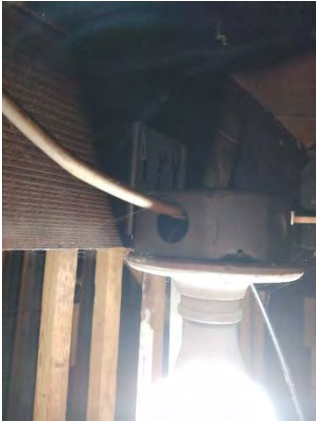
1. Bushing needed to make safe

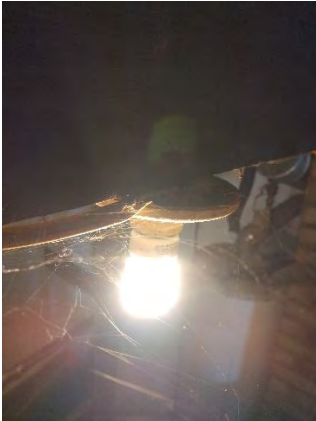
2. Box required for light fixture in basement.

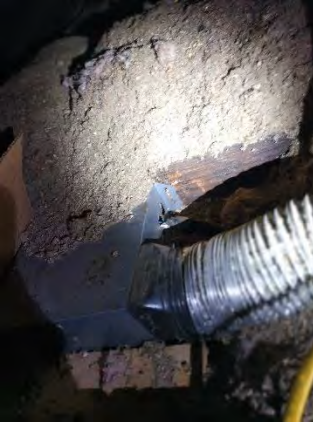
3. Fan tied into old knob and tube wiring, requires new wiring to circuit not on knob and tube

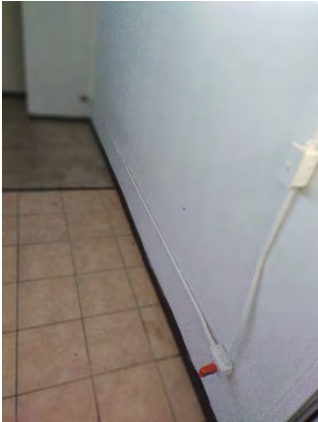
4. Outlet has no power, more investigation needed or removal of outlet.

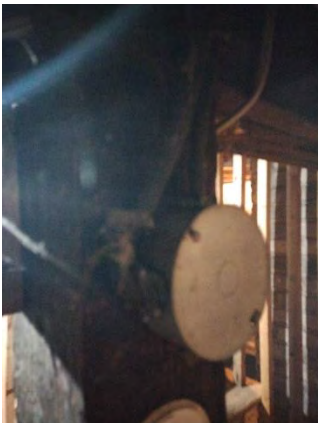
5. Knob and tube tied into informative note only likely no action needed.

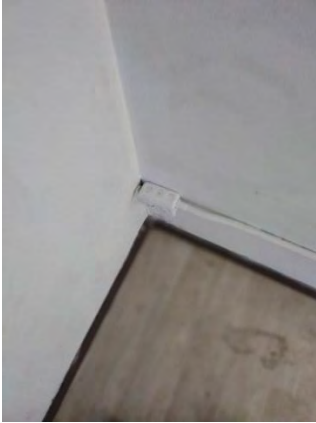
6. Box not secure to wall, required to attach box securely to wall.

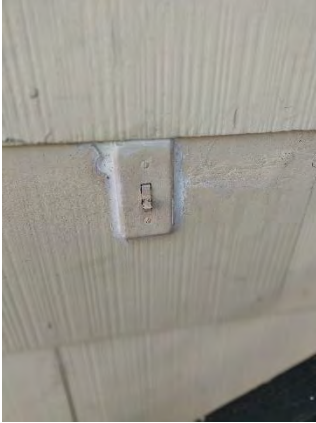
7. Switch is not rated for outdoor/wet location new cover listed for use in wet location required.

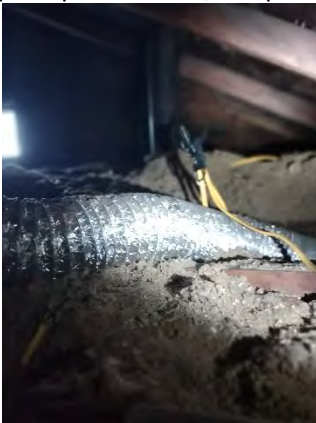
8. Open splice in attic, all splices required to be inside a listed electrical box.

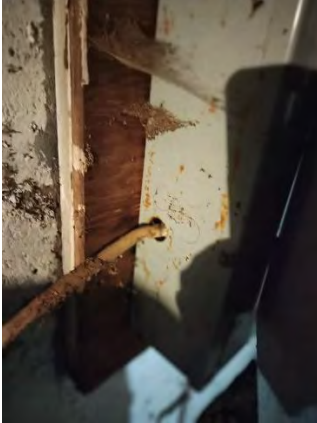
9. Bushing required at main electrical panel.

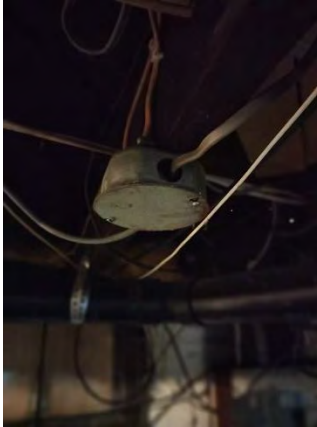
10. Bushing required in basement junction box.

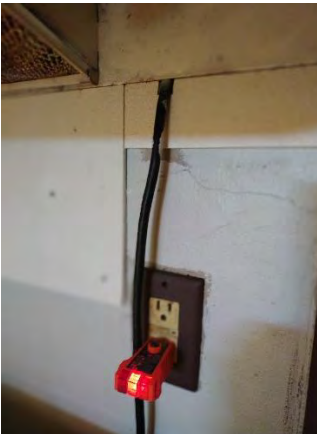
11. Hood power cord improperly installed, risk of shorting circuit. Requires dedicated hood circuit and accesable outlet or hard wiring of hood.
