**Subject:** 1059 Minnehaha Ave. E Appeal

**Date:** Thursday, November 17, 2022 3:34:39 PM

File #: 16 - 056670

Folder Name: 1059 MINNEHAHA AVE E

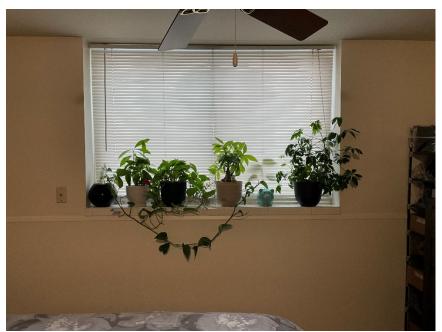
Unit 6 Window has bars on exterior but also has 2 other separate and means of escape.

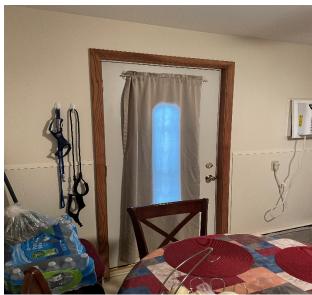
Unit 6 unit door leading directly to the outside.

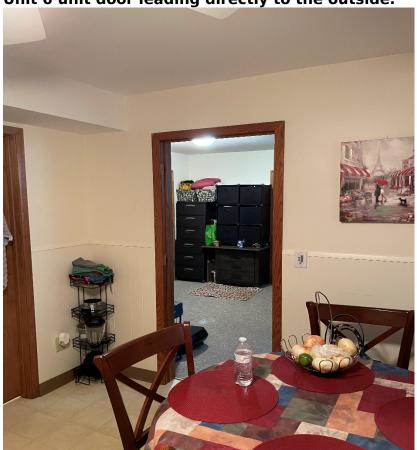
Unit 6 picture of kitchen going into bedroom.

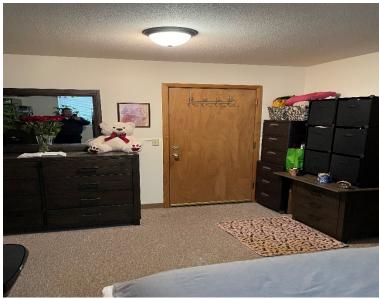
Unit 6 bedroom full size door leading into apartment hallway.

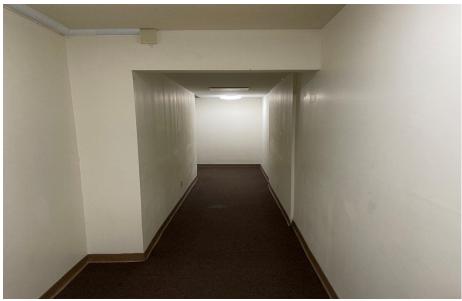
Hallway outside unit 6 facing north. Has washer and dryer to the left.

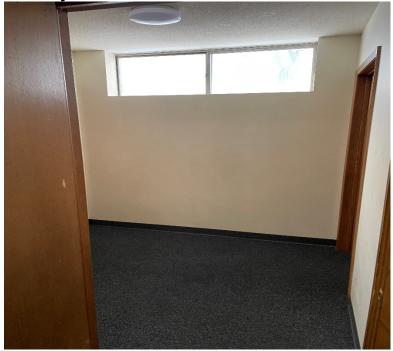
Door leading outside of hallway from Unit 6.

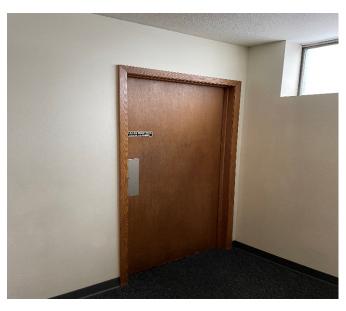
Door into 1 of 2 stairwells leading directly to exterior

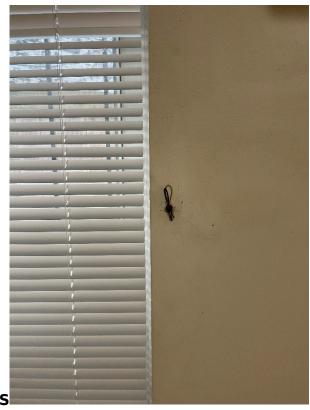
Pin to release bars from window in unit 1.

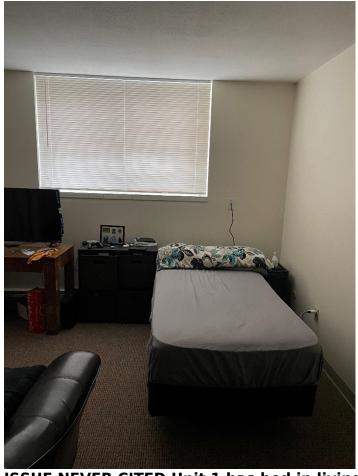
However one item not cited was the living room being used a bedroom and there are bars on the windows. I advised the owner he will be getting a new letter from me to remove or relocate the bed to an approved sleeping area.

ISSUE NEVER CITED Unit 1 has bed in living room that does not have any escape window. Owner advised must relocate bed to approved bedroom or remove.

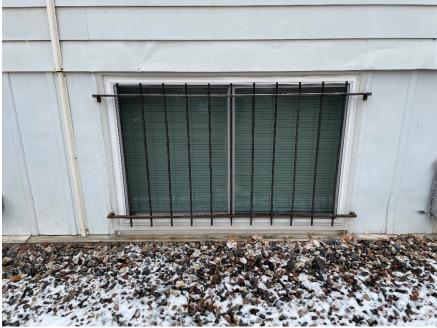
Unit 1 living room window from exterior showing no removable bars.

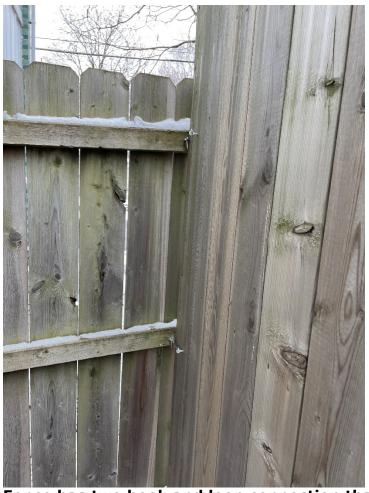
Fence has two hook and loop connection that are easily removable from the inside. Fence can also also easily be pushed over. (It was designed this way to allow escape.)
