**AEDS / Little Africa Building**

Structural Damage Assessment

Steel Roof Trusses/ CMU Walls

May 6, 2022

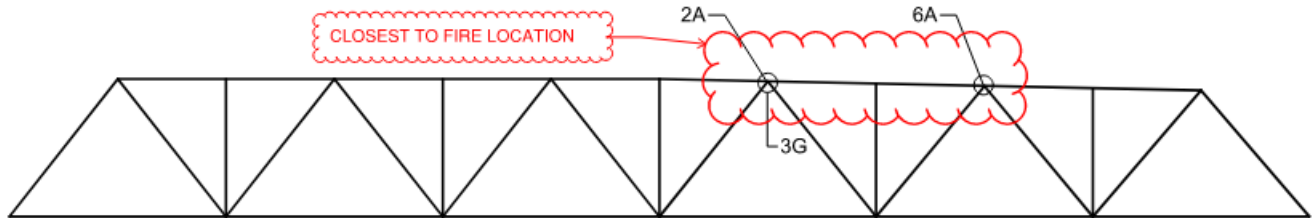
### T1 DIAGRAM

The long span roof trusses are constructed of steel angles and plates. The top and bottom chord and diagonal members are double angles. All connection points are made with gusset plates that are typically riveted and then bolted at construction splice points. Relative to the attached truss diagram, the T1 truss, located adjacent to the mezzanine, was closest to the fire with the T2 truss being nearby on the edge of the fire. The T3 truss was farther away and a sample was taken of the angles to act as the control sample for comparison. The diagram provided shows the layout of each truss and the location of the test samples. Samples 2 and 3 were observed to be closest to the center of the fire. The attached test results provide the data for each sample. Photos 1 & 2 are representative of the truss configuration.

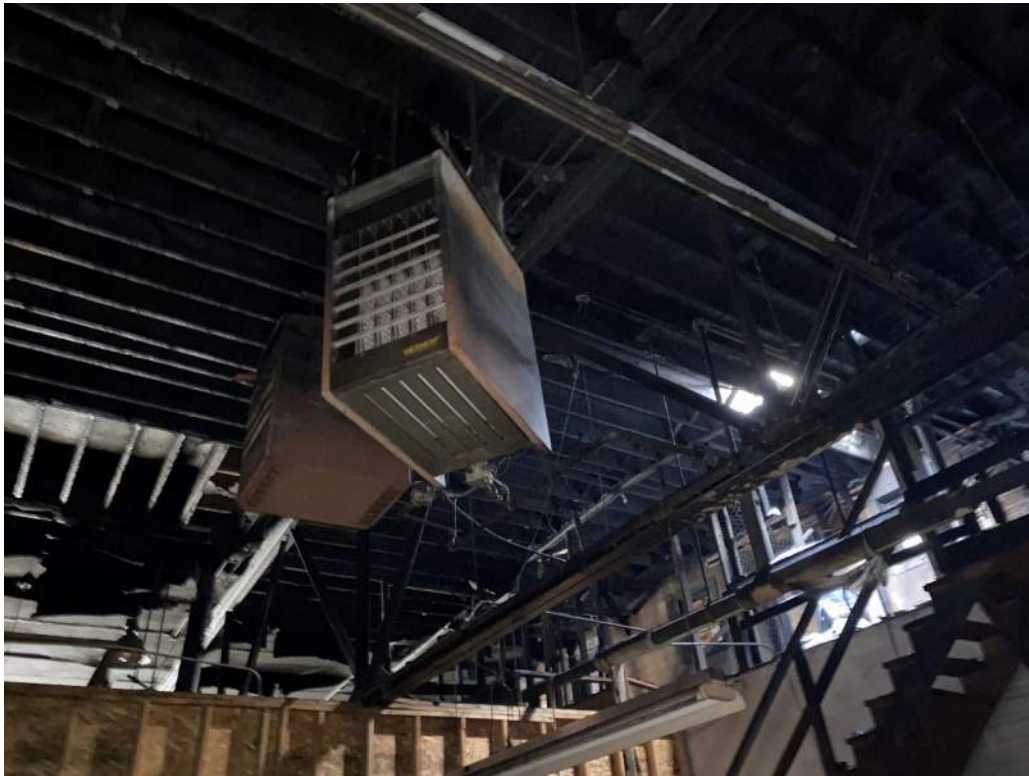
The conclusion of the steel testing report is that the steel roof trusses were not exposed to the fire long enough to cause any damage. The steel trusses can be reused in place when the wood framing is replaced. During the demolition process of removing the damaged wood framing, the lateral stability of the trusses should be maintained. Temporary lateral bracing may be required during the construction process.

**PHOTO #1: View of T1 truss near file location.**

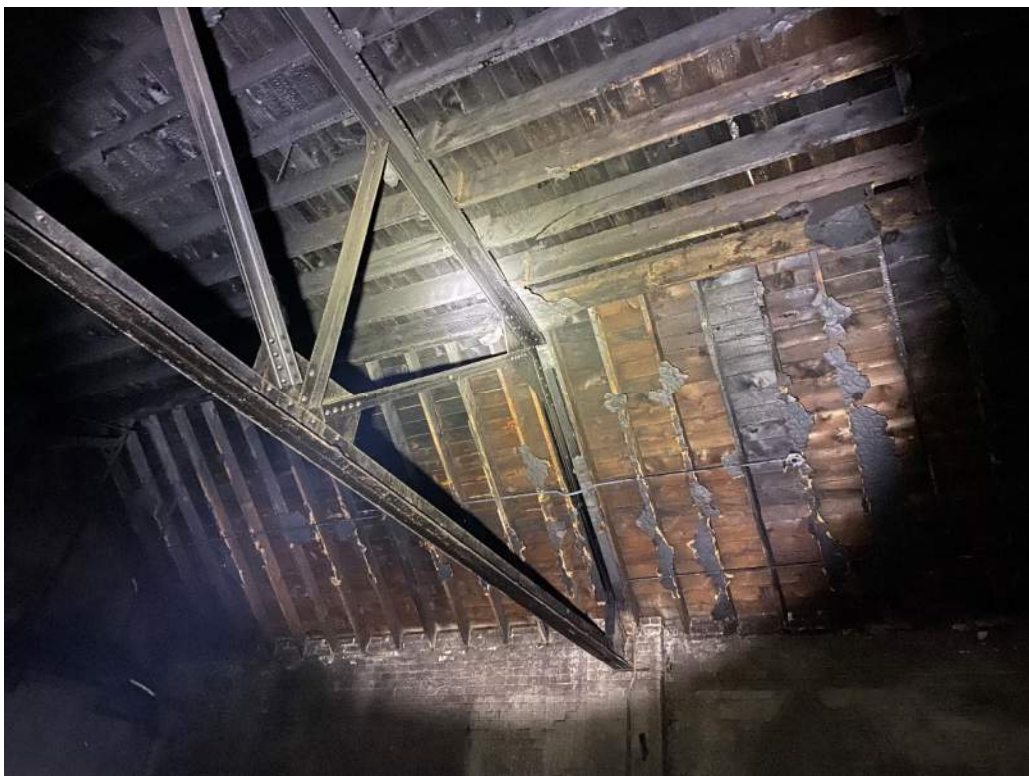
**PHOTO #2: View of north end of T1 truss.**

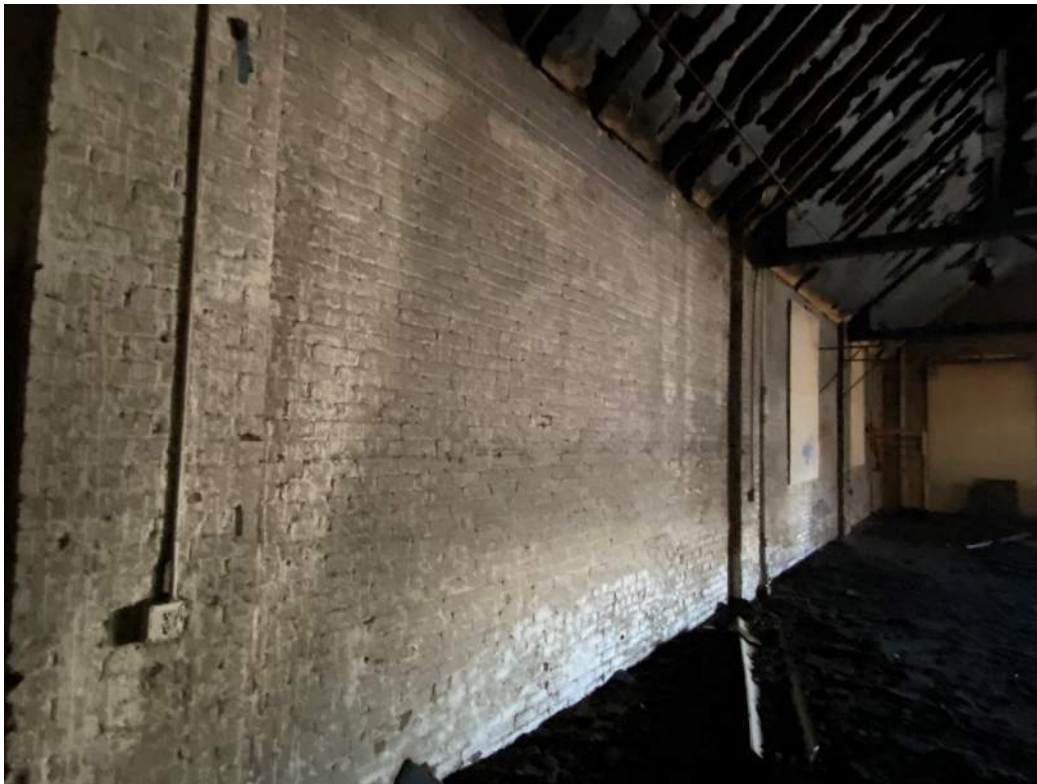
The masonry wall adjacent to the fire was also reviewed. From visual observations it was readily apparent that the primary heat of the fire did not reach the north wall which was closest to the fire. The wall is painted and there were not any indications of paint bubbling on the surface. The wall appears to be dirty from smoke exposure which is typical for fire conditions like this. See Photos 3 & 4 for visual reference.

The masonry walls adjacent to the fire also appear to be in relatively good condition as they were not damaged in the fire. However, there may be some repairs necessary for future occupancy that are more visible on the exterior of the building that are related to water damage issues. These conditions are not part of this report but should be considered for the proposed upgrades to the property.

**PHOTO #4: View of North wall closest to fire location**
