PORT AUTHORITY OF THE CITY OF SAINT PAUL  
[Parcels 2 and 6 – Substandard Building and Coverage Findings]

### **Proposed Redevelopment**

*Former St. Paul, MN 3M Corp Campus  
(Beacon Bluff Redevelopment)*

Compass Rose, Inc No. STPPA-001

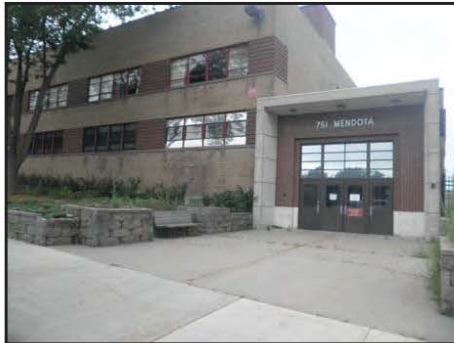
Overview

Defects in exterior building shell Deteriorating and rotting wood structure at column and floor points, masonry foundation wall and bearing points show evidence of settlement cracks, mortar joints missing/loose voids in brick grout, cracks settling in concrete at various locations.

Chipped and/or damaged drywall in a few locations. Numerous tripping hazards and lack of guard rails at floor openings. Layout exhibits obsolescence.

Defects in exterior building shell: window frames need paint, glazing broken or missing: deteriorating brick and block: roof leakage problem exists: water-damaged ceiling areas need to be replaced: rusted exterior metal doors. Asbestos and lead hazards have been identified and is considered critical level in various locations.
