Foundation Inspection

852 4th St

St. Paul, MN 55106

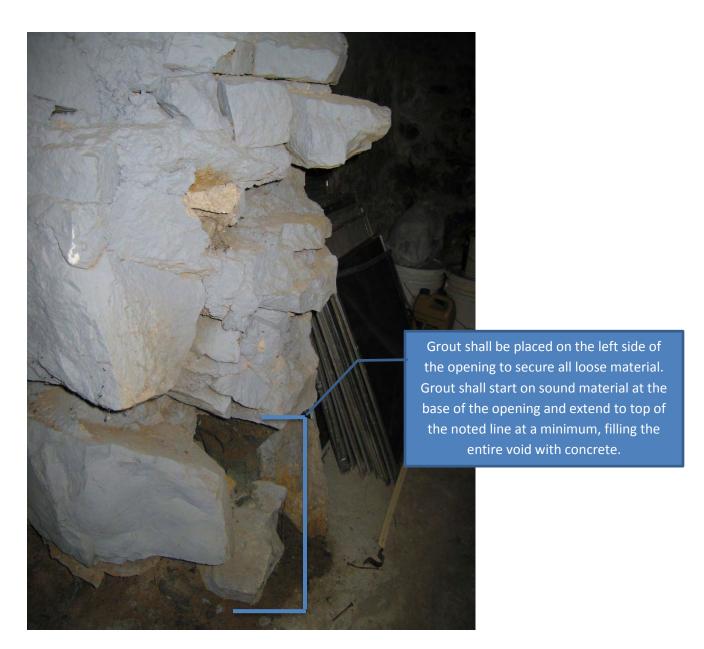
Picture A: Left side of doorway

To the right of the stairway a hole has been placed in the foundation wall. This hole serves as a doorway for possible storage. The attached Exhibit A contains pictures this doorway. It is my recommendation that the lower parts of the doorway (Pictures A & C) and the upper part of the doorway (Picture B) be grouted and/or tuck pointed to prevent any further degradation of the stone in this area.

The concrete grout used to repair this area shall have a compressive strength no less than 2000 psi and use aggregate no larger than 0.75 inches in diameter. The existing loose rock may be used as filler in this area provided that they are fully grouted into place.
