**Date:** September 15, 2011  
**File #:** 11 - 276186  
**Folder Name:** 23 ISABEL ST W  
**PIN:** 072822110042

**HP District:**  
**Property Name:** O.A. Beal House  
**Survey Info:** RA-SPC-1952

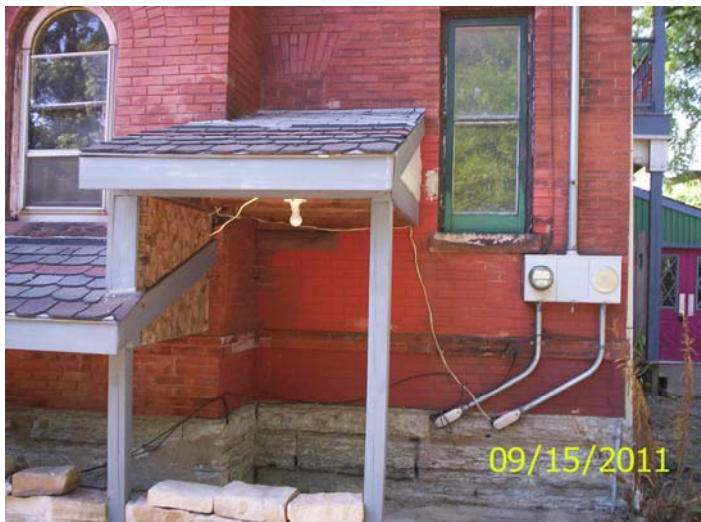
Unapproved exterior electrical wiring

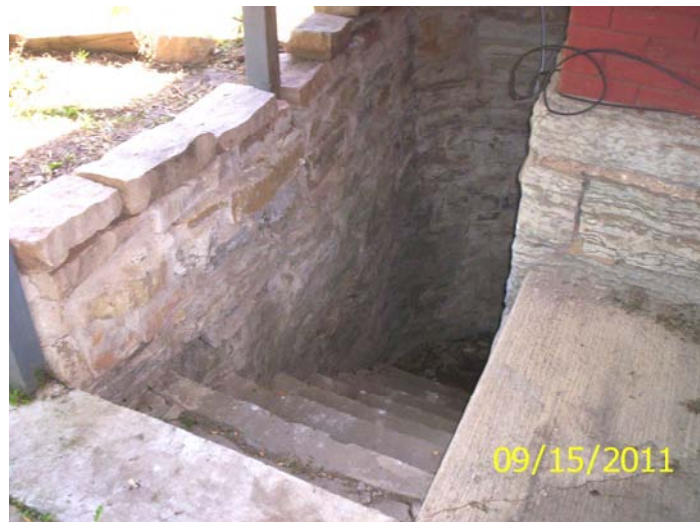
Bulge in wall, deteriorated masonry

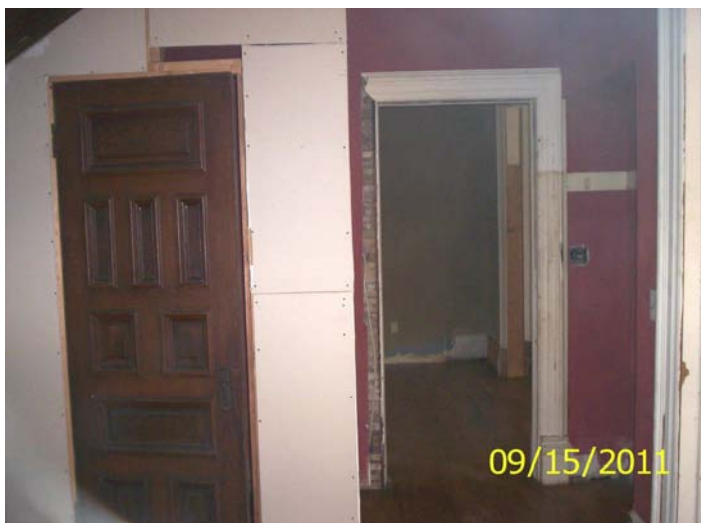
Unfinished rehab

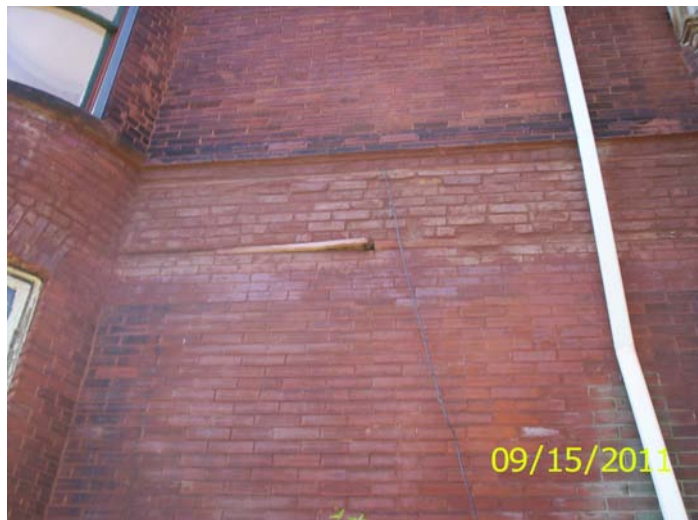
**Open wall**

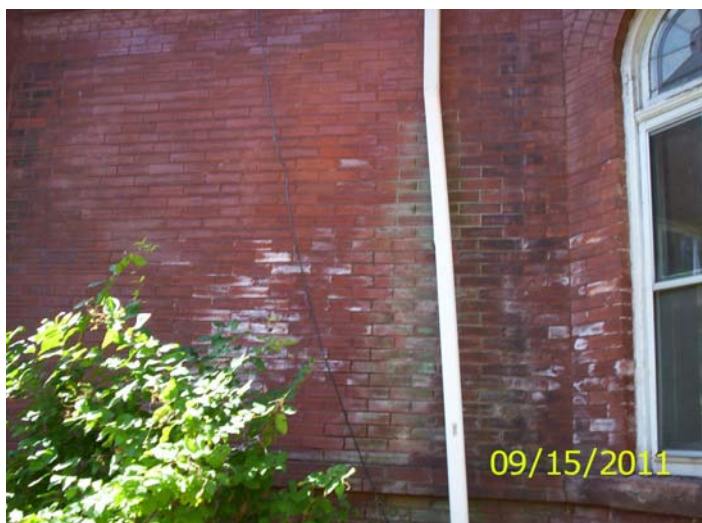
**Water damaged masonry**

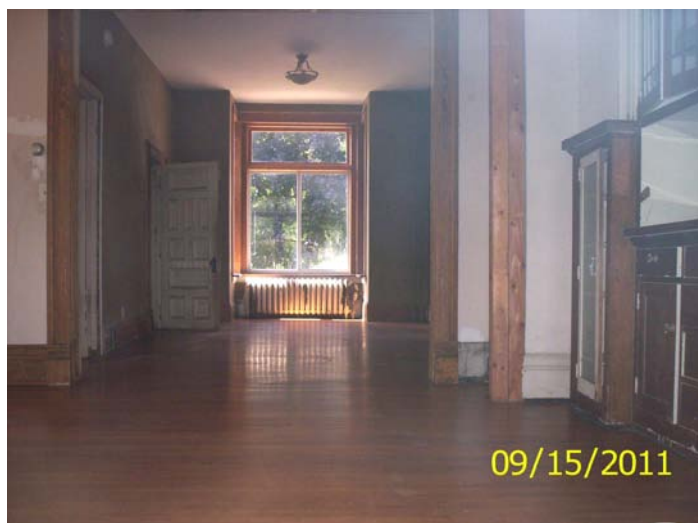
**Unfinished rehab**

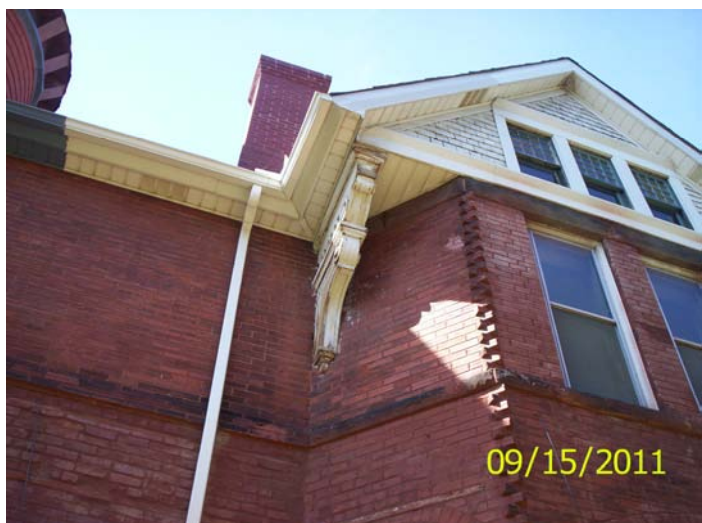
**Missing caulk, open wall**

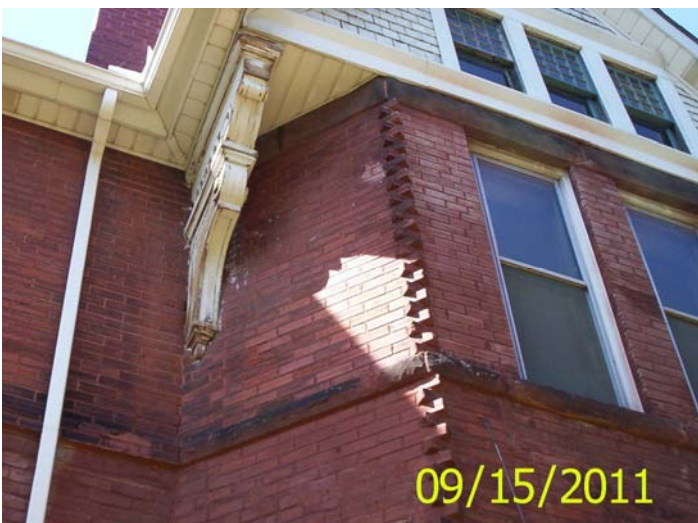
**Missing caulk, open wall**

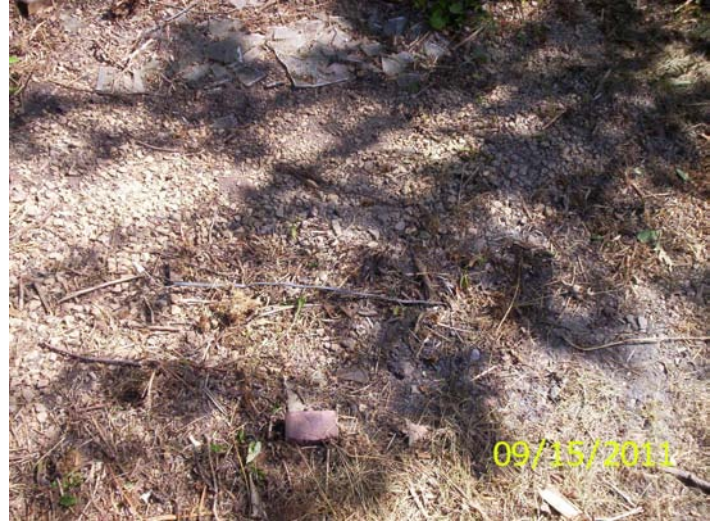
**Electrical conductors coming out of the ground**
